**City of Isle of Palms  
2018 Beach Restoration Project**

**2018  
FINAL REPORT**

[CSE-2453FR]

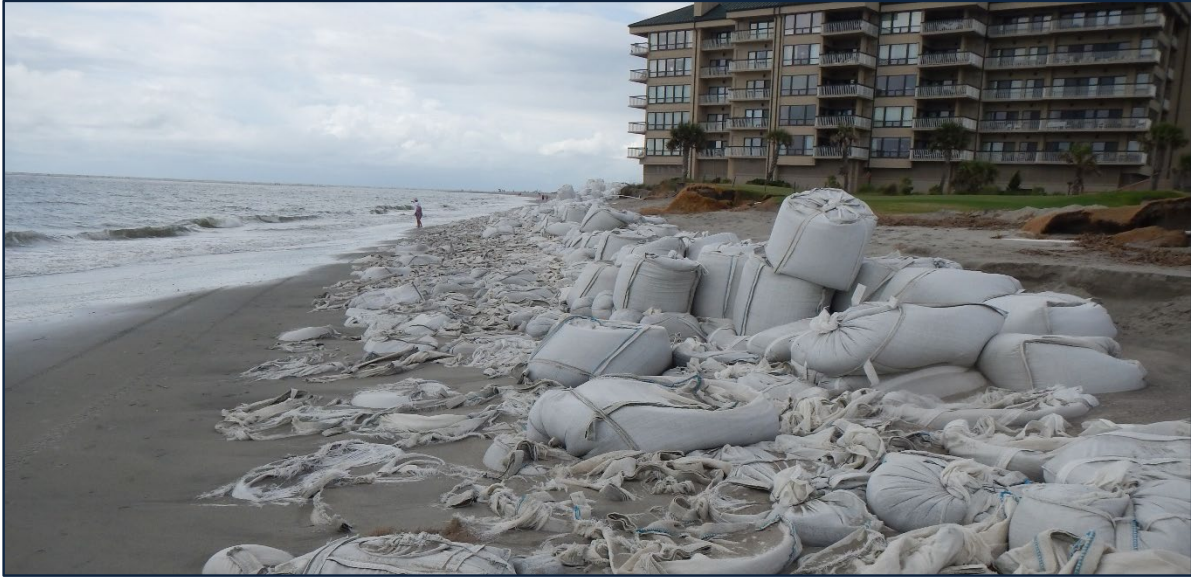
**FIGURE 2.5.** To prevent additional erosion, sandbags were installed along several structures from Shipwatch to Ocean Club from 2004 to 2007.

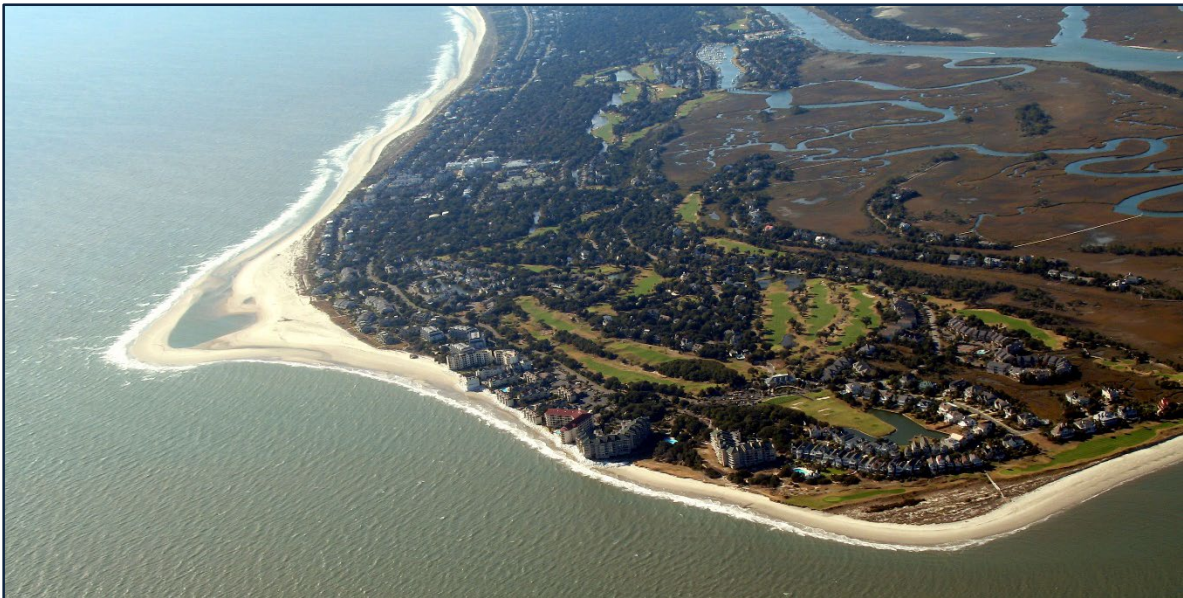
Erosion reached such a severe condition in 2007 that there was little to no beach along portions of the east end of the island, even at low tide (Figure 2.6). The Wild Dunes Community Association contracted with CSE to evaluate the causes of erosion and prepare a feasibility study outlining alternatives for restoration (CSE 2007). CSE recommended nourishing the beach using sand from an offshore borrow area and began the steps to obtain a permit for the work. The City of Isle of Palms then took ownership of the project and served as the applicant for the permits. Permits were obtained (P/N 2007-02631-2IG), and the City contracted with Weeks Marine for a project including nourishment of 847,000 cy of sand over 10,200 lf (linear feet) of beach. The project extended from 200 ft north of 53rd Avenue to the 17th green of the Links Course.

**FIGURE 2.6.** Isle of Palms in 2007 prior to beach nourishment.

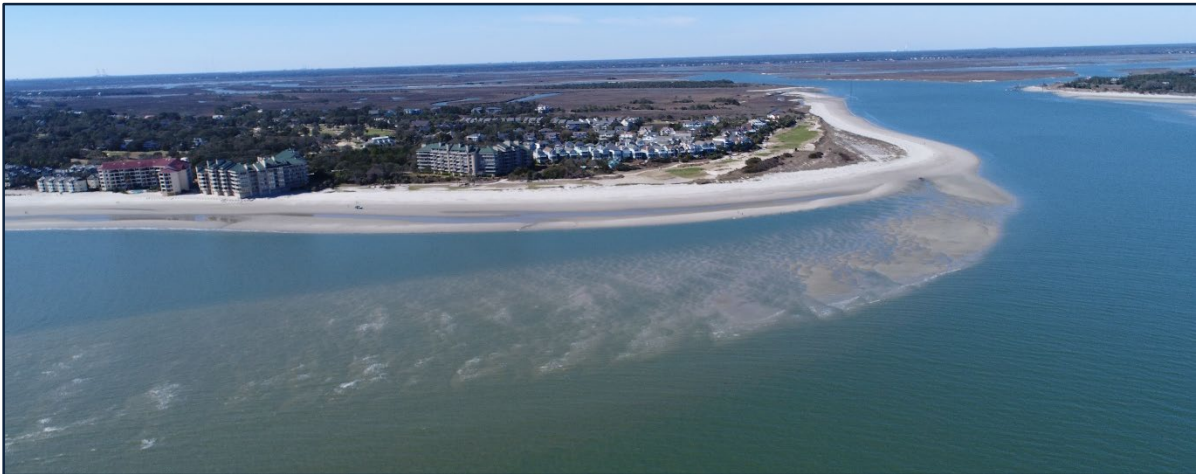
**FIGURE 2.14.** Trailing-ebb-spit extending from the northeast end of the island on the landward side of the Dewees Inlet channel. Rapid erosion along the eastern end of Reach 6 likely contributed to this event.

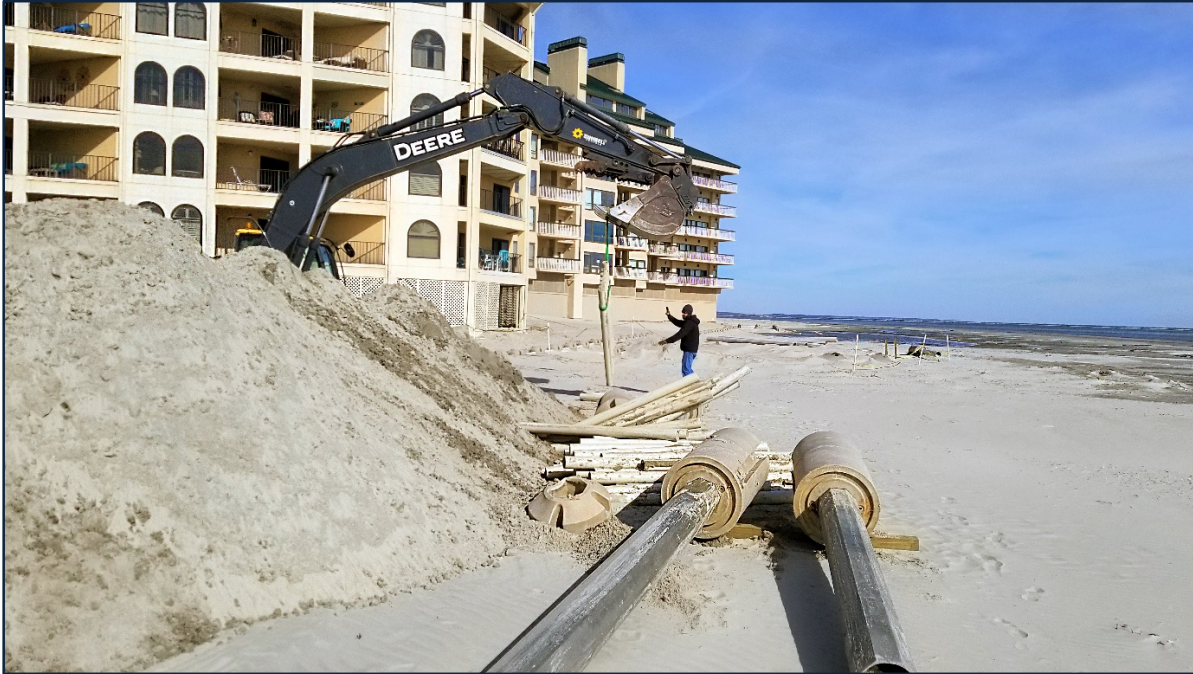
**PHOTO 3.** Removal of Wave Dissipation System in front of the Ocean Club Villas on 2 January 2019 prior to pumping.

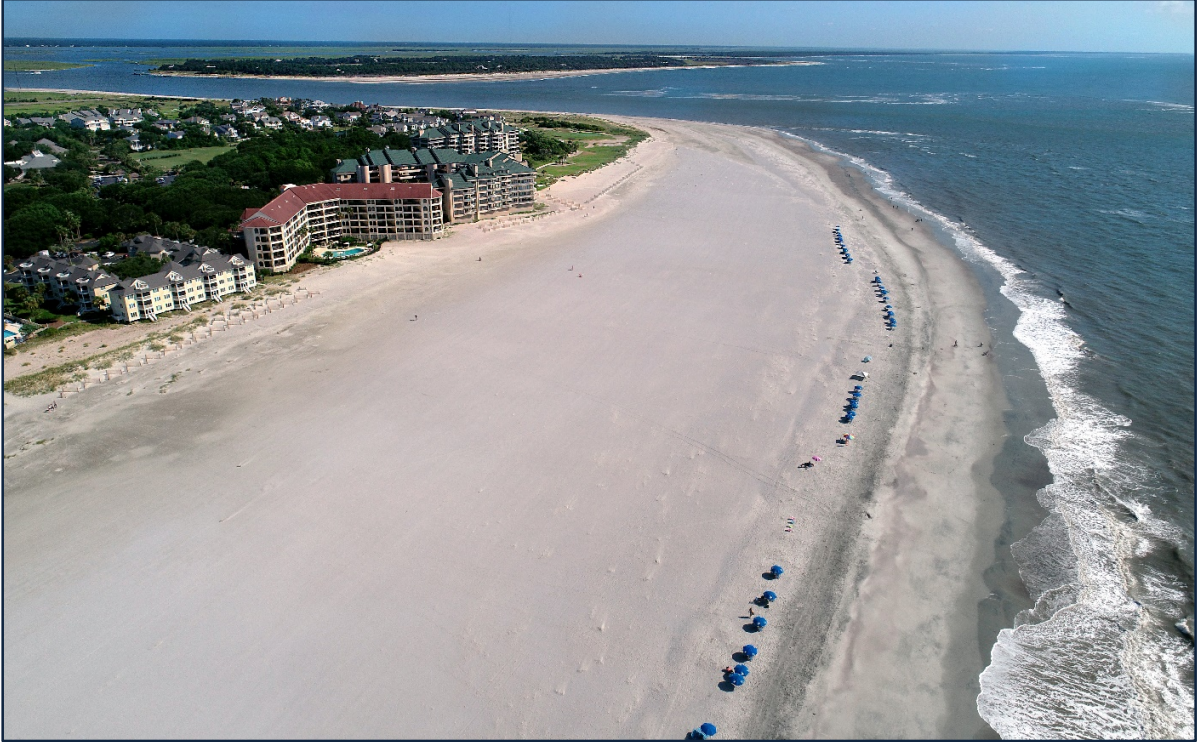
**PHOTO 13.** Condition of beach in front of Port O' Call, Seascape, and Ocean Club Villas almost 5 months after the project on 17 August 2018.

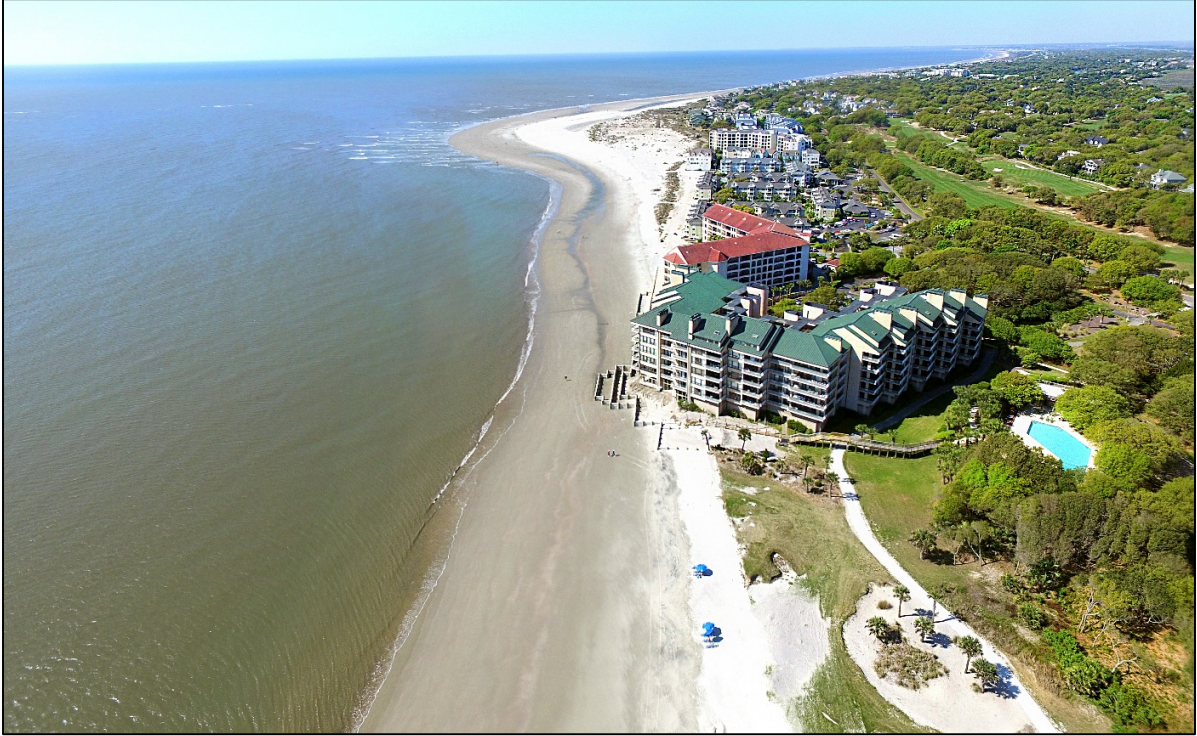
**PHOTO 15.** Pre-project aerial view from the north end of the island with the Ocean Club Villas and Wave Dissipation System in the forefront.

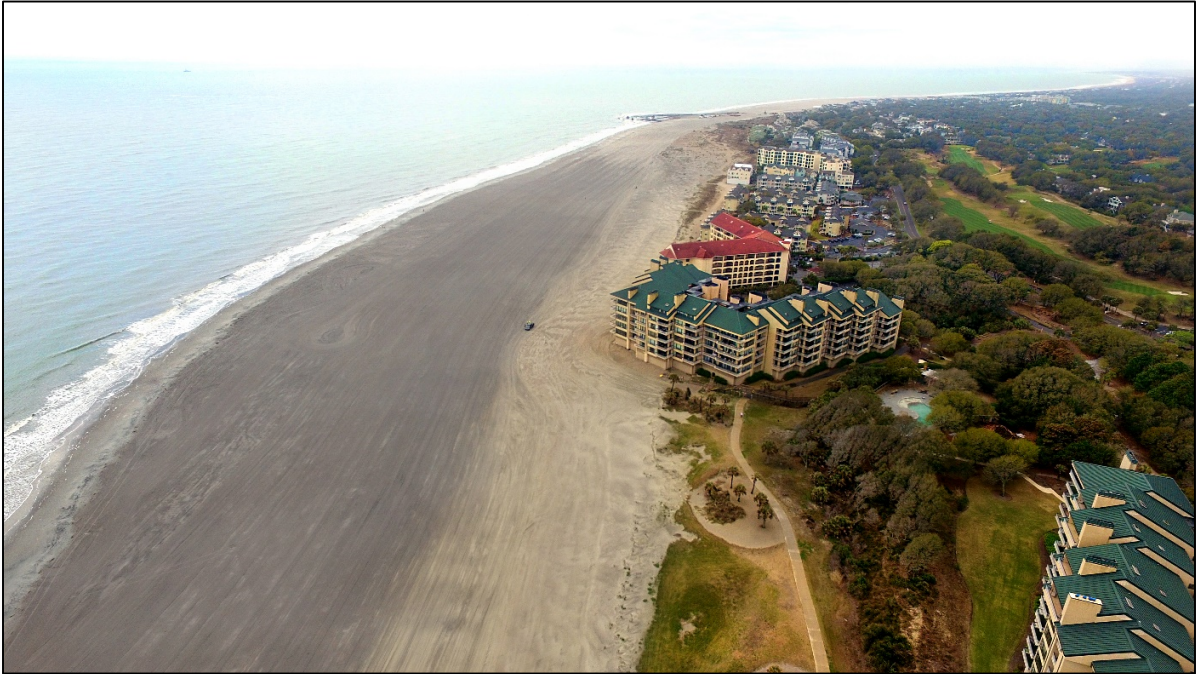
**PHOTO 16.** Aerial view of the north end just before project completion.

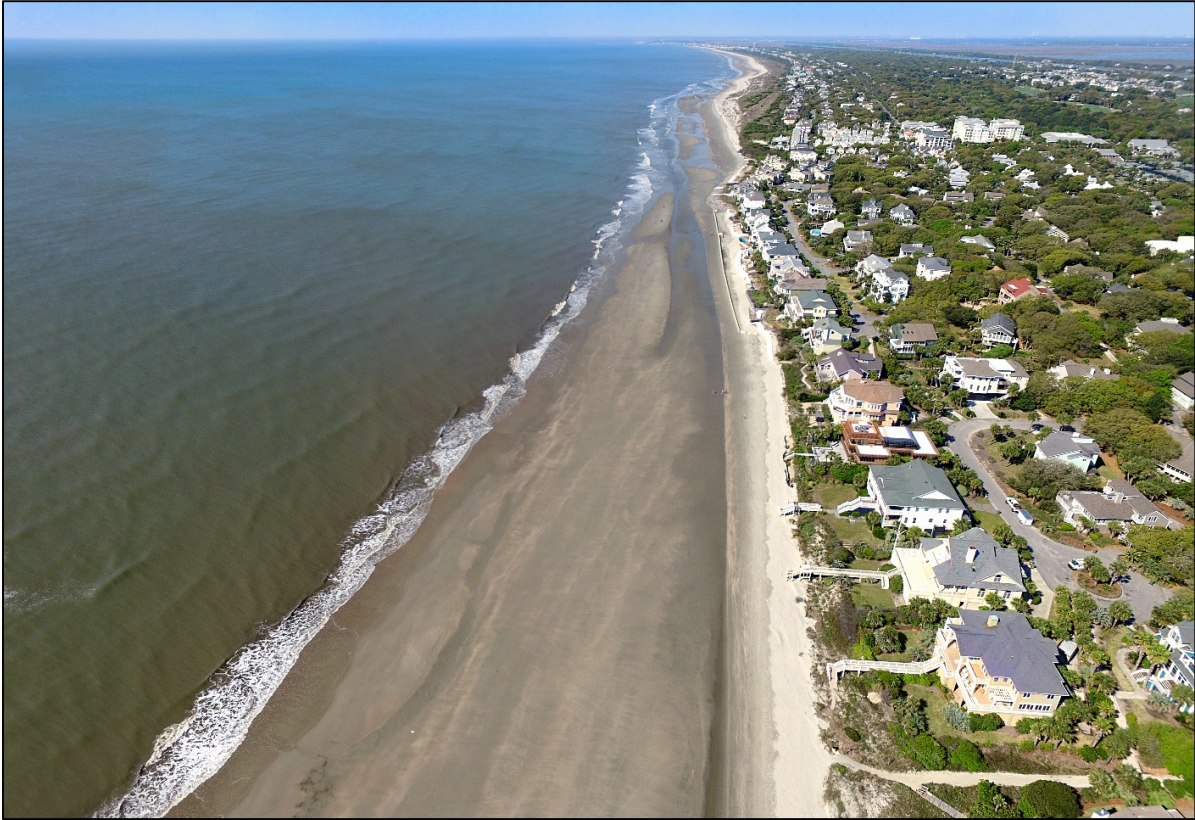
**PHOTO 17.** Pre project look at Reach 1 (Stations 236+00 through 280+00) with Wave Dissipation System in front of houses at Beachwood East.

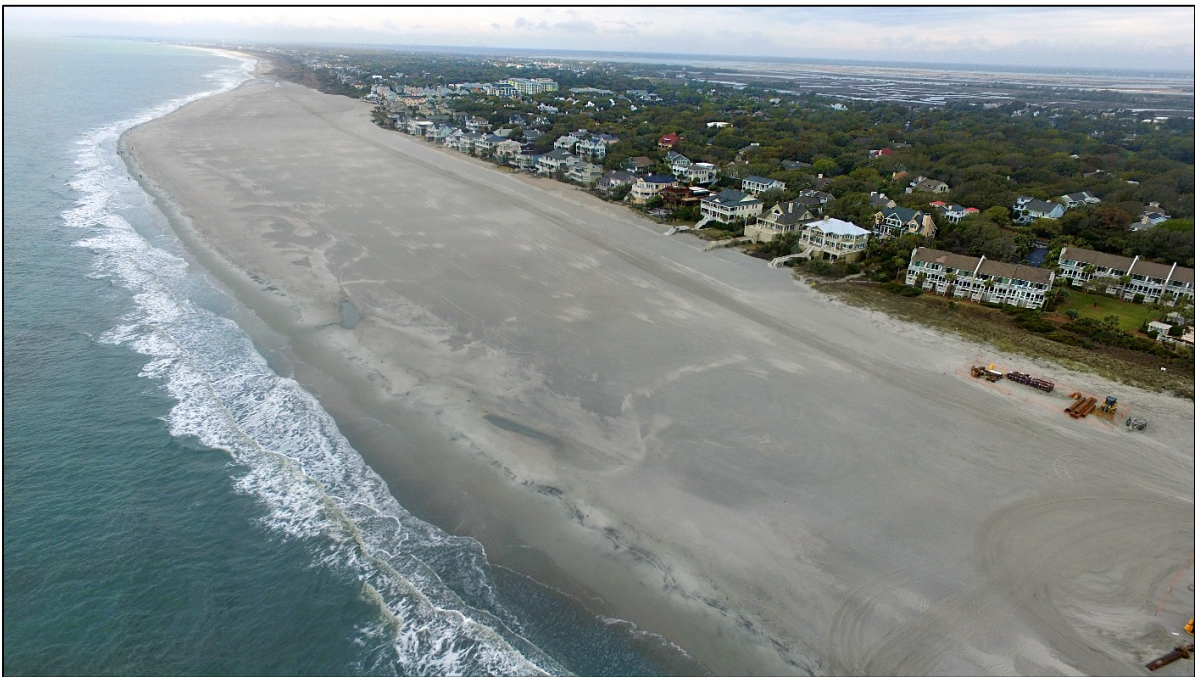
**PHOTO 18.** Reach 1 (Stations 236+00 through 280+00) on 19 March 2018, 4 days before project completion.

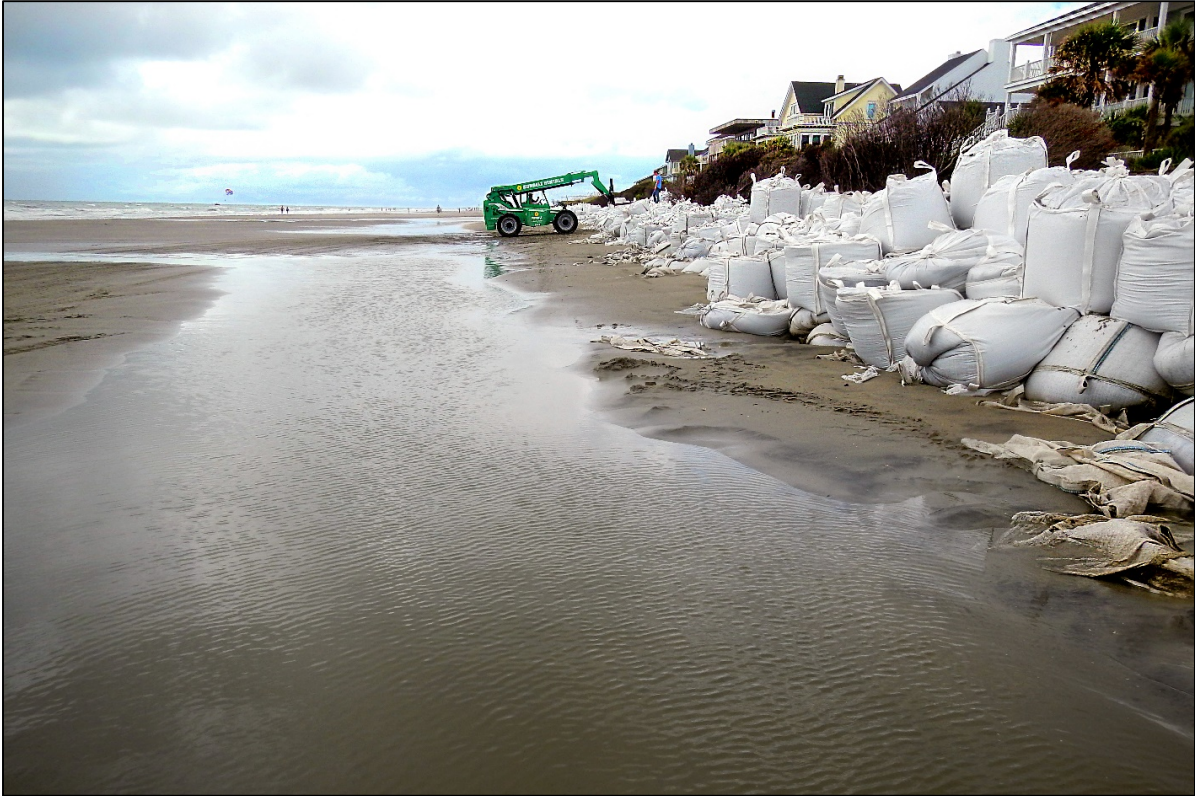
**PHOTO 19.** Looking south at Beachwood East back in 2014 during sandbag installation.

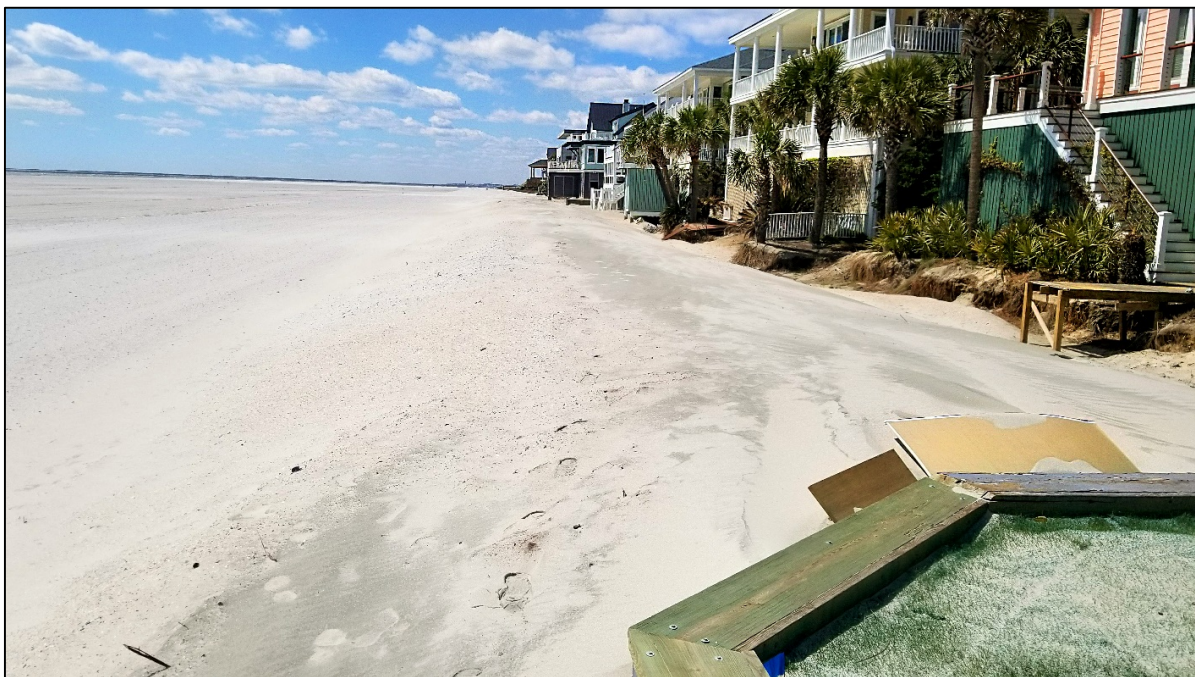
**PHOTO 20.** Beachwood East in March 2018 after construction.

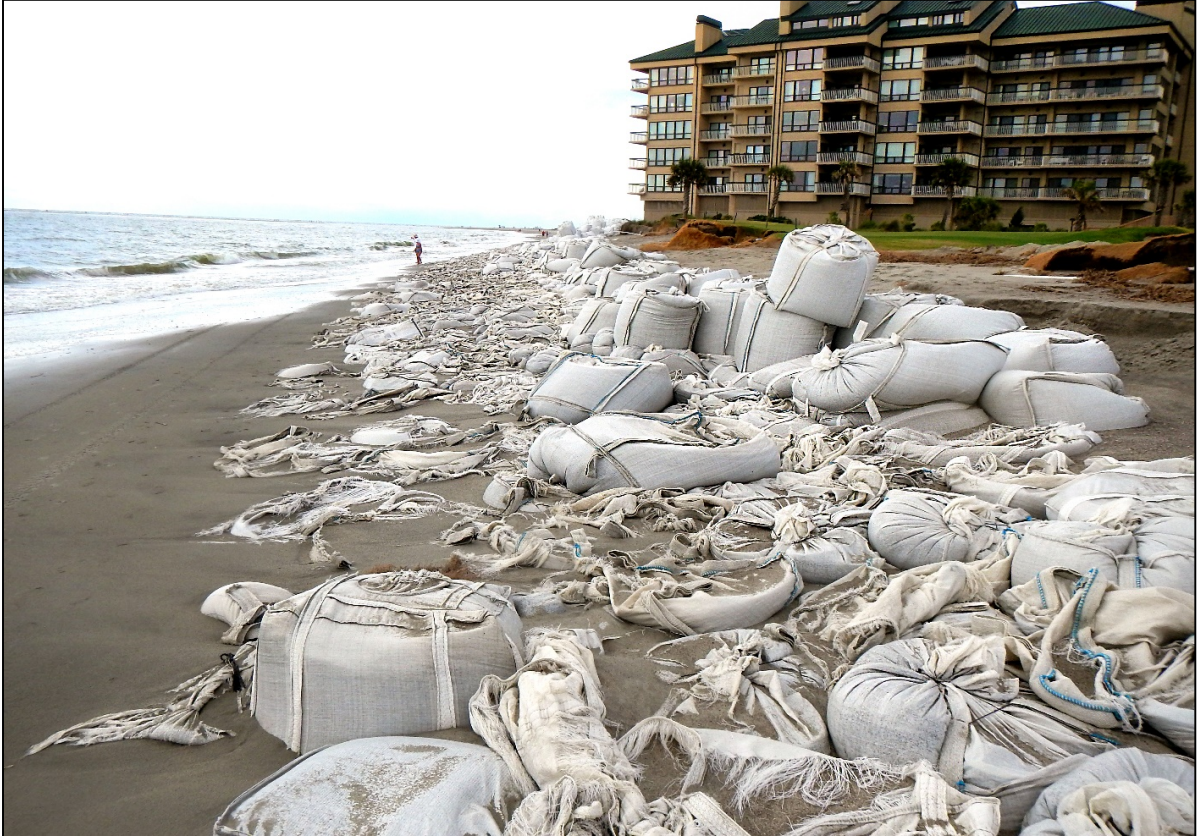
**PHOTO 21.** Looking south at the Ocean Club Villas in September 2014 during sandbag installation.

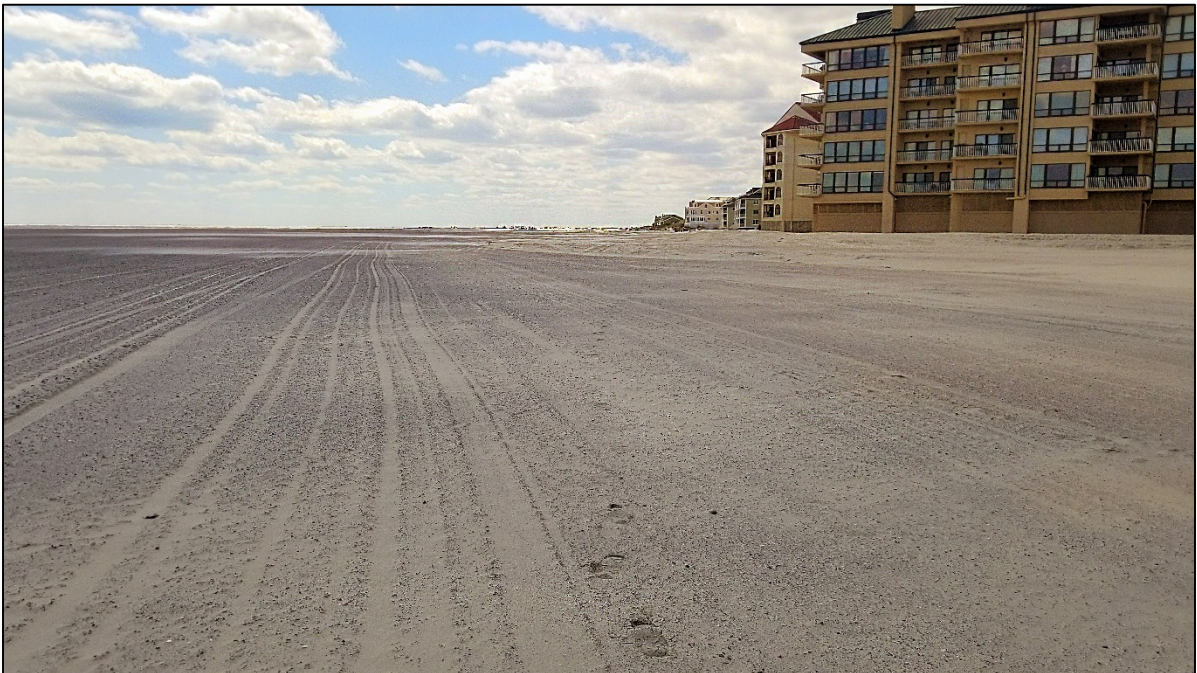
**PHOTO 22.** Beachfront at Ocean Club Villas in March 2018 after construction.
