**2018 Isle of Palms Restoration Project
Year 1 Monitoring Report**

2019
MONITORING REPORT

Year 1 (2019) Monitoring Report Annual Beach and Inshore Surveys

[2492YR1 — Monitoring Year 1]

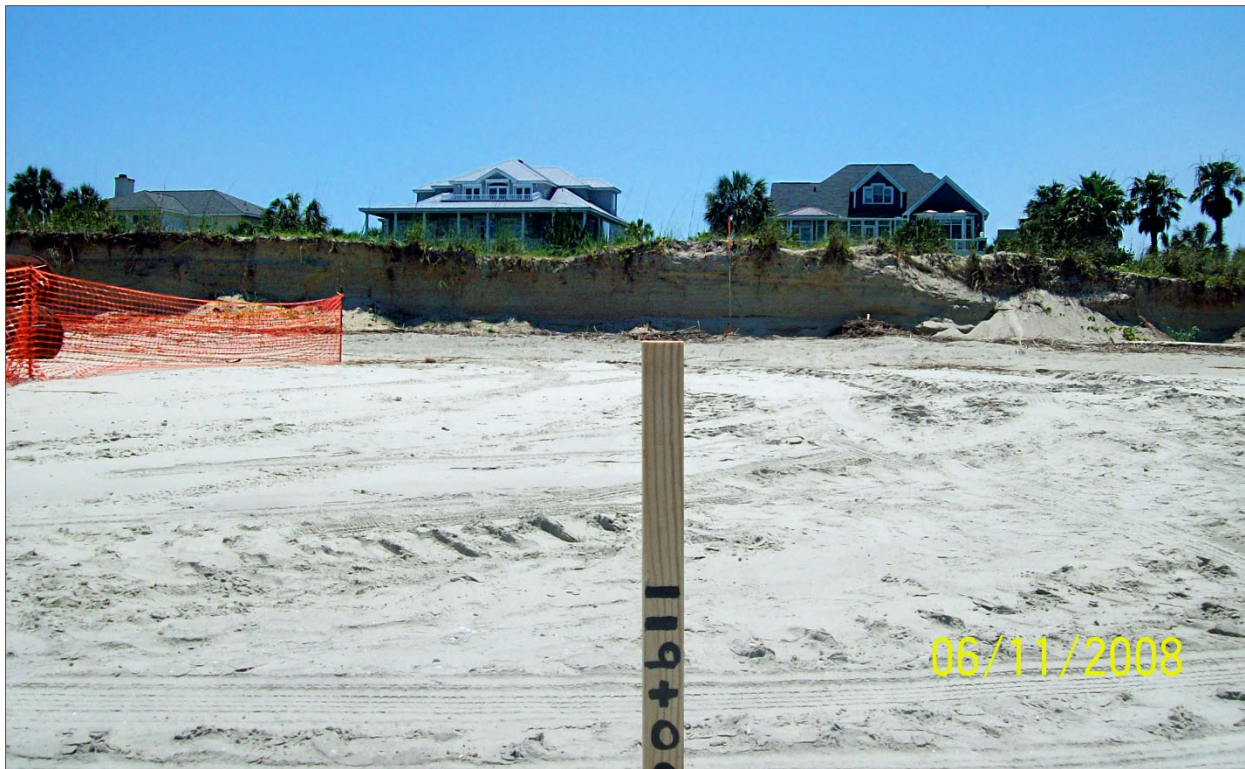
FIGURE 4.5. In 2008, a significant erosional escarpment was documented along most of Reach 7 seaward of the 17th tee box of the Links Course.

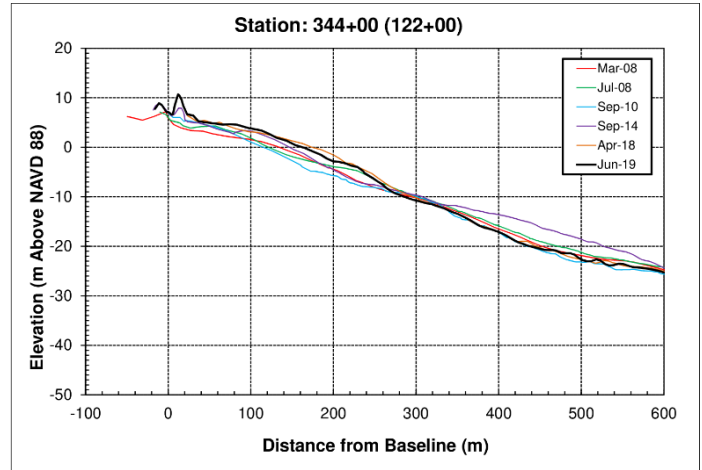
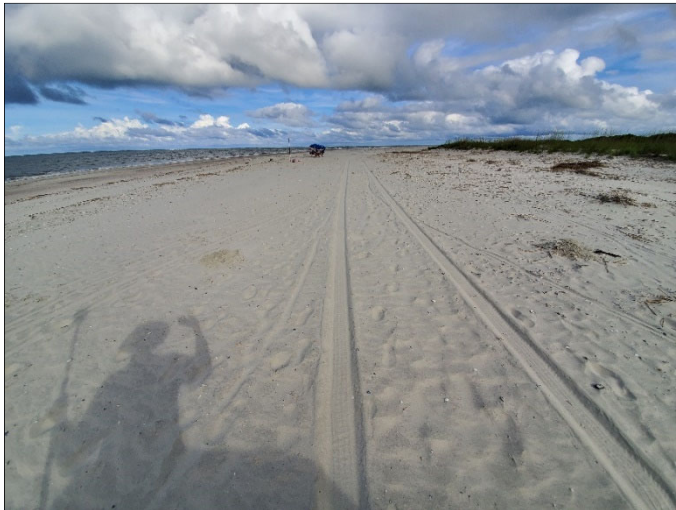
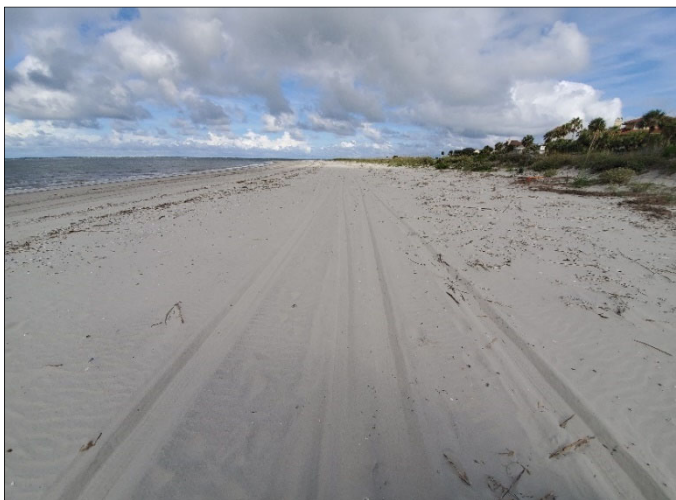
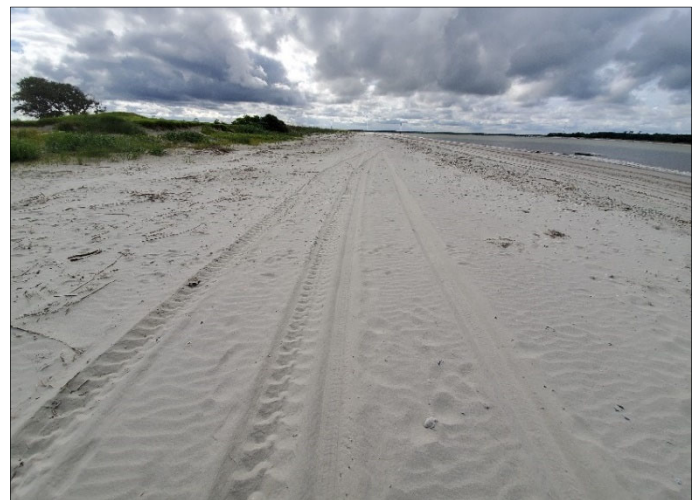
FIGURE 4.7. Beach profiles and ground photos from Reach 7. Photos are from stations 334 (left) looking seaward, 346 looking seaward (bottom left), and 346 looking landward (bottom right).

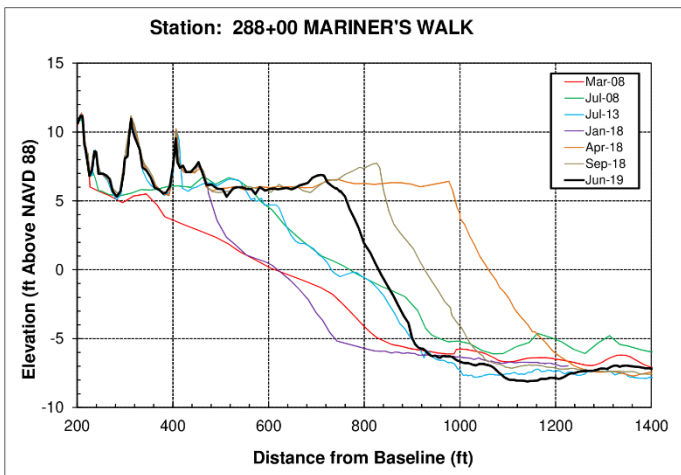
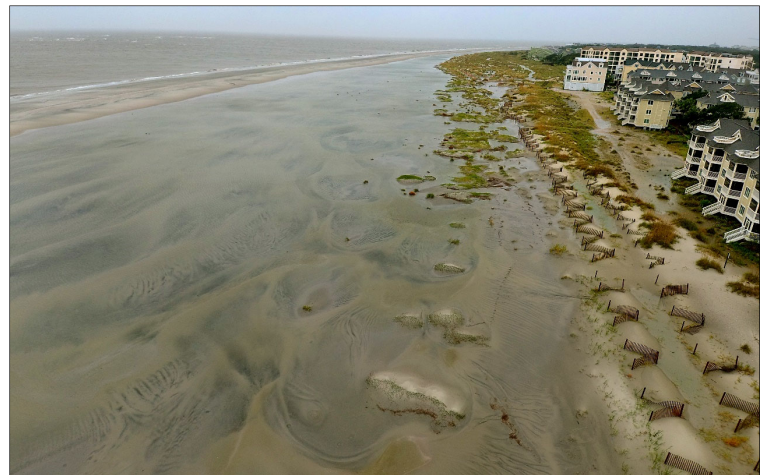
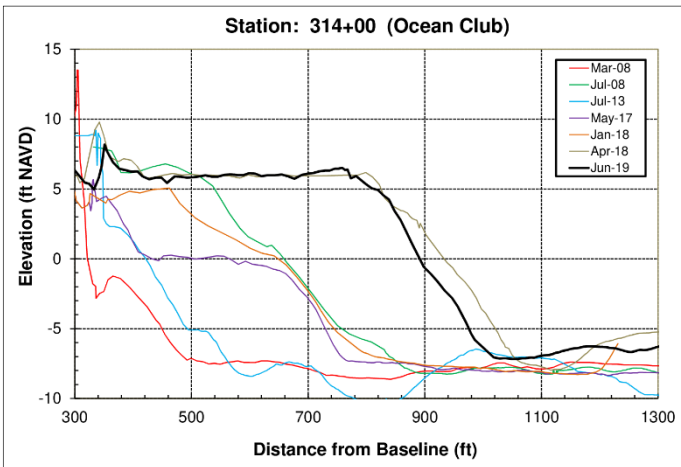
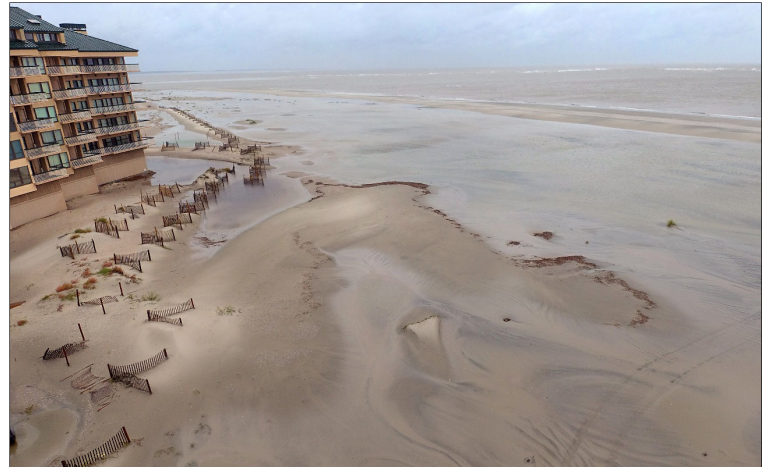
All stations east of line 296 (Shipwatch) show a greater sand volume in June 2019 than at any other time since monitoring began in 2007. Overall, the reach holds 1,112,800 cy more sand than the 2007 condition. Nourishment projects in 2008 and 2018 have resulted in an average annual accretion rate of 19.0 cy/ft per year along Reach 6. While the volume totals are very positive, the reach is subject to localized areas of very dynamic volume changes and needs to be monitored closely.

FIGURE 4.10. Reach 6 profiles. The rapid erosion in this area is suspected to be a continuation of the higher erosion trend observed prior to the 2018 project.

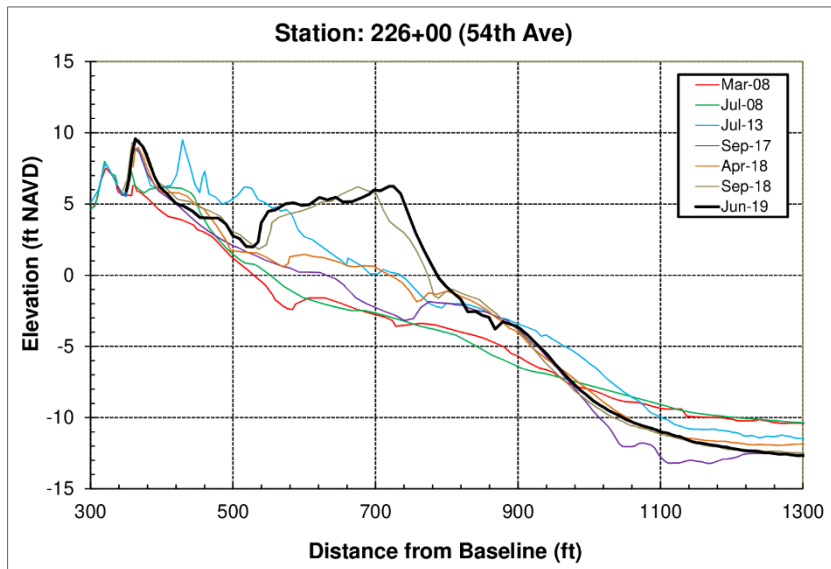
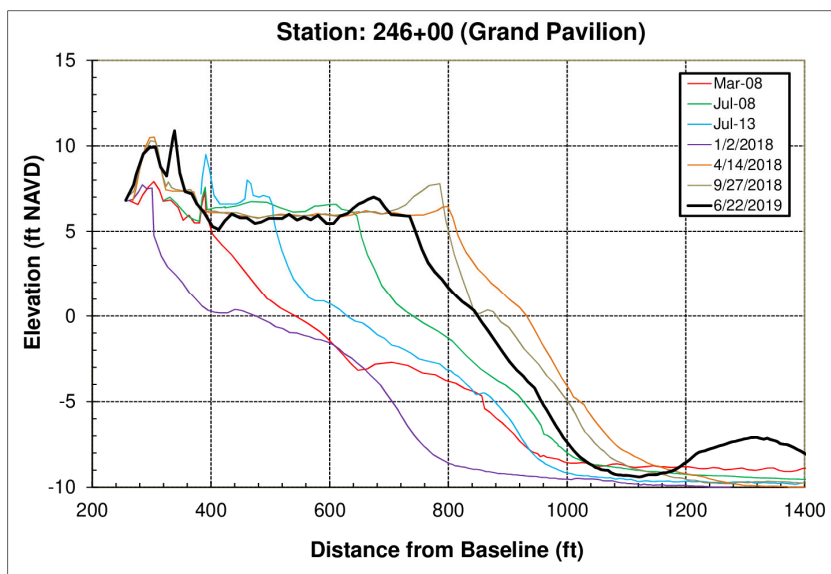
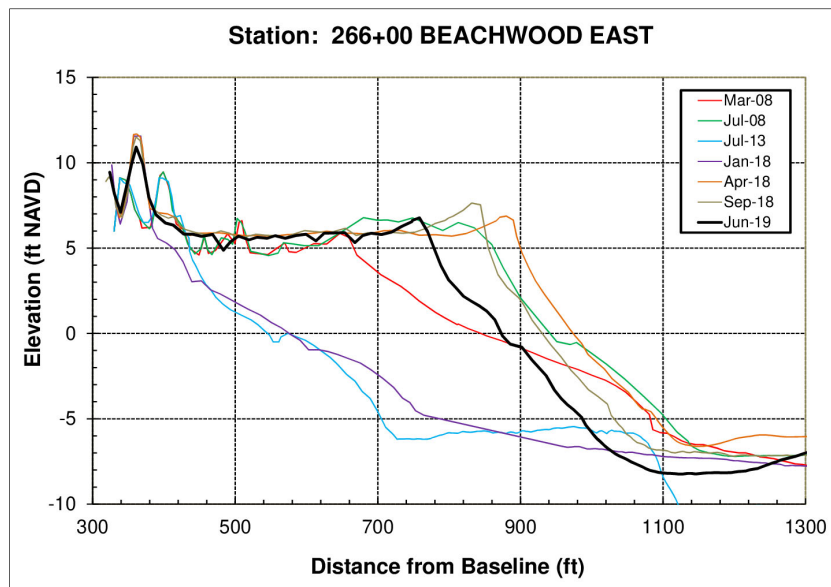
CSE expects the rapid changes observed since the 2018 project to reduce in scale over the next few years as the initial adjustment phase of the nourishment fill tapers off. Profiles show that much of the volume change measured since the post-project survey (April 2018) occurred by September 2018. The September 2018 survey was obtained by CSE as part of a research partnership with DELFT University (Netherlands) for five graduate students studying coastal engineering. Shoreline change was much less severe between September 2018 and June 2019.

FIGURE 4.15. Reach 5 profiles. The data shown indicates that the berm fronting Grand Pavilion and Beachwood East remains ~400 ft wider than pre-project condition.

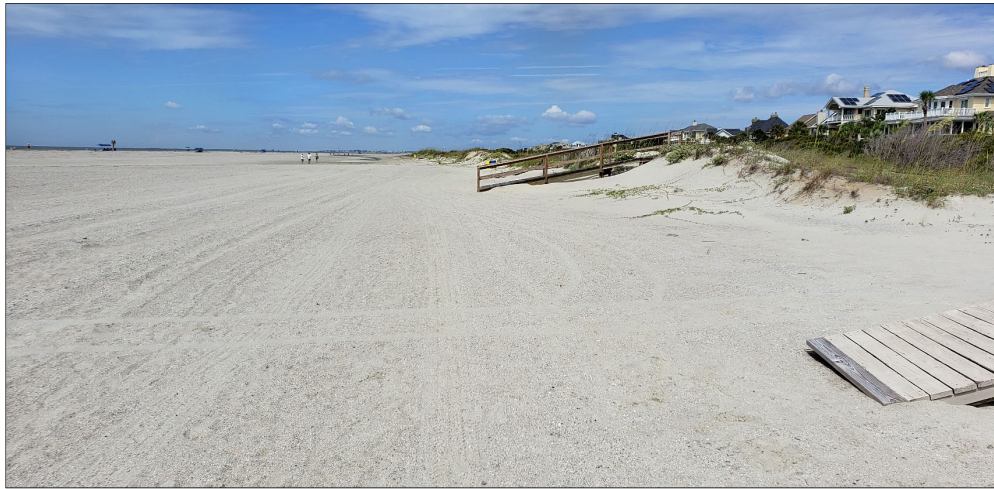
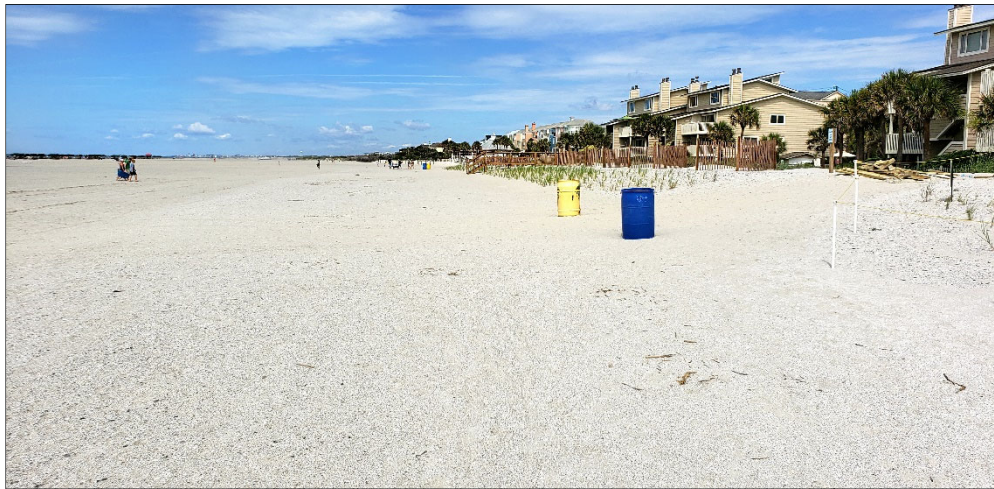
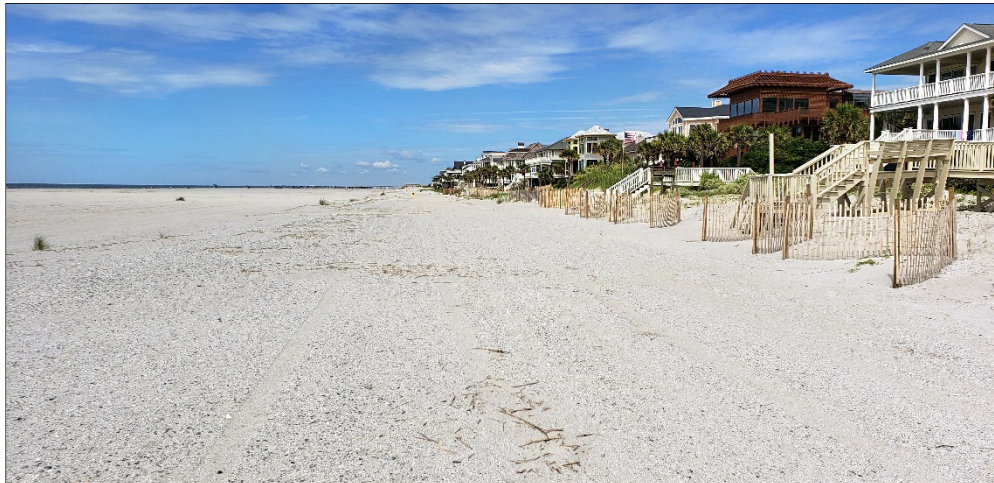
FIGURE 4.16. Ground photos of Reach 6. There remains a low swale on the landward side of the berm, seaward of the pre-project dune line.

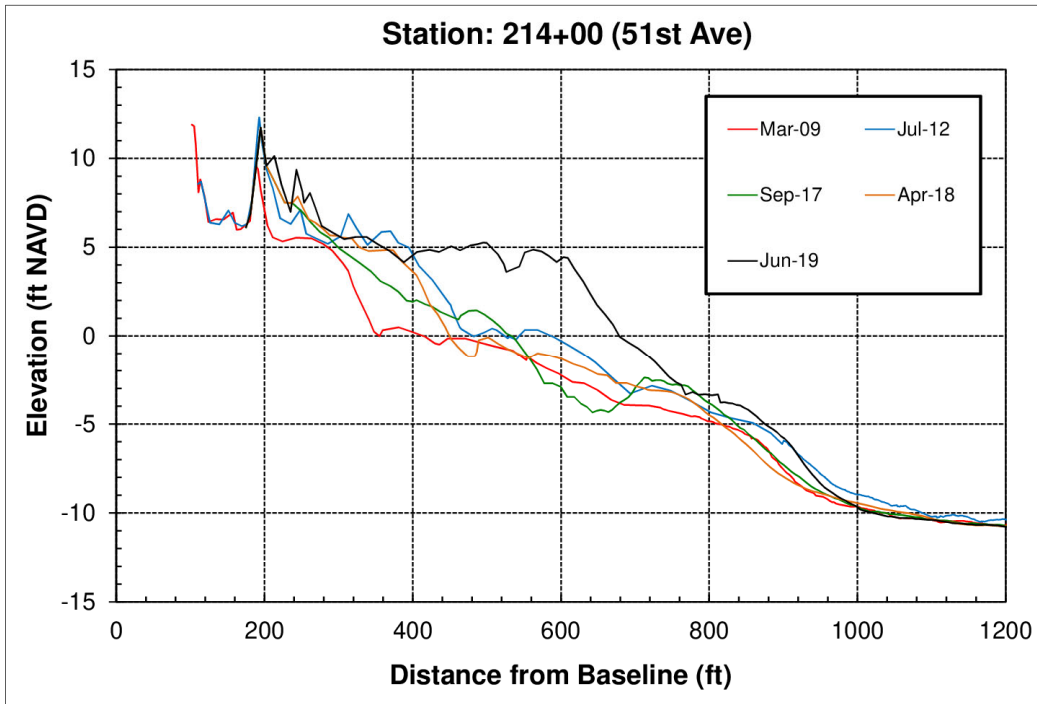
FIGURE 4.20. Profiles along the northern 2,000 lf of beach gained up to 66 cy/ft of sand. This accretion resulted in a large ridge and runnel system along the wet sand beach and a shift of the dry sand berm over 200 ft seaward.

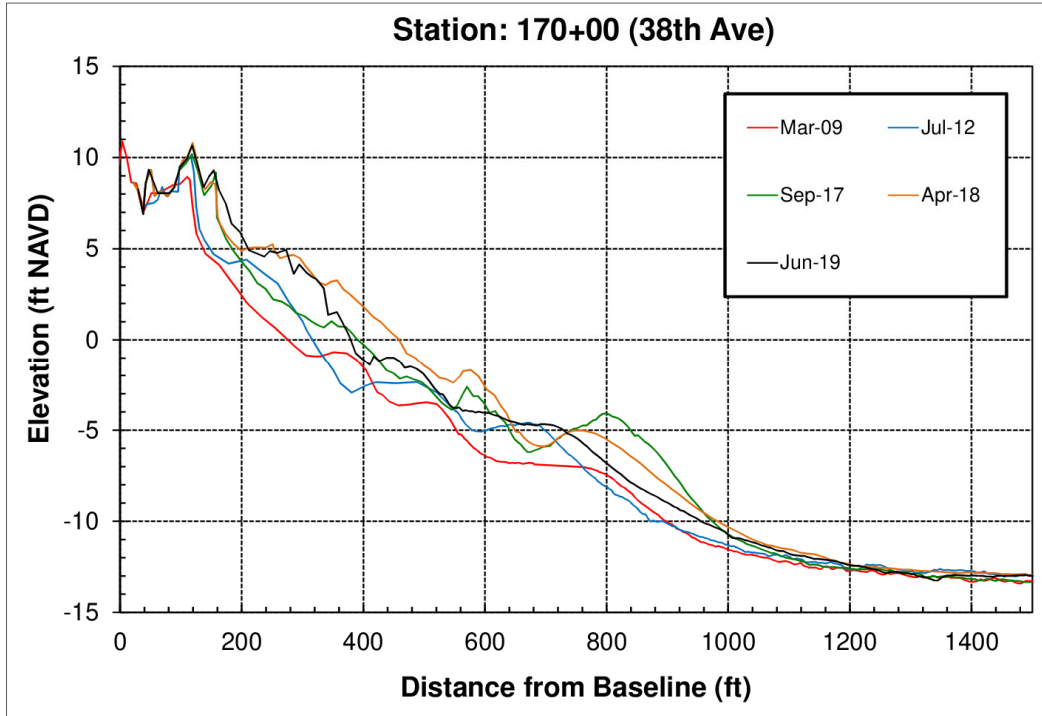
FIGURE 4.21. Stations 160–170 (35th–38th Ave) eroded over 20 cy/ft in 2019. The erosion was limited to the wet sand beach and was likely the result of an ephemeral intertidal bar welding and spreading downcoast.

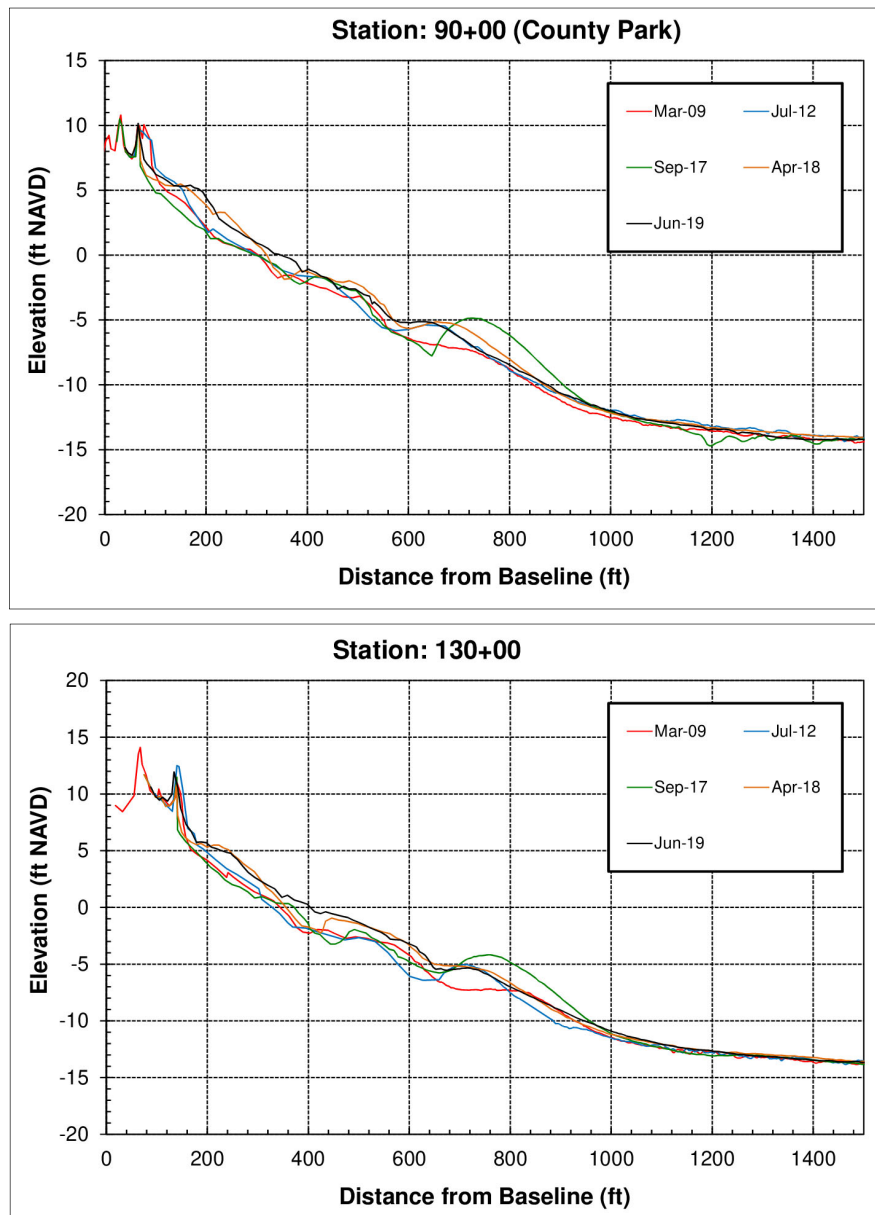
FIGURE 4.24. According to these profile plots the base of the dune has increased in width over the past year along most of the reach; however, it is still eroded compared to the pre-*Matthew* condition along the western end of the reach.

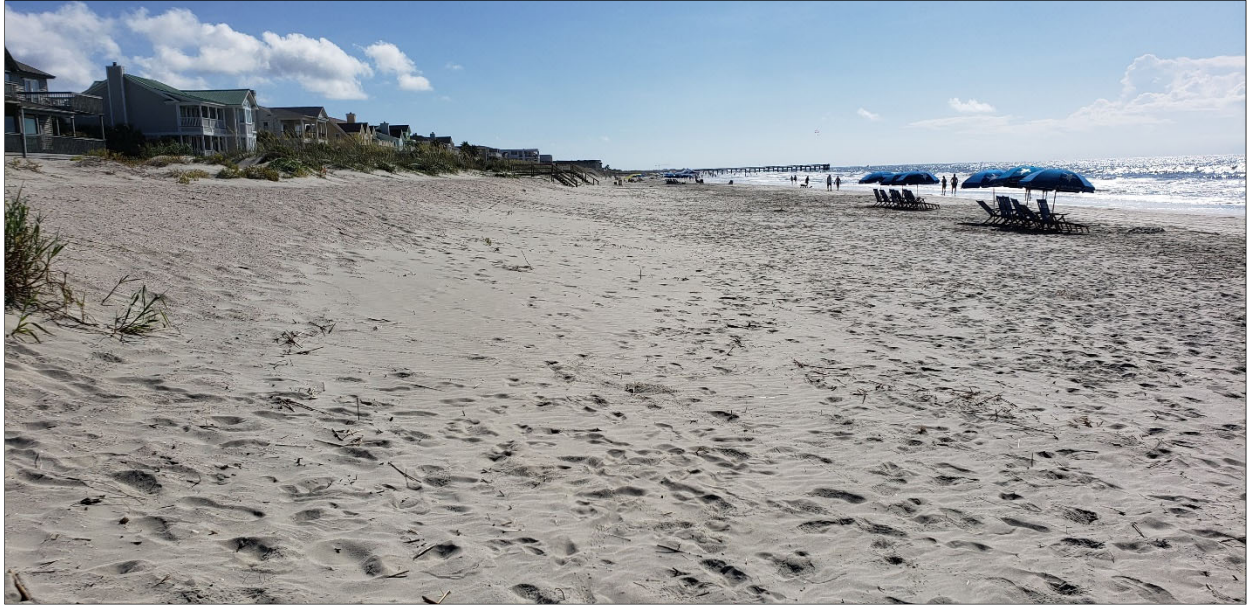
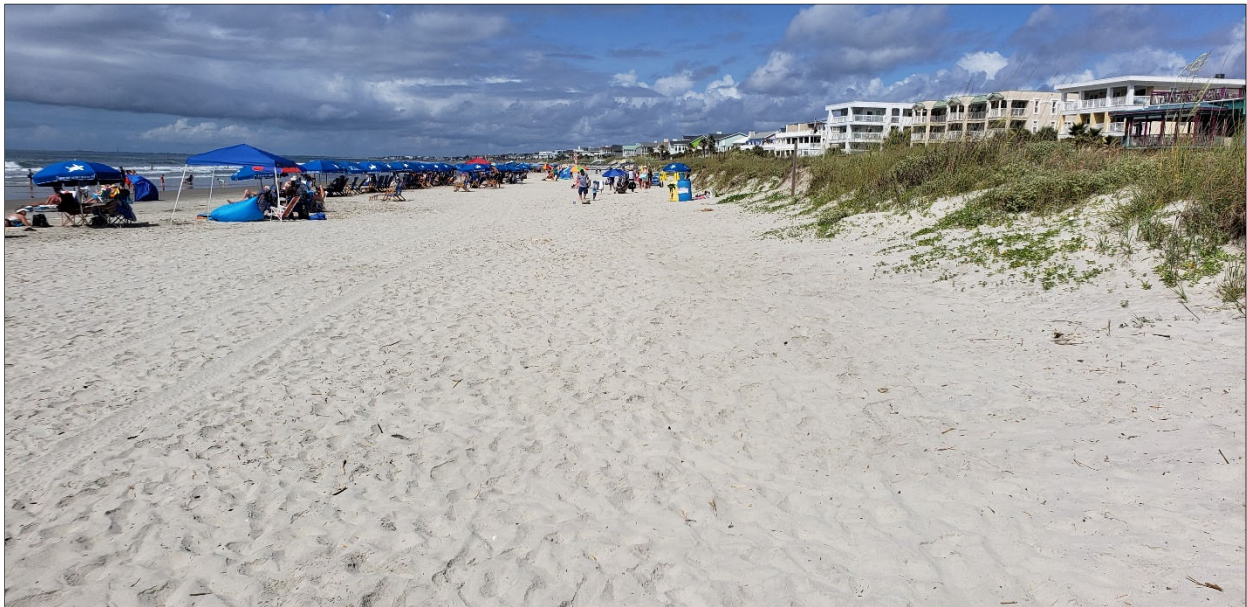
Over the past year, the reach lost 16,000 cy (3.2 cy/ft) of sand. Every station in the reach eroded, ranging from losses of -0.2 cy/ft to -7.4 cy/ft. There was minor dune erosion along most of the reach over the past year; however, the dune remains healthier than the 2017 condition. Compared to the 2009 condition, the eastern half of the reach has accreted while the western half has eroded. Photos show the healthier condition of the eastern end of the reach (south of the pier) compared to the western end (Fig 4.27). One positive finding of the 2019 survey is that the dune constructed following Hurricane *Irma* remains mostly in place, and is beginning to show natural vegetative growth along the crest and slope of the dune. This dune was scraped from the intertidal beach following the storm to accelerate the natural beach recovery cycle.

FIGURE 4.27. Compared to the 2009 condition, the eastern half of the reach has accreted while the western half has eroded. **[UPPER]** The healthier condition of the eastern end of the reach (south of the pier). **[LOWER]** Western end which is undergoing a higher rate of erosion.

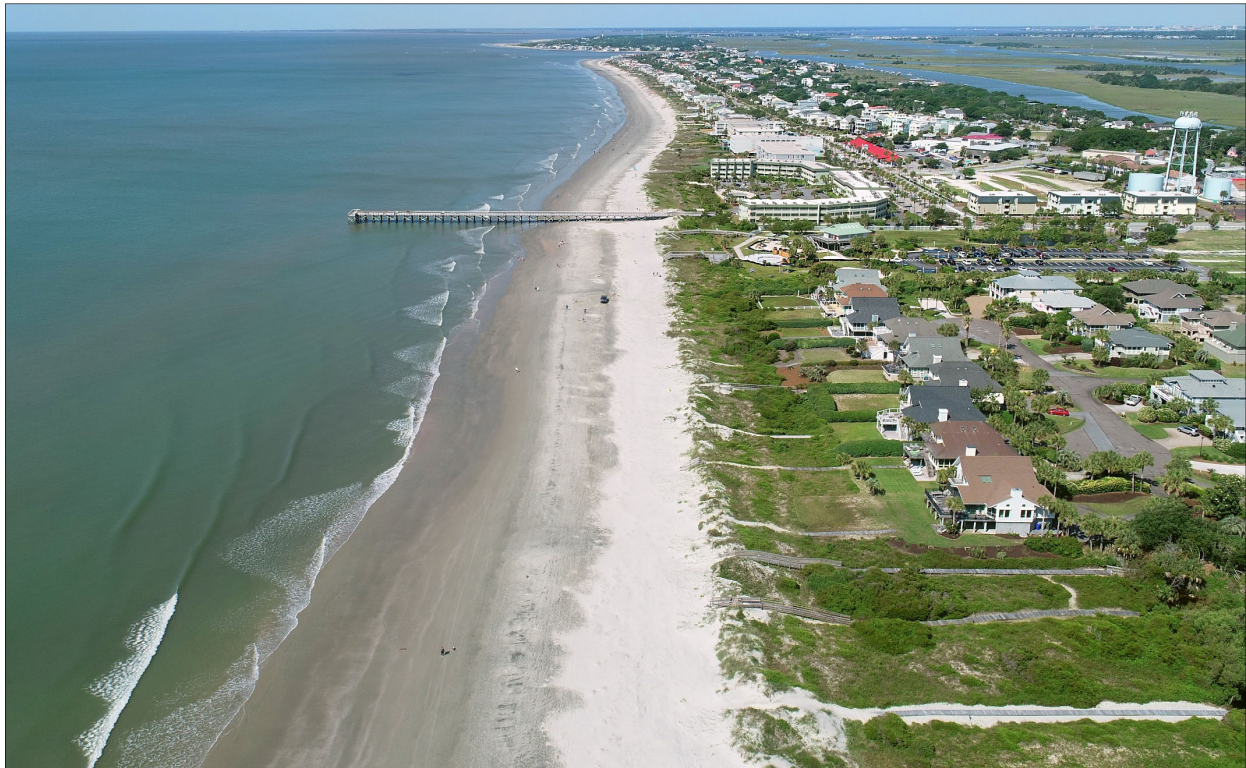
An aerial photo (Fig 4.28) of the reach shows a crescent-shaped beach extending south of the pier, with a pronounced landward offset of the shoreline south of the pier. It is unclear whether the crescent shoreline is a result of sediment trapping from the pier or if it is a result of natural morphologic features associated with Breach Inlet. The shoreline morphology coupled with the lower accretion rate observed in this area should be closely monitored, as building setbacks along this area are generally lower than Reaches 3–4.

FIGURE 4.28. Aerial view of Reach 2. Since monitoring began in 2009, Reach 2 has been the most stable reach, typically showing lower magnitudes of volume change compared to the other reaches along Isle of Palms.

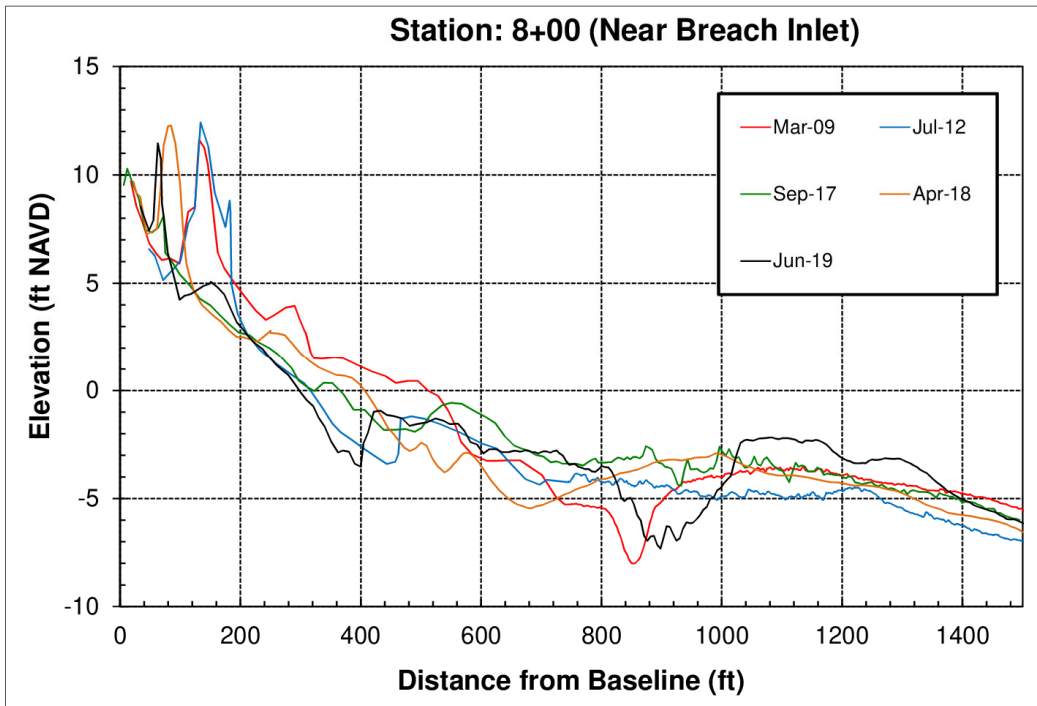
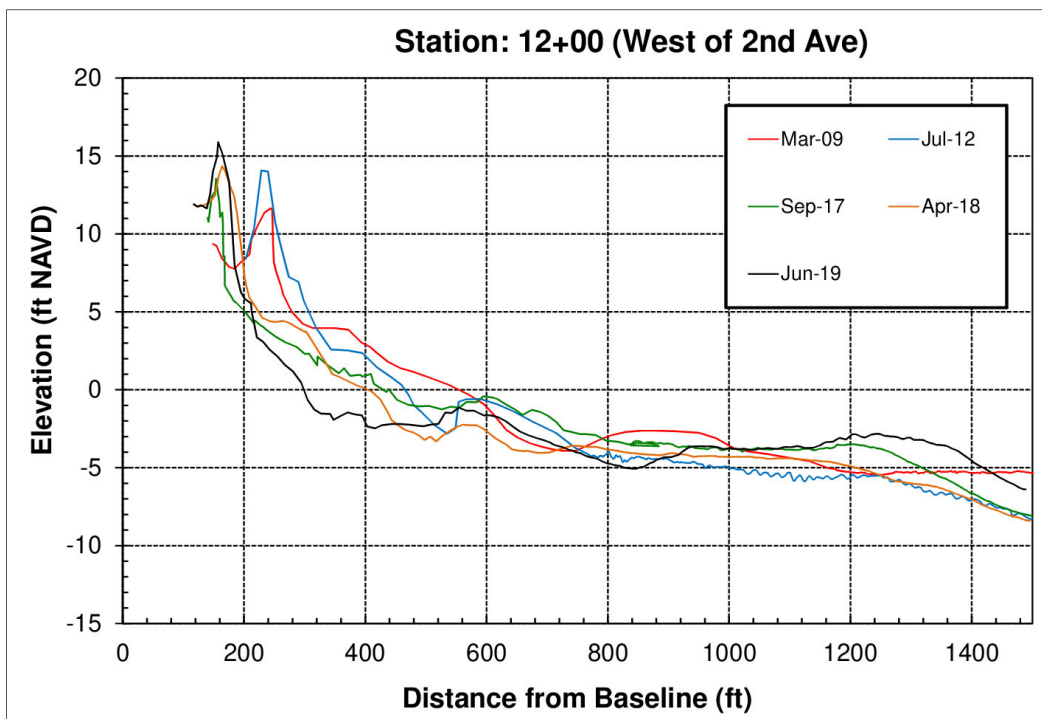
Similar to Reach 2, Reach 1 has shown variable periods of erosion and accretion, with the long term trend showing erosion since 2009. Over the past year, the majority of the profiles measured erosion, with the exception of stations 12 and 16. Erosion was most severe at stations 0–8, which are located along the western-most end of the island at Breach Inlet. Profiles from this area show additional dune erosion over the past year, adding to losses observed since 2012. Further east within the reach, there was also dune erosion; however, to a lesser extent than further east. Overall, the reach lost ~32,000 cy (7.3 cy/ft) of sand from 2018 to 2019. Since 2009, the reach has lost approximately 180,000 cy of sand. While the erosion value is higher than historical trends, the majority of volume loss has been restricted to the portion of the profile below the high tide line (Figure 4.30), meaning that the dunes have been more stable than the erosion rate would suggest. Changes in the lower portion of the profile are likely related to morphological changes in the Breach Inlet delta and are less likely a result of lower sediment inputs from upcoast.

FIGURE 4.30. Profile plots for Reach 1 indicate that while the erosion value is higher than historical trends, the majority of volume loss has been restricted to the portion of the profile below the high tide line. This means that the dunes have been more stable than the erosion rate would suggest.

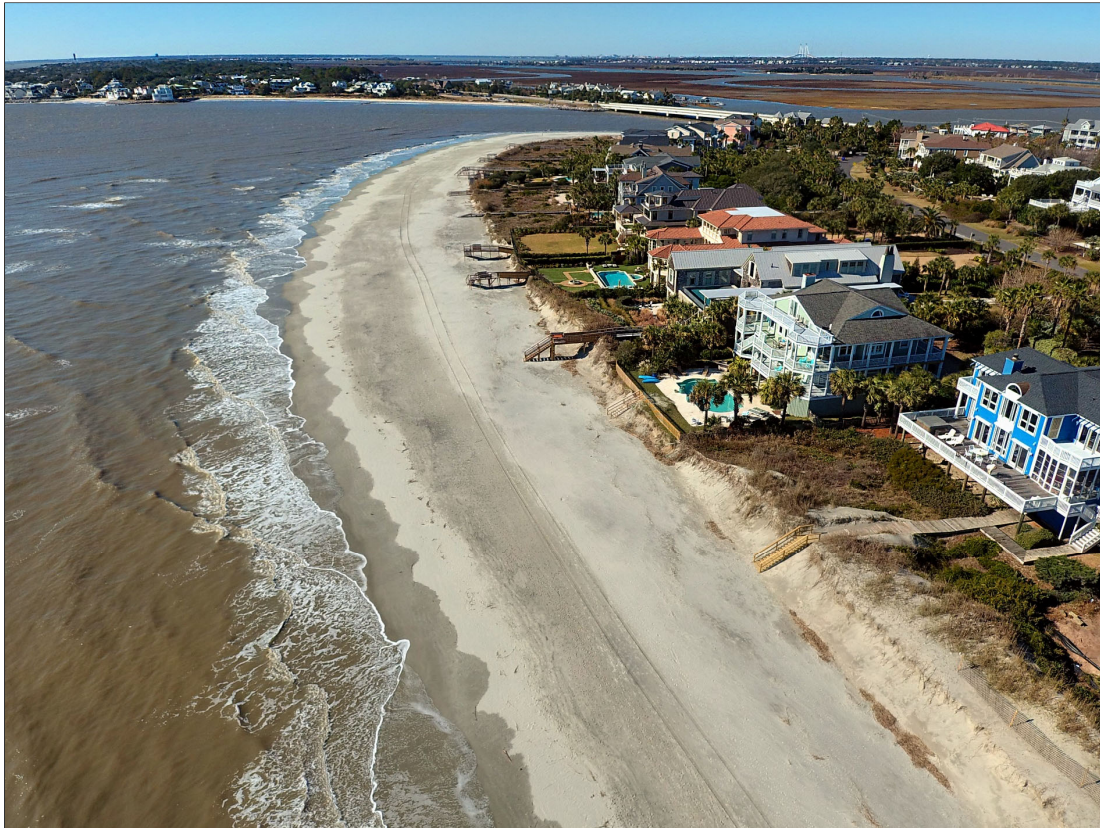
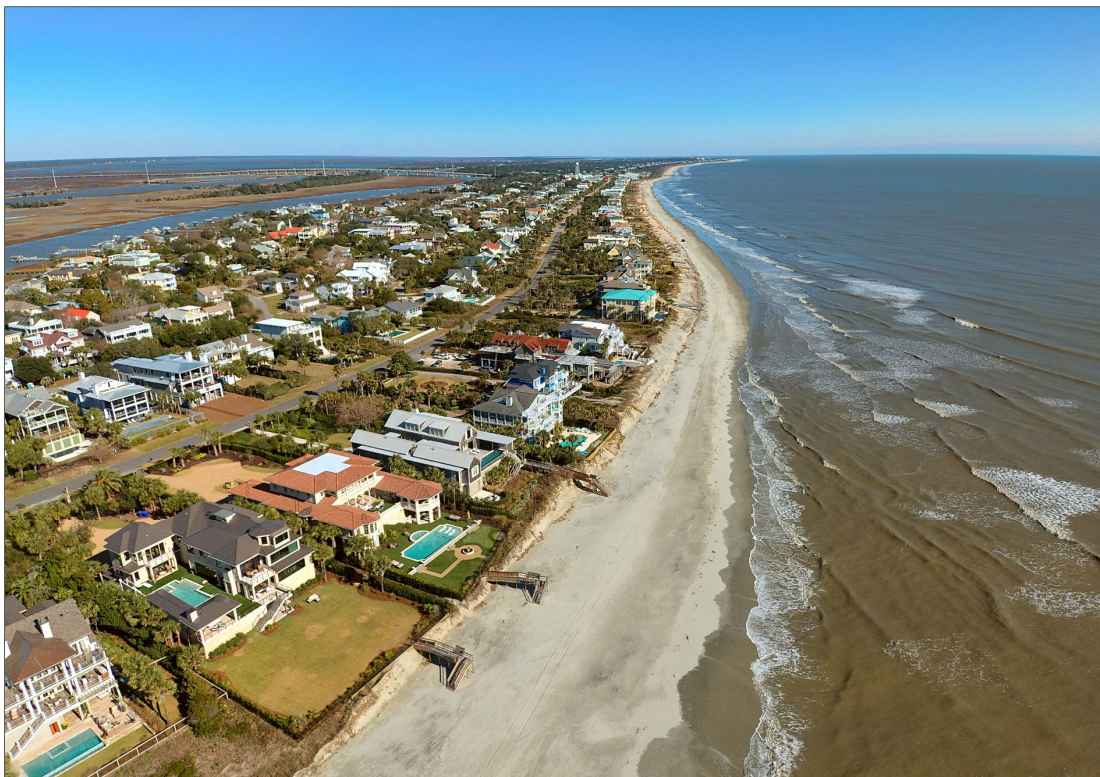
Figure 4.31 shows that in December 2019, most of the dune constructed following Hurricane *Irma* remained in place north of 2nd Ave, but was mostly eroded west of Station 20+00. West of Station 20+00, there are a few properties where erosion threatened to encroach onto landscaped lawns or swimming pools. The houses are still set back from the waterline providing some protection from storm events; however, no additional significant flood protection exists due to the lack of elevated dunes. CSE observed some recovery of the area in 2020 and noted growth of the dunes and a new dry sand beach in place. The Breach Inlet reach has been dynamic since 2009 and needs to be closely monitored moving forward. CSE recommends the City pursue discussions with the US Army Corps of Engineers (USACE) to attempt to place material along this area as a beneficial use of dredged material when the Intracoastal Waterway is dredged in the future.

FIGURE 4.31. Aerial photos taken in December 2019 show that most of the dune constructed following Hurricane *Irma* remained in place north of 2nd Ave, but was mostly eroded west of Station 20+00.

CSE recommends the City pursue discussions with the USACE to determine the feasibility of placing sand from the next federal dredging effort of the Intracoastal Waterway along the Isle of Palms beach near Breach Inlet. Partnering with the USACE may provide benefits to both the USACE and IOP through the beneficial use of dredged material. This effort will likely require the City to secure permits and/or complete engineering studies to support any additional effort the USACE requires beyond their existing work plan or permits; however, there may be the opportunity to place sand along the beach at a net lower cost.

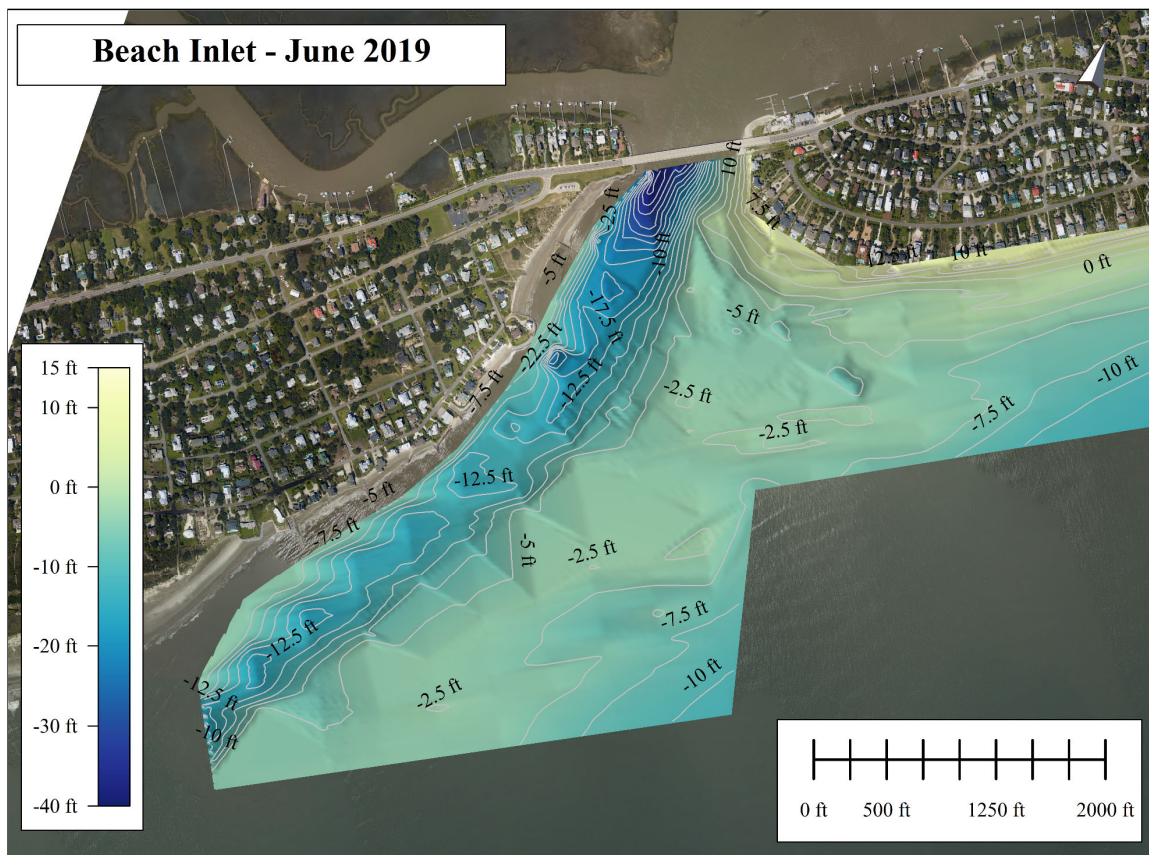
FIGURE 4.32. A digital terrain model spanning the majority of the Breach Inlet channel. The model shows a well-defined main channel abutting Sullivan’s Island. When the channel is well defined and the northern shoal is unbroken, it is likely that more sand will be drawn away from the Isle of Palms beach near the inlet due to a weakening of the trapping effect of the delta.

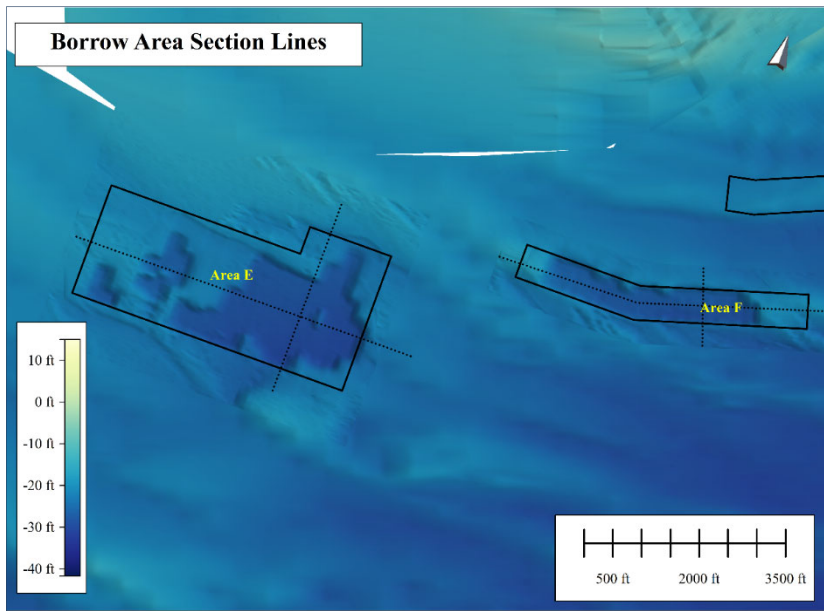
Less infilling was observed in Area F, as the sections lines from 2018 and 2019 generally average a similar depth. The north/south section view shows the landward and seaward edges of the dredged area showed significant shifting of sand from the upper slope to the lower portion of the slope.

FIGURE 5.2. Cross sections of the borrow area bathymetry for Borrow Area E and Borrow Area F.
