October 30, 2015

RE: Isle of Palms Post-Storm Survey Results [CSE 2447-01]

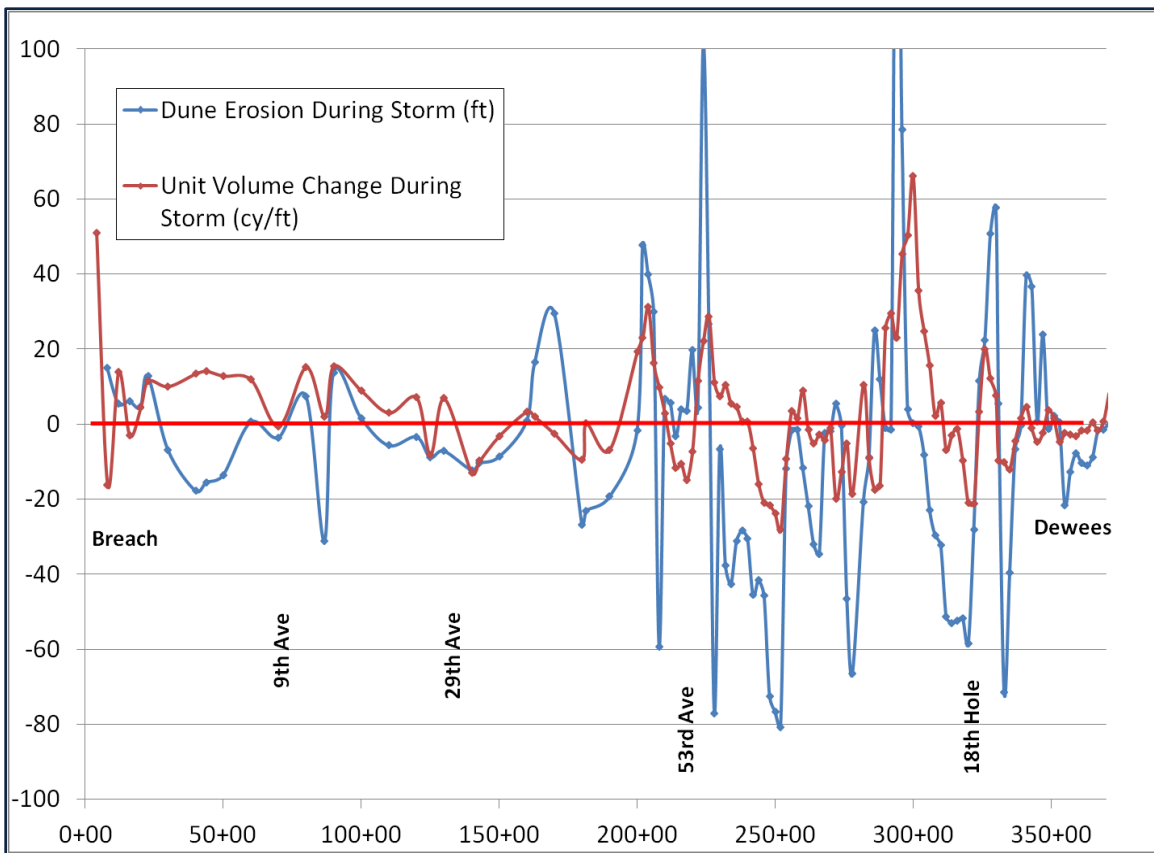
Measures of dune erosion are more variable than the volume change as variations in localized topography can skew some of the results. For instance, at station 228, there is an apparent net recession of almost 80 ft; however, inspection of the profile shows that the measured loss is a result of erosion of a small incipient dune feature which existed on the seaward edge of the berm in August 2015 (profiles included in Attachment 1). This dune feature intersected the +6 ft elevation contour in August, but was flattened in October. The primary dune remained intact and did not show any signs of recession. Additionally, gains in the lower portion of the profile led to a net increase in volume at station 228.

FIGURE 4. Plot showing linear dune erosion (in feet and measured at the +6 ft NAVD contour) and unit volume change (in cy/ft) occurring between August and October 2015. Positive values indicate accretion and negative values erosion.

The plot of Figure 4 showed areas of significant volume loss or dune recession separated by areas showing little dune impacts and accretion. In some areas, the beach showed a net gain of sand but erosion of the dune line (for example stations 30+00 – 60+00 between 5th and 8th Avenues and 230+00 – 238+00 between 55th and 57th Avenues). Photos show the dune erosion of up to 20 ft along the stretch of beach extending from 4th Avenue to approximately 8th Avenue; however also note a flat storm berm ~40-50 ft wide along the upper wet sand beach (Fig 5). A runnel was present in the wet sand beach just below the flat berm. Along this area, multiple ridge and runnels were present along the beach.

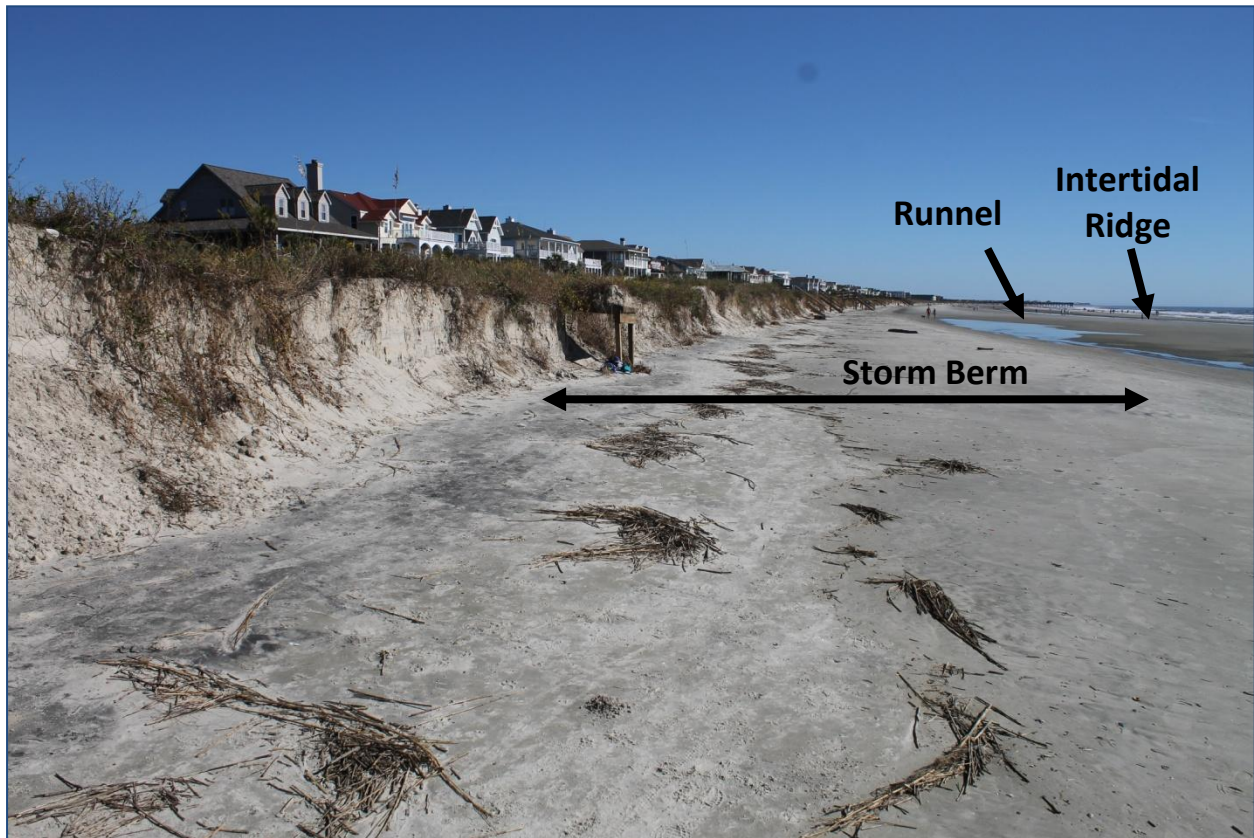
FIGURE 5. Ground photo from October 2015 of the beach at 5th Avenue looking east. The storm produced a large escarpment and ridge and runnel along the low intertidal beach. A relatively flat storm berm ~50 ft wide extends along the upper beach just below the dune. This is a typical post-storm beach condition (see Fig 2).

As mentioned previously, erosion due to the storm eroded up to 20 ft of the dune along the beach along 5-6th Avenues, where previous erosion had already left the area with a narrow beach. There appears to be some influence of the Sea Cabins Pier on the beach condition in this area, as there is a buildup of sand east of the pier, and an erosional arc south of it (Fig 8). Though houses along this stretch have sufficient setbacks from the water, the dune filed is low, and the only substantial storm protection is the higher primary dune where the erosion occurred. It would be advantageous to utilize the available emergency measures to scrape sand and rebuild the primary dune along this area.

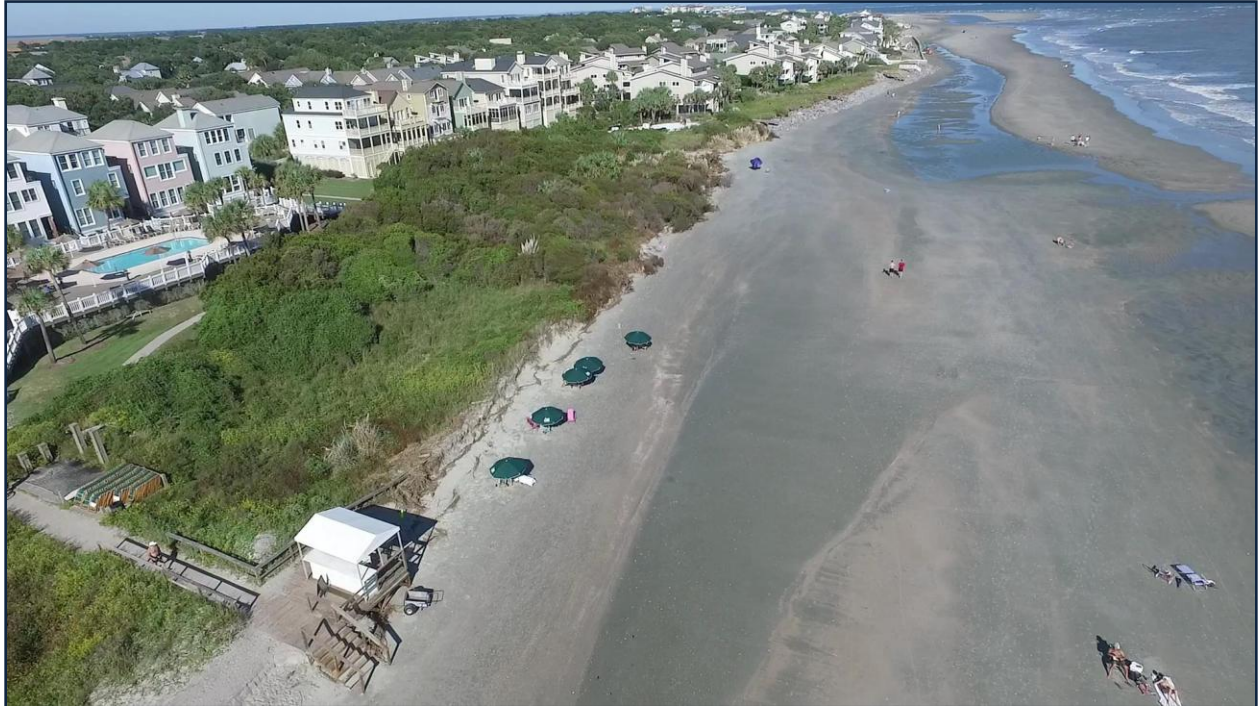
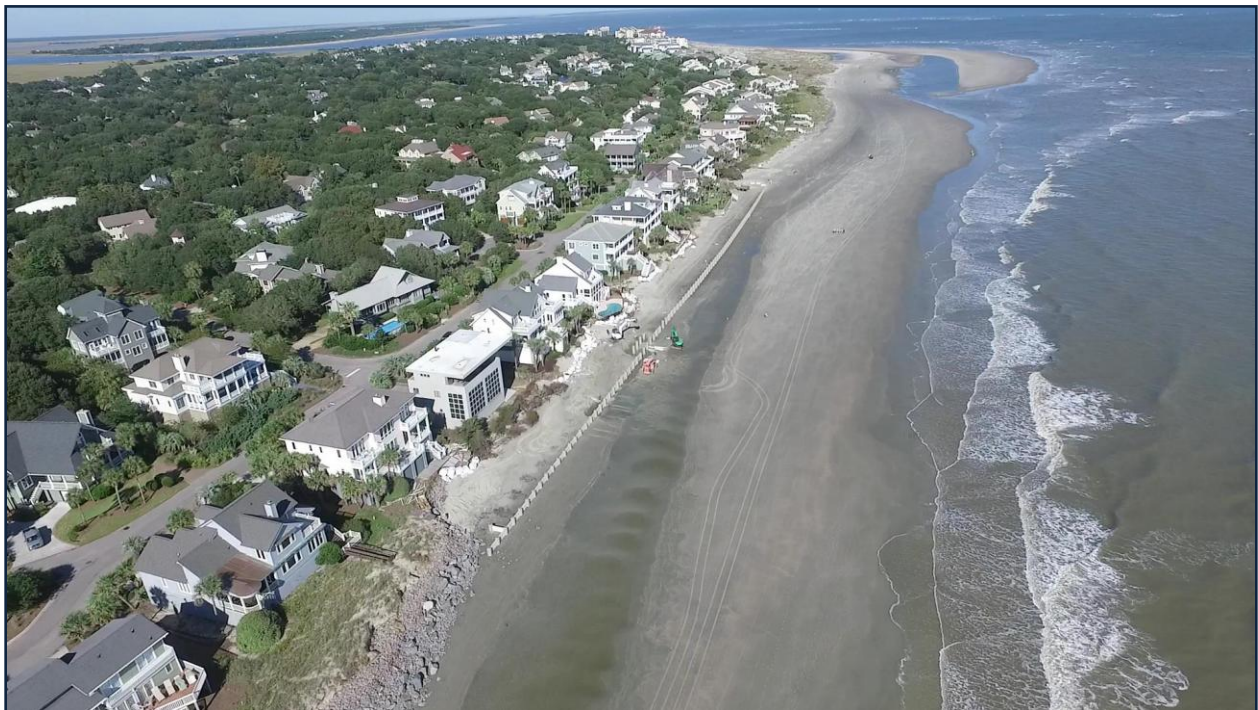
The areas showing the most severe dune erosion were between 4th and 8th Avenues, 41st and 43rd Ave, 55th Ave and the Grand Pavilion, and Port O’Call through the 18th Hole. The most severely eroded area was the area near the Grand Pavilion, which lost up to 80 ft of dune and dry sand area and up to 28 cy/ft of sand volume. Most all of the dry sand area created in the 2008 nourishment project was eroded between the Grand Pavilion boardwalk and Seagrove (Fig 6).

FIGURE 6. October 2015 post-storm aerial images of the area near the Grand Pavilion (upper) and Beachwood East (lower). The Grand Pavilion walkover is in the foreground of the upper image. This area experienced the most dune erosion and volume loss during the storm. The experimental wave dissipation device along Beachwood East was damaged during the storm. Houses here have installed sandbags and have little-to-no, dry-sand beach fronting the structures.

Just east of the Grand Pavilion area, the area fronting Beachwood East also eroded significantly, losing up to 30 cy/ft in volume. The lack of dunes in the area prior to the storm, coupled with the emergency sandbags and experimental wave dissipation system, resulted in little measured dune erosion despite the sand loss. Prior to the storm, there was no obvious evidence that the wave dissipation system was preserving the upland sand. Essentially there was no dune to erode prior to the storm. The storm caused visible damage to the wave dissipation system by uplifting piles and displacing the horizontal members. Erosion eliminated all of the vegetated area fronting several houses along Beachwood East leaving several portions of decks, swimming pools, or other infrastructure at the escarpment line (see Fig 6). This area has been impacted by focused erosion over the last year and remains the most vulnerable to structural damage. Due to the existing conditions of the permit for the experimental wave dissipation system, CSE is unsure of the allowable emergency measures in this area.

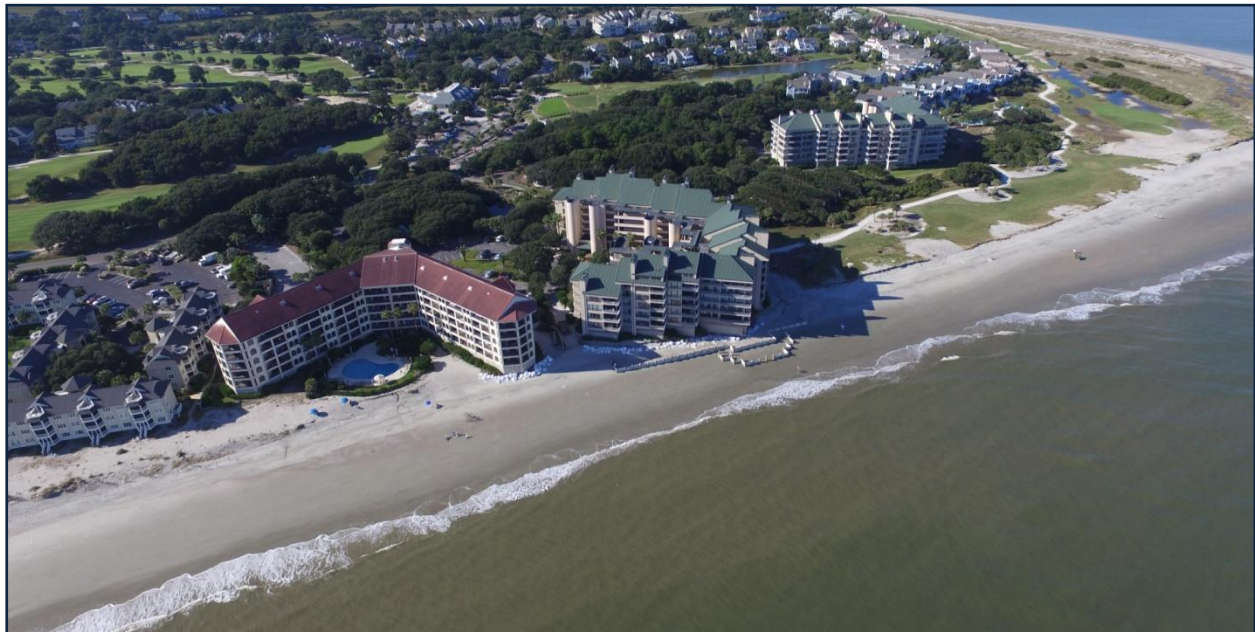
Similar to the beach near Grand Pavilion, the area fronting Port O’Call, Seascape, Ocean Club, and the 18th hole lost up to 60 ft of dry sand or dunes, much of which was sand remaining from the shoal management project completed the previous winter. The resulting condition left no dry sand beach fronting the eastern end of Seascape or the entire Ocean Club building (Fig 7). There is still a dry sand buffer fronting Port O’Call, though ~40 ft was lost during the storm. Ocean Club currently has a wave dissipation system installed, though it does not appear to be maintaining a dry beach landward of the structure.

FIGURE 7. October 2015 post-storm aerial images of the area near Seascape and Ocean Club. The intertidal beach width is narrow in front of Ocean Club, limiting the availability and practicality of emergency sand scraping.

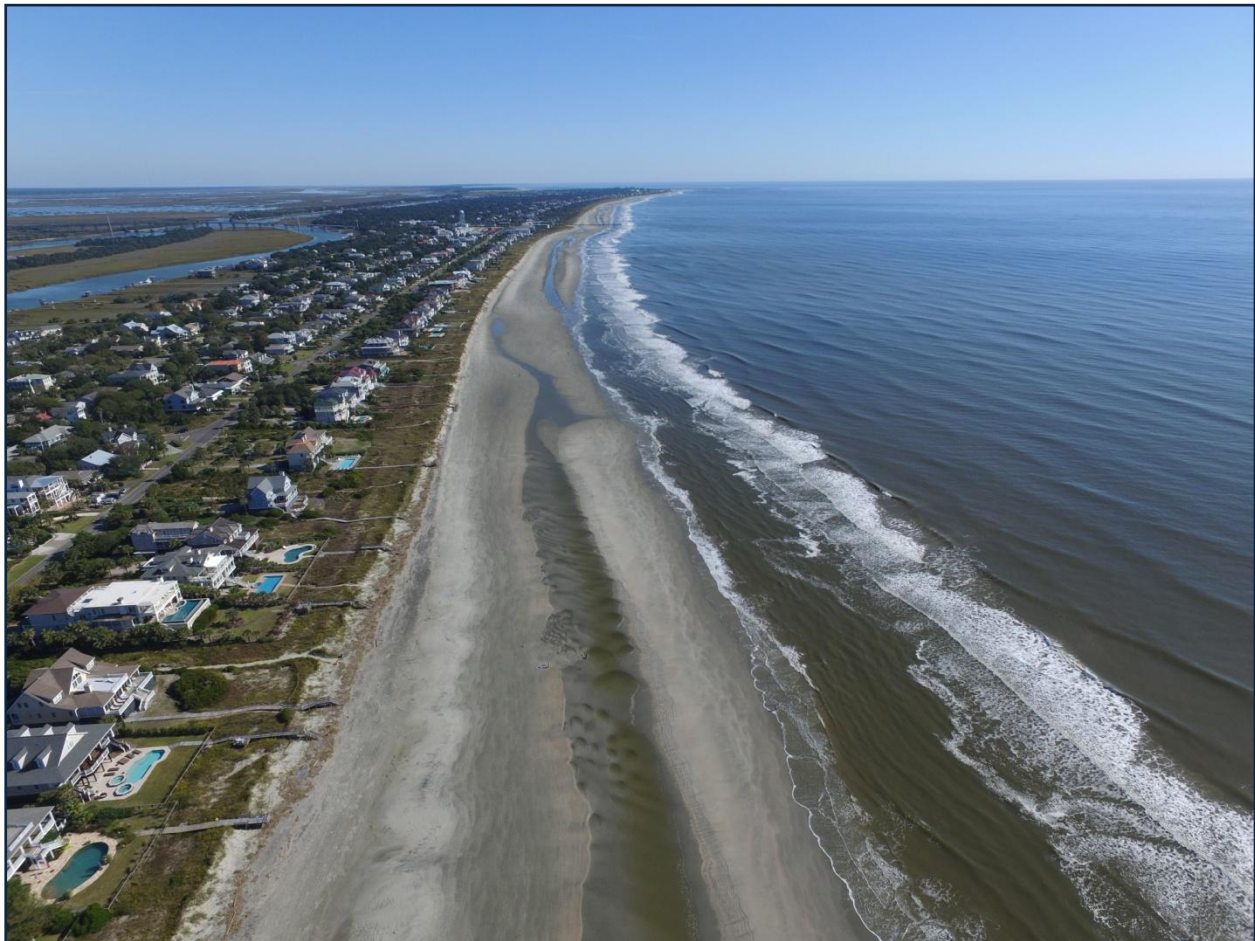
FIGURE 8. October 2015 post-storm aerial images of the area between Breach Inlet and Front Beach. The intertidal beach width is wide in this area, despite an erosional arc centered at 5th Avenue. Emergency sand scraping may be beneficial in restoring the eroded primary dune.

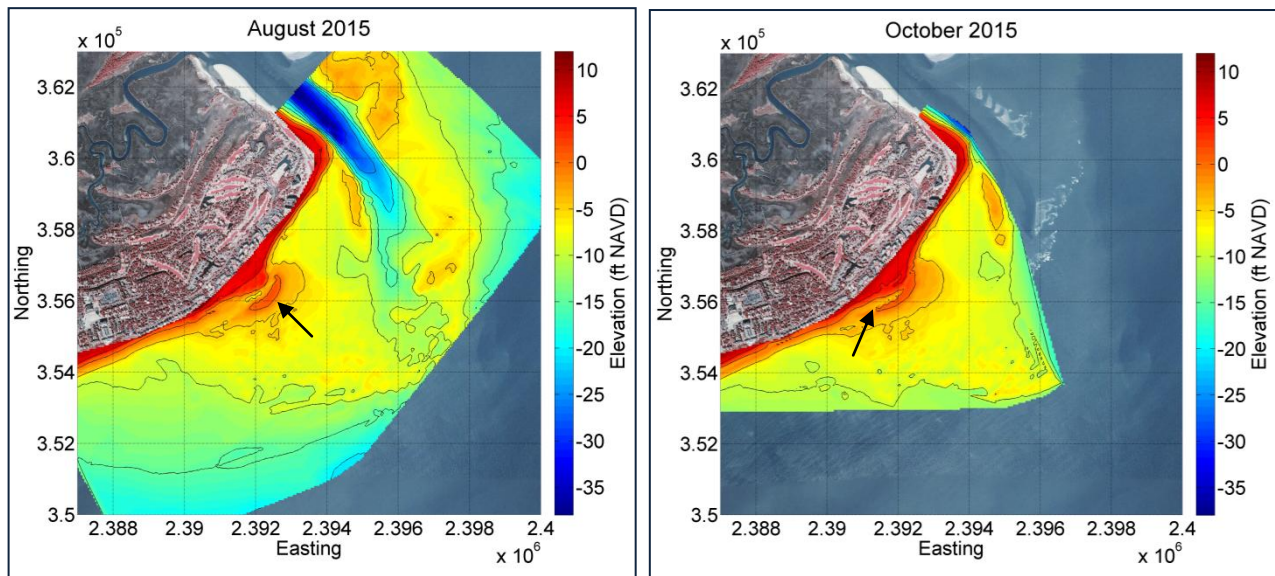
Digital terrain models of the shoal from August and October are shown in Figure 9 and highlight the migration and attachment of the shoal (red hues). The attachment at the east end should facilitate sand spreading toward the east from the attachment site. CSE does not expect recovery of the western site (Beachwood) until the western edge of the shoal fully attaches (Fig 10). This is being prevented by additional sand seaward of the shoal along the western side. Also note the continued buildup of the trailing ebb spit offshore of the northeast tip of the island. This feature has built substantially over the past four years, gaining sand which was lost from the beach. Eventually this sand will return to the beach as a shoal-bypass event.

FIGURE 9. Digital terrain models of the Dewees Inlet delta and east end of Isle of Palms. The shoal is visible as the red hue separated from the beach in the left image, and attached on the right image (arrow). The October storm resulting in the offshore shoal fully merging with the beach along the east end, while the main body of the shoal migrated ~200 ft landward. The western end of the shoal remains unattached.

The shoal is positioned favorably for a shoal management project, which would transfer sand from the seawardmost accessible portion of the shoal and place it along the most severely eroded areas where existing permits presently allow. Any emergency erosion measures in areas receiving sand would need to be removed in conjunction with a sand transfer project.

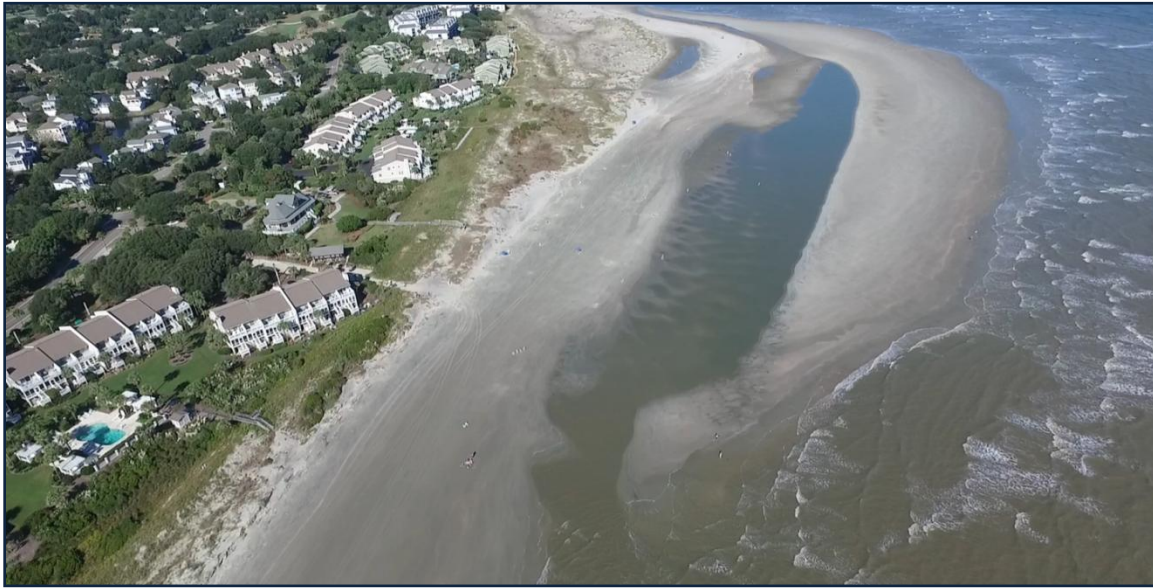
FIGURE 10. October 2015 post-storm aerial image of the attaching shoal along Wild Dunes community. The western edge of the shoal remains unattached (lower portion of image), while the eastern edge is attached. Transferring sand from the attached shoal to the eroded areas would be beneficial to facilitate additional merging of the shoal sand.
