September 17, 2012

RE: Pre-Project Lighting Survey
Isle of Palms Shoal Management Project [CSE 2384]

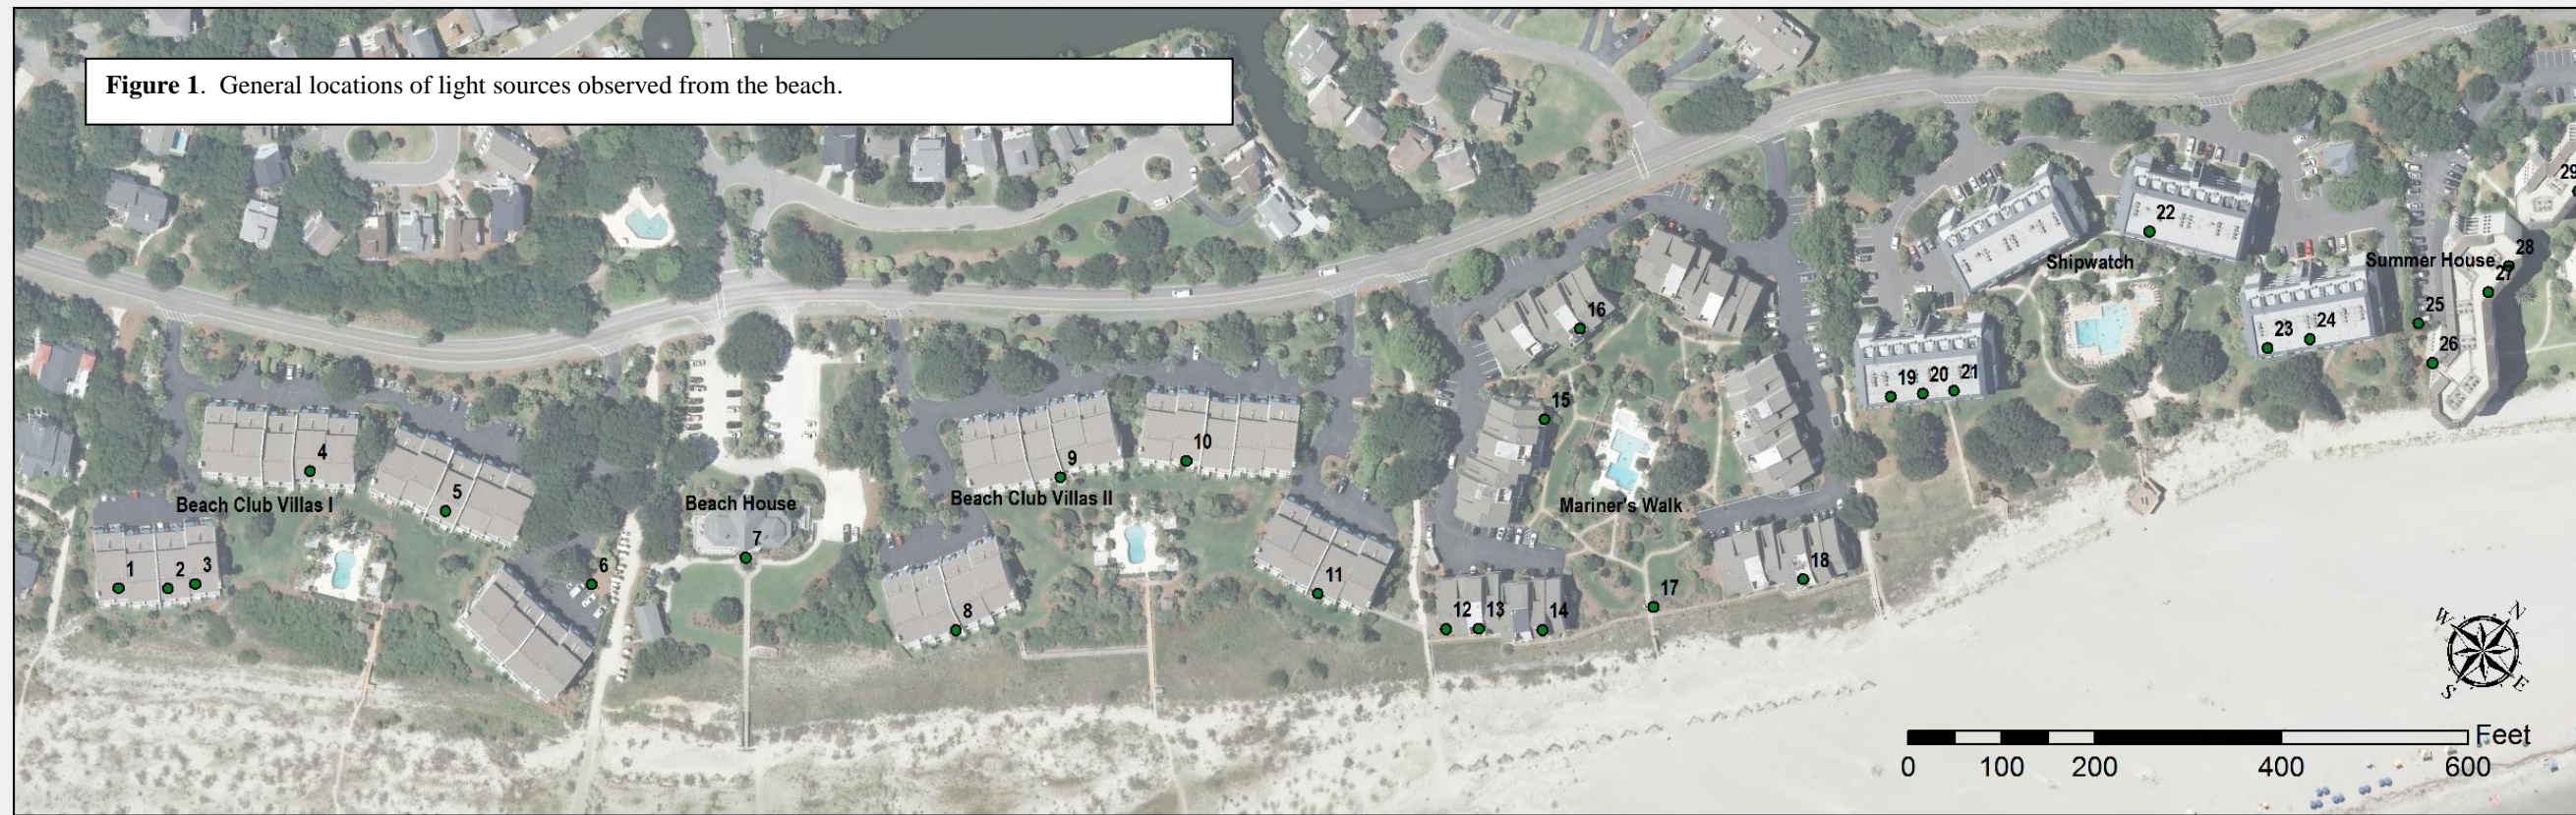
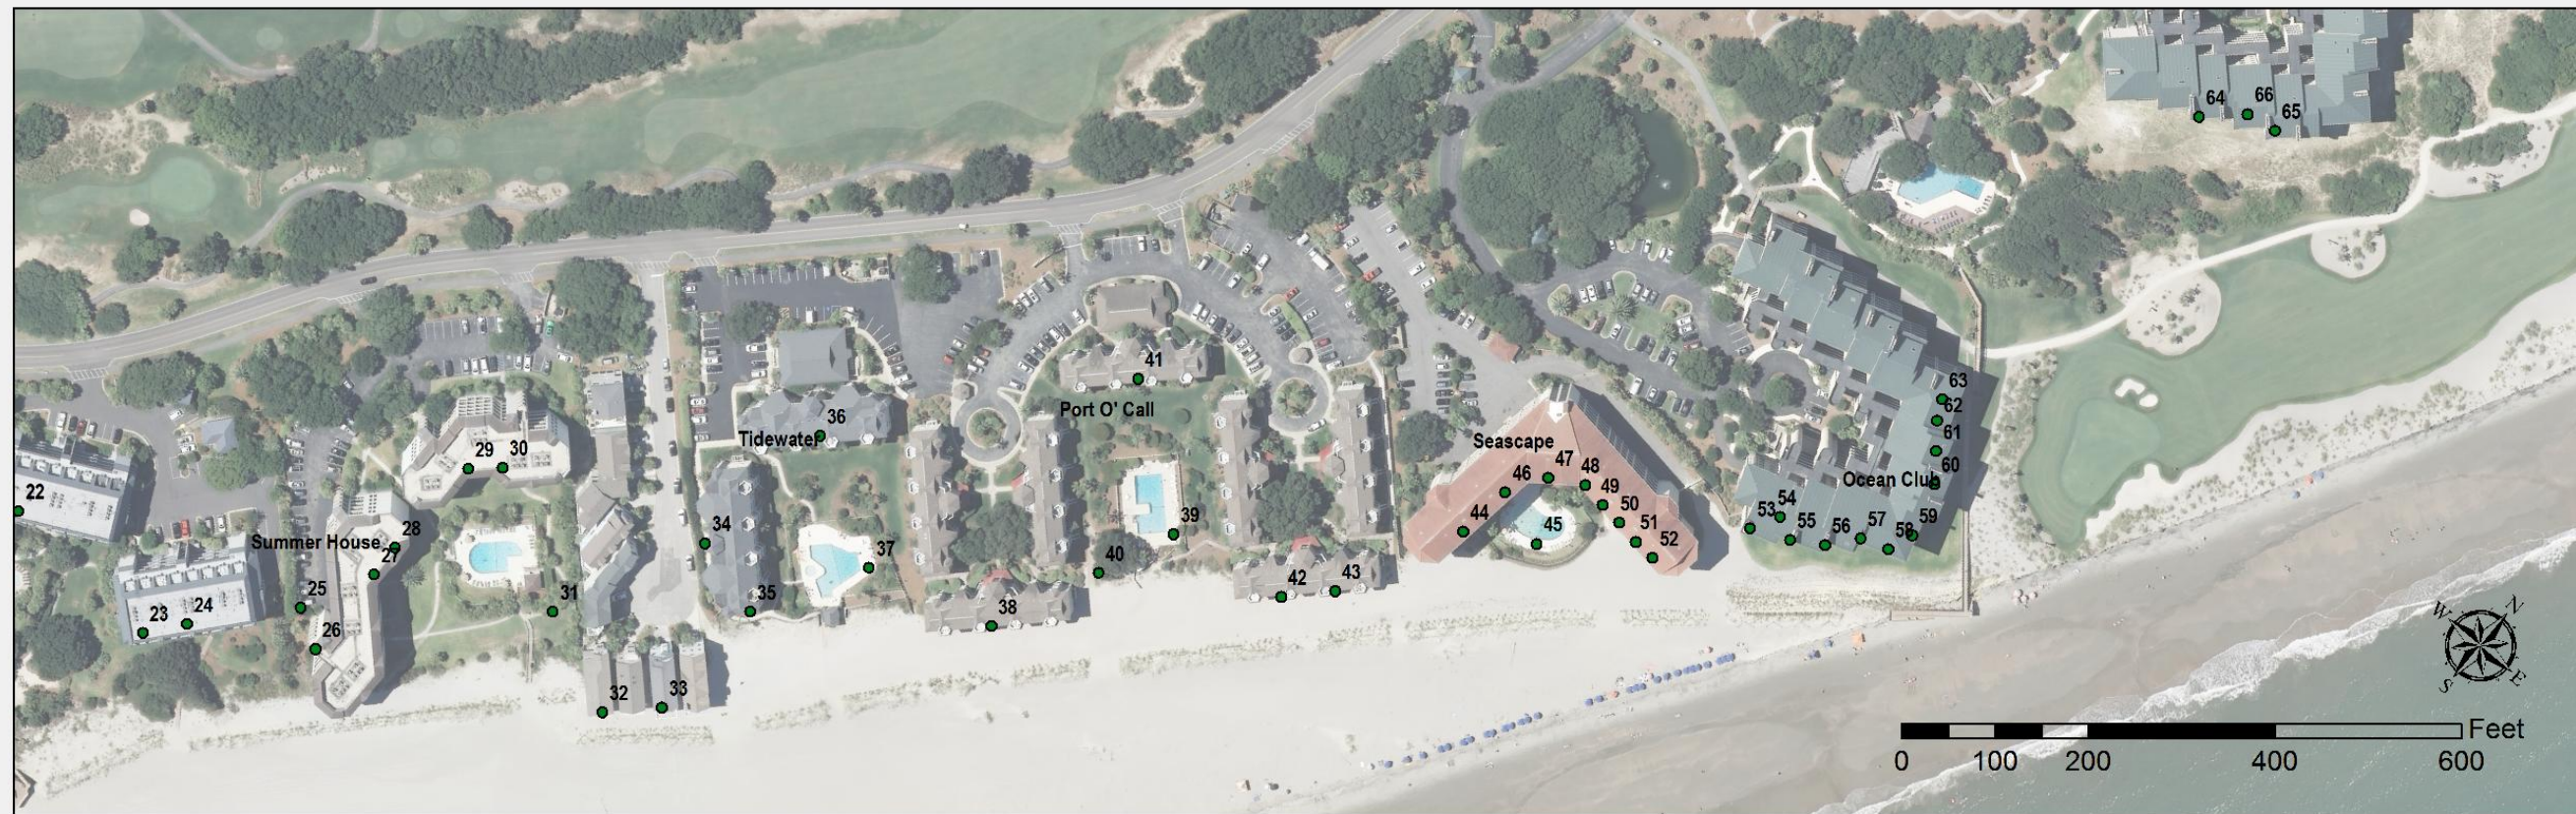
Figure 1. General locations of light sources observed from the beach.

WD POBH — The Property Owners Beach House only had courtesy lighting along the stairwells that lead up to the porch. These were the only lights directly visible from the beach. This was an improvement over the March survey findings.

Beach Club Villas I and II — Several units had lamps (08) and balcony lights (02) directly visible from the beach and others had interior lighting which illuminated walls or curtains, producing ambient lighting observable from the beach (05). Lights around the pools were not visible in this survey. A pole light in the parking area at the north end of BCV I was directly visible from the beach (06).

Mariner's Walk — Several units had lamps (13) or TVs directly visible from the beach, and others had interior lighting which illuminated walls or curtains, producing ambient lighting observable from the beach (14). Several balcony lights were directly visible from the beach (15, 16). A shielded light near the pool was directly visible from the beach (17).

Shipwatch — Several units had lamps directly visible from the beach (22), and others had interior lighting which illuminated walls or curtains, producing ambient lighting observable from the beach (21). Multiple sources of direct lighting were observable at the ground level (24).

Summer House — Several units had lamps (28) directly visible from the beach, and others had interior lighting which illuminated walls or curtains, producing ambient lighting observable from the beach. A shielded light near the pool was visible from the beach (31). The stairwell on the southwest side of the building had multiple direct light sources (26).

Summer Dunes Lane Properties — One unit had ceiling lights directly visible from the beach (32), and others had interior lighting which illuminated walls or curtains, producing ambient lighting observable from the beach (33).

Tidewater — Several units had interior lighting which illuminated walls or curtains, producing ambient lighting observable from the beach (35, 36). One unit along Summer Dunes Lane had a balcony light directly observable from the beach (34). There is a pole light near the pool directly visible from the beach (37).

Port O'Call — Several units had lamps, TVs, or ceiling lights directly visible from the beach (42), and others had interior lighting which illuminated walls or curtains, producing ambient lighting observable from the beach (38). Multiple pole lights around the pool were a direct light source (39). Luminaries on the beach walkovers were not shaded and were a direct light source (40).

Seascape — Several units had lamps or TVs directly visible from the beach (46, 48, 51), and others had interior lighting which illuminated walls or curtains, producing ambient lighting observable from the beach (47). Pole lights around the pool provided a direct source of light (45). Lighting in the ground-floor garage provided a direct light source (44). Landscape lighting and the above lighting illuminated the walls of the complex. Balcony lights on the landward side of the building are visible from the beach (50, 52).

Ocean Club — Several units had lamps, ceiling lighting, or TVs directly visible from the beach (55, 56, 57, 60), and others had interior lighting which illuminated walls or curtains, producing ambient lighting observable from the beach (54, 61). Parking lights from the garage underneath the building were also directly observable from the beach (56, 62).

CSE recommends the City provide notices to each regime reminding them of the ordinance and identifying specific problems revealed from this survey. Regime managers should be encouraged to have maintenance personnel or volunteer owners periodically observe the property at night from the beach to identify light sources and recommend source-specific solutions to ensure that the property is in compliance with the ordinance and is not impacting sea turtles. CSE offered additional suggestions in the report from the March 2012 lighting survey which may still apply.
