# 2018 Isle of Palms Restoration Project

## Year 2 (2020) Monitoring Report Annual Beach and Inshore Surveys

[2492YR2 — Monitoring Year 2]

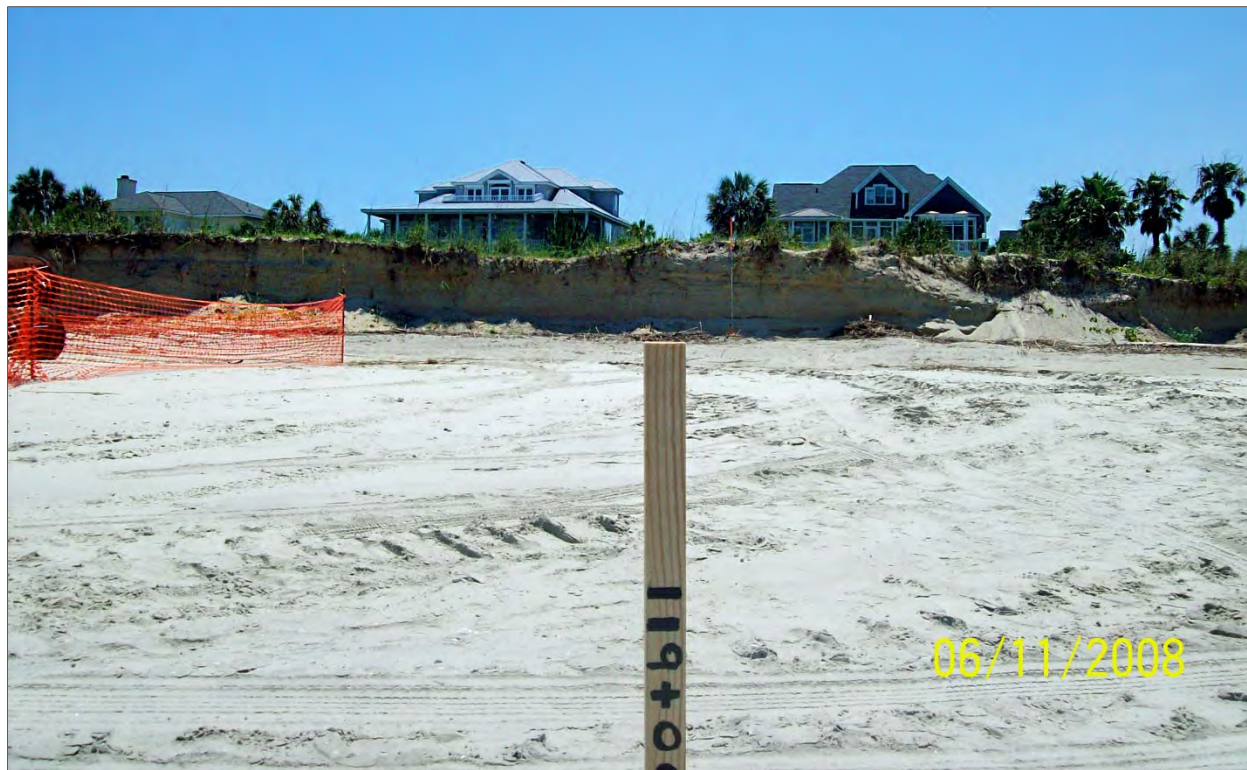
**FIGURE 4.5.** In 2008, a significant erosional escarpment was documented along most of Reach 7 seaward of the 17<sup>th</sup> tee box of the Links Course.

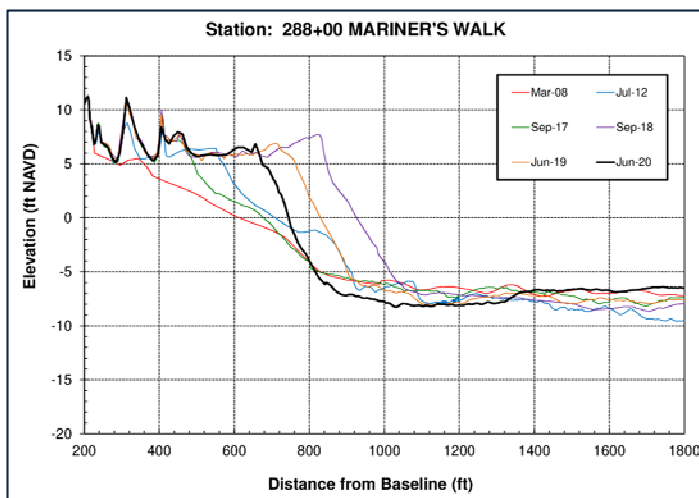
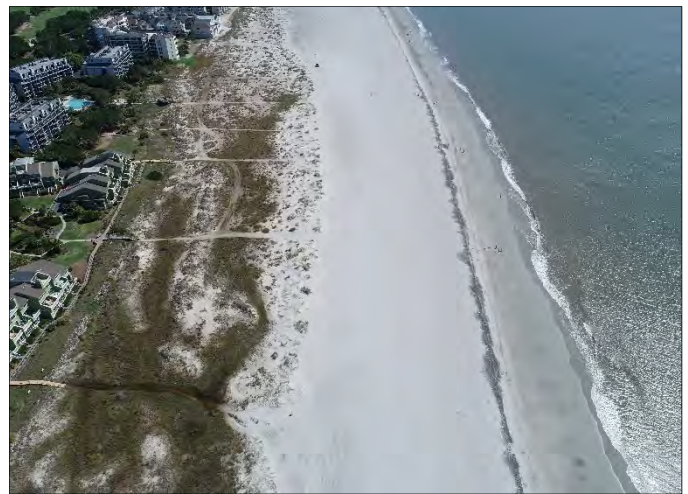
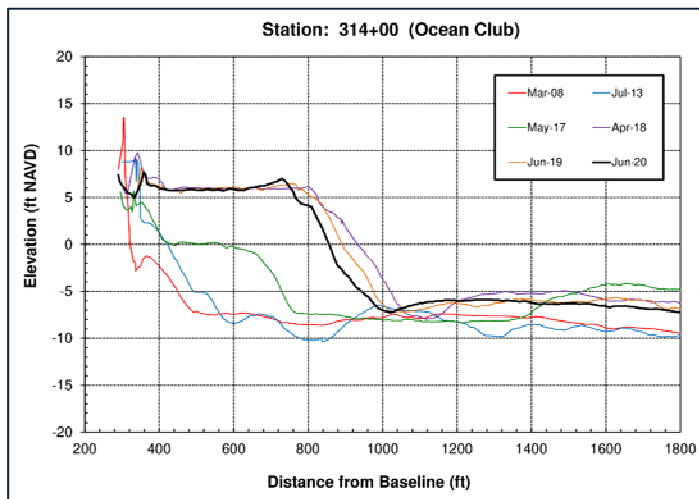
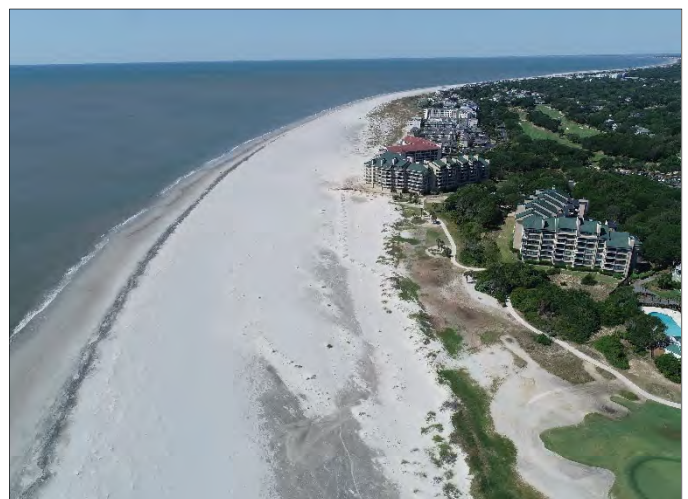
Overall, the reach holds 992,600 cy more sand than the 2007 condition. Nourishment projects in 2008 and 2018 have resulted in an average annual accretion rate of 15.7 cy/ft per year along Reach 6. While the volume totals are very positive, the reach is subject to localized areas of very dynamic volume changes and needs to be monitored closely.

**FIGURE 4.10.** Reach 6 profiles. The rapid erosion in this area is suspected to be a continuation of the higher erosion trend observed prior to the 2018 project.

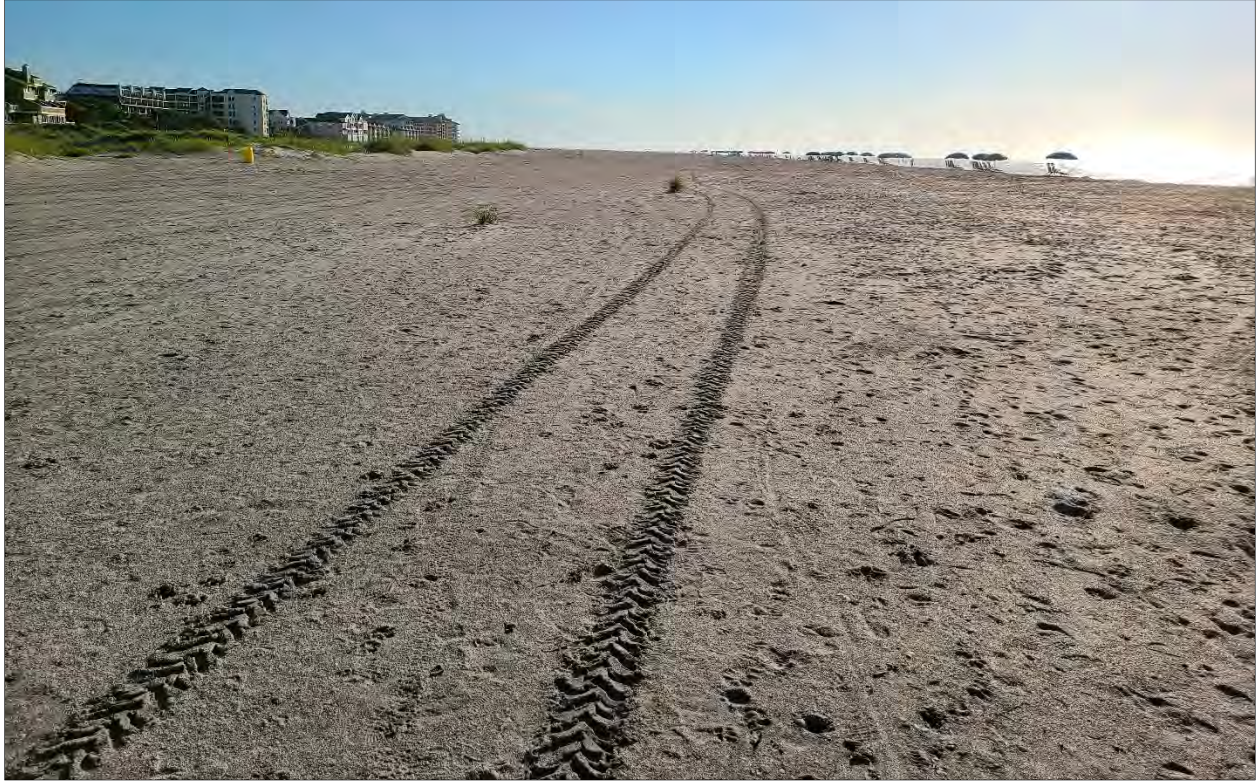
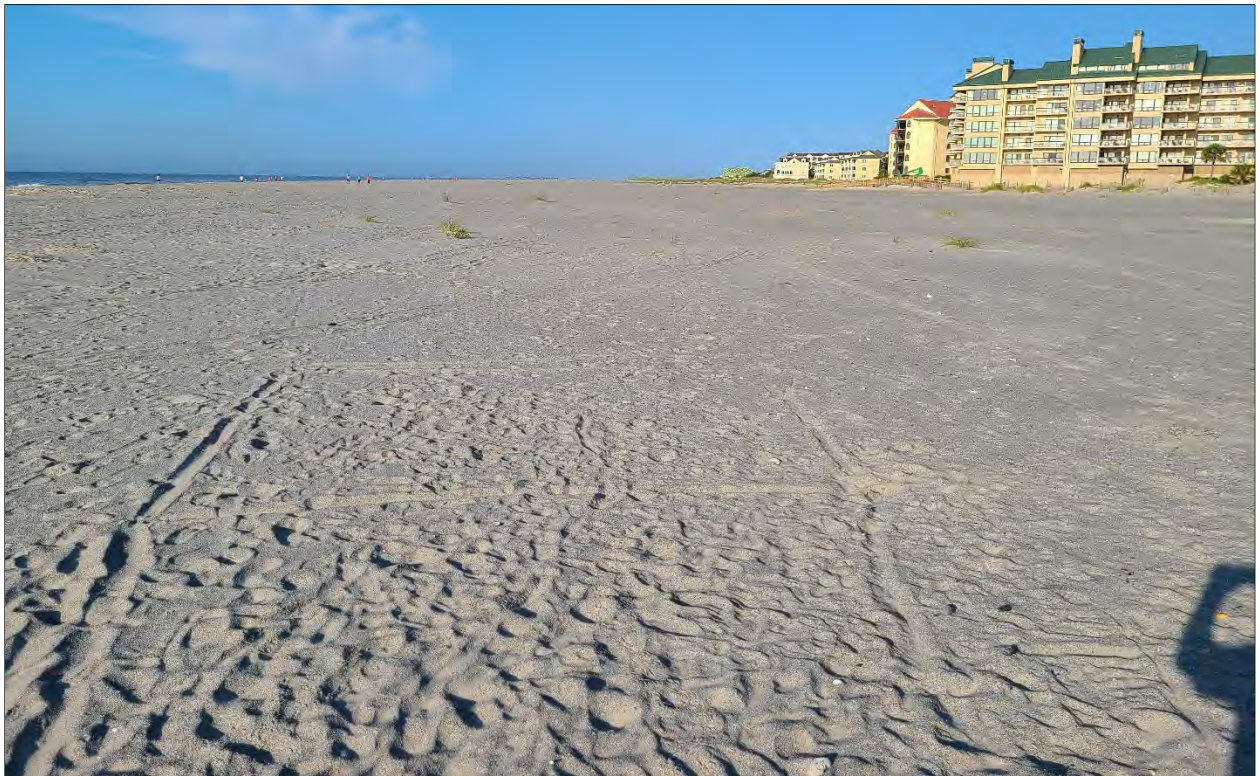
**FIGURE 4.12.** Ground photos from Station 284 [UPPER] and Station 320 [LOWER] in June 2020.

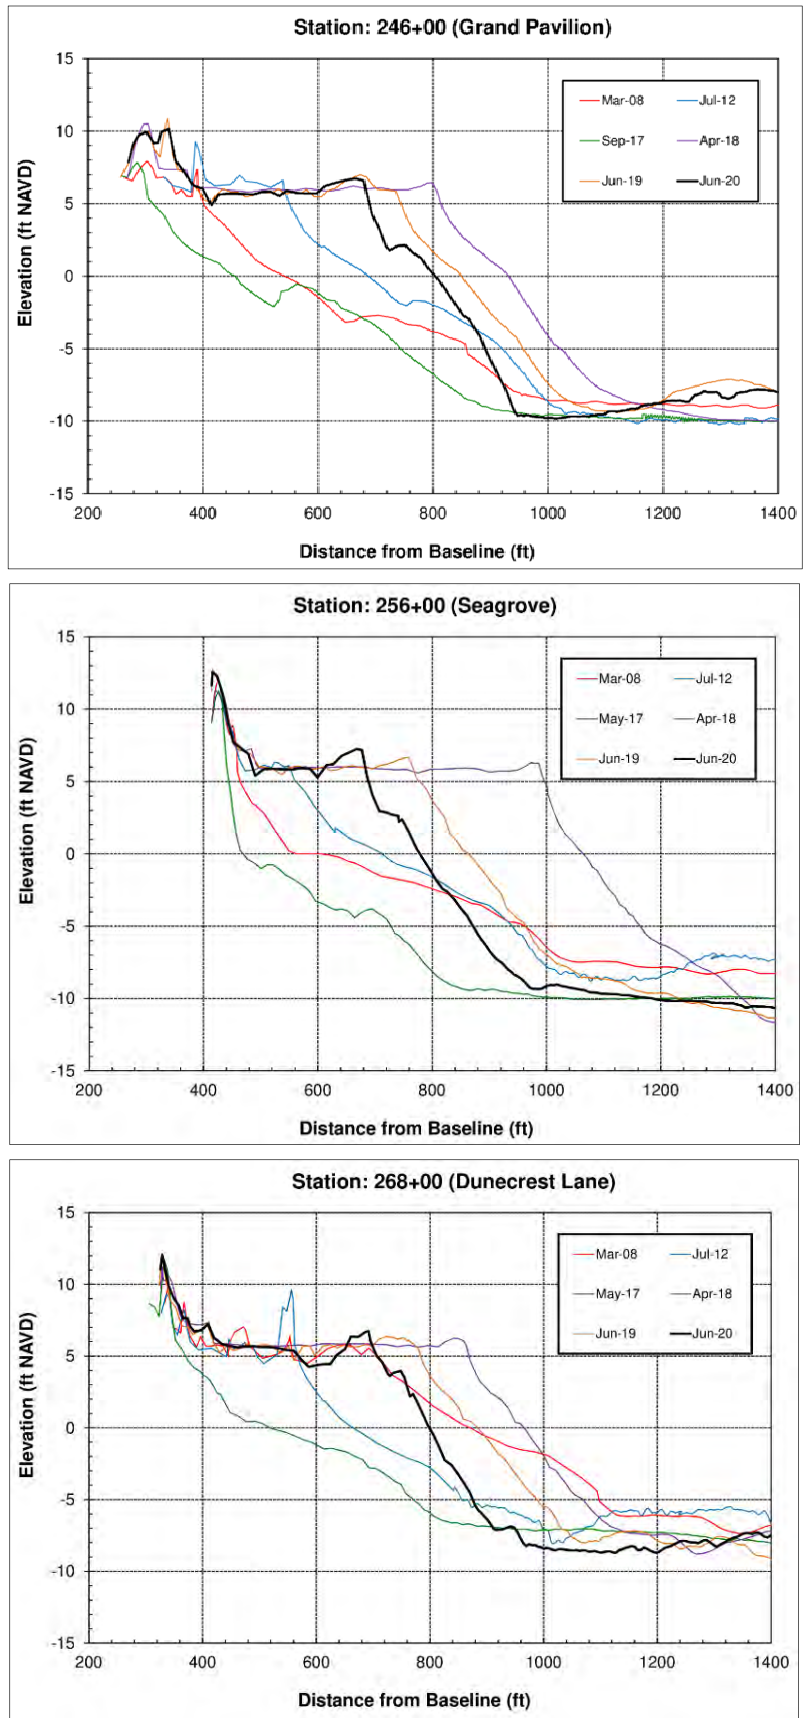
**FIGURE 4.15.** Reach 5 profiles. The data shown indicates that the berm fronting Grand Pavilion and Beachwood East remains ~400 ft wider than pre-project condition.

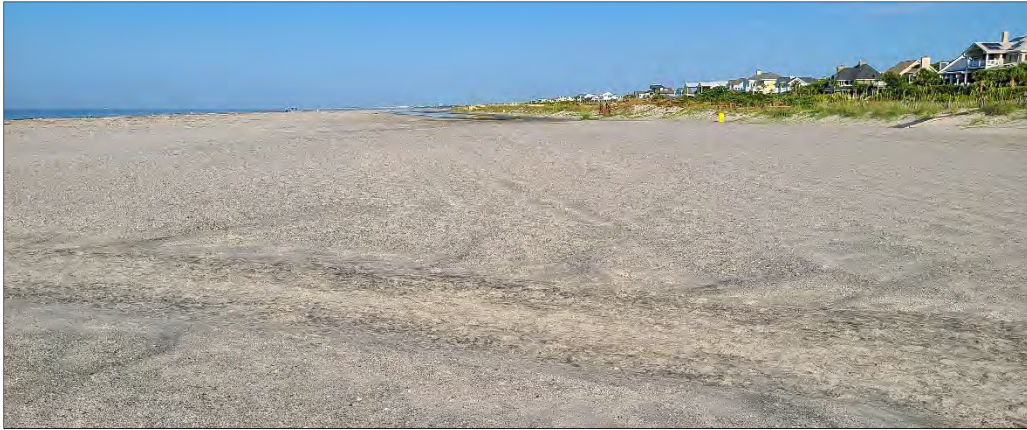
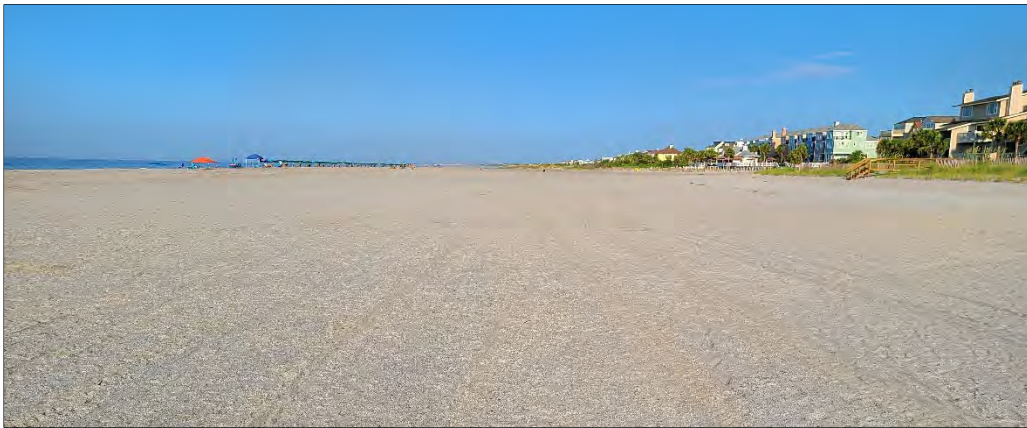
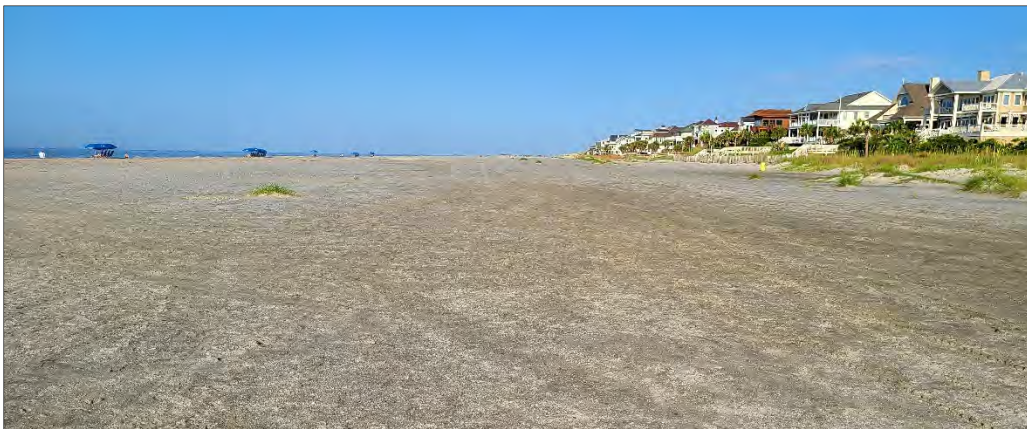
Similar to Reach 6, there were some positive trends in the erosion rates compared to the previous year. Between stations 250–266 (eastern Grand Pavilion, Seagrove, and Beachwood East), erosion averaged ~90 cy/ft from 2018 to 2019 but decreased to 32.5 cy/ft over the past year. Downcoast sand spreading was also less evident, which indicates less material was being lost from the project area. Profiles from within the reach (Figure 4.15) show the berm west of the Grand Pavilion boardwalk is similar in width to the 2019 condition and over 200 ft wider than the pre-project condition. At Seagrove (Station 254), the berm is ~300 ft wider than pre-nourishment, and the dune remains healthy. Around Beachwood East, the berm is still 300 ft wider than the pre-project condition, despite rapid erosion over the past two years. There remains a low swale on the landward side of the berm, seaward of the pre-project dune line (Figure 4.16).

**FIGURE 4.16.** Ground photos of Reach 6 in June 2020 showing Station 240 [UPPER], Station 256 [MIDDLE], and Station 276 [LOWER].

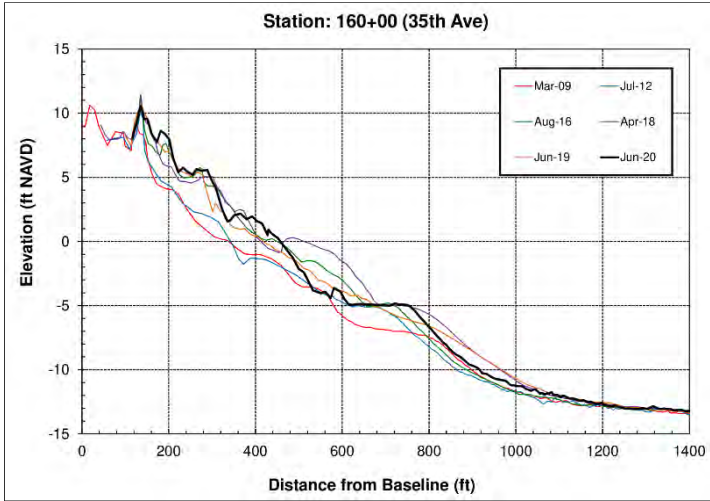
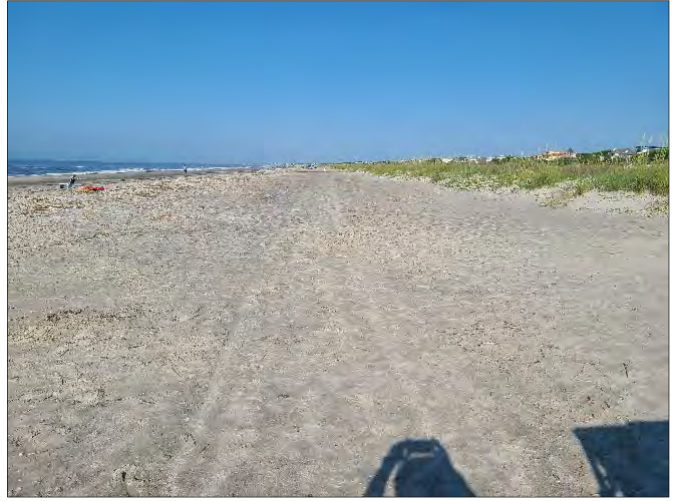
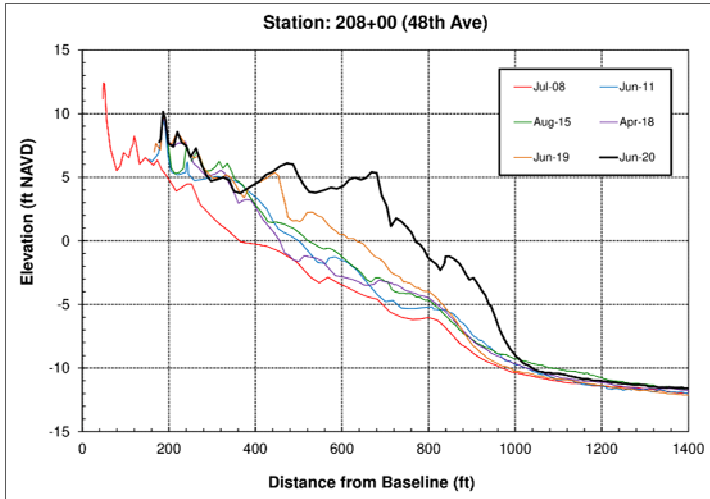
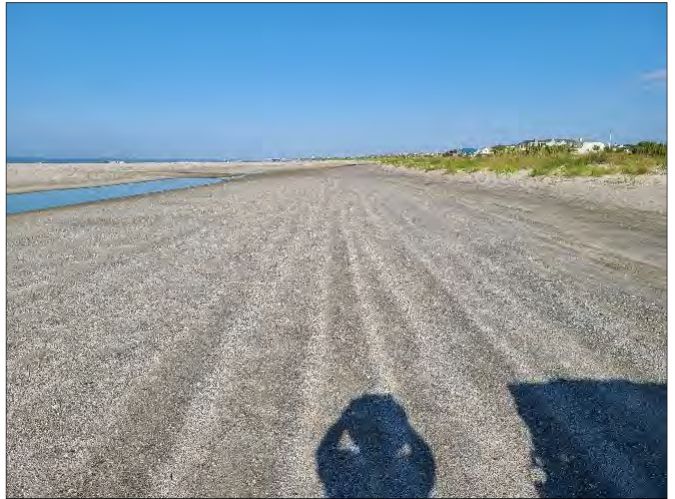
**FIGURE 4.20.** Profiles along the northern 2,000 lf of beach gained up to 128 cy/ft of sand since 2018. This accretion resulted in a large ridge and runnel system along the wet sand beach and a shift of the dry sand berm over 200 ft seaward.

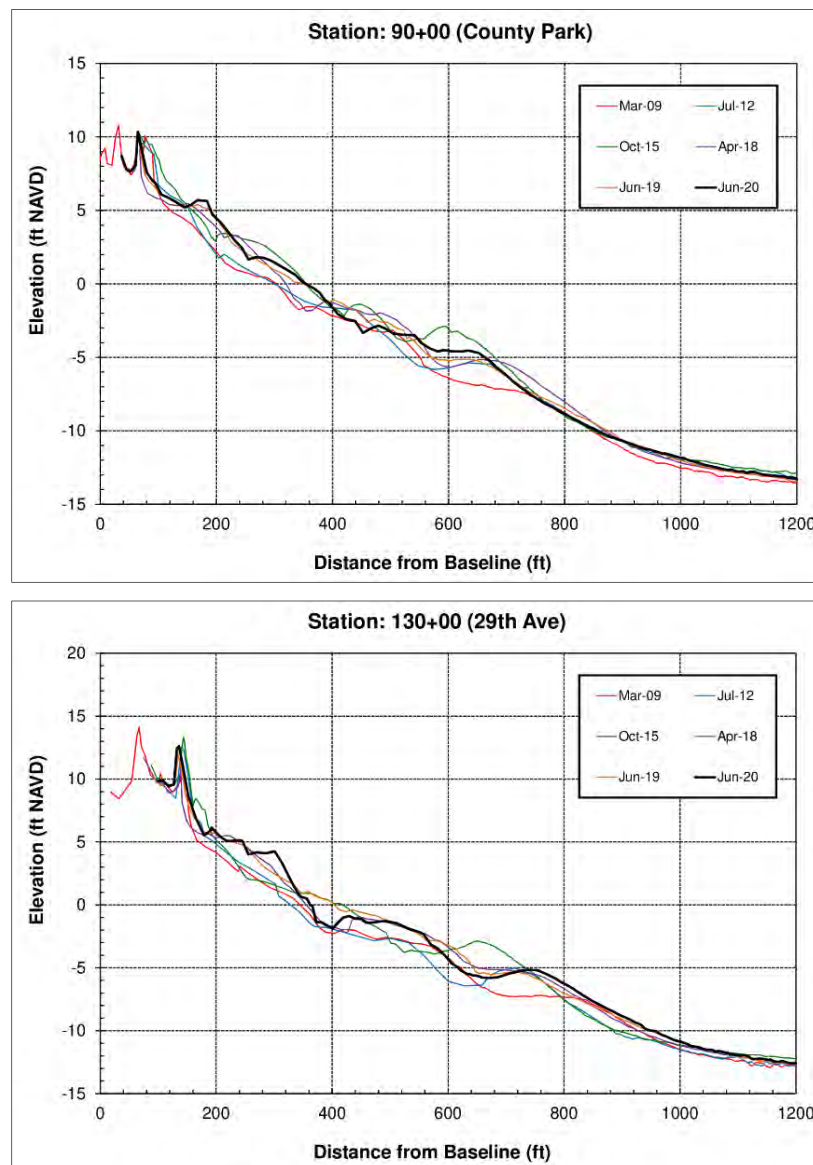
**FIGURE 4.24.** According to these profile plots the base of the dune has increased in width over the past year along most of the reach; however, it is still eroded compared to the pre-*Matthew* condition along the western end of the reach.

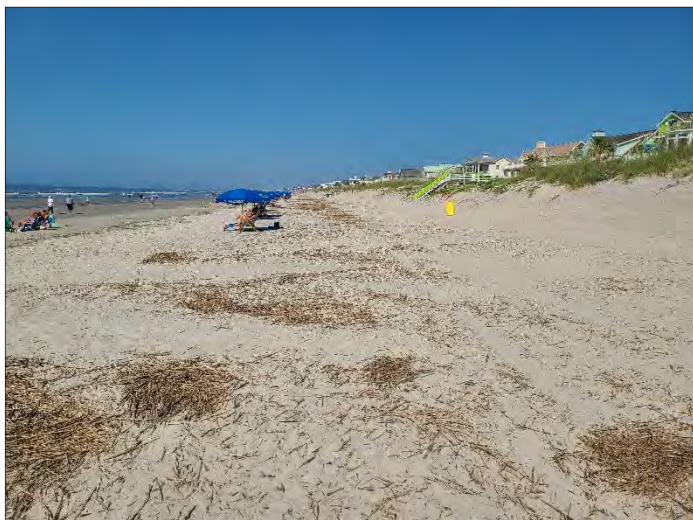
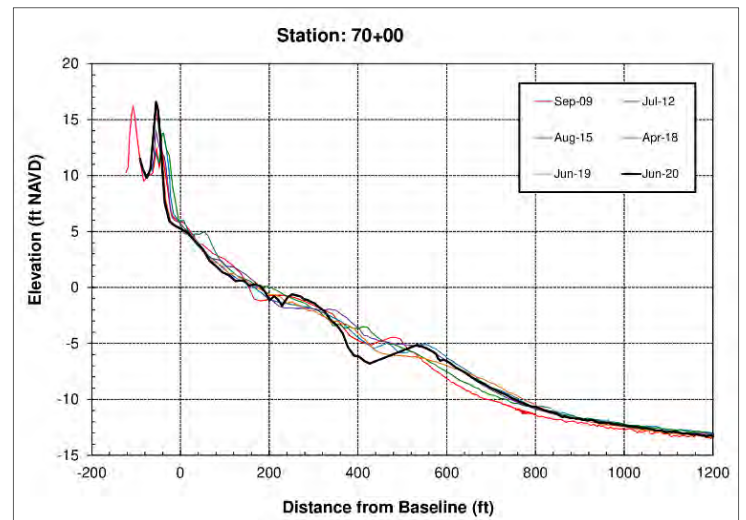
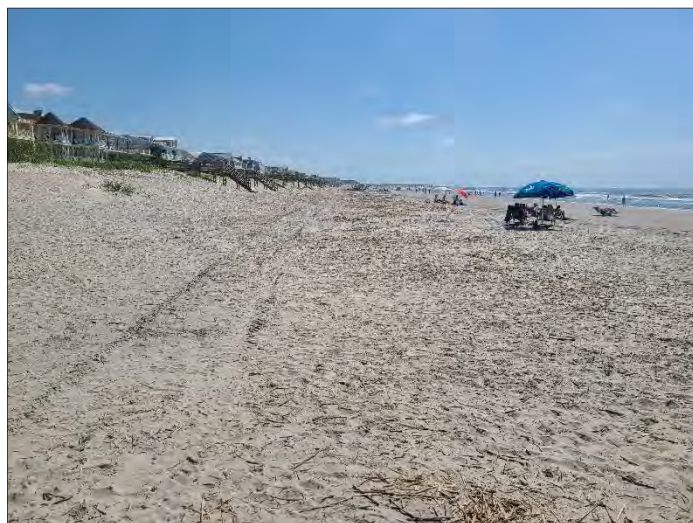
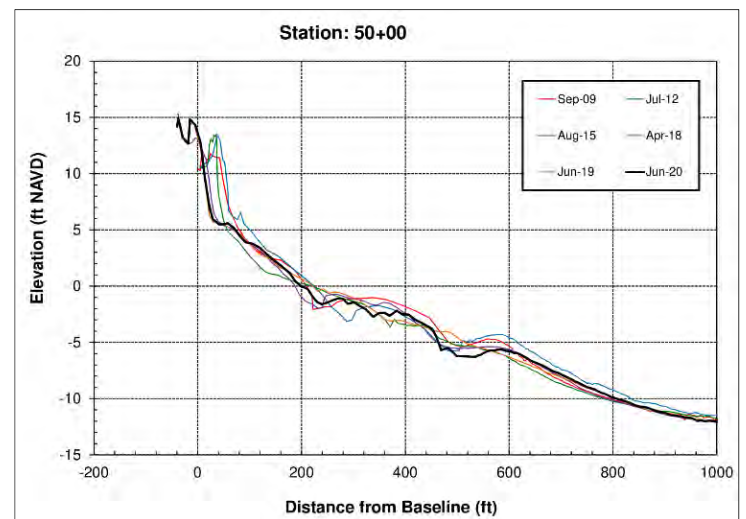
Photos and profiles show the healthier condition of the eastern end of the reach (south of the pier) compared to the western end (Fig 4.27). The dune constructed following Hurricane *Irma* remains mostly in place three years after construction. This dune was scraped from the intertidal beach following the storm to accelerate the natural beach recovery cycle.

**FIGURE 4.27.** June 2020 photos of Reach 2. [UPPER LEFT] View west from Station 70. [LOWER LEFT] View east from Station 3115 at the west end of Reach 2. The photos show a healthy beach with dry sand seaward of the dune. Profiles show that the dune remains more landward than the 2012 condition; however, it has been fairly stable since 2017.

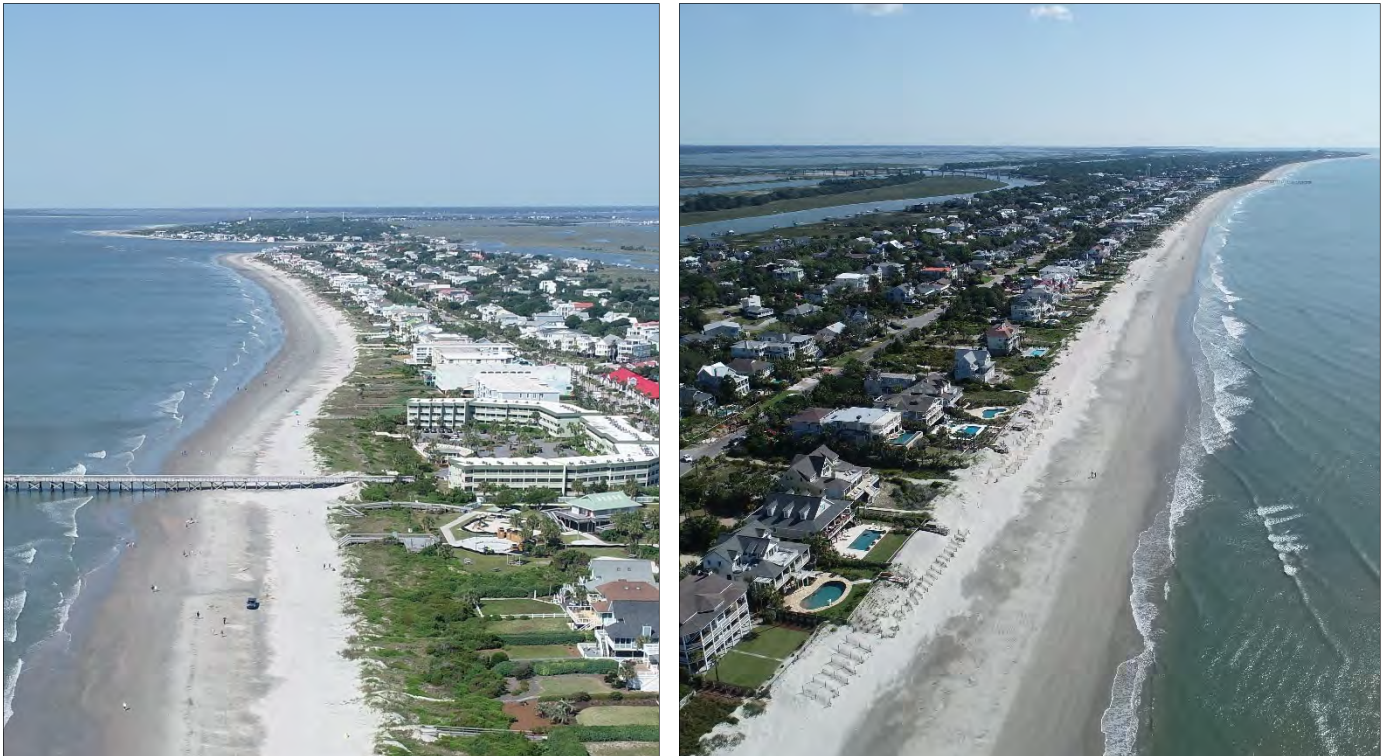
Aerial photos (Fig 4.28) of the reach show a crescent-shaped beach extending south of the pier, with a pronounced landward offset of the shoreline south of the pier. It is unclear whether the crescent shoreline is a result of sediment trapping from the pier or if it is a result of natural morphologic features associated with Breach Inlet. The shoreline morphology coupled with the lower accretion rate observed in this area should be closely monitored, as building setbacks along this area are generally lower than Reaches 3–4.

**FIGURE 4.28.** Aerial views of Reach 2 in June 2020. Since monitoring began in 2009, Reach 2 has been the most stable reach, typically showing lower magnitudes of volume change compared to the other reaches along Isle of Palms. The arc in the shoreline west of the pier indicates that the pier may act to trap sand, which may impact Reach 2 in certain wave conditions.

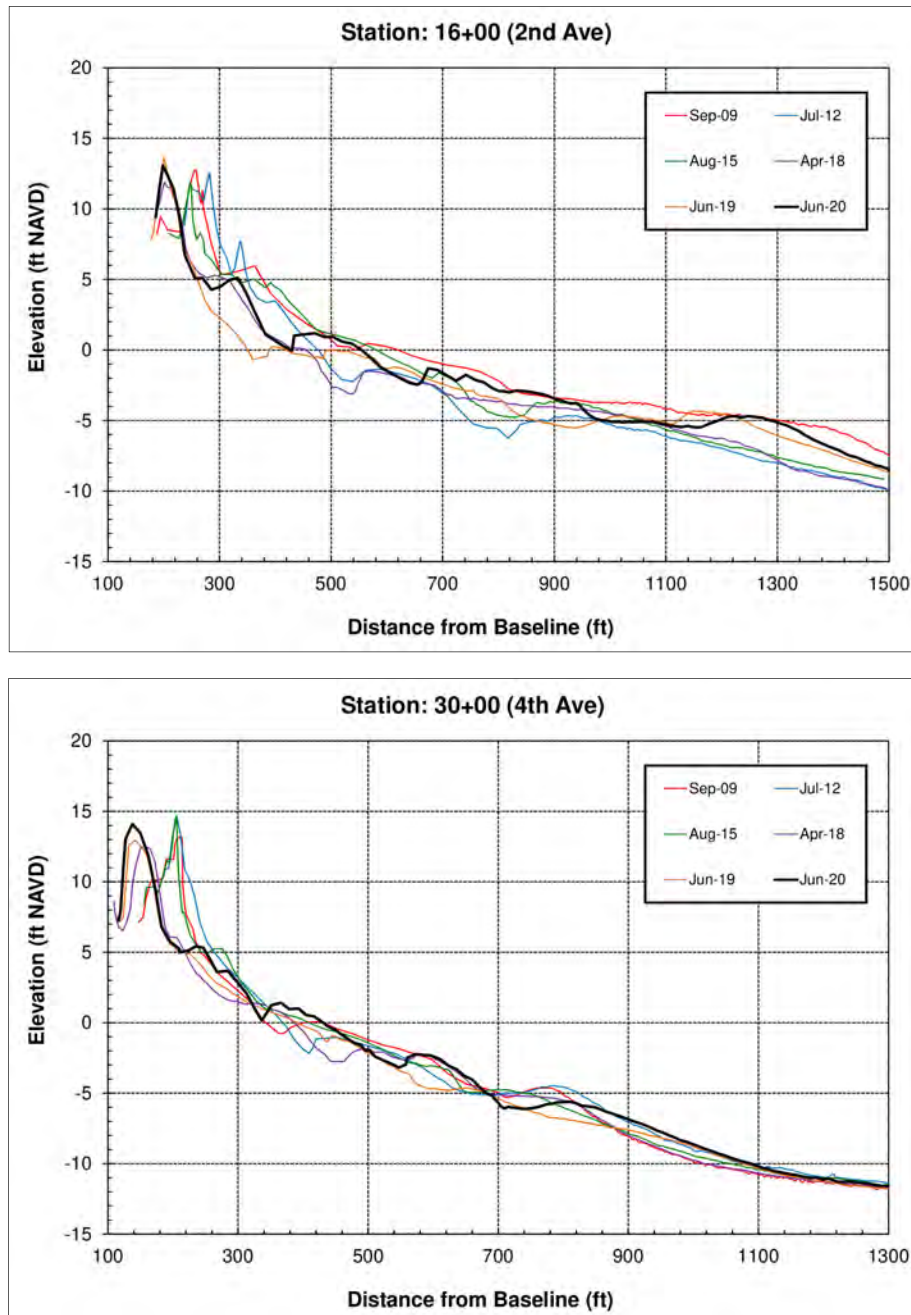
Profiles from this area show growth or stability of the dune and formation of a dry sand berm seaward of the dune. A significant sandbar was also present near the low tide elevation. The dune line along the reach is still ~80 ft landward of the 2012 position, which was the healthiest observed condition (prior to Hurricane *Sandy*). With the formation of the dry sand berm, additional dune growth is likely over the next year, as the berm acts as a source for wind-blown sand to accumulate along the toe of the dune. The dune placed after Hurricane *Irma* in 2017 has performed well north of 2<sup>nd</sup> Ave. West of there, the dune eroded through 2020 but has since rebuilt naturally.

**FIGURE 4.30.** Profile plots for Reach 1 indicate that while the erosion value is higher than historical trends, the majority of volume loss has been restricted to the portion of the profile below the high tide line. This means that the dunes have been more stable than the erosion rate would suggest.

The Breach Inlet reach has been dynamic since 2009 and needs to be closely monitored moving forward. CSE recommends the City pursue discussions with the US Army Corps of Engineers (USACE) to attempt to place material along this area as a beneficial use of dredged material when the Intracoastal Waterway is dredged in the future.

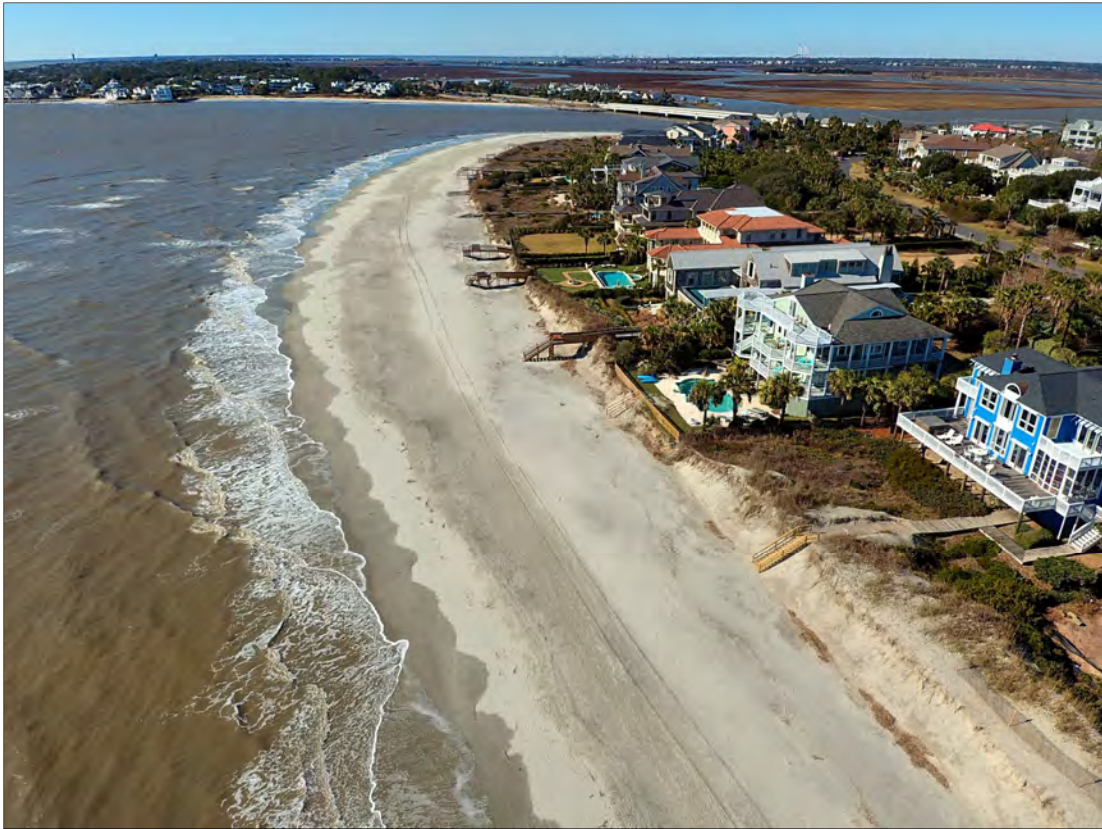
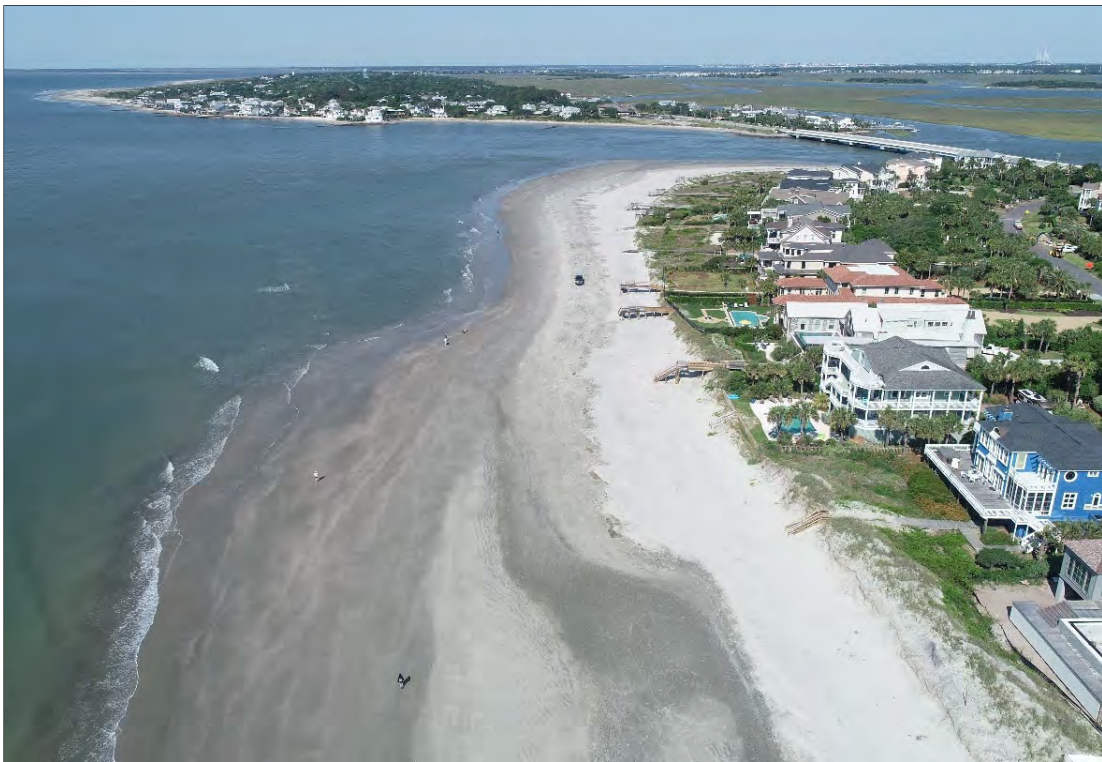
**FIGURE 4.31.** Aerial photos taken in December 2019 (upper) and June 2020 (lower) show significant accretion along the southern end of Isle of Palms.
