December 21, 2012

RE: P/N 2010-1041-2IG – Isle of Palms Shoal Management Project [CSE 2384]
Request for permit modification

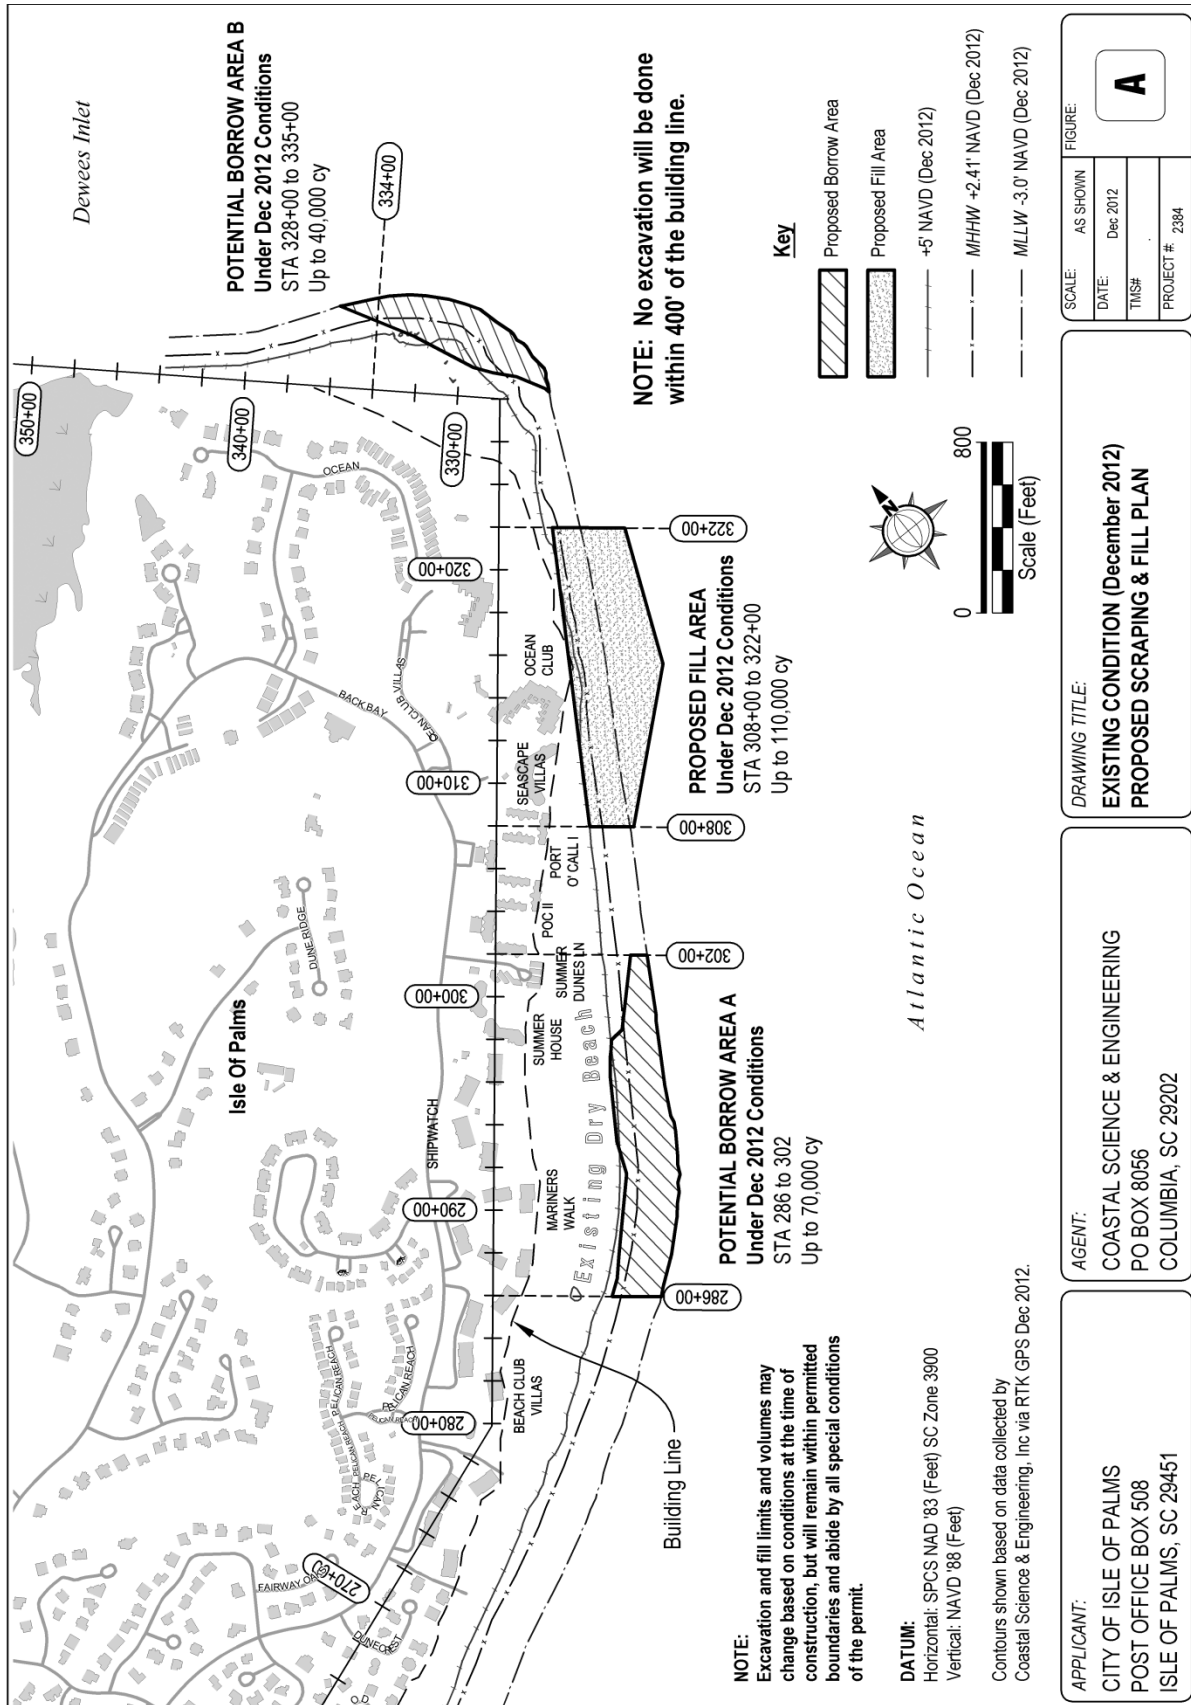
Figure 1. General construction plan for a winter 2013 scraping project if a permit modification is granted.

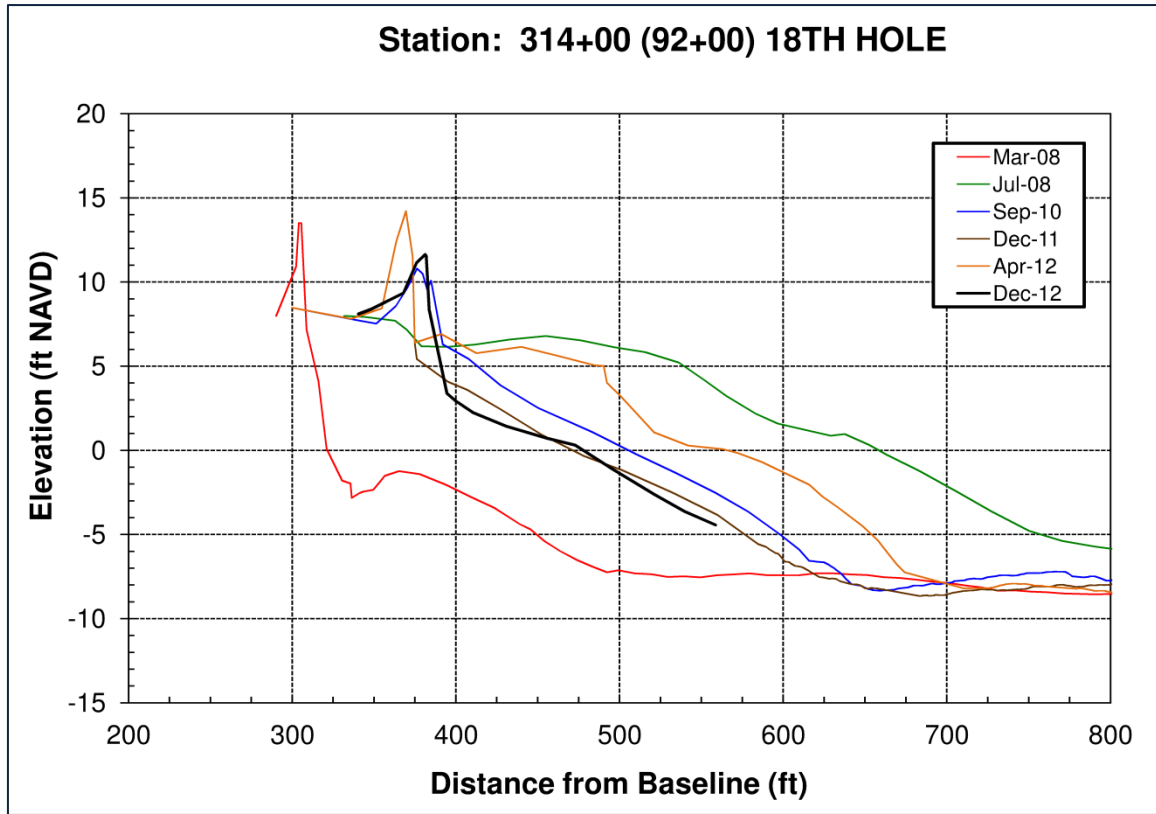
- 1) The 100 ft trigger has been met along a portion of the project area (Figure 2). Erosion has led to loss of dune area and is impacting walkovers and infrastructure. CSE expects erosion in the area to continue, and perhaps worsen over the next year due to the ongoing shoal-bypass event. Some type of erosion mitigation will be required to ensure that the ocean does not encroach on buildings.

Beach profiles from station 314+00 (Ocean Club) are shown in Figure 2. The red line represents the pre-nourishment profile of March 2008. Large-scale nourishment (via offshore dredge) restored the beach and added over 200 ft of beach width at this site. Erosion was rapid through 2010, then slowed through 2011. Presently, there is ~80 ft more beach compared to the pre-nourishment condition; however, the high-water line has breached dunes and threatens infrastructure. This threat has led to multiple additions of sand via small-scale inland trucking operations at high cost. As of this writing, private property owners have placed ~9,000 cy of sand at a cost of roughly \$176,000 (~20 dollars per cy). These small additions do little to offer protection during above-average tides or storm events, and due to the current erosional processes described above, are short lived.

Figure 2. Beach profiles from Station 314+00, at Ocean Club and the 18th green. The red and green lines represent the pre and post-2008-nourishment profiles, respectively.

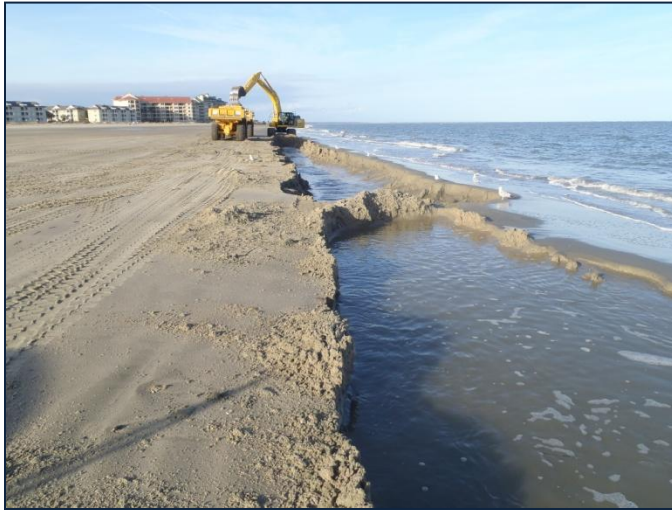
Figure 3.

Left: Typical excavations during the 2012 scraping project. Narrow channels were excavated following the tide.

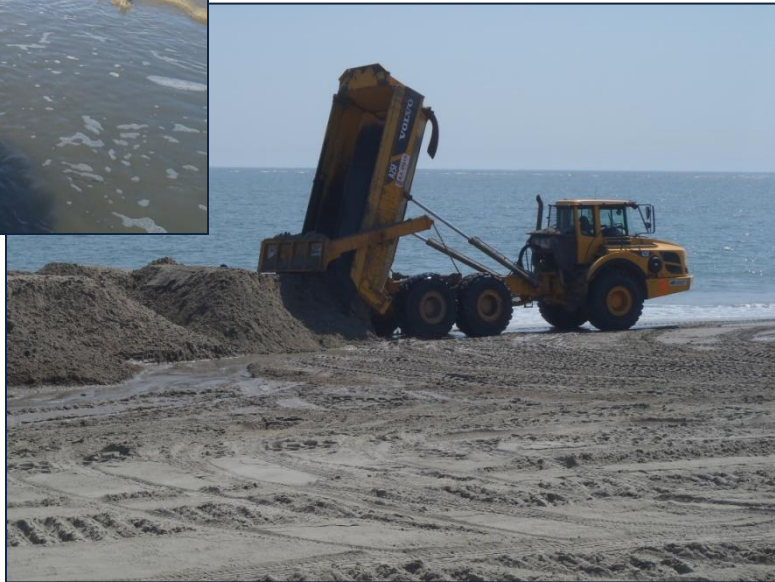
Below: Sand was placed in piles and the ensuing tide was allowed to shape the fill naturally.

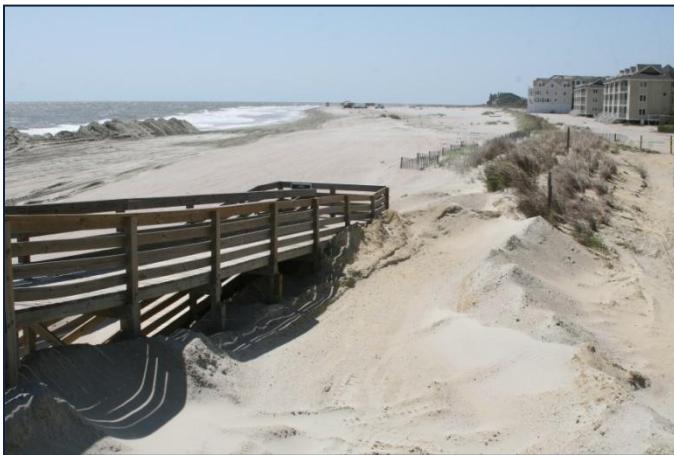
Above: The fill area near project completion in April 2012.

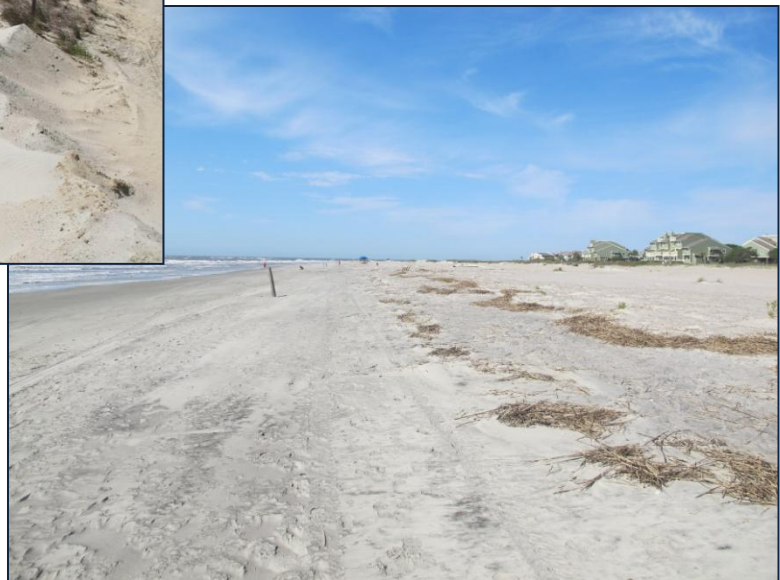
Right: The borrow area ~2 weeks after project completion in April 2012. No evidence of sand borrowing remained and the beach maintained a natural slope.

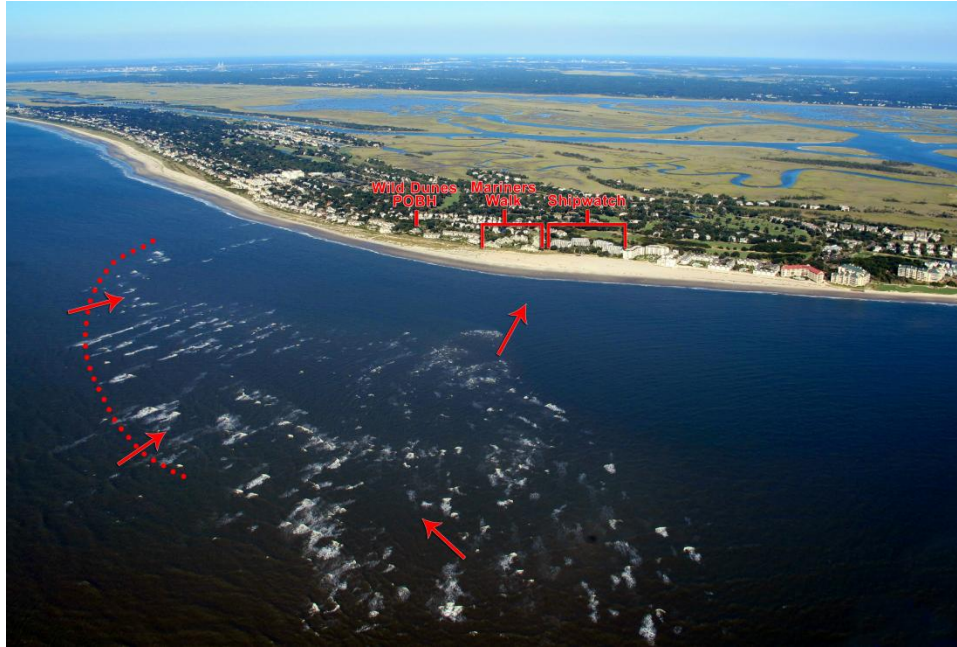
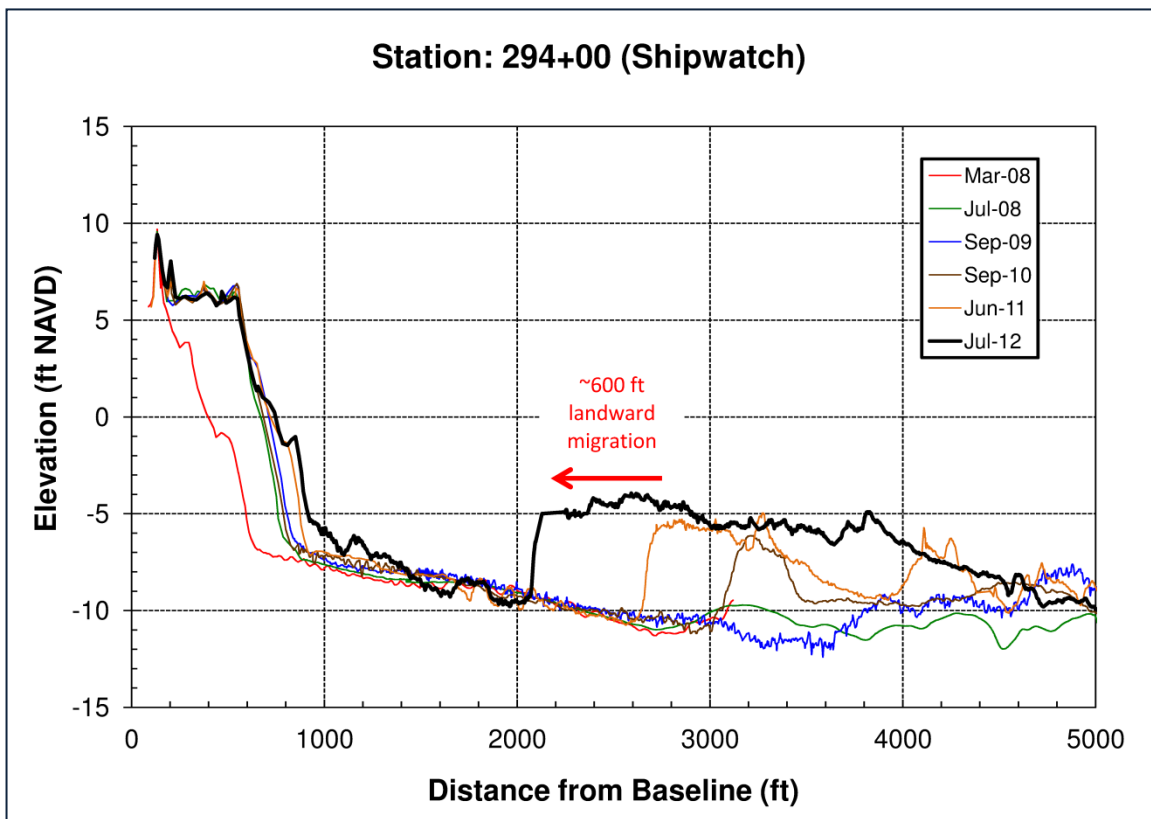
Since completion of the 2012 scraping project, nearly all the sand placed in the fill area has eroded and shifted to the north and south. Over 50% was lost between project completion in April and late July. Fall storms and Hurricane Sandy in late October removed the balance. The borrow area has generally remained stable and shows early stages of buildup as the offshore shoal moves closer to the beach (presently its leading edge is situated ~1,000 ft from Mariners Walk and it has been migrating landward at about 600 ft/yr – CSE 2012, Figure 4 in Appendix A).

Figure 4: [Upper] September 2012 aerial image of the northeast end of Isle of Palms. Breaking waves indicate the extent of shoal sand which is migrating towards the beach. The arrow in the center of the image shows the leading edge of the shoal offshore of Shipwatch, which was ~1,200 ft from the beach in July 2012. [Lower] Profiles from station 294 (Shipwatch) showing a ~600 ft/yr migration rate of the offshore shoal over the past year.

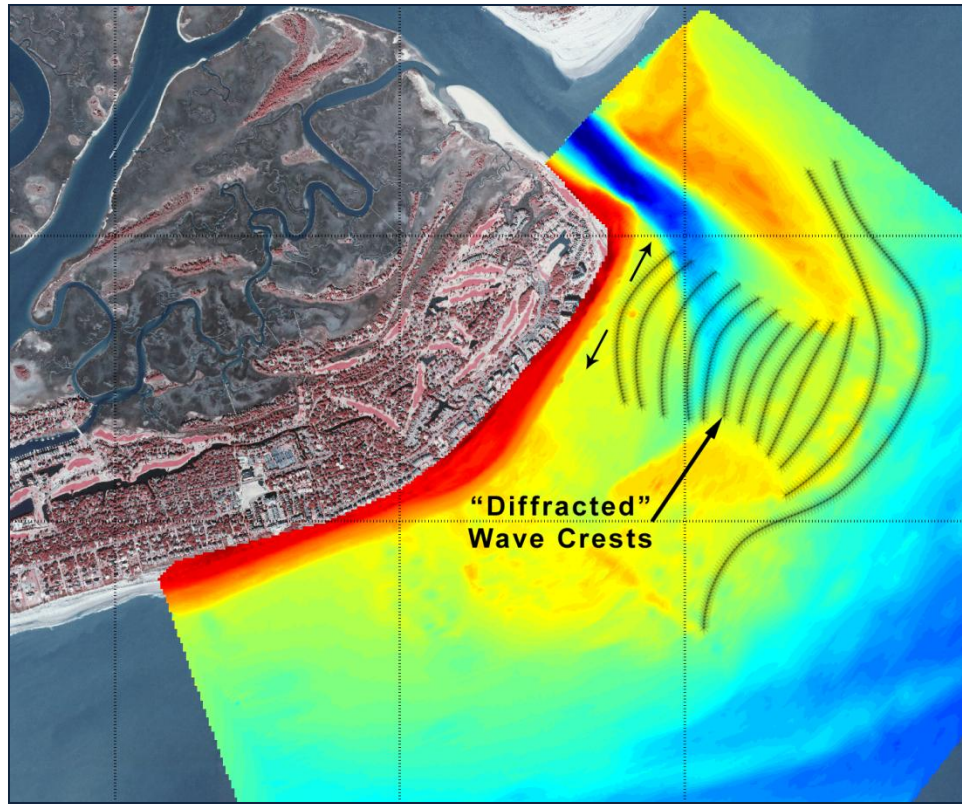
- 1) Limited quantity of sand moved, which was well below the volume anticipated in each scraping event under the permit.
- 2) Wave focusing (Figure 5 in Appendix A) through the new Dewees Inlet channel, which is presently positioned directly offshore of the fill area (near Ocean Club and the 18th hole of the Links Course). A channel break in the delta shoals allows larger waves to focus on the landward shoreline. Wave diffraction through the gap in the shoals directs sediment transport away from the center of the impact area (in this case, the erosion hotspot near Ocean Club).

Figure 5: Wave focusing through the gap in the inlet delta creates an erosional hotspot near Ocean Club and the 18th hole. A channel avulsion event occurring over the past 4 years has relocated the channel from a southerly location to the present location.

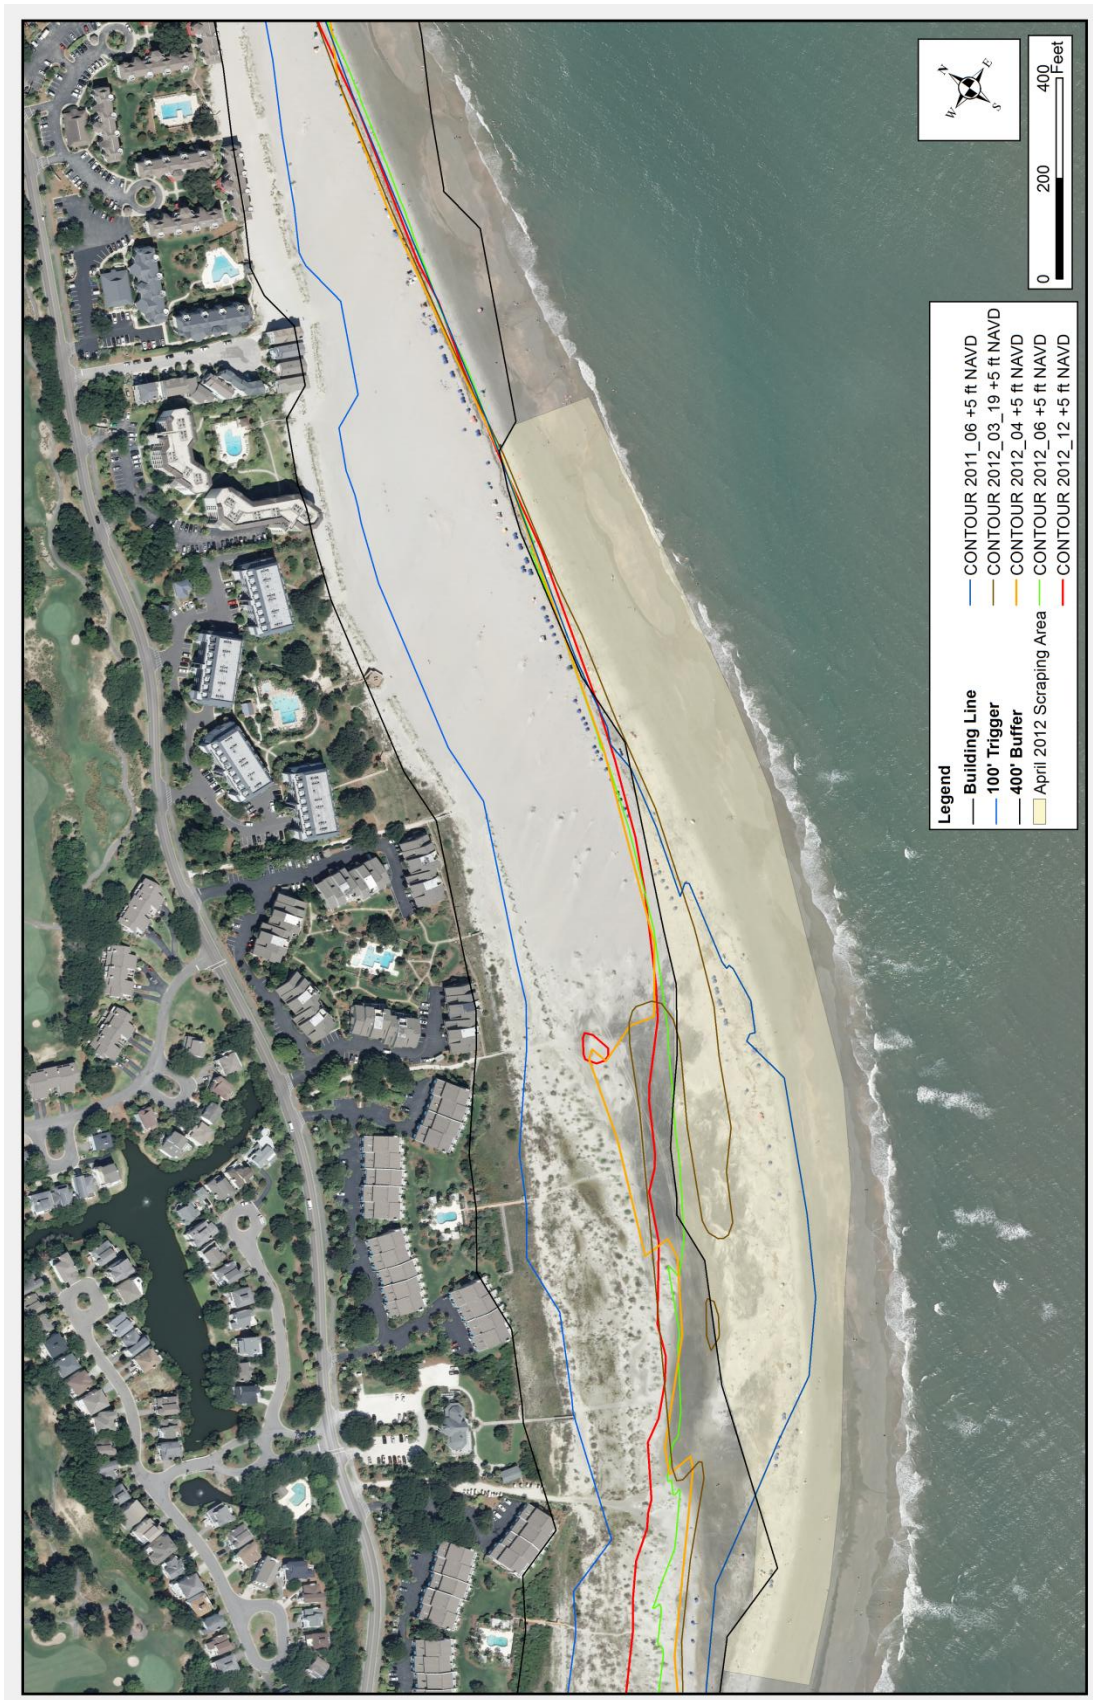
Figures 6-8 show the location of the +5 ft NAVD contour (approximate normal high-tide swash line) for 5 surveys between June 2011 and December 2012. Note that the background image was obtained in July 2011 and the beach condition has changed significantly since then, especially at the western end of the 2012 scraping areas (highlighted yellow area). At the 2012 borrow area (Fig 6), the western end of the area retreated between June 2011 and March 2012, before significant scraping had taken place. This retreat was due to sand losses from the previous shoal bypass events. This area is where oncoming shoals attached to the beach between 2007 and 2010, leading to a significant “bulge” in the shoreline and a wide beach. This area has eroded following attachment as the shoreline attempts to reach a more linear morphology. The eastern end of the borrow area has remained very stable over the past 1.5 years (and since large-scale nourishment in 2008). This is true despite removal of sand during the 2012 project.

Figure 6. Location on the +5 ft NAVD contour for recent dates along the northeast end of Isle of Palms. The borrow area for the 2012 scraping project is highlighted in yellow. Background imagery was obtained July 2011

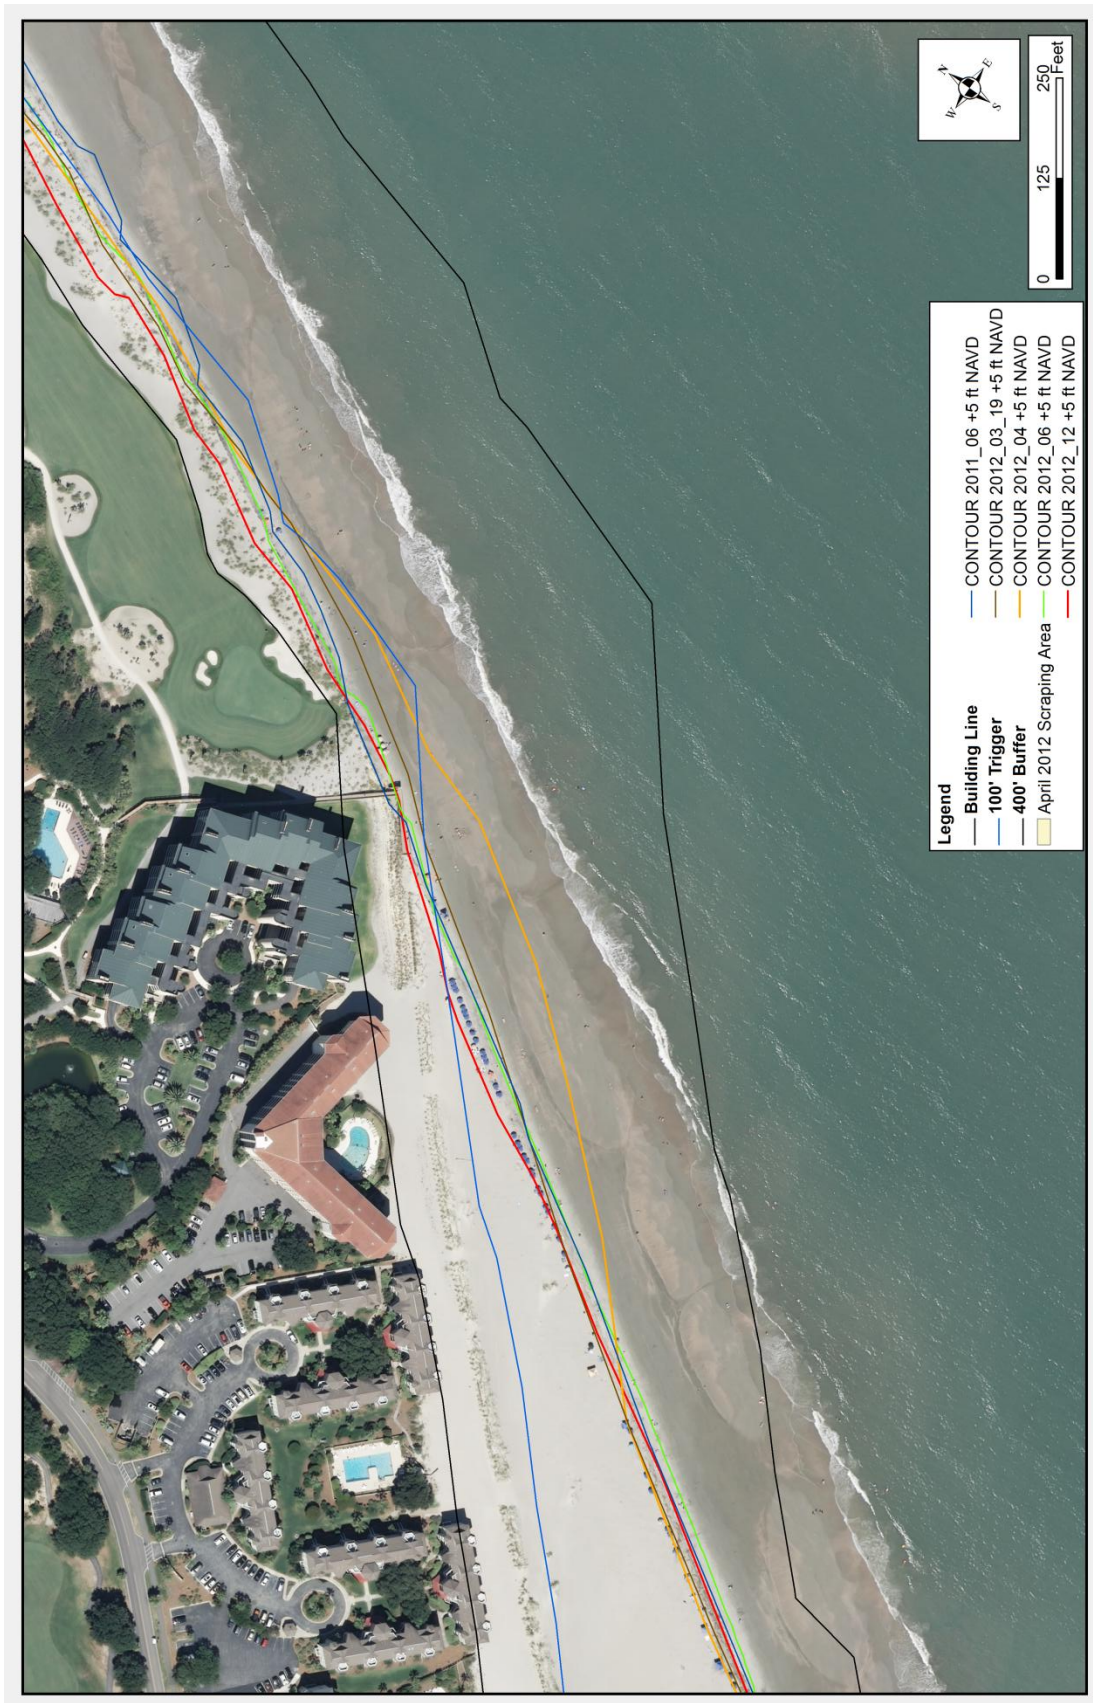
The 2012 fill area (stations 308-320 in Figure 1) is the location of the erosion hotspot, and has been fairly stable along the western portion of the image, and erosional at the central and eastern portion (near Ocean Club and the 18th hole). The effects of the 2012 project are visible in the seaward displacement of the April 2012 contour (orange line) compared to the June 2011 line (blue line). By July 2012 (green line), the contour had essentially returned to the June 2011 condition, and by December 2012 (red line), the contour is landward of the 2011 condition everywhere except at the Ocean Club walkover. This is a loss of ~100 ft of beach width since April 2012. The seaward displacement of the contour in December 2012 at Ocean Club is due to placement of upland sand by the property owners to rebuild a dune following Hurricane Sandy. The beach condition has reached a point where water no dunes remain in front of Ocean Club and the 18th hole. Water has breached the dune line along the fairway of the 18th hole and has entered bunkers and portions of the fairway.

Figure 7. Location on the +5 ft NAVD contour for recent dates along the northeast end of Isle of Palms. This area was the location of the 2012 scraping project fill area. Background imagery was obtained July 2011.

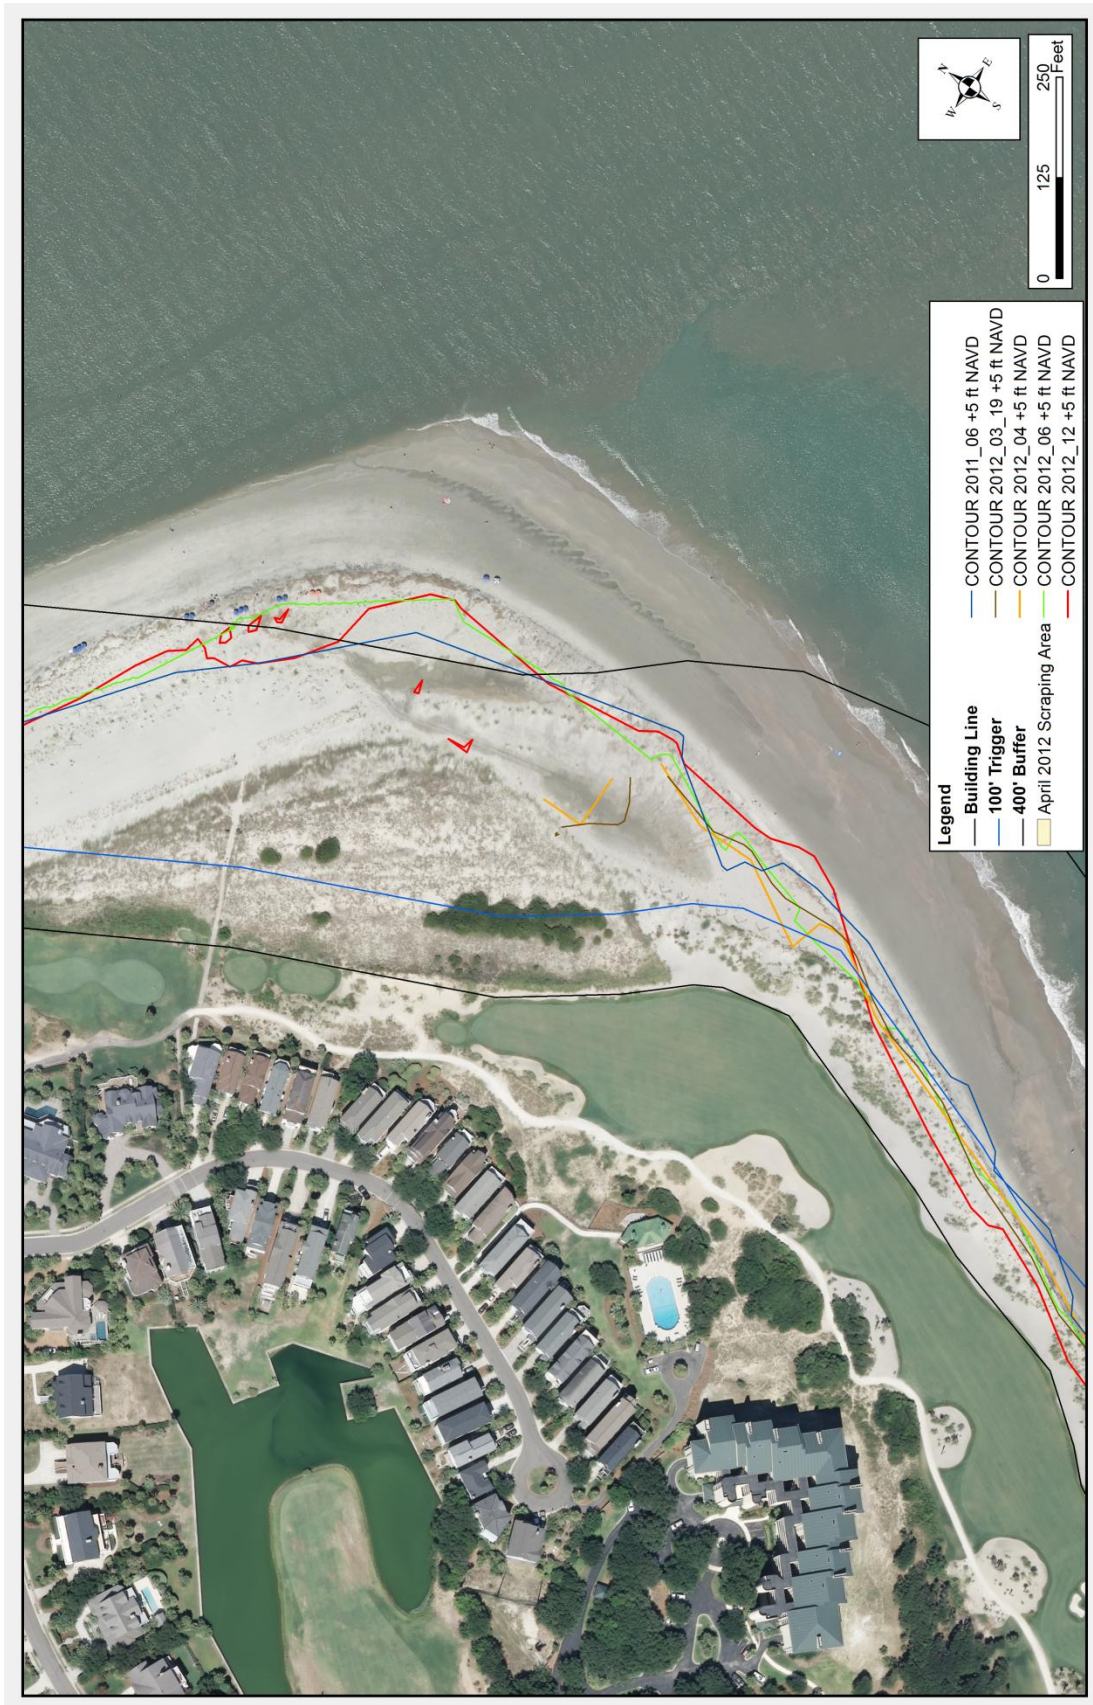
Figure 8. Location on the +5 ft NAVD contour for recent dates along the northeast end of Isle of Palms. This image shows the northeastern point of the island, and may be used as a borrow source under the existing permit.
