RE: Hurricane *Irma* Beach Damage Assessment [CSE 2453-*IRMA*]

Volume Change in the 2008 Engineered Beach Area

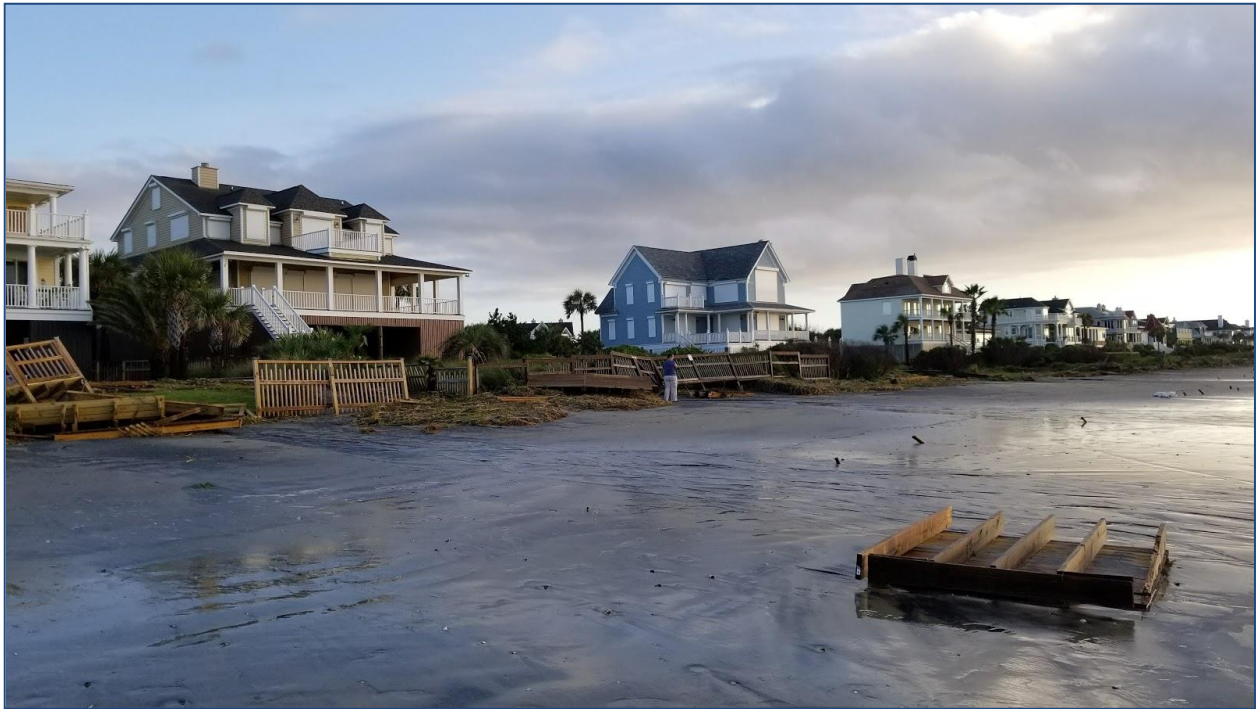
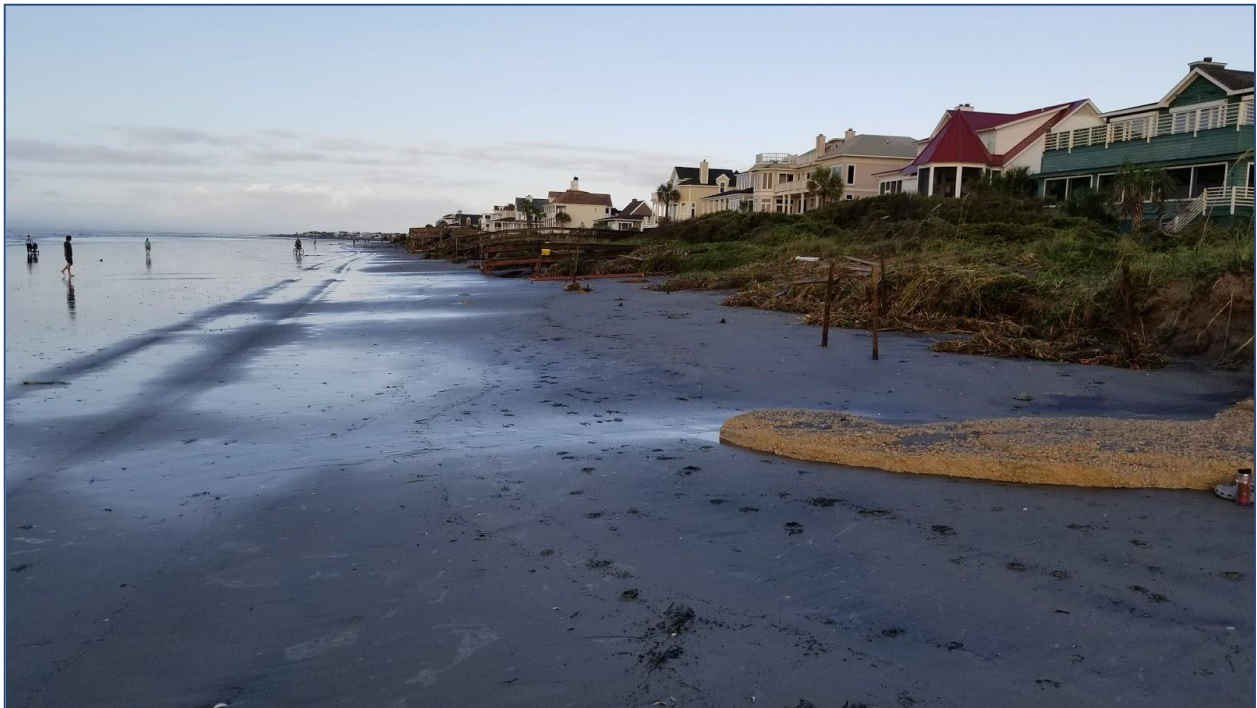
Impacts along the island were variable with some stations gaining volume during the storm and others eroding (see profiles and volume changes in Attachment 1). Generally, most stations lost sand in the upper beach profile (dune and dry-sand beach). Most stations showed a corresponding growth of an underwater sandbar, which compensated for losses higher in the profile. The exception was the area between 54th Avenue and Shipwatch (stations 226–296), which mostly lost sand along the entire profile. Along the south end of the island, all of the emergency berm which was constructed following Hurricane *Matthew* (2016) was eroded, and additional upland area was also lost. CSE considered the area between Breach Inlet and 10th Avenue to be eminently threatened should another storm event occur. CSE recommended the City conduct a beach-scraping project to construct an emergency berm to prevent further damage in this area (west limit 32°46'32.89", 79°48'38.64"; east limit 32°47'01.50", 79°47'24.90").

Photos from Isle of Palms following Hurricane *Irma*. These photos show the general beach condition along the southern end of the island.

Sand scraping was completed between 13 September and 24 October 2017 via an emergency contract issued to Robert Collins Company. The contract was for scraping an emergency berm ~6 ft high and ~20 ft wide using sand from the low-tide beach in accordance with State Emergency Order 17-EO-HI 3, State Permit 2016-00803, and USACE Authorizations SAC-2014-00299, SAC 2017-01418, and SAC 2017-01419. The total cost of the scraping work was \$246,200.

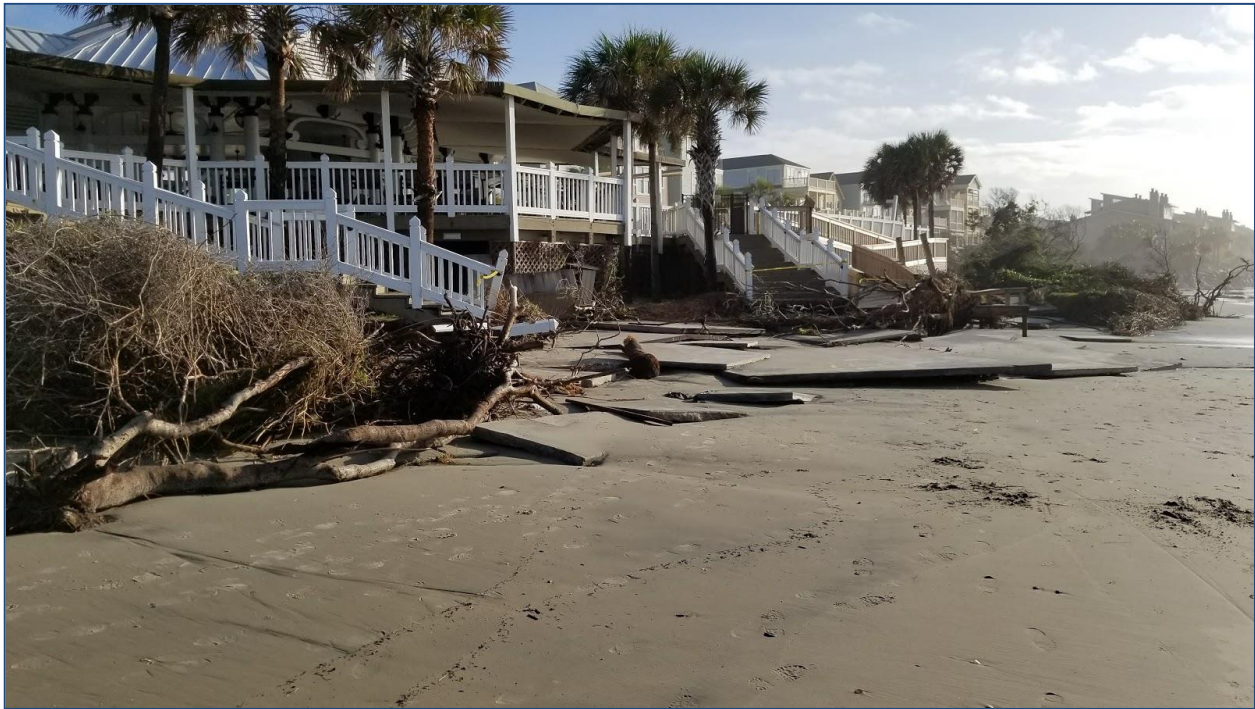
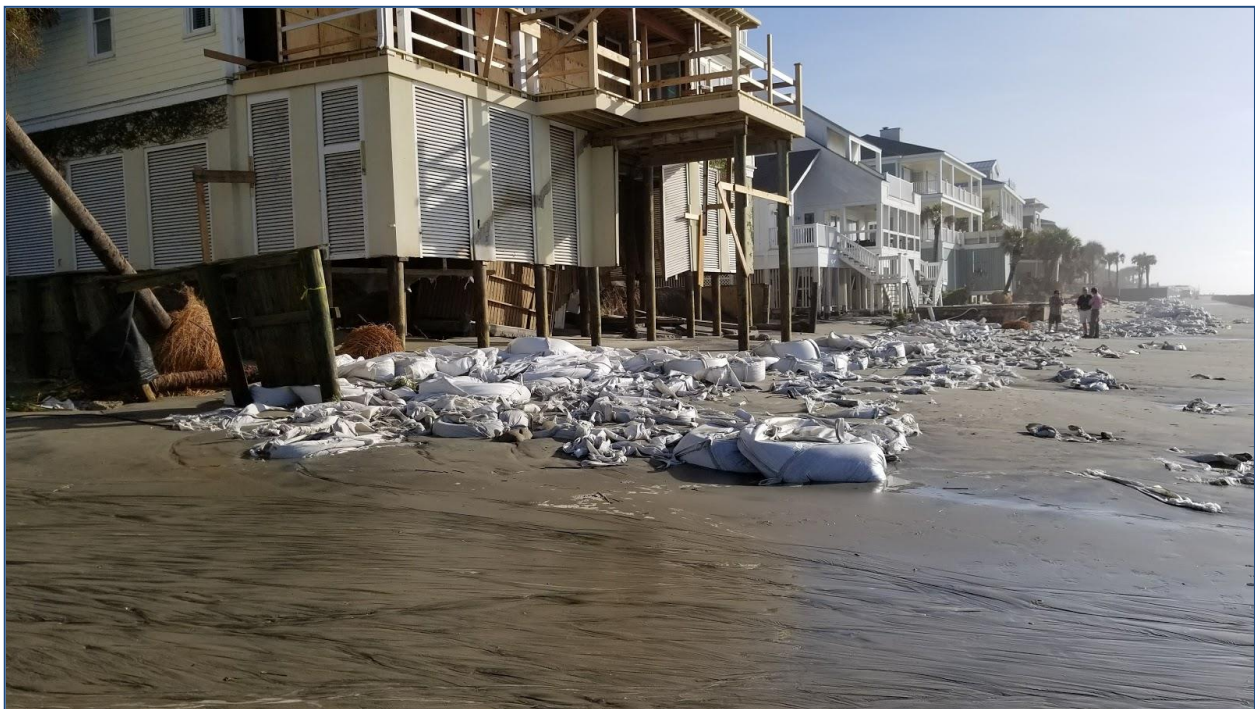
CSE also recommended emergency berm construction along portions of Wild Dunes, including the area fronting the Grand Pavilion and Beachwood East (west limit 32°48'05.00", 79°44'18.93"; east limit 32°48'14.44", 79°43'49.70"). These areas suffered structural damage to walkovers or sand overwashing onto streets and had no dune or dry-sand beach following Hurricane *Irma*. Properties here are likely to suffer additional damage with future minor storm events or significant high tides.

Photos from Isle of Palms following Hurricane *Irma*. These photos show the beach condition near the Wild Dunes Grand Pavilion (upper) and along Beachwood East (lower).
