**2018 Isle of Palms Restoration Project
Year 3 Monitoring Report**

2021
MONITORING REPORT

2018 Isle of Palms Restoration Project
Year 3 (2021) Monitoring Report
Annual Beach and Inshore Surveys

[2492YR3 — Monitoring Year 3]

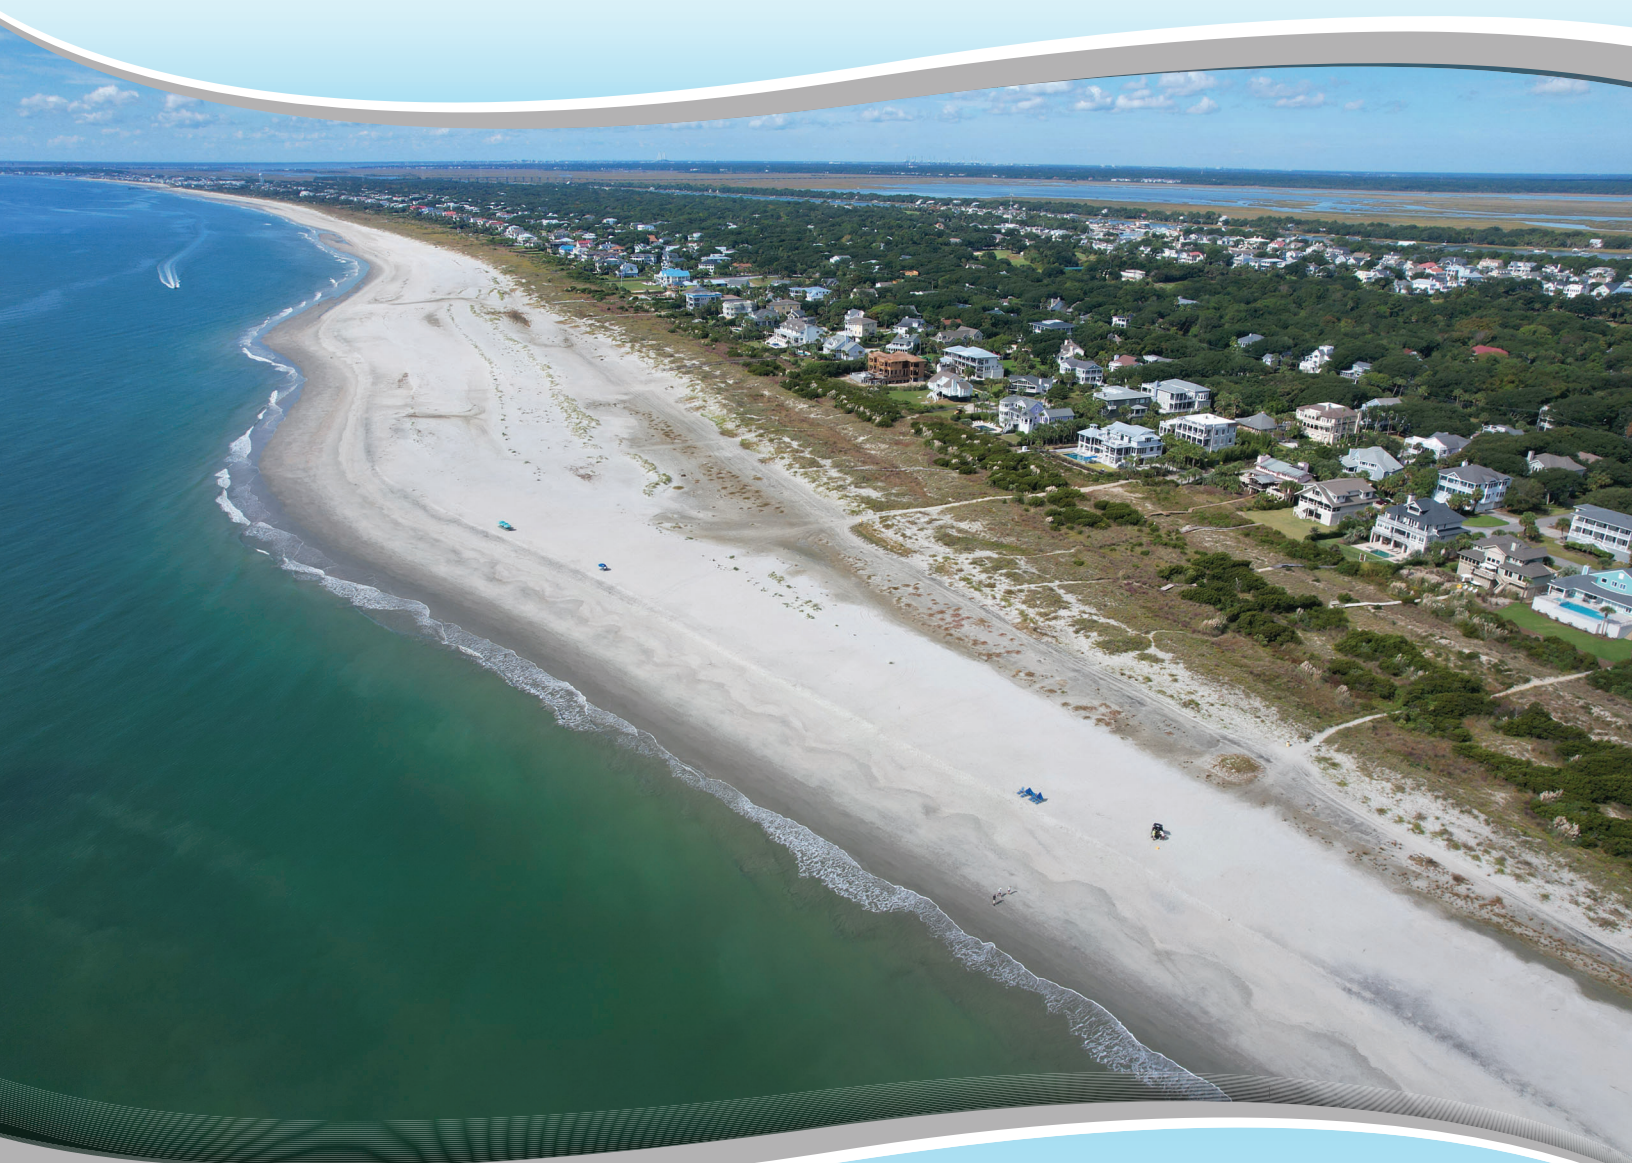
COVER PHOTO: This image was collected in October 2021 from above the beach access path between 54th Ave and 55th Ave, looking southwest towards the Pier. There is a notable seaward bulge in the water line between 45th Ave and 55th Ave, which is the result of the 2018 renourishment project sand migrating with prevailing waves, winds, and currents. This bulge is known as a sand wave and is a common occurrence along shorelines adjacent to recently-completed nourishment projects. This particular wave is expected to continue moving towards the pier and gradually become smaller.

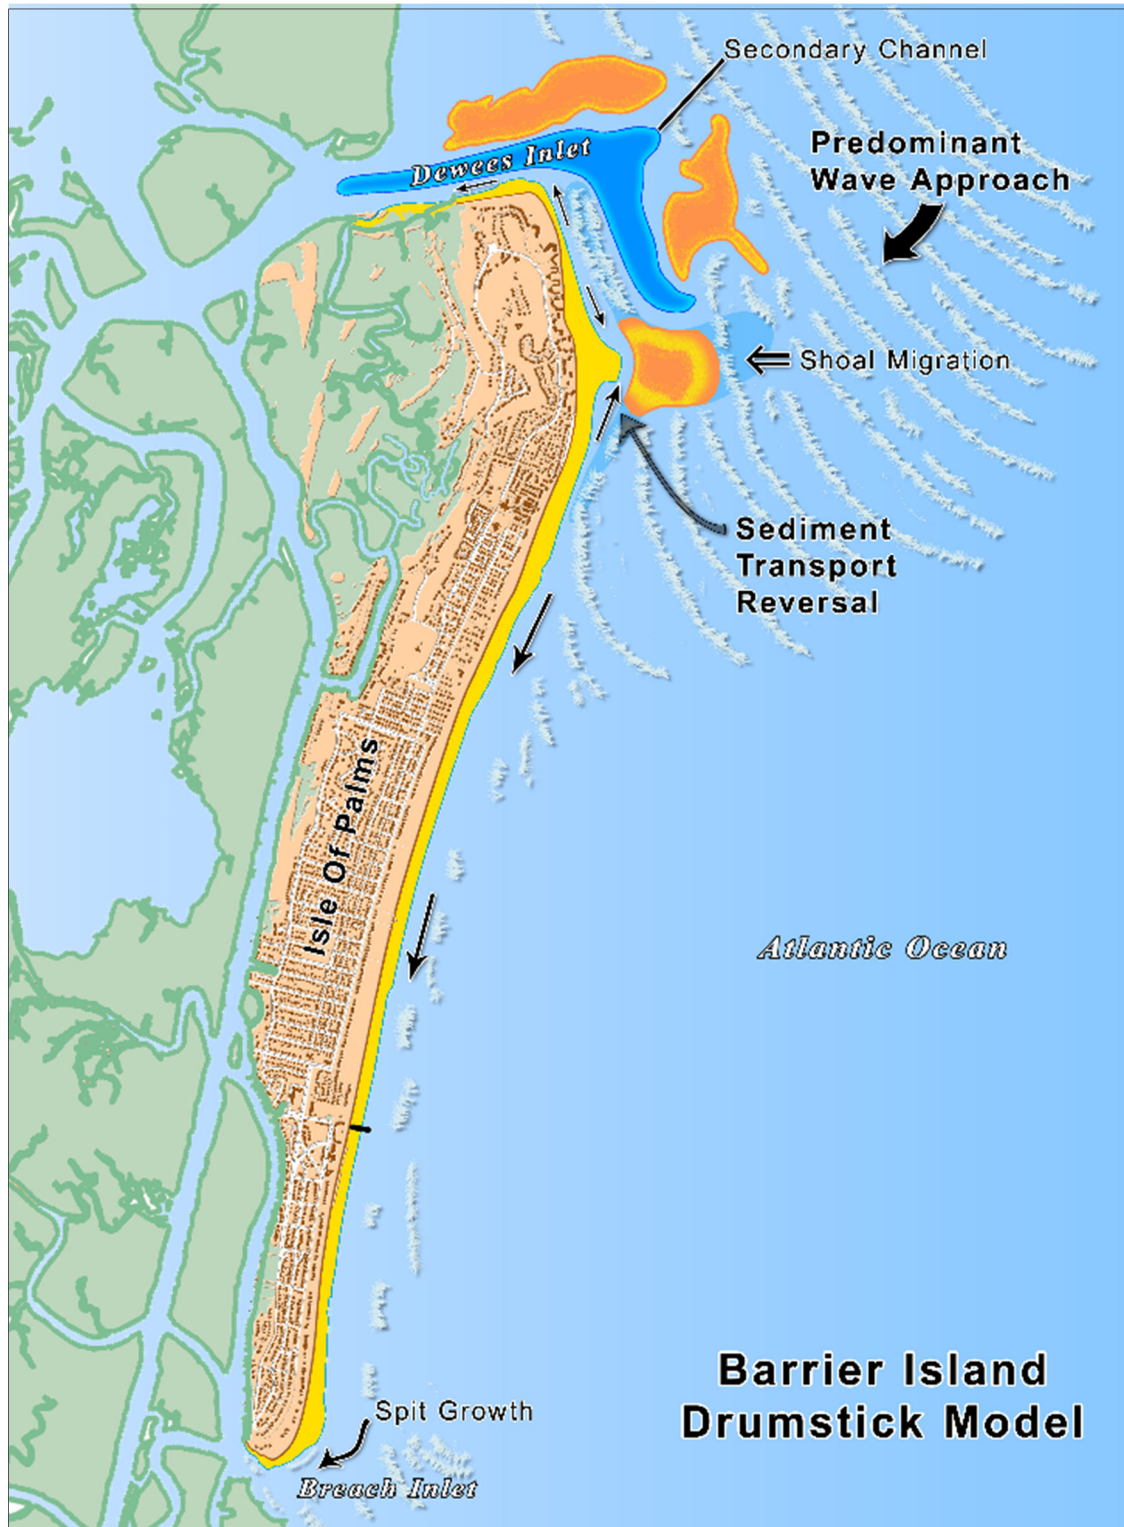
FIGURE 2.1. Schematic of the Isle of Palms showing the wider northeast end characteristic of a “drumstick” barrier island.

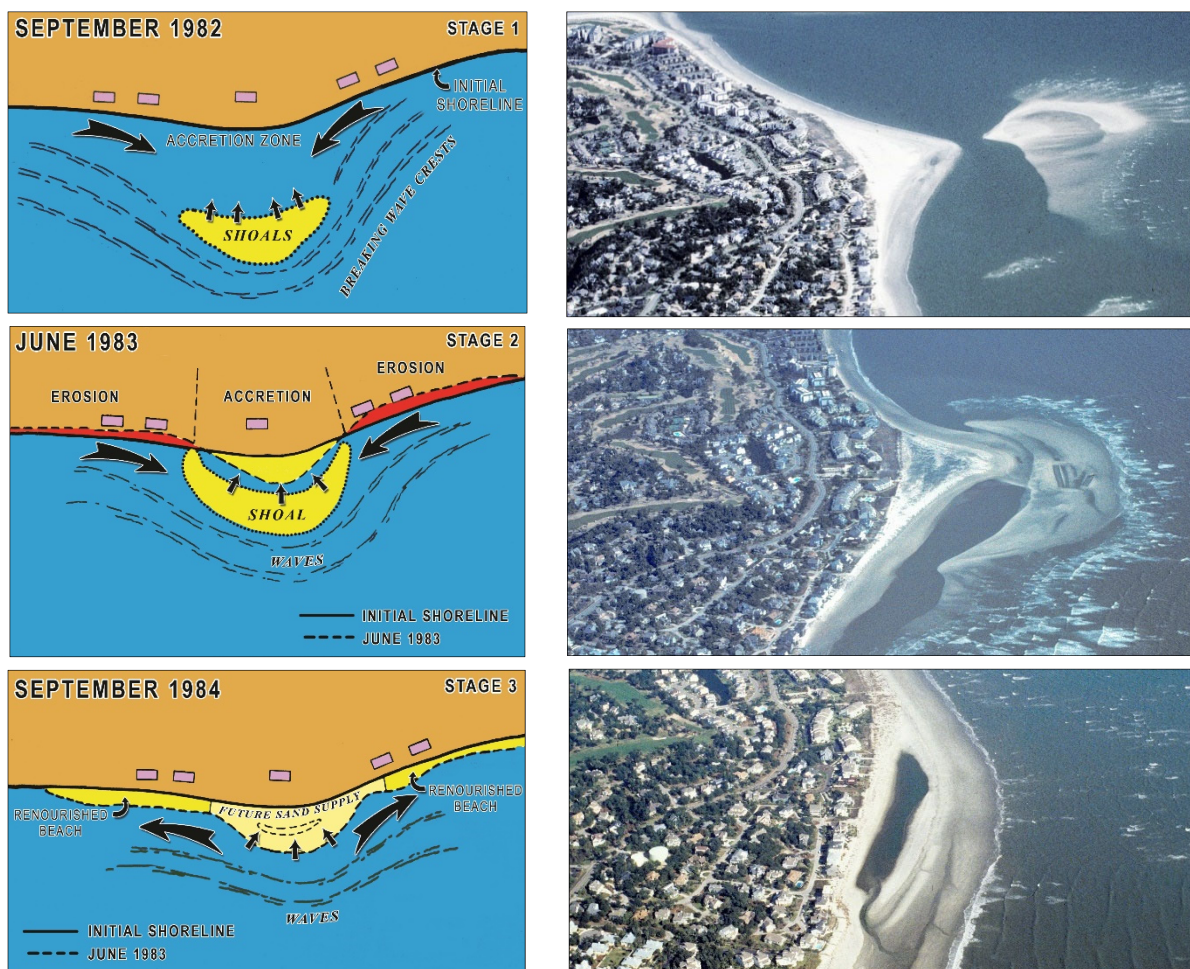
FIGURE 2.3. [LEFT] Schematic of the shoal-bypass cycle originally modeled from a bypass event at Isle of Palms. [RIGHT] A shoal-bypass event at northeastern Isle of Palms corresponding to the schematic. The upper photo shows a shoal in Stage 1 (1996). The middle image illustrates Stage 2 (1997). The bottom photo shows Stage 3 (1998).

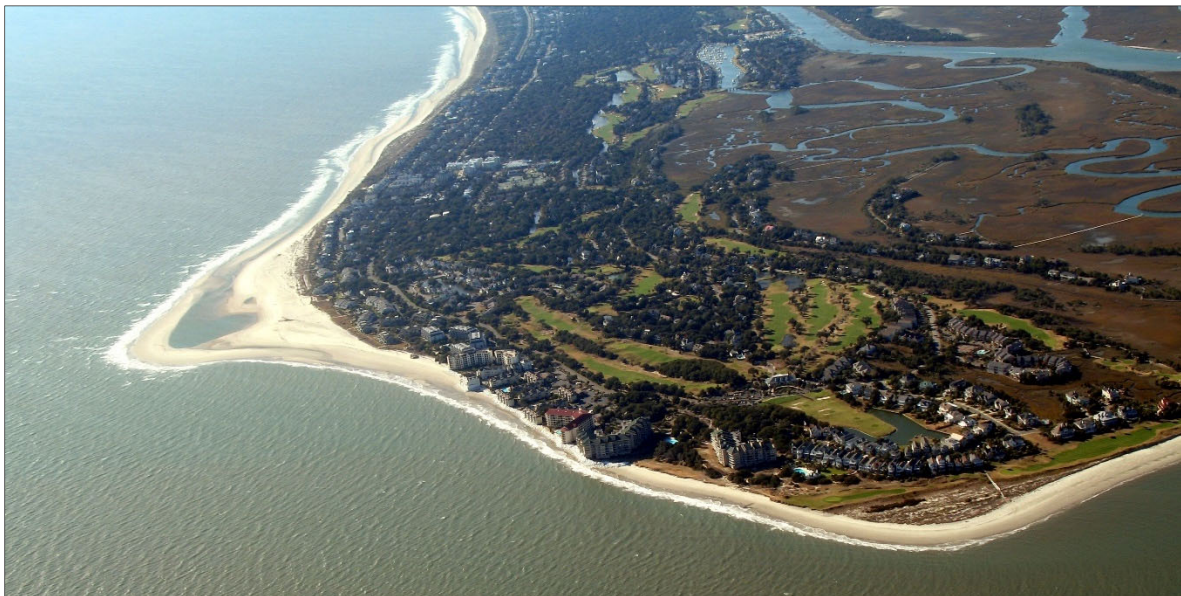
Erosion reached such a severe condition in 2007 that there was little-to-no beach along portions of the east end of the island, even at low tide (Figure 2.6). The Wild Dunes Community Association contracted with CSE to evaluate the causes of erosion and prepare a feasibility study outlining alternatives for restoration (CSE 2007). CSE recommended nourishing the beach using sand from an offshore borrow area and began the steps to obtain a permit for the work. The City of Isle of Palms then took ownership of the project and served as the applicant for the permits. Permits were obtained (P/N 2007-02631-2IG), and the City contracted with Weeks Marine for a project involving nourishment of 847,000 cy of sand over 10,200 lf (linear feet) of beach. The project extended from 200 ft north of 53rd Avenue to the 17th green of the Links Course.

FIGURE 2.6. Isle of Palms in 2007 prior to beach nourishment.

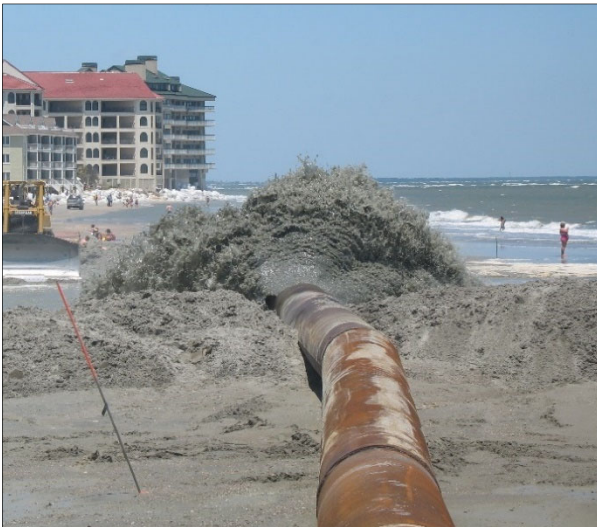
FIGURE 2.7. [ABOVE] 2008 beach nourishment project (completed on 15 July 2008).

The 2008 project was completed between 15 May and 15 July 2008 (Figure 2.7). As part of the project, Weeks Marine removed all sandbags from the project area, which totaled ~9,400 bags. Homeowners removed an additional 4,680 bags from under buildings. Averaging ~25,000 cy of sand per day, the dredge *RS Weeks* pumped sand from three borrow areas 2–3 miles from the beach. The nourishment was placed in three reaches and included ~270,000 cy between 53rd Ave and Dune Crest Ln (Reach A), 552,400 cy from Mariners Walk to the 18th Fairway (Reach B), and 25,000 cy from the 18th tee to the 17th fairway (Reach C). Figure 2.8 shows the layout of the 2008 project. Figure 2.9 shows a post-project aerial photo (2008) which compares to the project area before renourishment (2007).

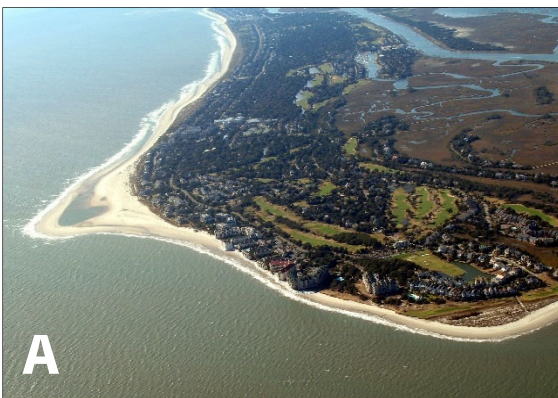
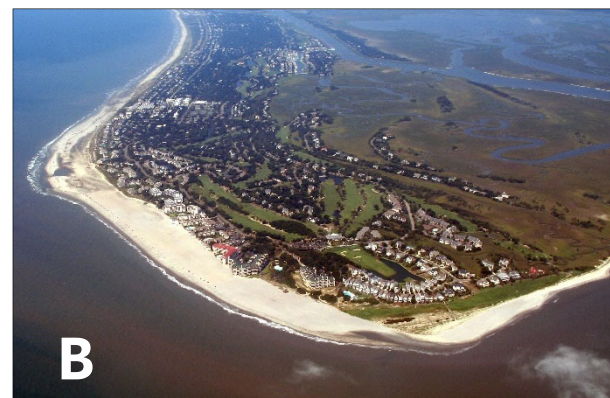
FIGURE 2.9. [LEFT] Isle of Palms in 2007 prior to nourishment. **[RIGHT]** The project area in 2008 following nourishment

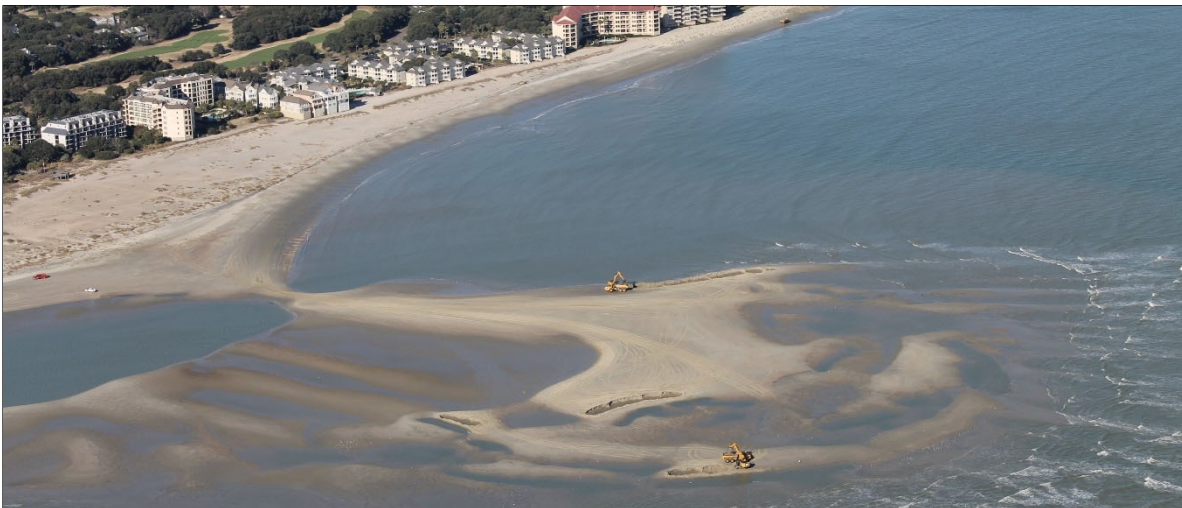
FIGURE 2.10. January 2015 aerial image of the 2014–2015 shoal management project showing equipment transferring sand from an attaching shoal to the eroded beach.

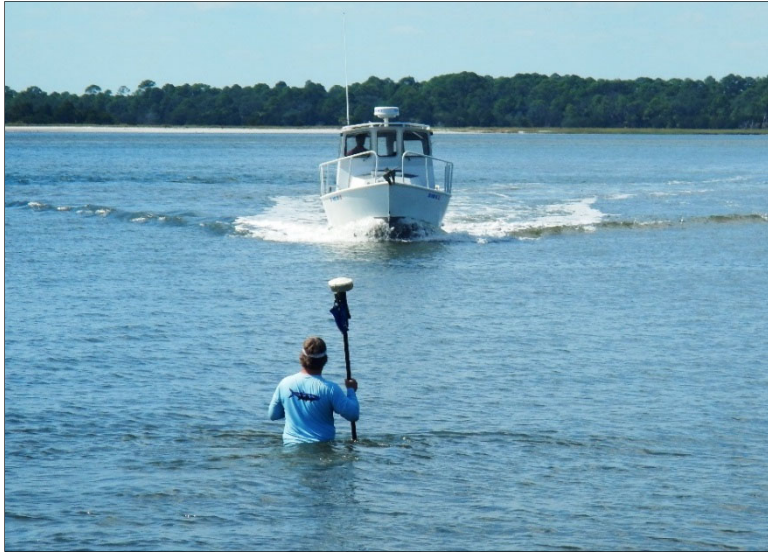
FIGURE 3.2.

Surveying beach profiles involve collection of land-based data at low tide and hydrographic data collection overlapping the land-based work.

Topographic data were collected via RTK-GPS (Trimble™ R10 GNSS), which provides position and elevation measurements at centimeter accuracy. Beach profiles were obtained by collecting data at low tide along the dunes, berm, and active beach to low-tide wading depth. Overwater work was then performed at high tide to overlap the land-based work (Fig 3.2) and was collected with RTK-GPS coupled with an Odom CV100™ precision echosounder mounted on CSE’s survey vessel, the *RV Southern Echo*.

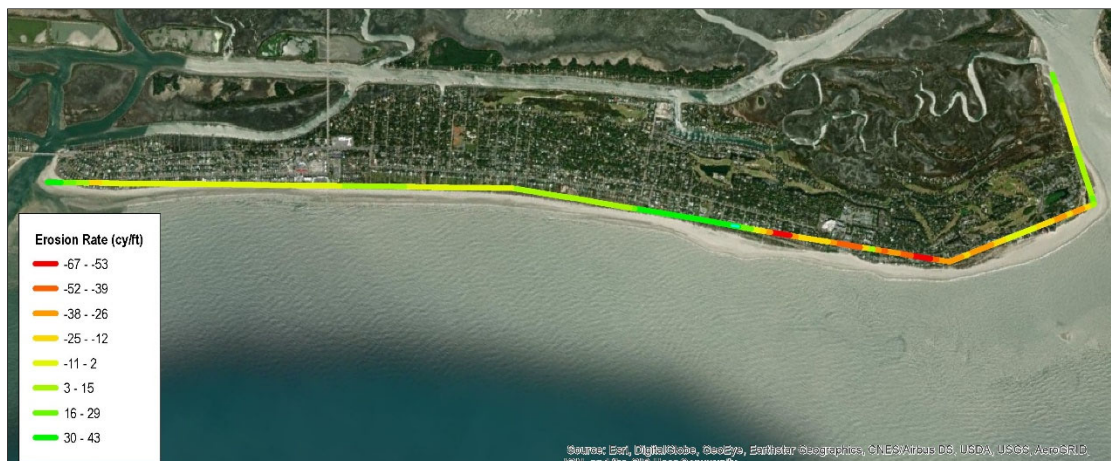
The Isle of Palms beach lost ~191,200 cy of sand between June 2020 and July 2021. This compares to a loss of 59,605 cy of sand between June 2019 and June 2020. Figure 4.1 shows a map of the island with the distribution of volume change as colored lines. In the figure, warmer colors indicate erosion, while cooler colors show areas that gained sand. Erosion dominated the east end of the island (2018 project area), while much of the beach south of 53rd Ave gained volume. As observed in the past several surveys, erosion was most severe along Dunecrest Lane and Beach Club Villas. Accretion was most pronounced between 31st and 53rd Ave. Figure 4.2 graphs the beach volume change for each surveyed profile. Across the entire island, the beach holds ~1,159,900 cy more sand than the 2017 pre-nourishment condition and ~914,300 cy more sand than in 2009 (Figure 4.3). Details of beach volume change for each reach of the island are discussed in the following sections.

FIGURE 4.1. Line map showing erosion and accretion patterns over Isle of Palms from April 2019 – July 2021.

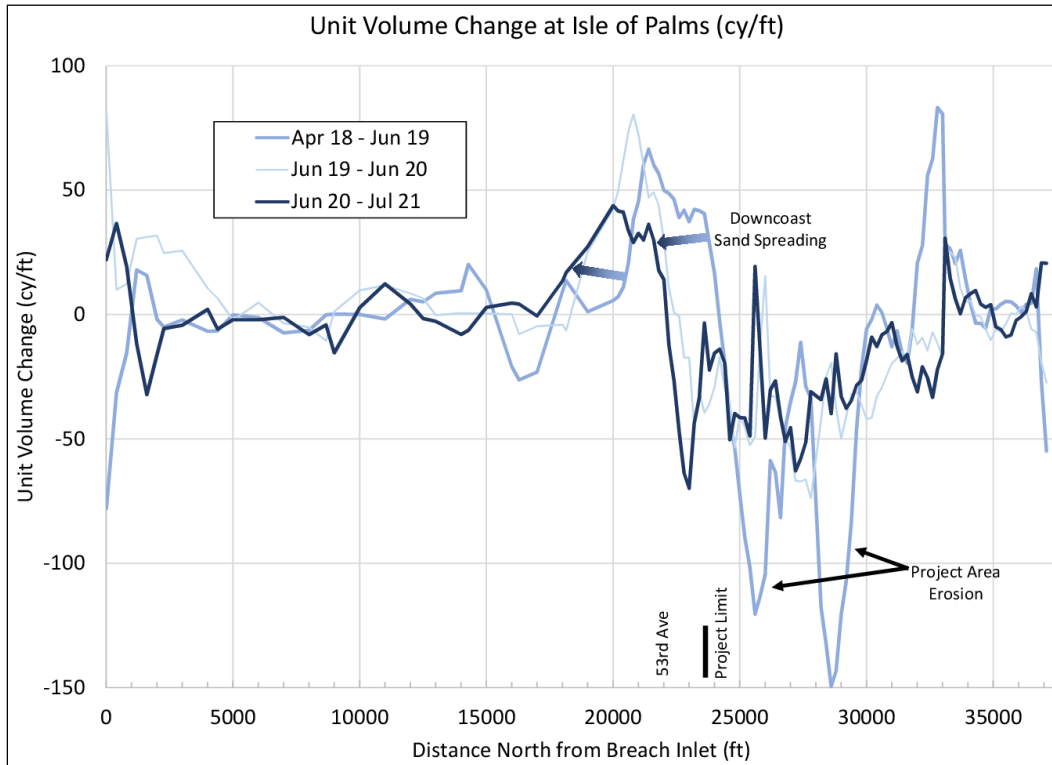
FIGURE 4.2. Beach unit volume change from 2018–2019, 2019–2020, and 2020–2021 for each monitoring line at Isle of Palms. The X axis represents distance from Breach Inlet in feet. This graph highlights the erosion occurring in the project area and accumulation of spreading sand adjacent to the project area.

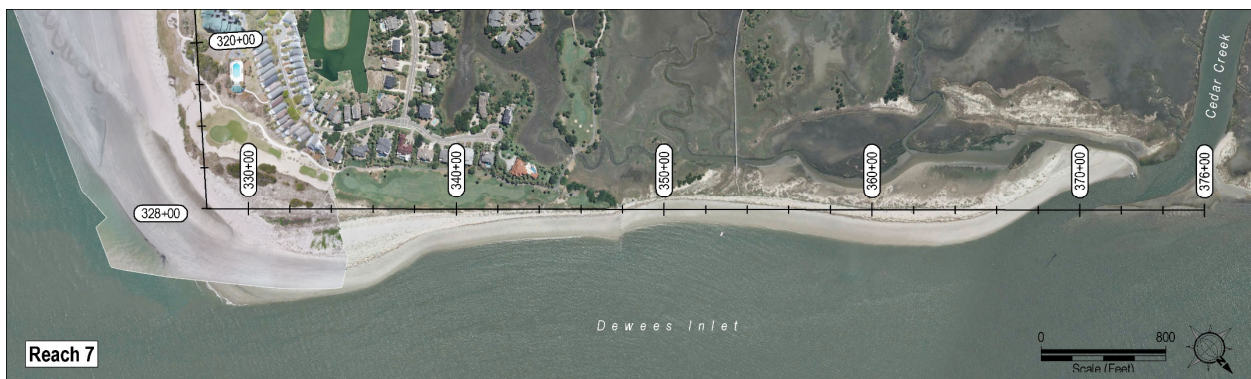
FIGURE 4.4. Baseline stationing along Reach 7 encompassing the length of beach between lines 330 and 370.

Reach 7 encompasses the length of beach between lines 330 and 370 that span the shoreline fronting the Dewees Inlet channel (Figure 4.4). The inlet shoals shelter large waves from impacting this portion of beach, resulting in the profile generally showing a narrow dry sand berm and a steep beach face. The steep beach face reduces the total profile volume needed for a stable profile compared to oceanfront areas. The seaward end of the reach was included in the 2008 nourishment project and remained relatively stable in the following years. The healthy condition in 2018 did not require nourishment as part of the last project, and this condition has persisted through the 2021 survey.

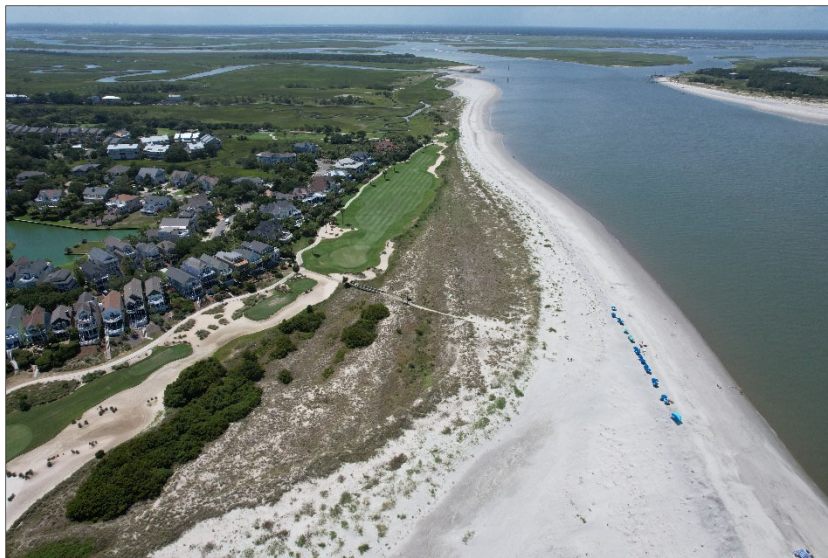
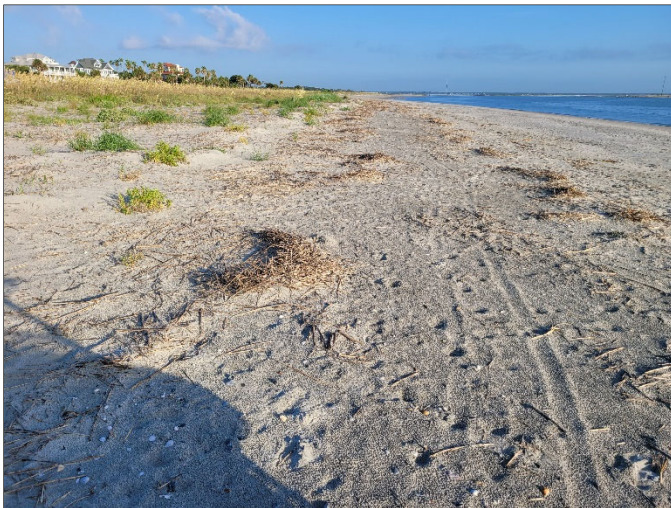
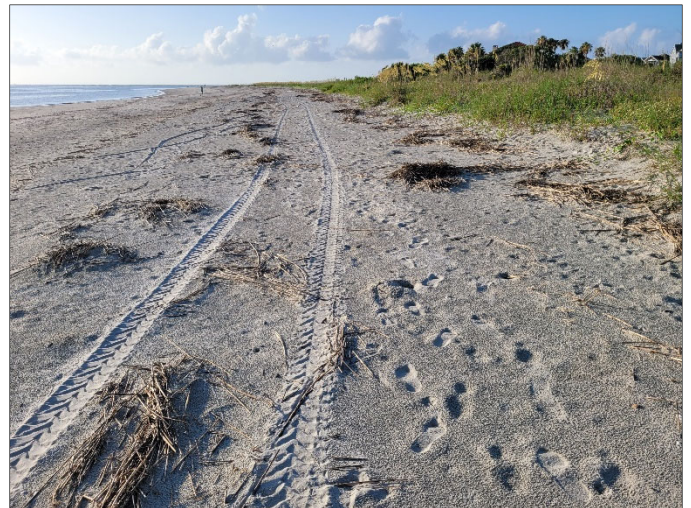
FIGURE 4.6.

[UPPER] Beach profiles from Reach 7.

[MIDDLE] Aerial photo of Reach 7 collected July 2021.

[LOWER] Ground photos from Station 334 **[LEFT]** looking landward and Station 350 looking seaward **[RIGHT]** in July 2021.

with the area gaining approximately 150 ft in width and increasing in elevation. Stations further inland were more stable, as shown in the profiles from Station 334. Ground photos from Station 334 show unvegetated dry sand with scattered beach wrack and grasses, indicating stability and colonization of dune-building species. Photos from further inland also show a very healthy dry sand beach with a vegetated dune well landward of the typical high tide line (Fig 4.6).

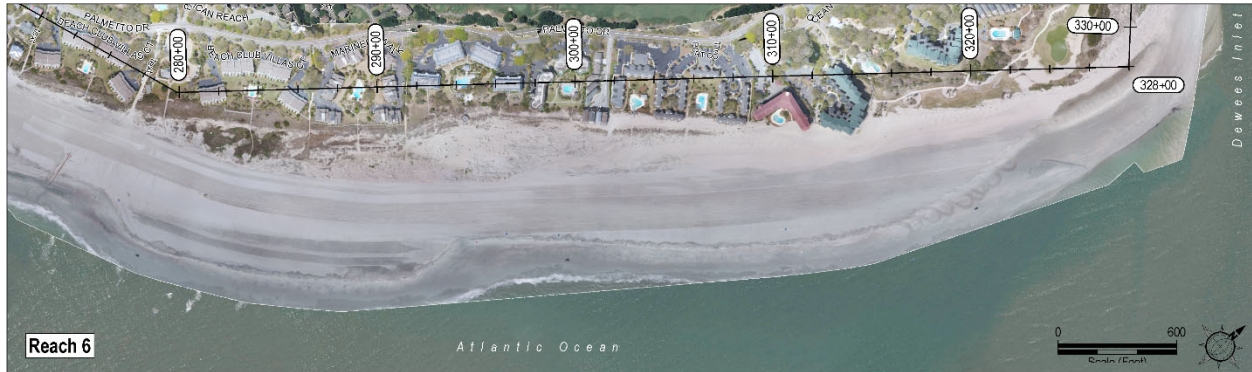
FIGURE 4.7. Baseline stationing along Reach 6 encompassing ~4,900 lf of beach between Wild Dunes Property Owners Beach House and the 18th Hole of the Links Course.

Reach 6 encompasses ~4,900 linear feet of beach between the Wild Dunes Property Owners Beach House (Station 280) and the 18th Hole of the Links Course (Station 328+00) (Figure 4.7). Along with Reach 5, shoal bypass events directly impact this length of beach. Depending on the location of bypass events, the shoreline can move hundreds of feet over a few months (Kana et al 1985, Gaudiano 1998). As a result, the waterline periodically encroaches on properties along this reach.

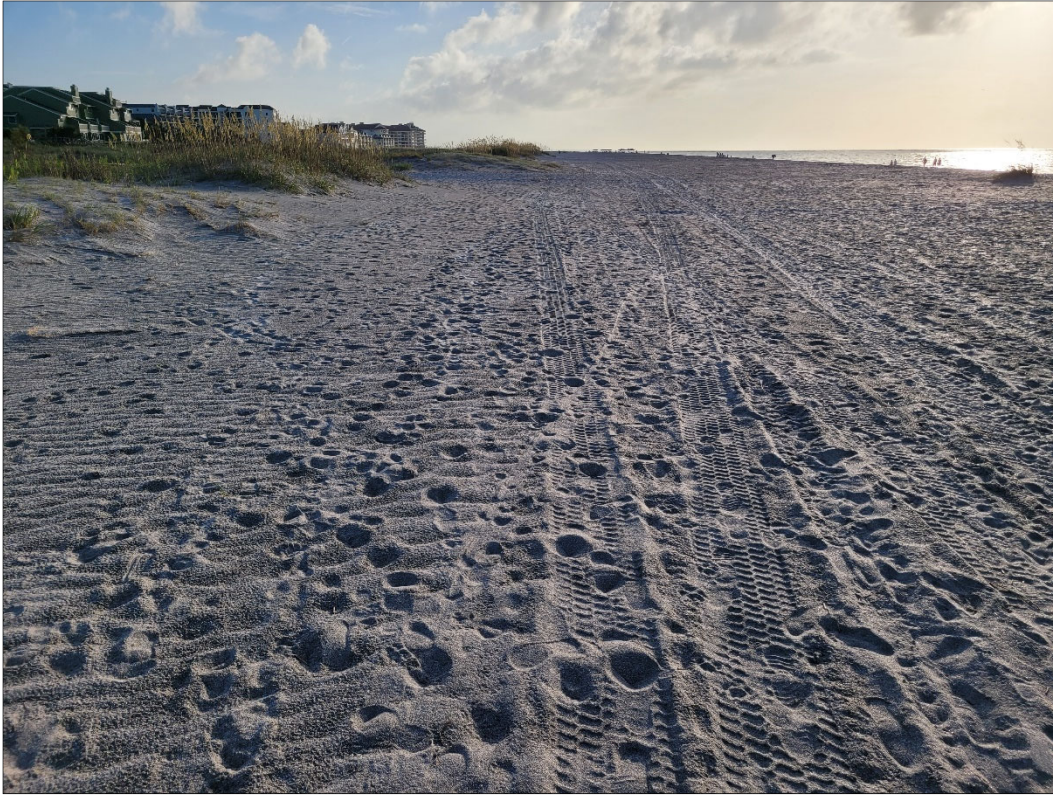
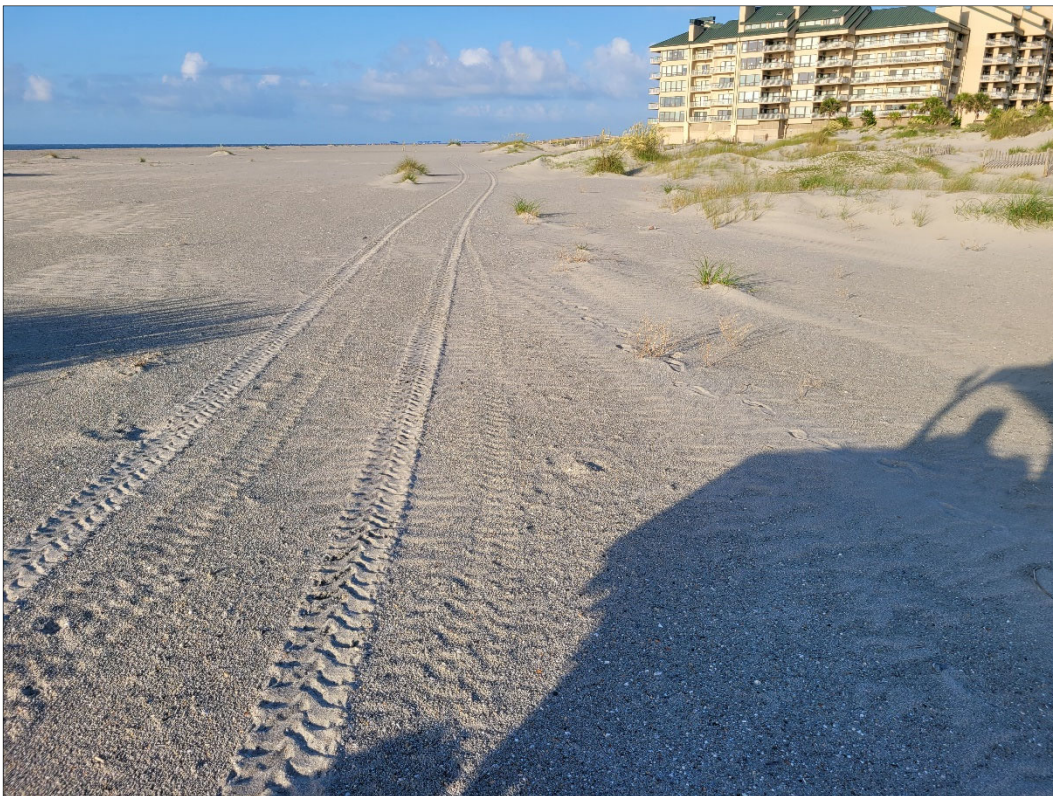
FIGURE 4.10. Ground photos from Station 284 [UPPER] and Station 320 [LOWER] in July 2021. As of July 2021, the seawardmost Ocean Club units were >400 ft from the normal high tide line.

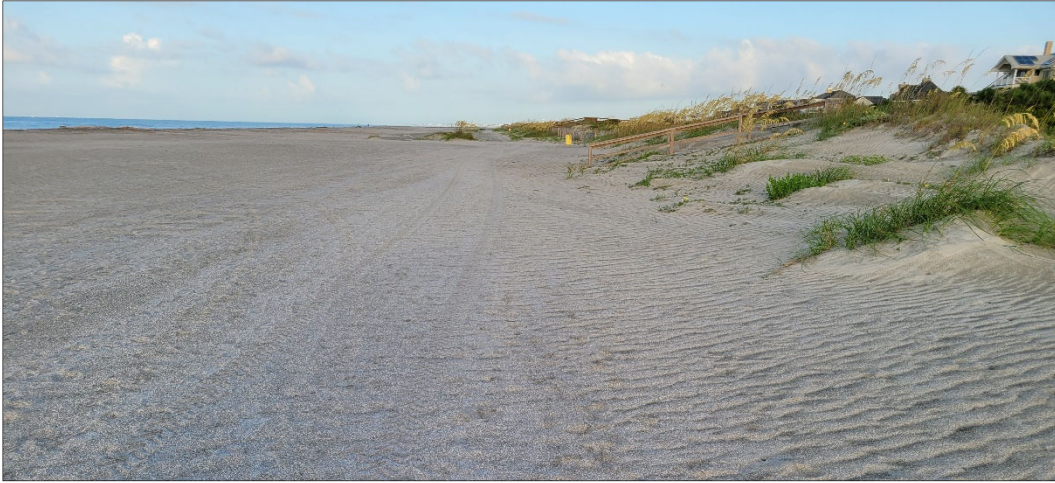
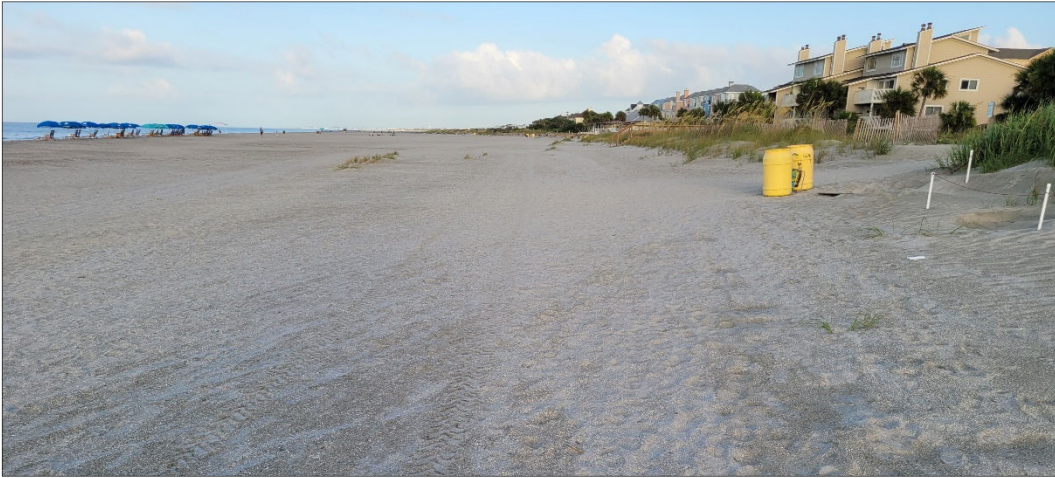
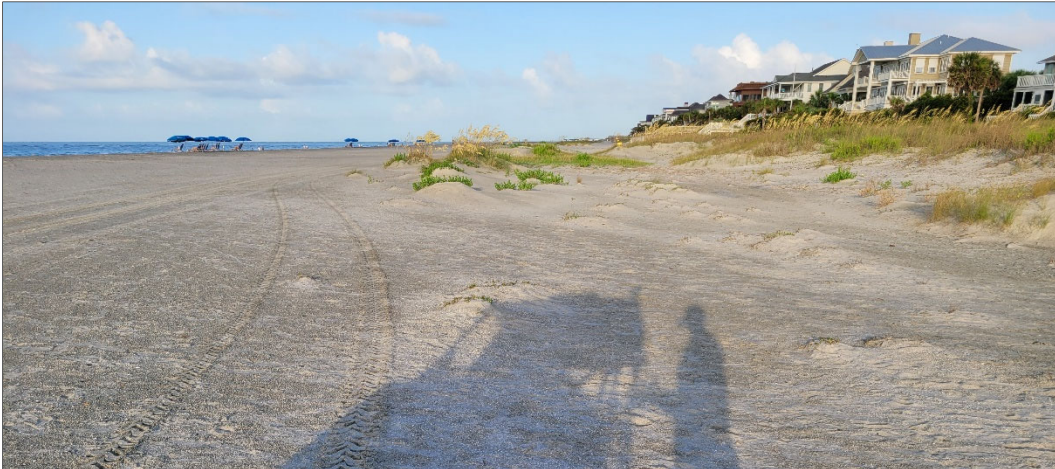
FIGURE 4.14. Ground photos of Reach 6 in July 2021 showing Station 240 [UPPER], Station 256 [MIDDLE], and Station 276 [LOWER].

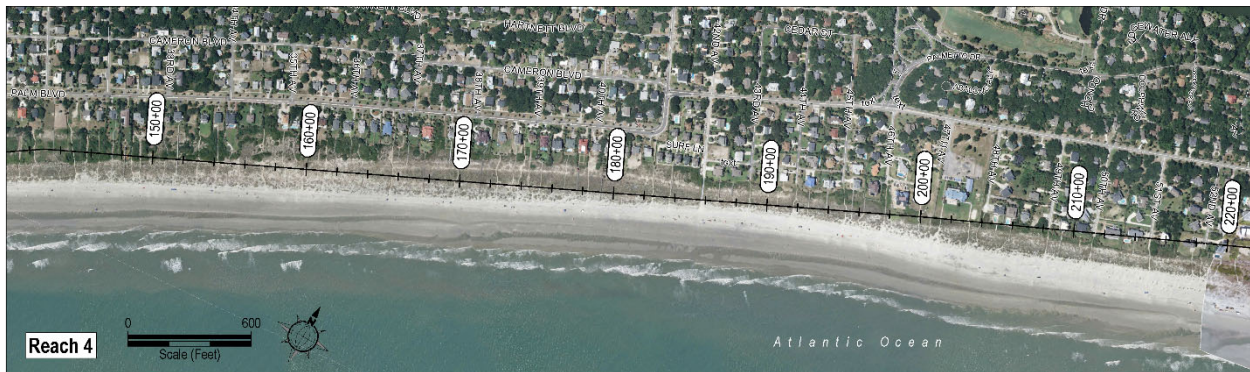
FIGURE 4.17. Baseline stationing along Reach 4 spanning the length of beach between 31st Ave and 53rd Ave.

Reach 4 includes the length of beach between 31st and 53rd Avenues (stations OCRM 3140 to CSE 222+00 – Fig 4.17 and Fig 4.18). This reach is ~7,910 ft long and immediately downdrift of the 2008 and 2018 project area. It is also outside of the direct influence of Dewees Inlet and maintains a more typical and consistent beach profile shape. By being positioned downdrift of the nourishment area, it receives nourishment sand spreading from the placement area as well as spreading shoal sand. The reach has gained sand every year since 2009 except for 2016, the year after Hurricane *Matthew* impacted Isle of Palms.

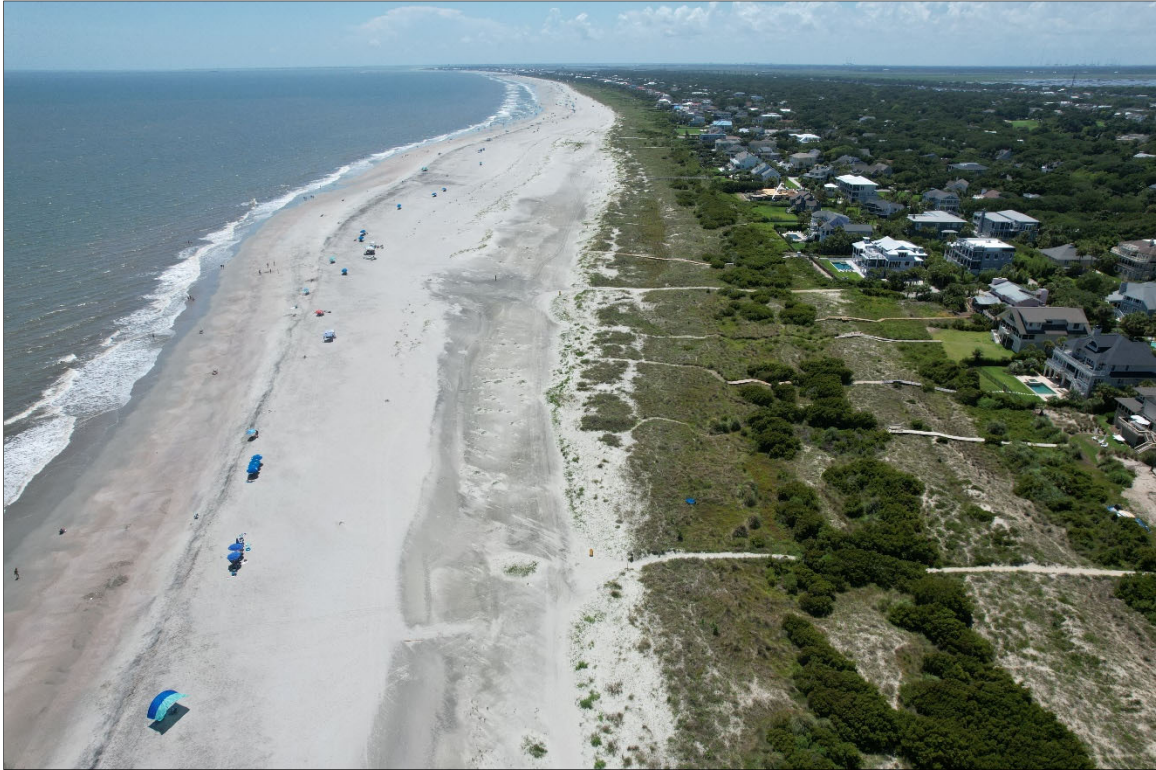
FIGURE 4.18. By being positioned downdrift of the nourishment area, Reach 4 receives nourishment sand spreading from the placement area as well as spreading shoal sand. This reach has gained sand every year since 2009 except 2016. As the vegetated dunes expand, sheltered locations (such as low-lying areas behind protective dune ridges) will gradually transform into a shrub habitat with larger areas of wax myrtle replacing dune grasses.

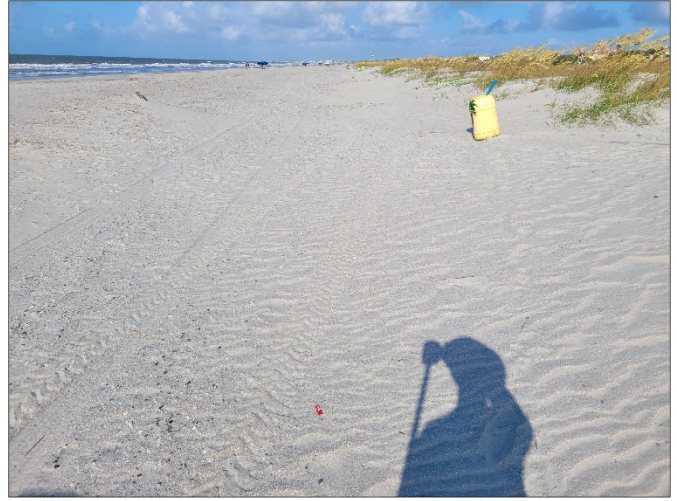
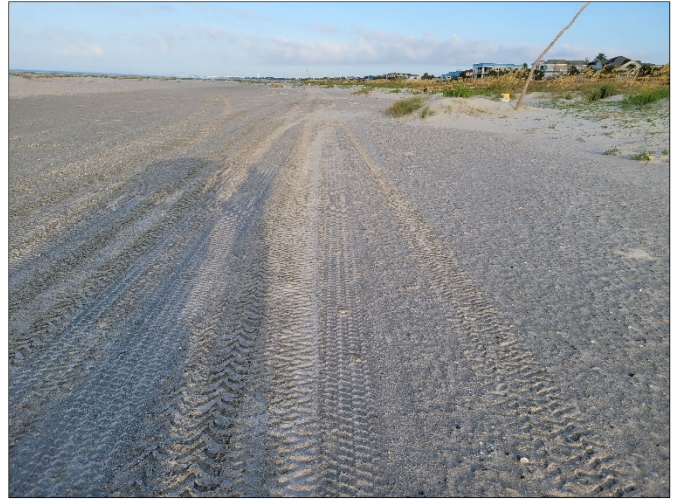
The reach receives sand eroded from the east end of the island, particularly reaches 5 and 6, with that sand originating from shoal bypass events or nourishment. A significant influx of sand along the northern half of the reach has been observed since the 2018 project; profiles along the northern 2,000 lf of Reach 4 gained up to 66 cy/ft (Station 214) of sand from 2018–2019. The peak in accretion moved ~600 ft west to Station 208 from 2019 to 2020 (80.4 cy/ft). As of July 2021, the peak in accretion was located at Station 200 (~800 ft further west; 43.8 cy/ft). This accretion resulted in a large ridge and runnel system along the wet sand beach and a shift of the dry sand berm over 200 ft seaward (Figure 4.19).

FIGURE 4.19. [LEFT] Profiles along the northern 2,000 lf of beach gained up to 150 cy/ft of sand since 2018. This accretion resulted in a large ridge and runnel system along the wet sand beach and a shift of the dry sand berm over 200 ft seaward. [RIGHT] Ground photos from Station 170 [UPPER] and Station 216 [LOWER] in July 2021.

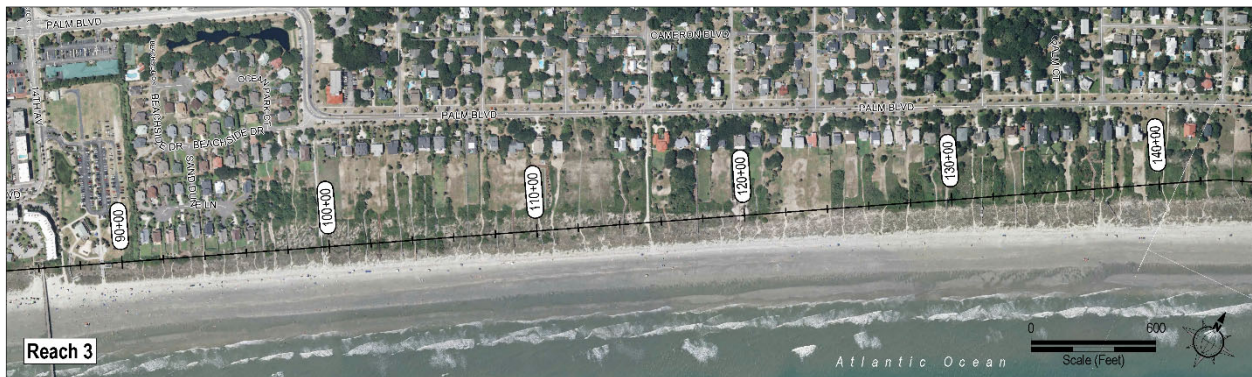
FIGURE 4.20. Baseline stationing along Reach 3 spanning the length of beach from the Sea Cabins Pier to 31st Ave.

Reach 3 extends from the Sea Cabins Pier to 31st Avenue (OCRM monuments 3125 to 3140 – Fig 4.20 and Fig 4.21). Like Reach 4, the long-term trend in this area is stable to accretional. Dwellings in the reach are well set back from the beach, generally between 400 ft and 500 ft, except at the western end where Sand Dune Lane and the county park are set back ~150 ft. The reach has shown periods of erosion and accretion since CSE began island-wide monitoring in 2009. This is typical for stable to moderately accretional beaches as variations in wave conditions from year to year and temporary changes in sediment supply lead to minor fluctuations in yearly volume change. Over the long term, the trend is accretion.

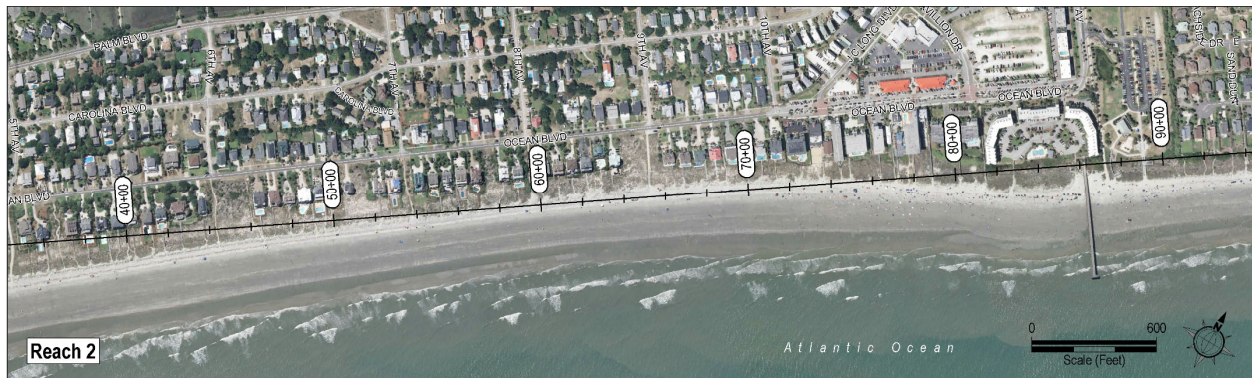
FIGURE 4.24. Baseline stationing along Reach 2 spanning between 6th Avenue and the Sea Cabins Pier.

Reach 2 spans 4,280 ft between 6th Avenue and the Sea Cabins Pier (OCRM monuments 3115–2125 – Fig 4.24 and Fig 4.25). It includes the oceanfront commercial area at the eastern end of the reach. Reach 2 shows an erosion/accretion pattern similar to Reach 3 with intermittent periods of accretion and erosion and a long-term accretion trend. Since monitoring began in 2009, Reach 2 has been the most stable reach, typically showing lower magnitudes of volume change compared to the other reaches.

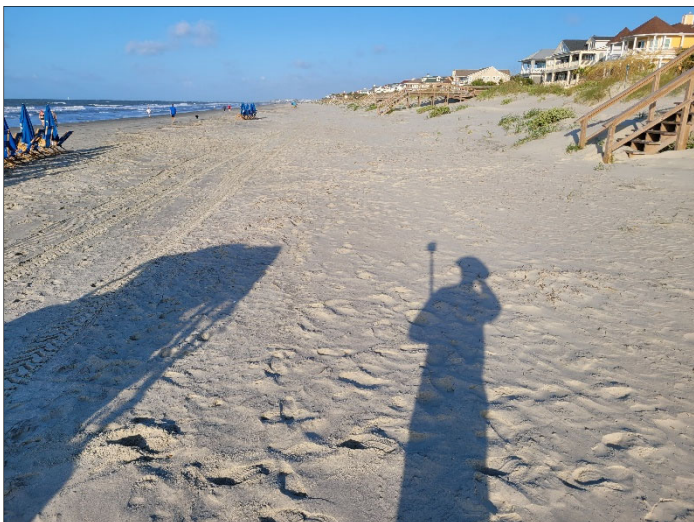
Photos and profiles show the healthier condition of the eastern end of the reach (south of the pier) compared to the western end (Fig 4.25). The dune constructed in 2017 following Hurricane *Irma* remains mostly in place three years after construction. This dune was scraped from the intertidal beach following the storm to accelerate the natural beach recovery cycle.

FIGURE 4.25. July 2021 photos of Reach 2. [UPPER LEFT] View west from Station 70. [LOWER LEFT] View west from Station 50. The photos show a healthy beach with dry sand seaward of the dune. Profiles show that the dune remains more landward than the 2012 condition; however, it has been fairly stable since 2017.

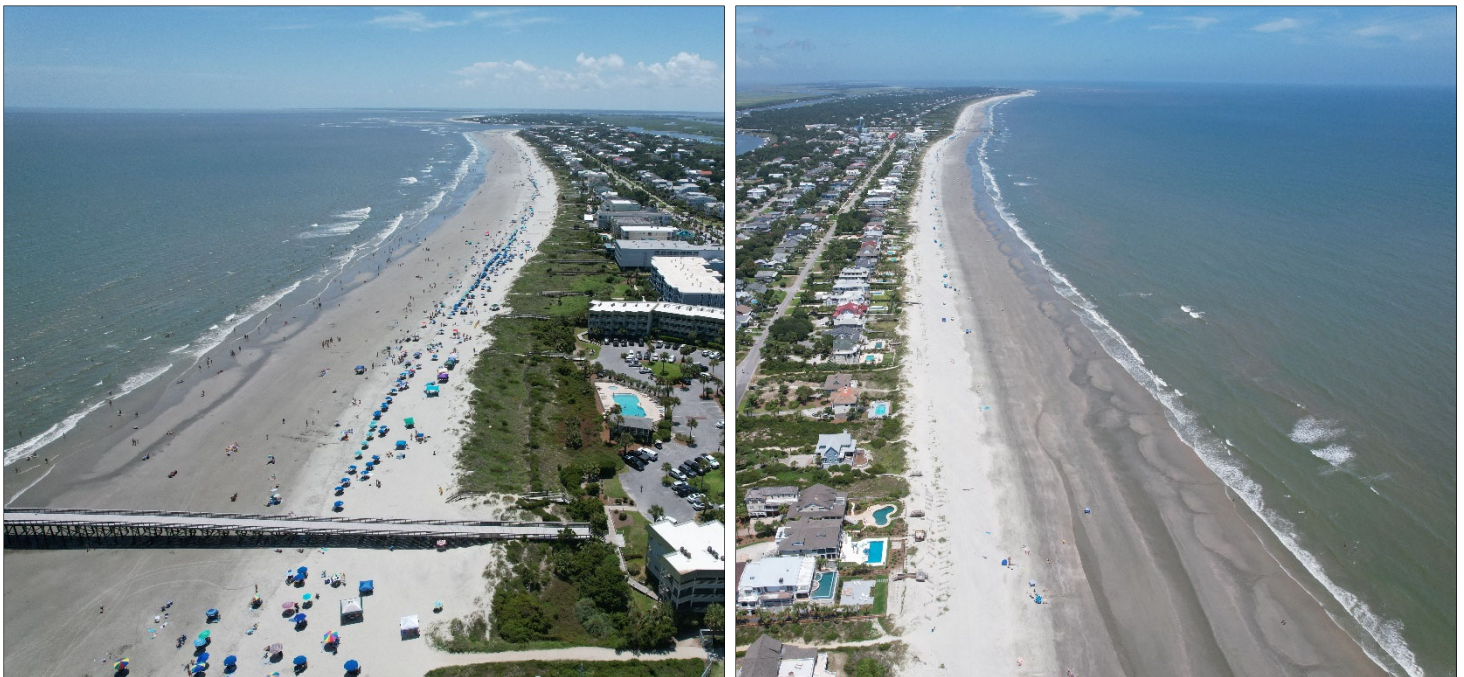
Aerial photos (Fig 4.26) of the reach show a crescent-shaped beach extending south of the pier, with a pronounced landward offset of the shoreline south of the pier. It is unclear whether the crescent shoreline is a result of sediment trapping from the pier or if it is a result of natural morphologic features associated with Breach Inlet. The shoreline morphology coupled with the lower accretion rate observed in this area should be closely monitored, as building setbacks are generally less than reaches 3–4.

FIGURE 4.26. Aerial views of Reach 2 in July 2021. Since monitoring began in 2009, Reach 2 has been the most stable reach, typically showing lower magnitudes of volume change compared to the other reaches along Isle of Palms. The arc in the shoreline west of the pier indicates that the pier may act to trap sand, which may impact Reach 2 in certain wave conditions.

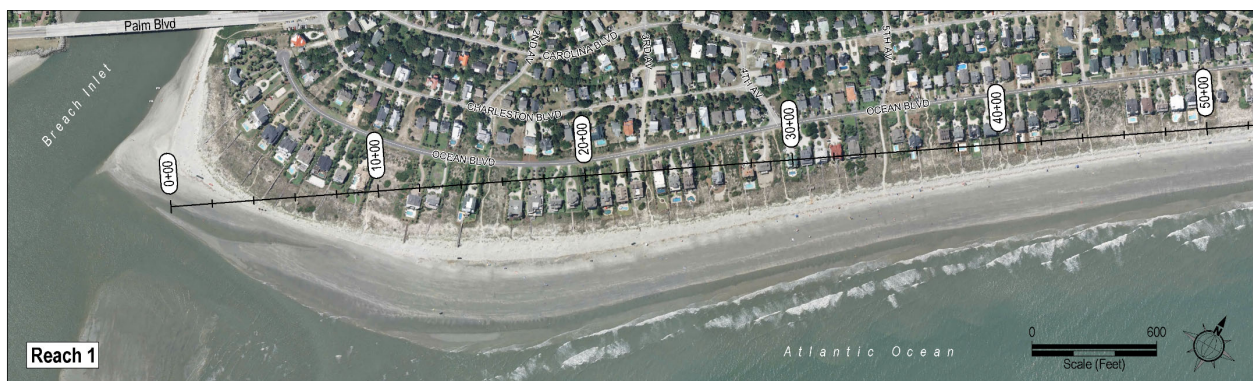
FIGURE 4.27. Baseline stationing along Reach 1 which encompasses the beach between Breach Inlet and 6th Avenue.

Reach 1 encompasses the beach between Breach Inlet and 6th Avenue (Fig 4.27) and is classified as an unstabilized inlet erosion zone due to the dynamic nature of the shoals associated with the inlet delta. The long-term trend in the reach is accretion, evidenced by a new row of houses being built seaward of the original “beachfront” row in the 1980s. Sand supply originates from shoal-bypass events at Dewees Inlet and longshore sand transport from north to south over the length of the Isle of Palms. Excess sand is deposited along the southern spit of the island and in the Breach Inlet ebb-tidal delta. Shoals of Breach Inlet form a protuberance in the shoreline, which backs sand up along the oceanfront much like a terminal groin traps sand. Changes in this area are related to bars from the inlet delta migrating onto the beach or marginal flood channels moving landward or seaward. Such natural processes lead to rapid changes in the beach volume compared to the central Isle of Palms reaches.
