**2018 Isle of Palms Restoration Project
Year 3 Monitoring Report**

2021
MONITORING REPORT

2018 Isle of Palms Restoration Project
Year 3 (2021) Monitoring Report
Annual Beach and Inshore Surveys

[2492YR3 — Monitoring Year 3]

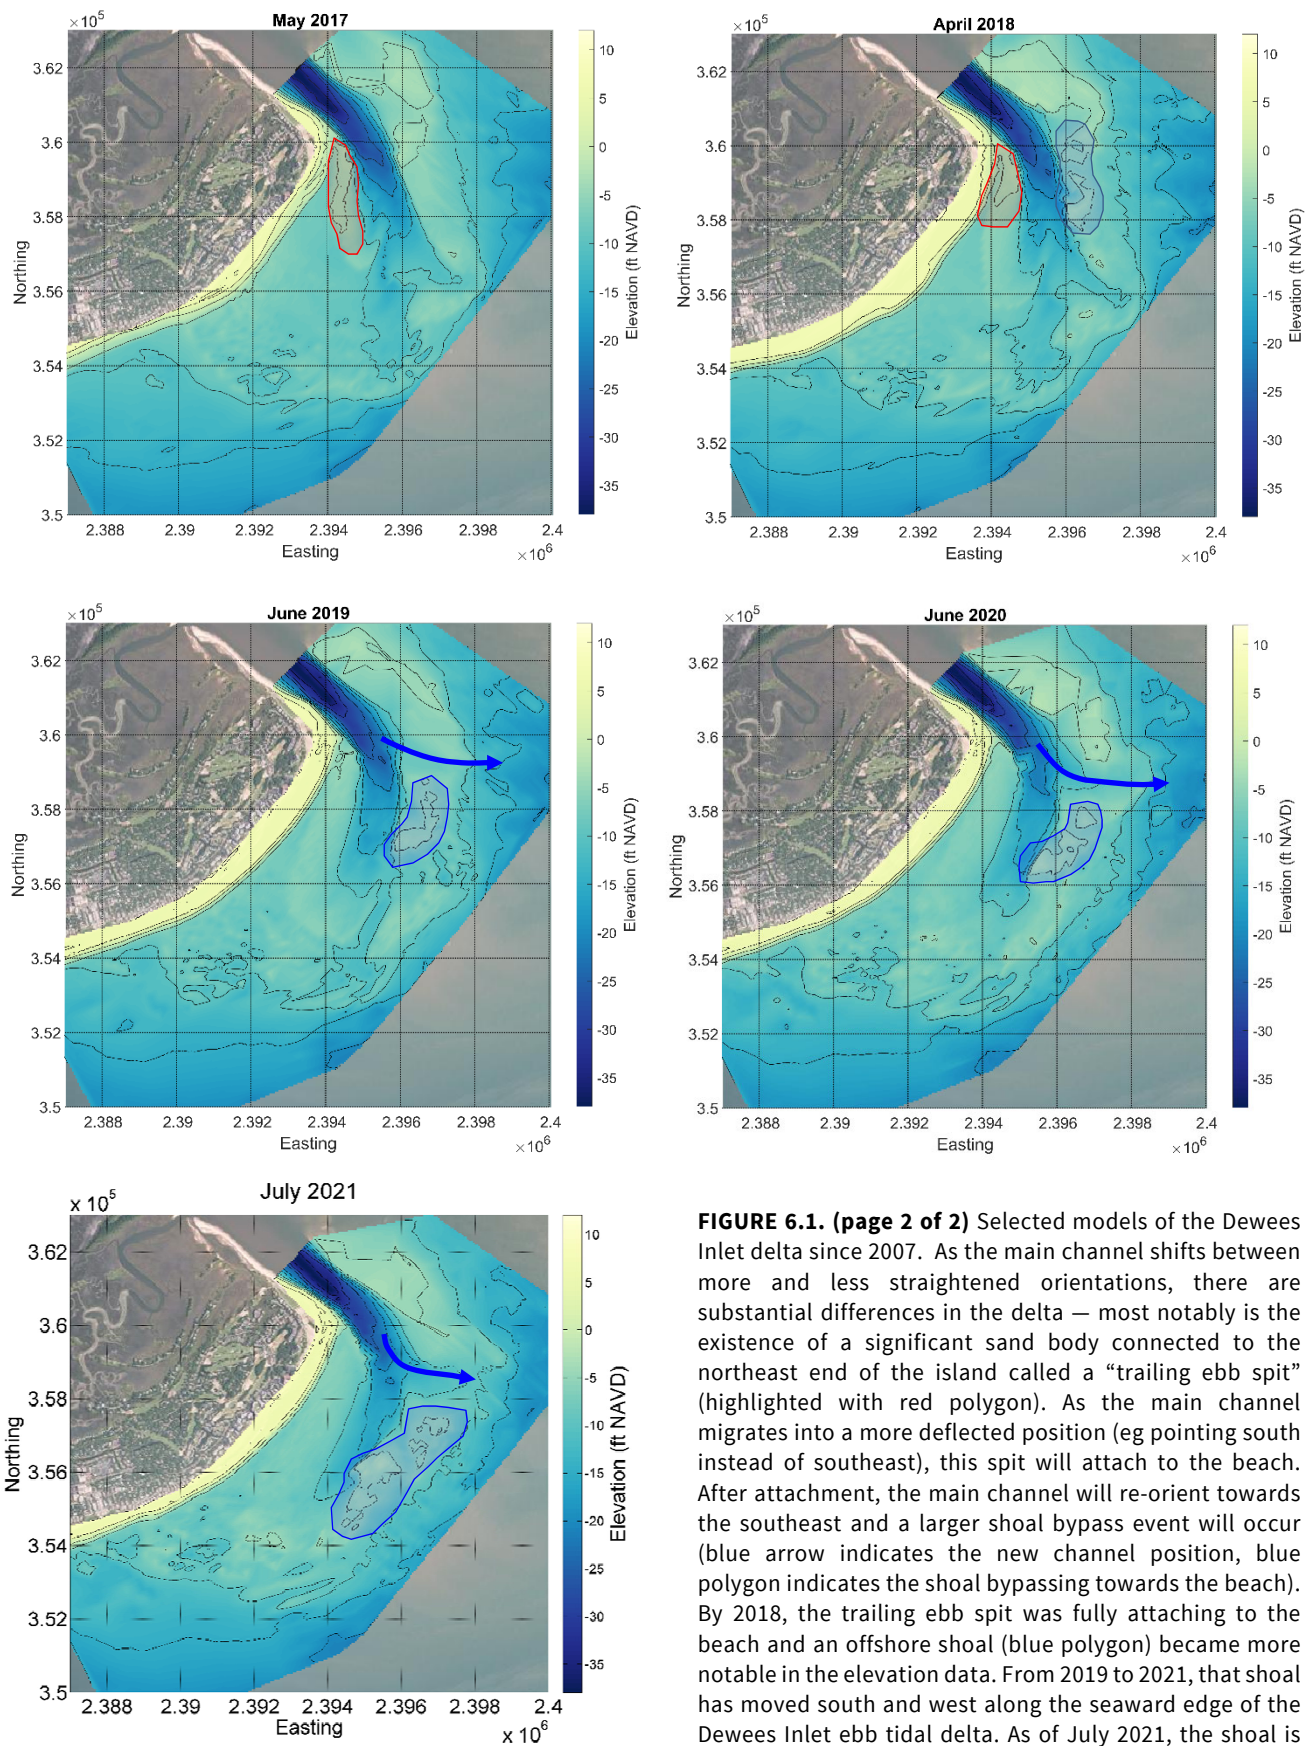
FIGURE 6.1. (page 2 of 2) Selected models of the Dewees Inlet delta since 2007. As the main channel shifts between more and less straightened orientations, there are substantial differences in the delta – most notably is the existence of a significant sand body connected to the northeast end of the island called a “trailing ebb spit” (highlighted with red polygon). As the main channel migrates into a more deflected position (eg pointing south instead of southeast), this spit will attach to the beach. After attachment, the main channel will re-orient towards the southeast and a larger shoal bypassing event will occur (blue arrow indicates the new channel position, blue polygon indicates the shoal bypassing towards the beach). By 2018, the trailing ebb spit was fully attaching to the beach and an offshore shoal (blue polygon) became more notable in the elevation data. From 2019 to 2021, that shoal has moved south and west along the seaward edge of the Dewees Inlet ebb tidal delta. As of July 2021, the shoal is ~2000 ft from Shipwatch Villas.

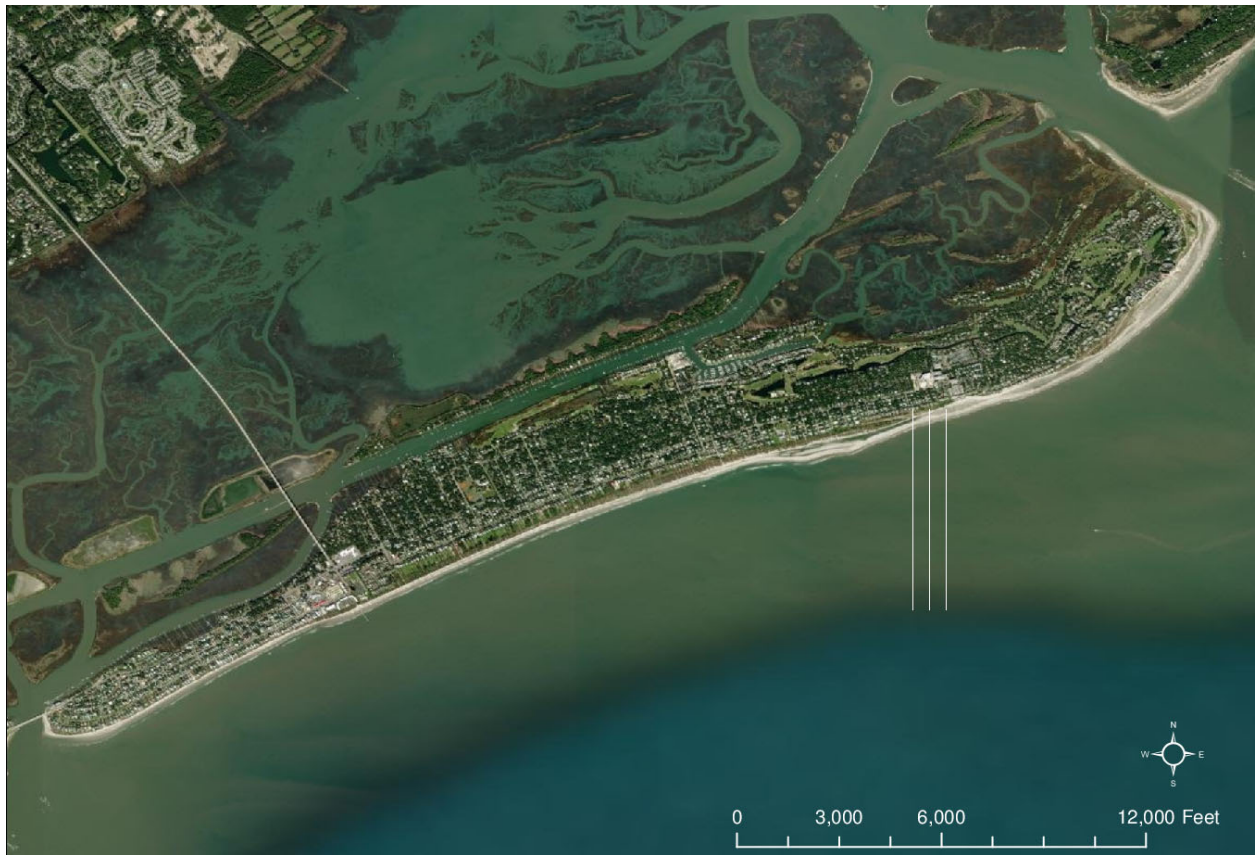
FIGURE 7.5a,b. Sea level inundation models around the Isle of Palms generated using data from NOAA (<https://coast.noaa.gov/digitalcoast/tools/slr.html>). Shades of yellow, orange, red, and maroon are used to signify SLR of 1, 2, 3, and 4 ft above present-day MHHW.
