The April 2014 survey included land-based survey work extending from landward of the frontal dune to (~)–5 feet (ft) NAVD (low-tide wading depth). The data allow for an analysis of dune recession or recovery and beach volume changes above low-tide wading depth. Beach volumes were calculated to –6 ft NAVD (which is approximately low-tide wading depth) for comparison with the previous quarterly surveys (October 2013 and January 2014).

**TABLE 1. Volume calculations for recent surveys at Breach Inlet. Volumes were calculated to -6 ft NAVD within the boundaries shown in the profile plots (Attachment 1). Reach 1 encompasses stations 0+00 through OCRM 3115. Reach 2 encompasses the beach between stations OCRM 31.15 and 80+00.**

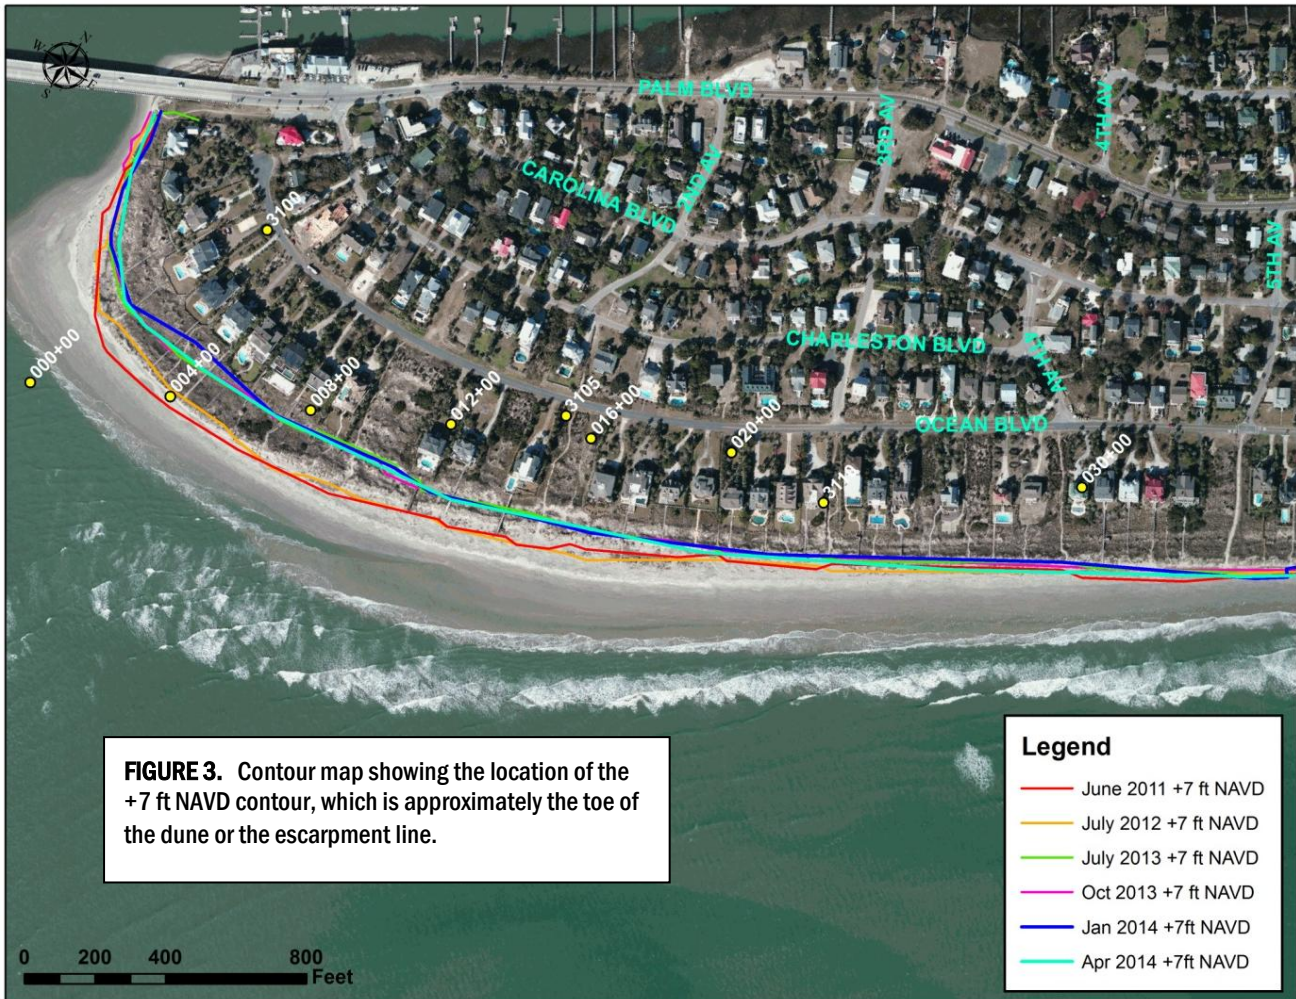
**FIGURE 3.** Contour map showing the location of the +7 ft NAVD contour, which is approximately the toe of the dune or the escarpment line.

CSE updated a contour map showing the position of the +7 ft NAVD elevation contour (approximate base of the dune or escarpment line) in Reach 1 (Fig 3). The map shows little change between the January and April 2014 position, except accretion near station 4+00. The stability of the contour is a positive sign for the beach condition as portions of the area lost over 100 ft of dunes between 2011 and 2013.

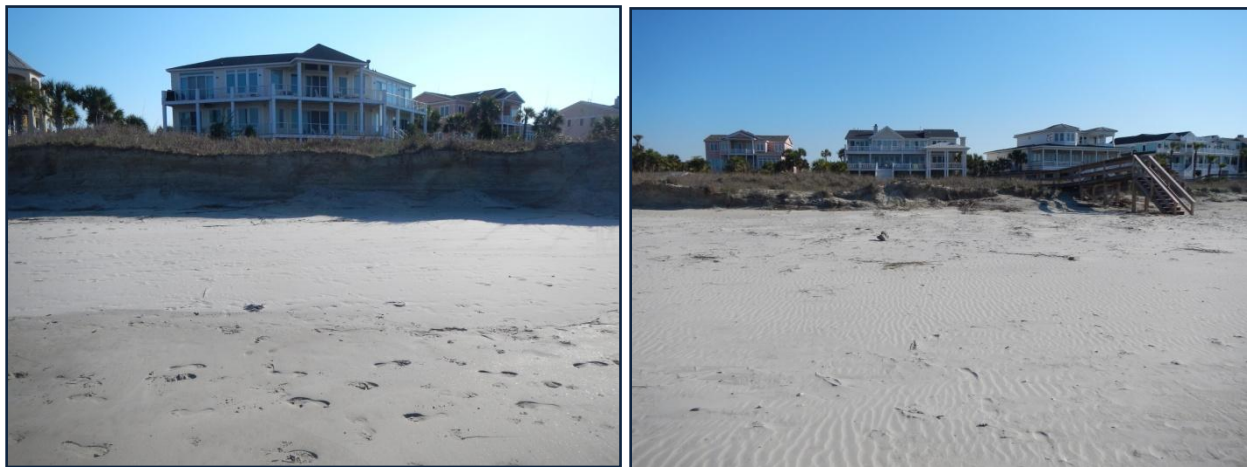
April 2014 images of the Breach Inlet shoreline (left, near the bridge) and station 0+00.

The most significant erosion was measured between stations 12+00 and 20+00 (2<sup>nd</sup> to 3<sup>rd</sup> Avenues), which lost an average of 25.3 cy/ft between January and April 2014. Figure 2 shows unit volumes for monitoring stations and is useful for visualizing how beach volume has changed over the past ~4.5 years. Despite net volume erosion at each station spanning lines 12+00 to 50+00, profiles show that the beach near the toe of the dune (or escarpment) was stable or accretional between stations 0+00 and 50+00 (inlet to ~7<sup>th</sup> Avenue). Erosion in these profiles was limited to the wet-sand and underwater profile, likely due to shifting of the northern bar of the Breach Inlet delta, which typically connects the inlet delta to the beach between stations 12+00 and 20+00. The escarpment continues to persist between stations 30+00 and 60+00 although only station 40+00 showed measurable landward retreat (~10 ft) of the escarpment between January and April 2014. There is also a fairly pronounced escarpment along the shoreline adjacent to the inlet (near the bridge), which has eroded since January.

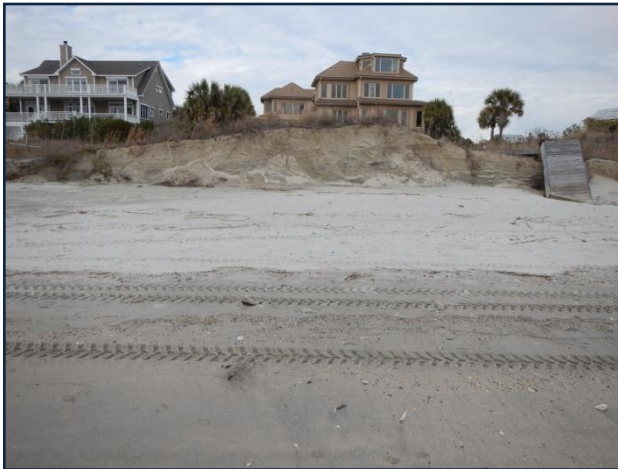
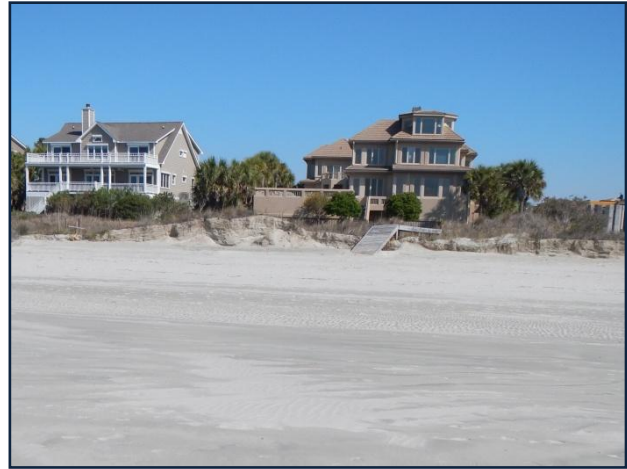
January 2014 (left) and April 2014 (right) images from station 8+00, looking toward the dune. The beach elevation increased in front of the escarpment between the two photo dates and no landward retreat was visible.

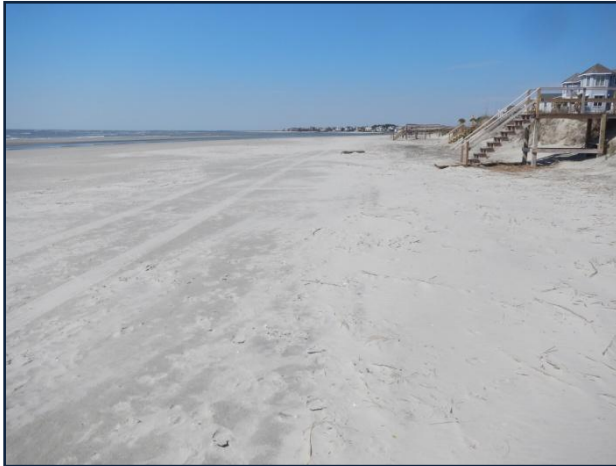
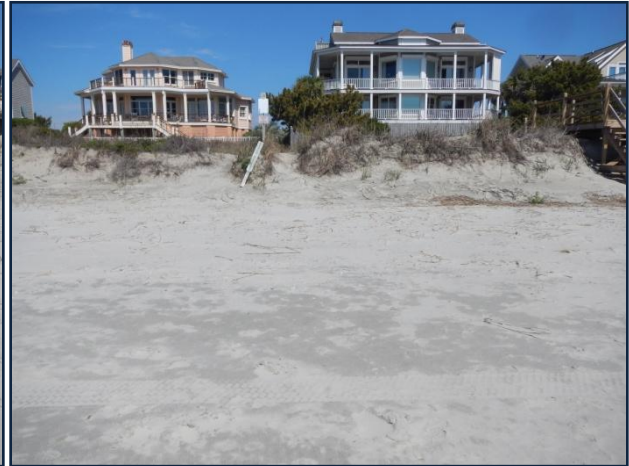
April 2014 images from station 20+00, looking west (left) and landward (right). Despite a net loss of 10 cy/ft at the station (January–April), the dry beach accreted and the old escarpment continues to heal.

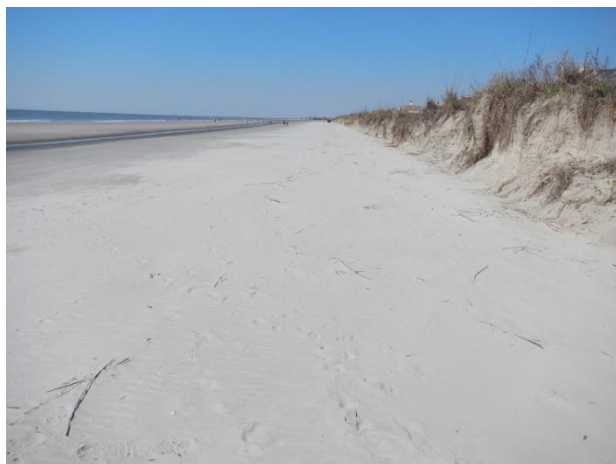
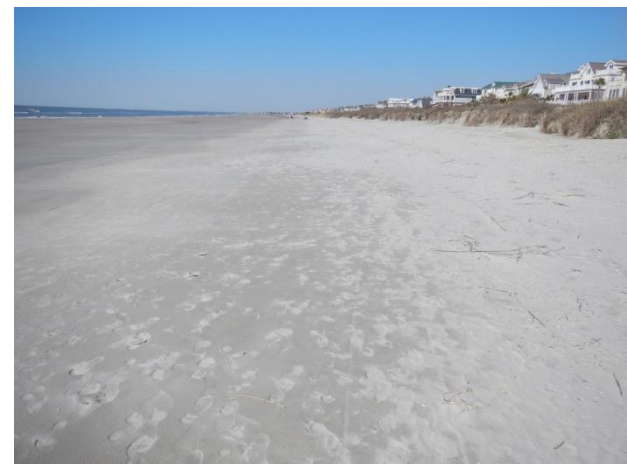
April 2014 images of station 40+00 (left) and station 60+00 (right), looking west. The escarpment retreated ~10 ft at station 40+00 between January and April 2014, and remained fairly stable at station 60+00.

The April 2014 survey shows that Reach 1 continues to be highly dynamic with no consistent pattern of erosion or accretion. Generally, the erosion of the dune in Reaches 1 and 2, which had retreated severely from 2011 to 2013, has ceased (except for line 40+00) although measured volume losses along the wet-sand beach and wading depth portion of the profile occurred at several stations. The most critically eroded area continues to be the stretch between stations 4+00 and 16+00, as houses in this area presently have the narrowest buffer between the structure and the water. CSE continues to anticipate the area recovering naturally over time, although the area should continue to be monitored at least semi-annually until significant recovery can be documented.
