**2008 BEACH RESTORATION PROJECT
ISLE OF PALMS SOUTH CAROLINA**

**Monitoring Report No 3
November 2011**

YEAR 3 MONITORING REPORT

Coastal Science & Engineering (CSE)
PO Box 8056 Columbia SC 29202-8056

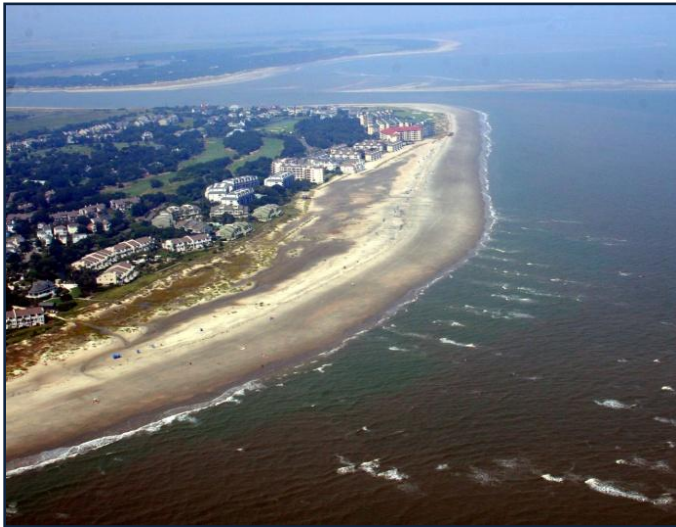
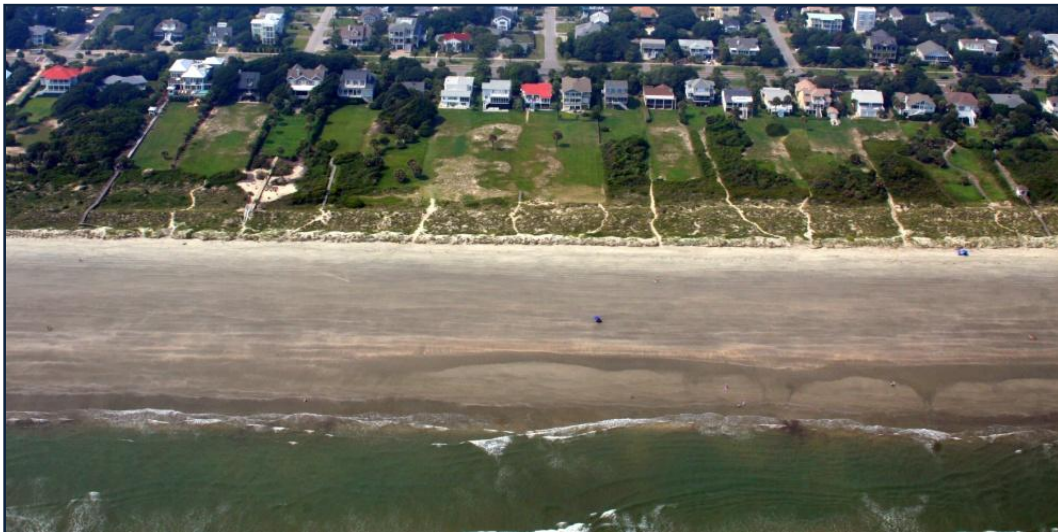
COVER PHOTO: Aerial views of Isle of Palms along the northeast end (upper) and 25th Avenue to 29th Avenue (lower) after passage of Hurricane *Irene* in August 2011.

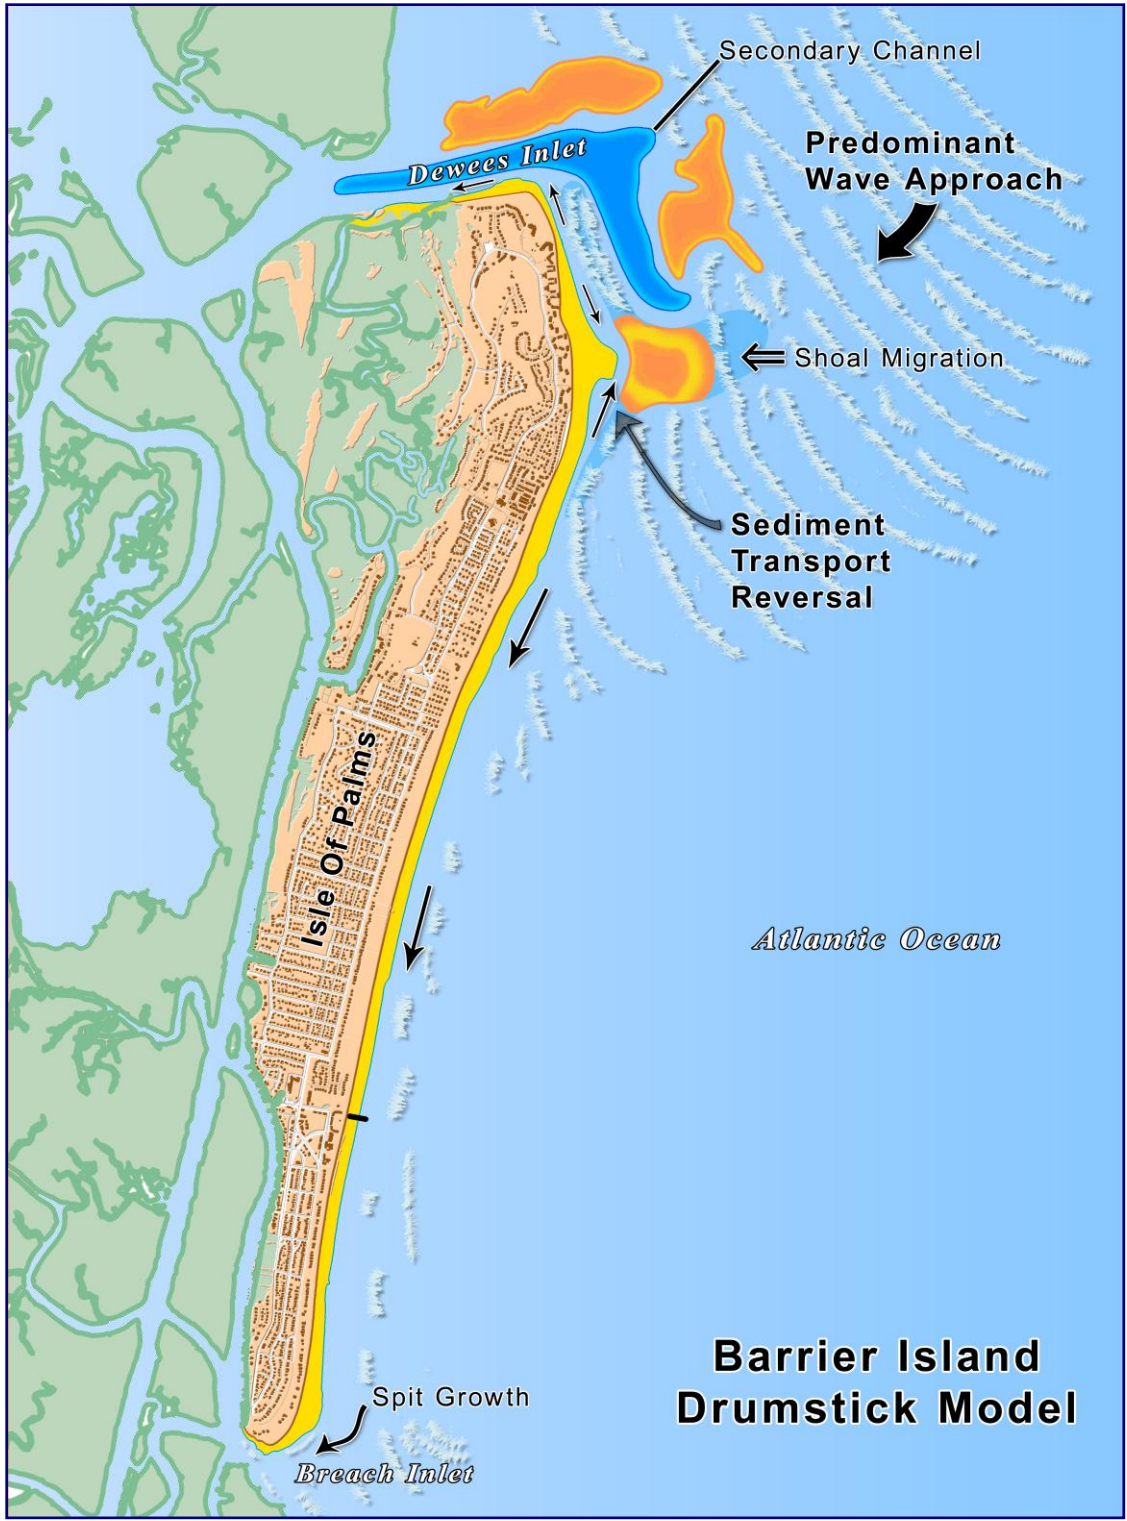
FIGURE 1.1. Isle of Palms is a typical “drumstick” barrier island (after Hayes 1979), where the upcoast end is wider due to sediment accumulation through shoal-bypass events, and the downcoast end usually forms a growing recurve spit. Other examples of drumstick barrier islands along South Carolina are Bull Island, Kiawah Island, and Fripp Island. Zones of sediment transport reversal generally occur in the lee of delta shoals which are situated offshore. Upon shoal attachment to the beach, transport directions in the vicinity of the shoal switch, spreading sand away from the attachment point (see for example — Fig 1.2).

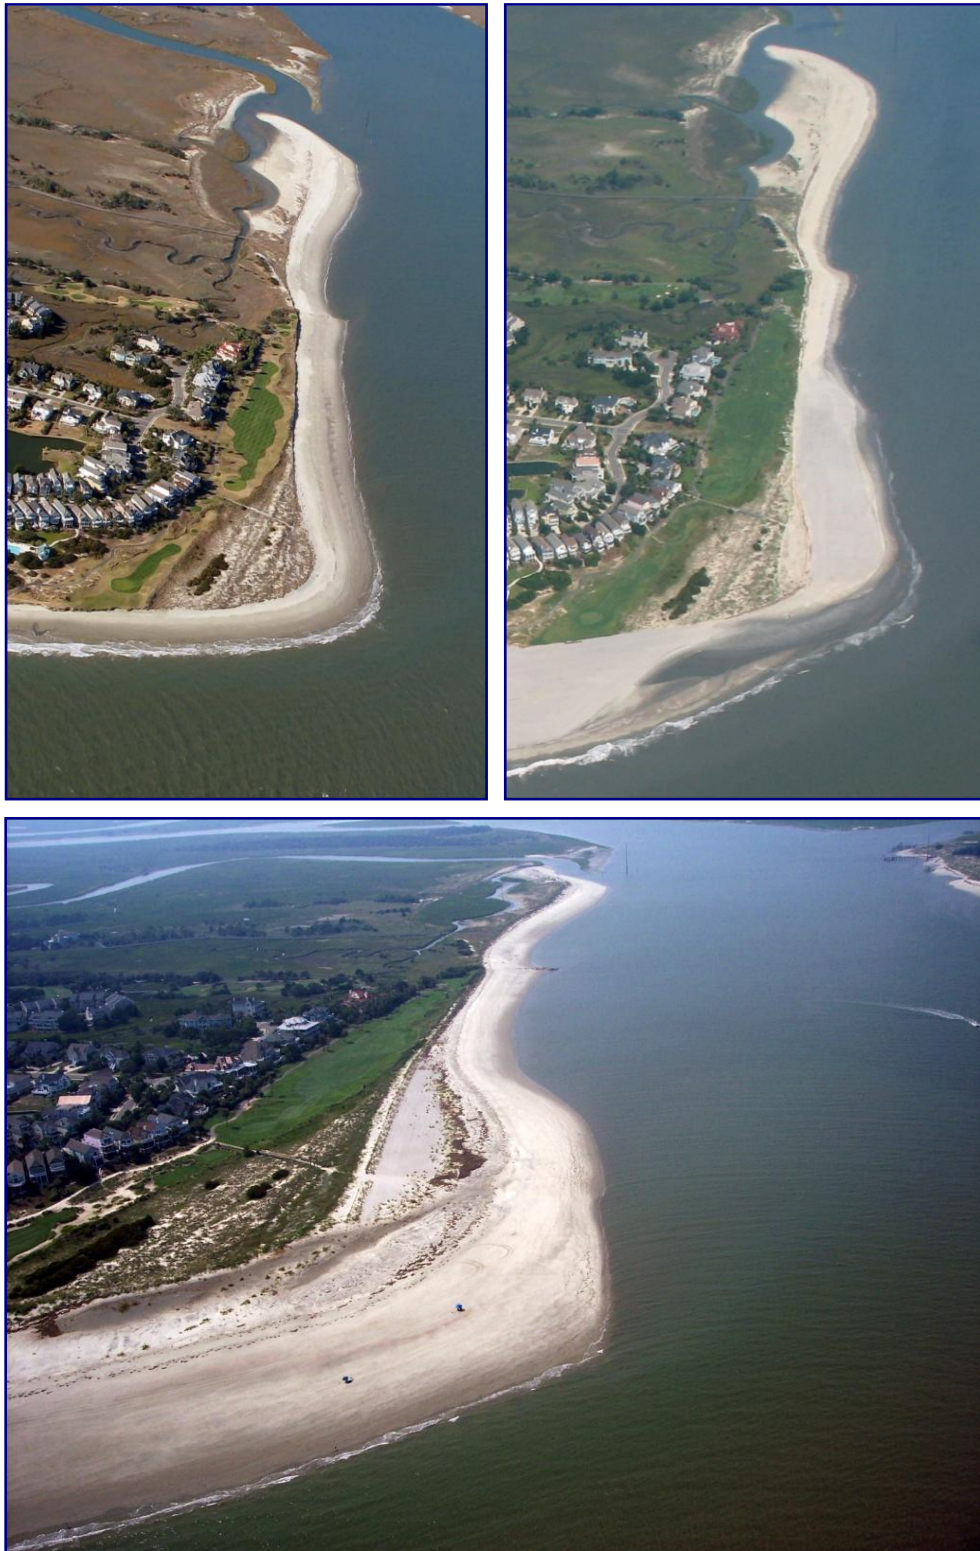
FIGURE 3.2. [UPPER LEFT] Reach 7 in December 2007. [UPPER RIGHT] June 2008 near the end of the project. [LOWER] August 2011 (post-Irene). [Upper images by TW Kana] [Lower image by S Traynum]

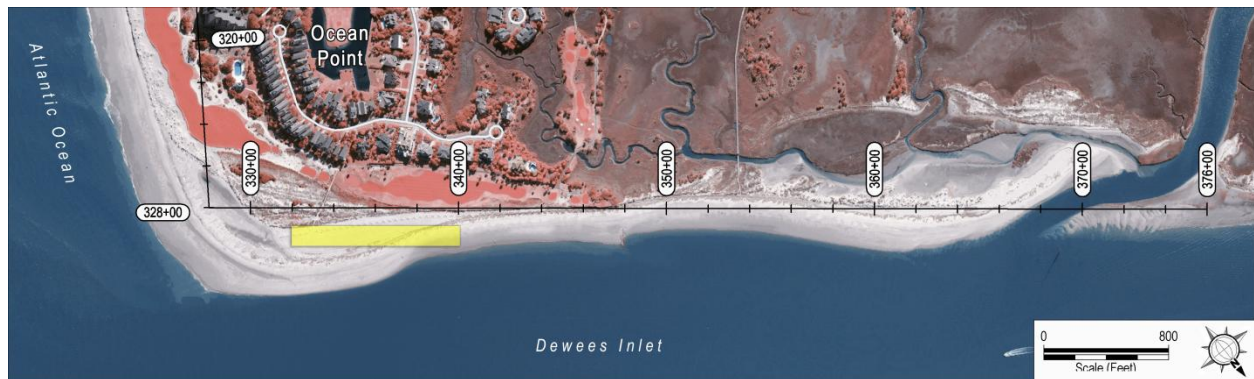
FIGURE 3.3. Station map of the Dewees Inlet area (Reach 7). Reach 7 spans from station 330+00 near the 18th tee to station 368+00 near Cedar Creek spit. The approximate limits of nourishment Reach C are identified by the yellow bar. The 1981 low profile groin is positioned near station 348+00. [March 2009 aerial image by Independent Mapping Consultants Inc]

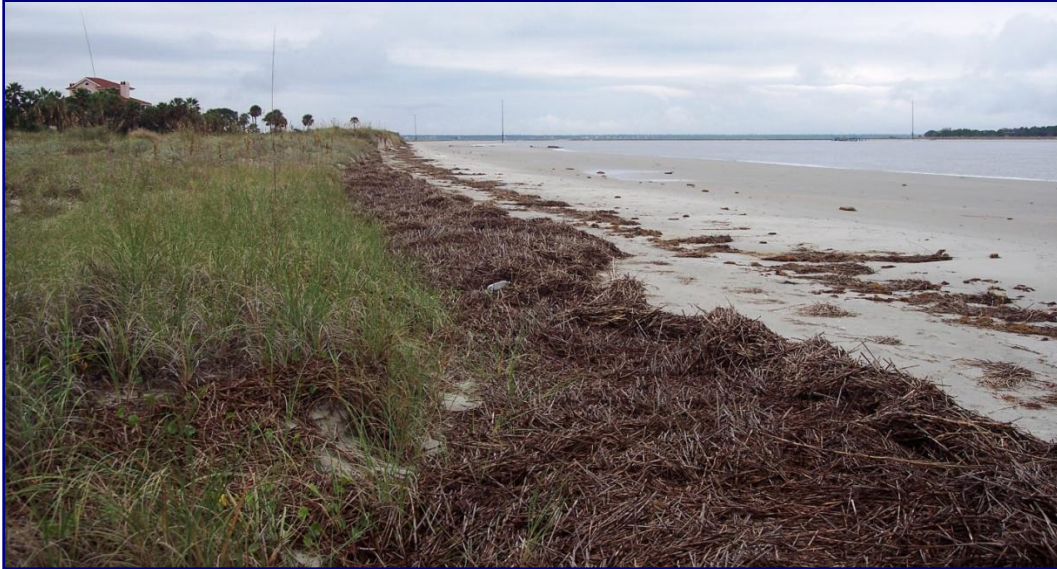
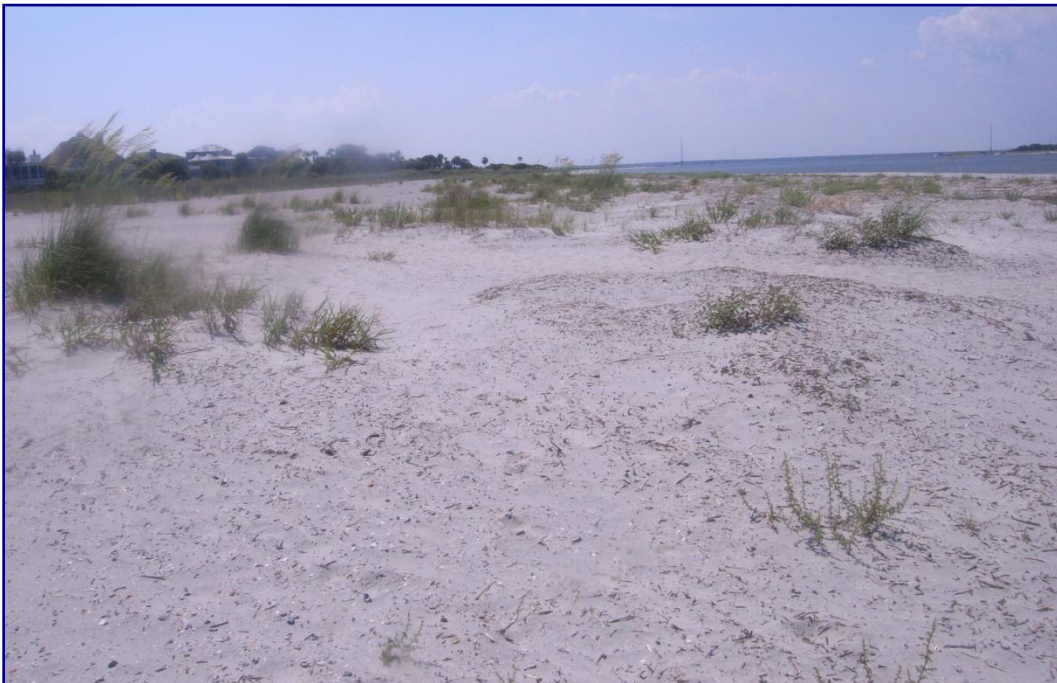
FIGURE 3.6. View looking northwest in Reach 7 in the vicinity of the 17th green of the Wild Dunes Links Course in October 2007 (upper) and June 2011 (lower).

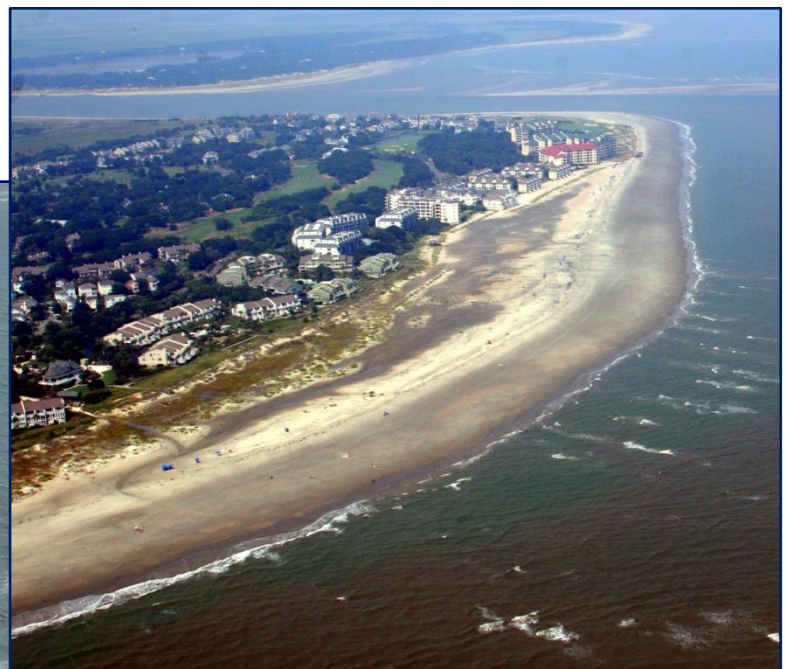
FIGURE 3.7. Reach 6 in December 2007 (upper left), June 2008 near the end of the project (upper right), and September 2009 (lower left) and August 2011 (lower right) following Hurricane Irene.

Reach 6 (Fig 3.7, previous page) extends from the Wild Dunes Property Owners Beach House ~4,900 ft northeast to the 18th fairway, where the beach turns into Dewees Inlet (station 280+00 to station 328+00, Fig 3.8). Shoal-bypassing events have highly impacted this area since the island's formation. Depending on the location and timing of the bypass events, the shoreline can change hundreds of feet over a period of several months (Kana et al 1985, Gaudio 1998). As was the case in 2007-2008, the shoreline may encroach on development in this reach when shoal-bypass events are prolonged. Previous studies have suggested that the background, long-term erosion for the northeastern end of IOP is between 15,000 cy/yr and 30,000 cy/yr even though the estimated average volume of sand added by each shoal-bypass event is ~500,000 cy (CSE 2007a). This means that, while large fluctuations in the shoreline and severe local erosion may occur, the long-term erosion rate for the area is relatively low. Sand simply migrates from one area of the beach to another and is either transported back to Dewees Inlet or downcoast to IOP, eventually being replaced by offshore sand through another shoal-bypassing event.

Prior to nourishment in June 2008, most of Reach 6 was severely eroded with profile volumes seaward of development well below an ideal condition. Property owners had piled sand bags against buildings for protection, and little or no dry beach was present (see Fig 1.3). The condition was beginning to improve just before the nourishment as the shoal attaching at the western end of the reach was in Stage 3 of the bypass cycle. Sand was moving from the shoal toward Dewees Inlet, but not quickly enough to restore the beach along most properties north of the Wild Dunes Property Owners Beach House.

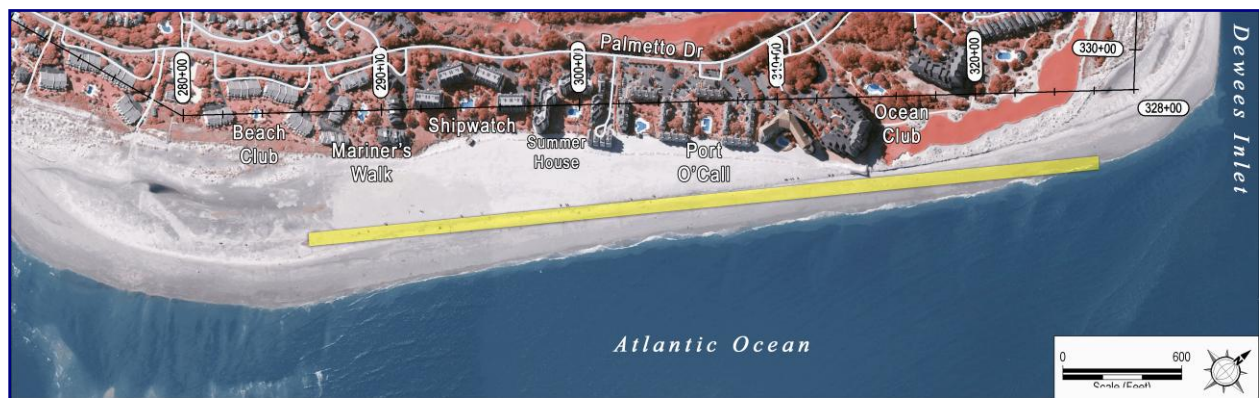
FIGURE 3.8. Reach 6 spans from the Wild Dunes Property Owners Beach House (station 280+00) to the 18th fairway of the Wild Dunes Links Course (station 328+00). The approximate limits of nourishment Reach B are identified by the yellow bar. March 2009 aerial image by Independent Mapping Consultants Inc.

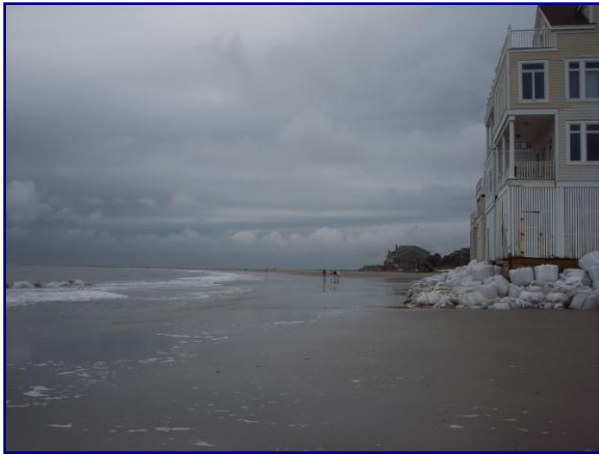
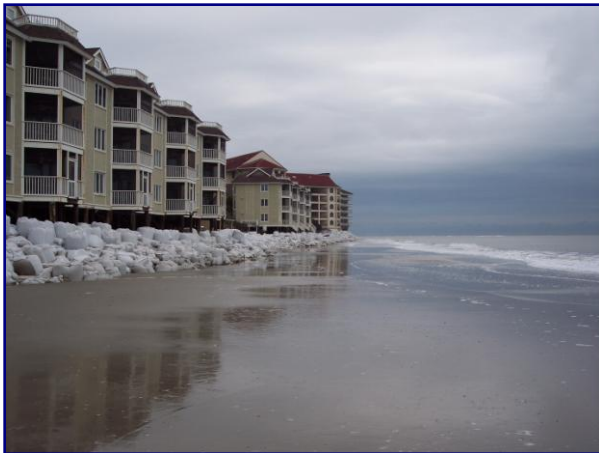
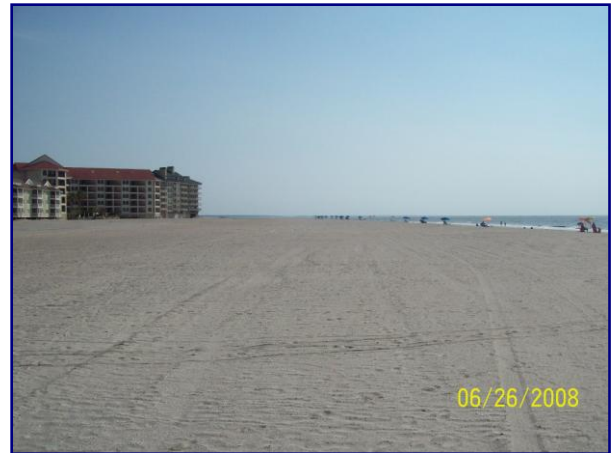
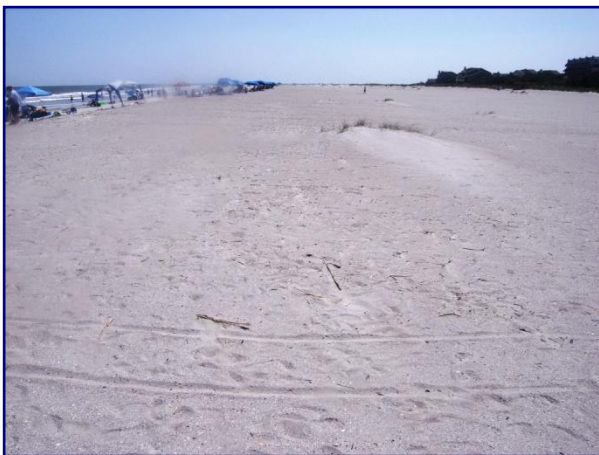
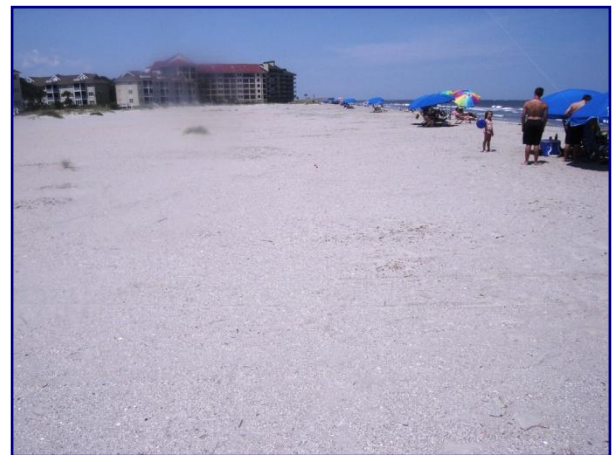
FIGURE 3.11.

[UPPER] View south in December 2007 near Summer Dunes Lane prior to the project.

[LOWER] The same area in June 2011 looking south (left image) and north (right image).

Overall, Reach 6 retains 464,800 cy (94.9 cy/ft) more sand than the pre-nourishment condition (Fig 3.11). It has lost ~162,800 cy (33.2 cy/ft) since July 2008. If accumulation between station 328+00 and 330+00 are considered, true losses from the beach between the Wild Dunes Property Owners Beach House and Dewees Inlet is reduced to ~113,000 cy (23.1 cy/ft).

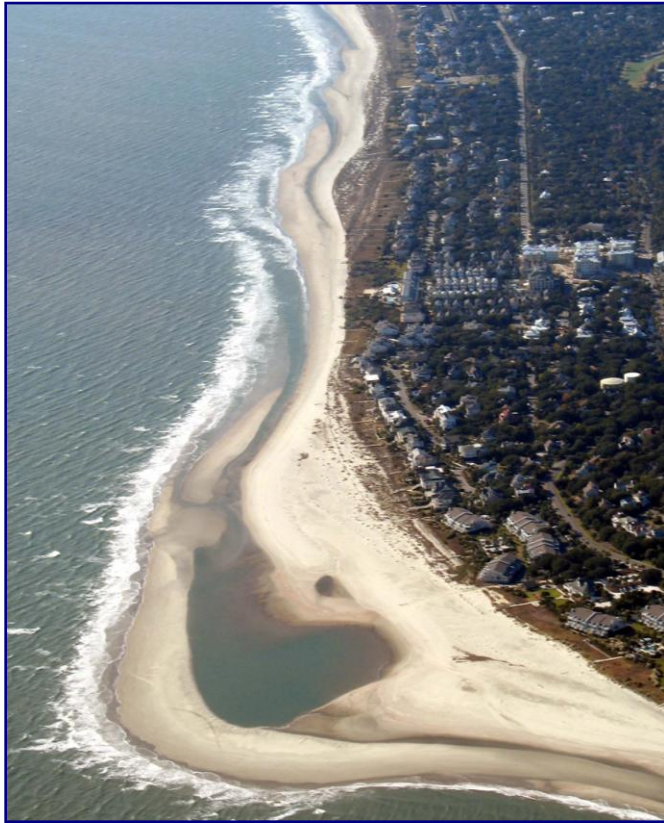
FIGURE 3.12.

[UPPER LEFT]
Reach 5 in December 2007.

Reach 5 (Fig 3.12, previous page) spans ~6,000 ft between 53rd Avenue and the Wild Dunes Property Owners Beach House and encompasses project Reach A (Fig 3.13, stations 222+00 thru 280+00). Like Reach 6, this area is greatly influenced by shoal-bypass events, especially at the northern end of the reach where the majority of shoals attach to the beach. Prior to the 2008 nourishment, an erosional arc had formed in the area of the Wild Dunes Grand Pavilion (Fig 3.14, station ~248+00). Erosional arcs are typical in areas adjacent to shoal attachment sites because of wave refraction and sediment transport reversals, which drive sand from these areas into the lee of the shoal during Stages 1 and 2 of the shoal-bypass cycle. Immediately prior to nourishment, the “2006” shoal had completely attached (Stage 3) at the northern end of the reach, and sand was beginning to spread into the eroded areas.

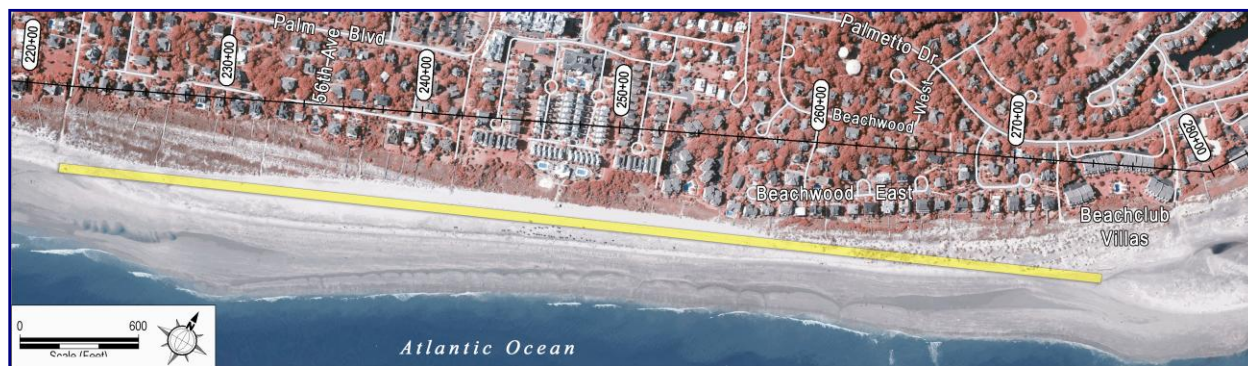
FIGURE 3.13. Reach 5 spans from 53rd Avenue (station 222+00) to the Wild Dunes POBH (station 280+00). The approximate limits of nourishment Reach A are identified by the yellow bar. [March 2009 aerial image by Independent Mapping Consultants Inc]

Reach 5 gained ~318,000 cy of sand between March and July 2008; this included nourishment and natural accretion from the shoal attachment (cf – Table 3.2). The design volume was 270,000 cy, and CSE estimates ~340,000 cy of sand were added to the project area between March and July 2008. [Note the project reach limits differ from the monitoring reach, producing the difference in accretion numbers.] Design fill unit volumes were ~75 cy/ft throughout area A, decreasing in the taper sections. Dry beach width increased up to ~225 ft in this reach.

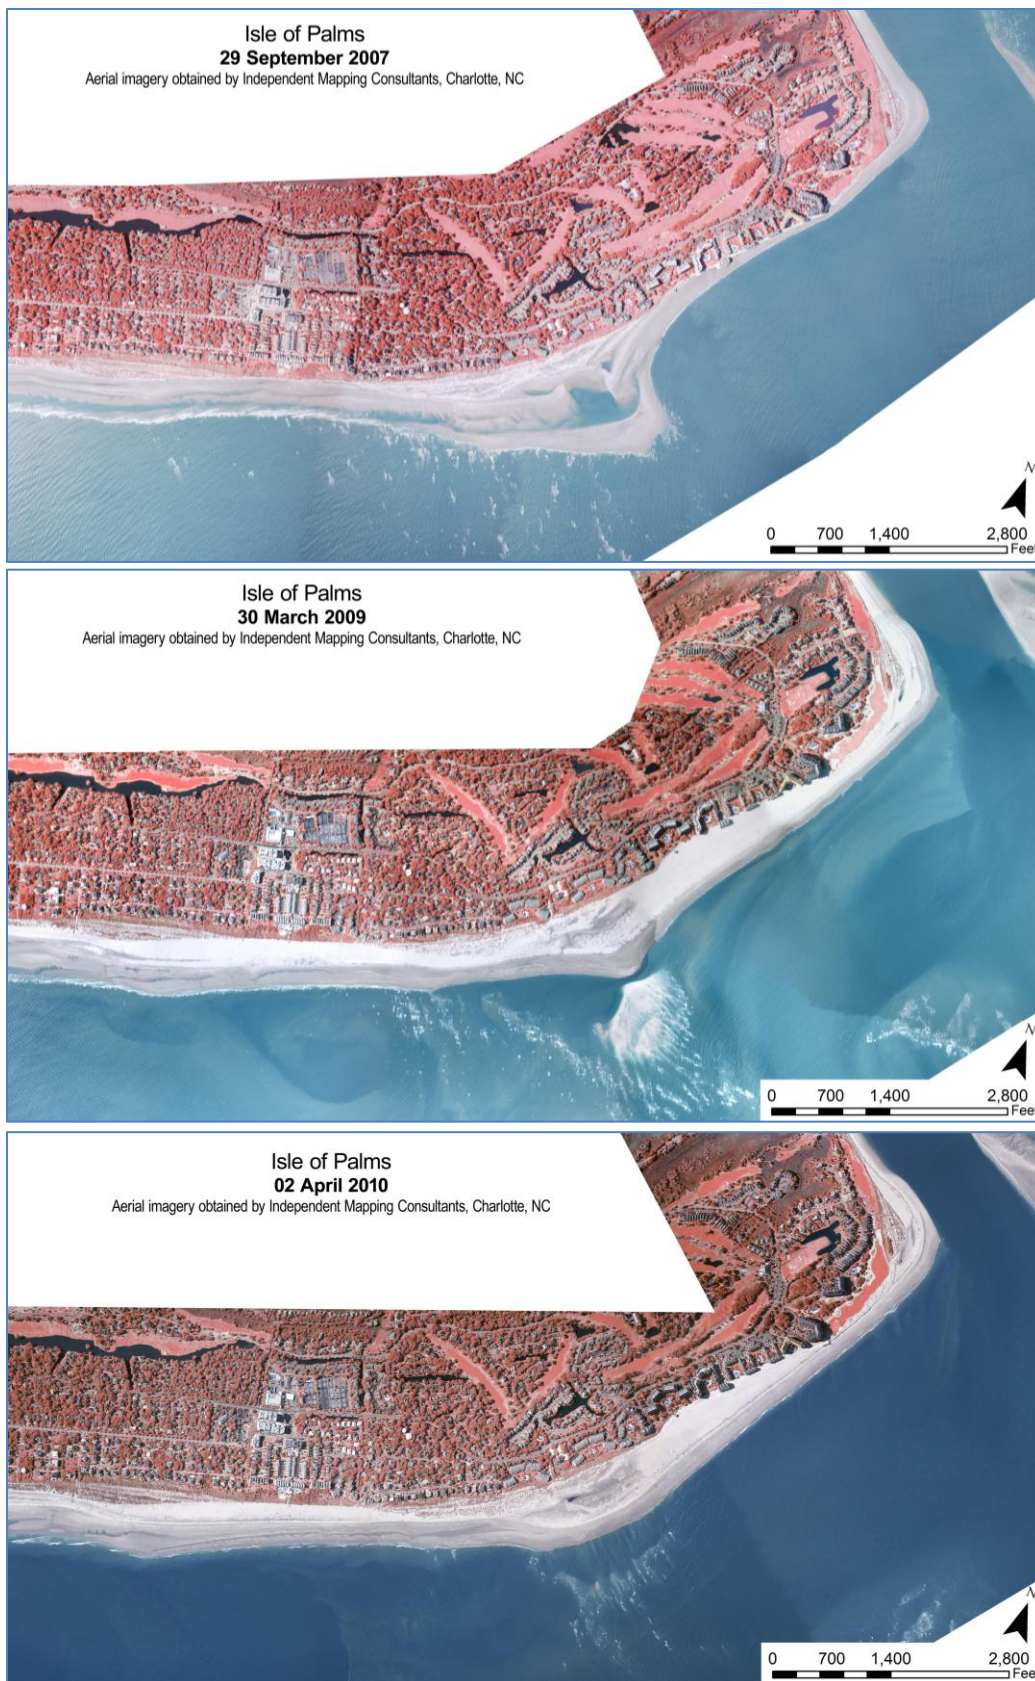
FIGURE 3.14. Reach 5 and Reach 6 in September 2007 (upper), March 2009 (middle) and April 2010 (lower). Note the erosional arc in the 2007 image adjacent to the Wild Dunes Grand Pavilion (left center of image). The “2008” shoal is visible in the middle image, and the “2010” shoal in the lower image. [See Figure 3.34 for 2011 image.]

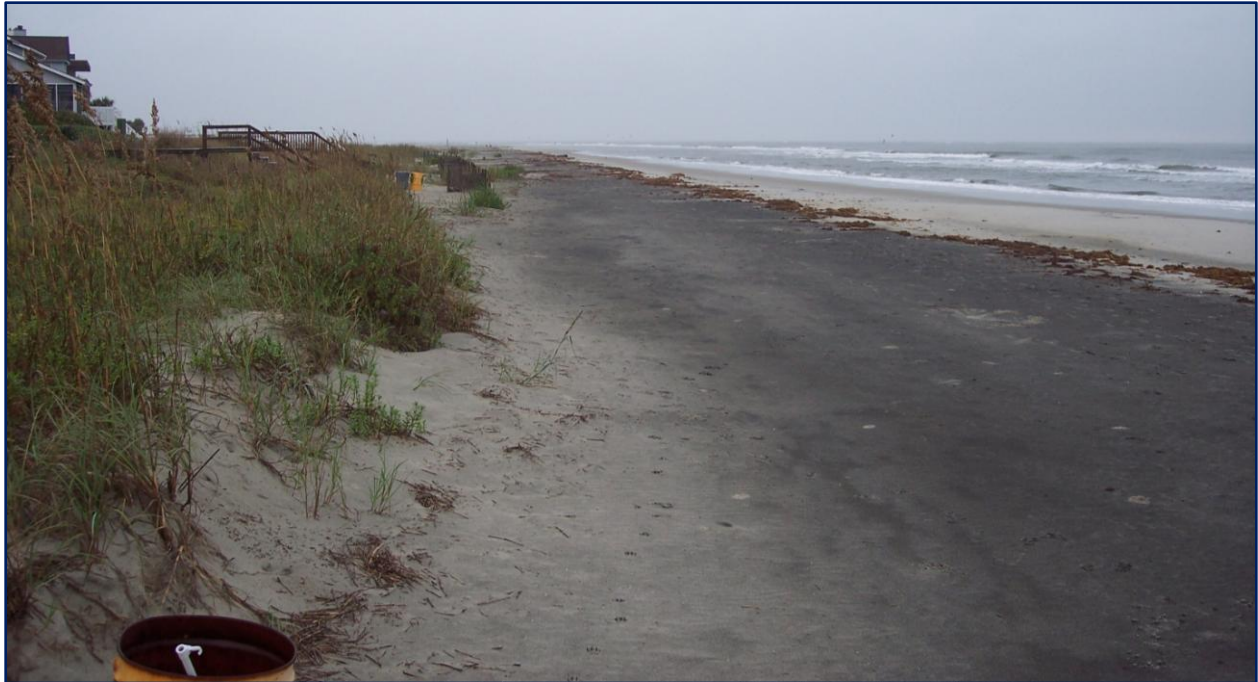
FIGURE 3.17. View northeast from station 254+00 (adjacent to Seagrove Villas) prior to the project in October 2007 (upper) and views northeast (middle left) and southwest (middle right) in September 2009. Station 248+00 views in June 2011, looking south (lower left) and north (lower right). An erosional arc associated with the 2006 shoal-bypass event had formed in this area prior to the project (see Fig 3.14). The dark-colored band of sediments in the upper photo are “heavy minerals” such as ilmenite which concentrate at the base of dunes along eroding shorelines. Light-colored sands are typically quartz and feldspar in this setting.

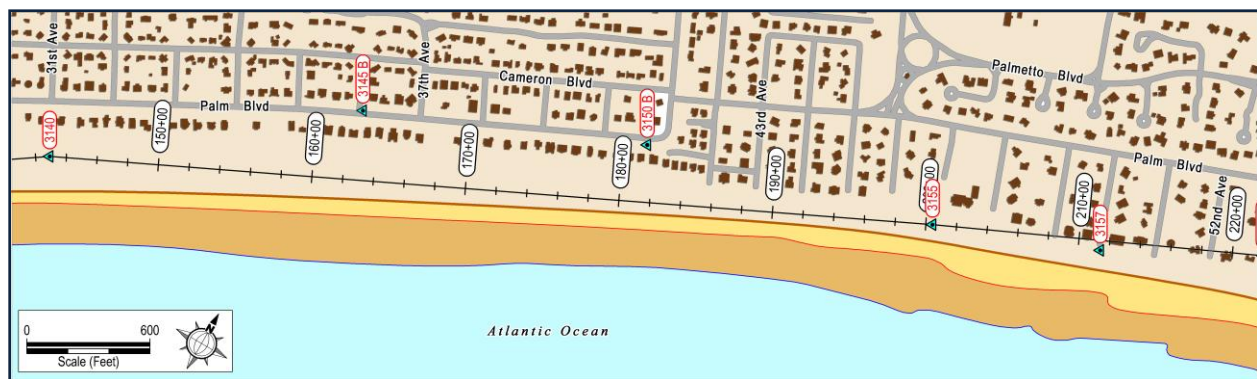
FIGURE 3.20. Reach 4 spans from stations OCRM 3140 (31st Avenue) to CSE 222+00 (53rd Avenue).

Reach 4 spans 7,910 ft between 31st Avenue and 53rd Avenue (stations OCRM 3140 to CSE 222+00, Fig 3.20). Being immediately downdrift of the 2008 nourishment project, it should, therefore, benefit from losses of nourishment sand from the project area. The reach lost ~1,800 cy (0.2 cy/ft) between March and September 2009, but has since gained sand. Between September 2010 and June 2011, all but one (total 19) station in Reach 4 accreted, averaging 6.9 cy/ft (cf – Fig 3.19). Highest accretion rates were observed at the northern end of the reach adjacent to the nourishment area. Significant accretion was also present between 41st Avenue and 46th Avenue and near 36th Avenue (11.5 cy/ft). Overall, the reach has gained 47,900 cy (5.1 cy/ft) since September 2010 and retains 121,200 cy (15.3 cy/ft) more sand than the March 2009 condition. Representative profiles are shown in Figure 3.21.

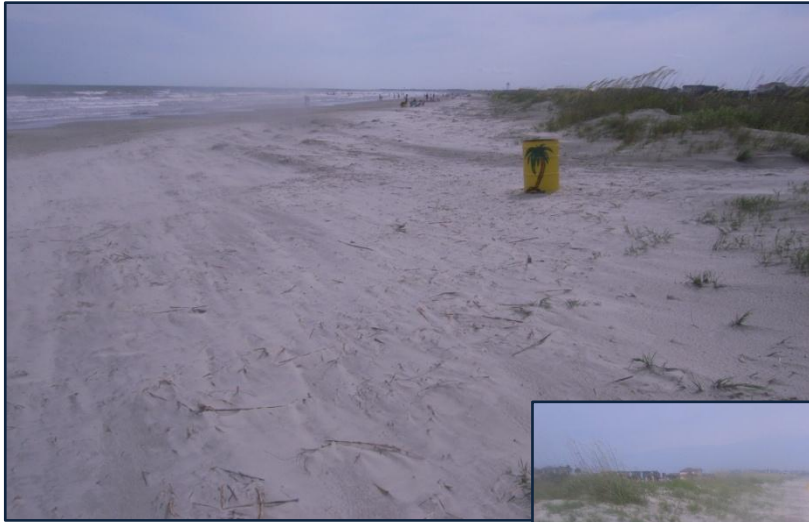
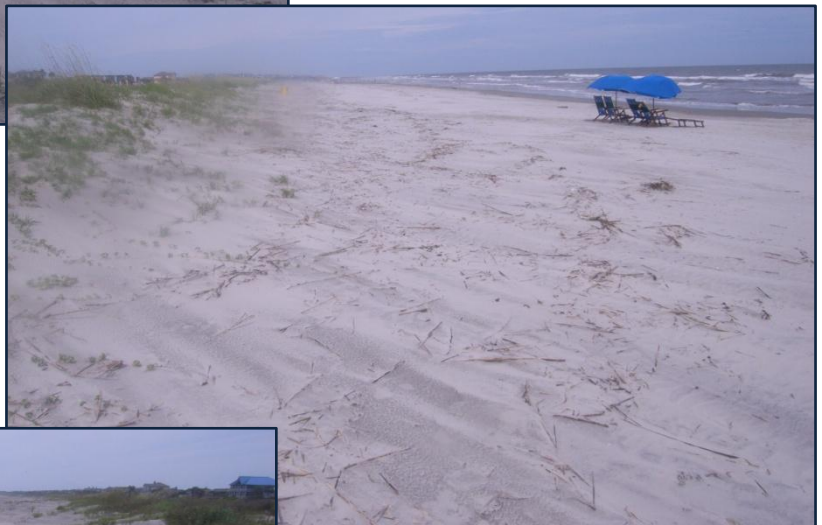
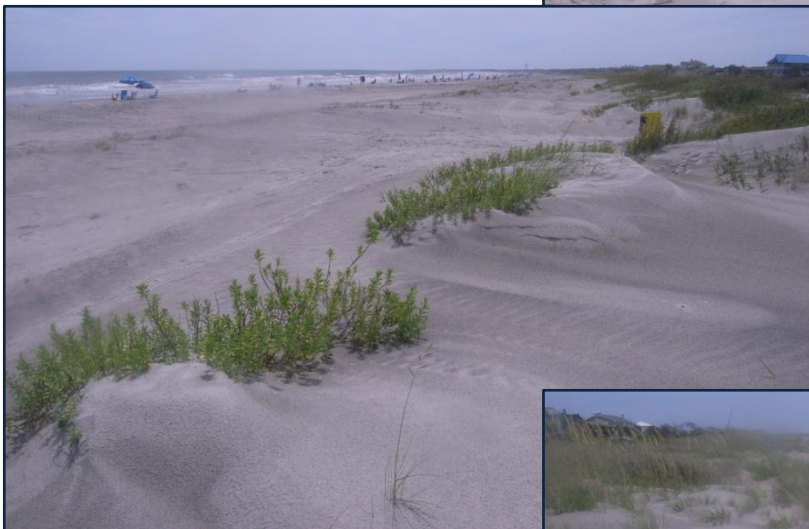
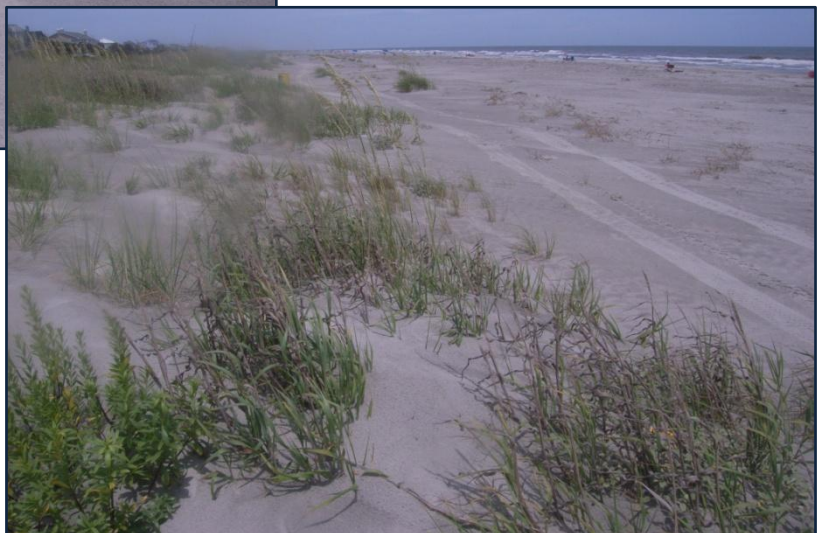
FIGURE 3.22.

Photos from station 170+00 (near 38th Avenue, upper two photos) and station 202+00 (near Citadel Beach House, lower two photos).

Historical accretion along this reach (combined with sufficient setbacks for development) has led to a substantial dune system between most structures and the beach. As long as there is slow steady accretion, the foredune will continue to build wider and higher, offering more storm protection to property behind the dunes (Fig 3.22).

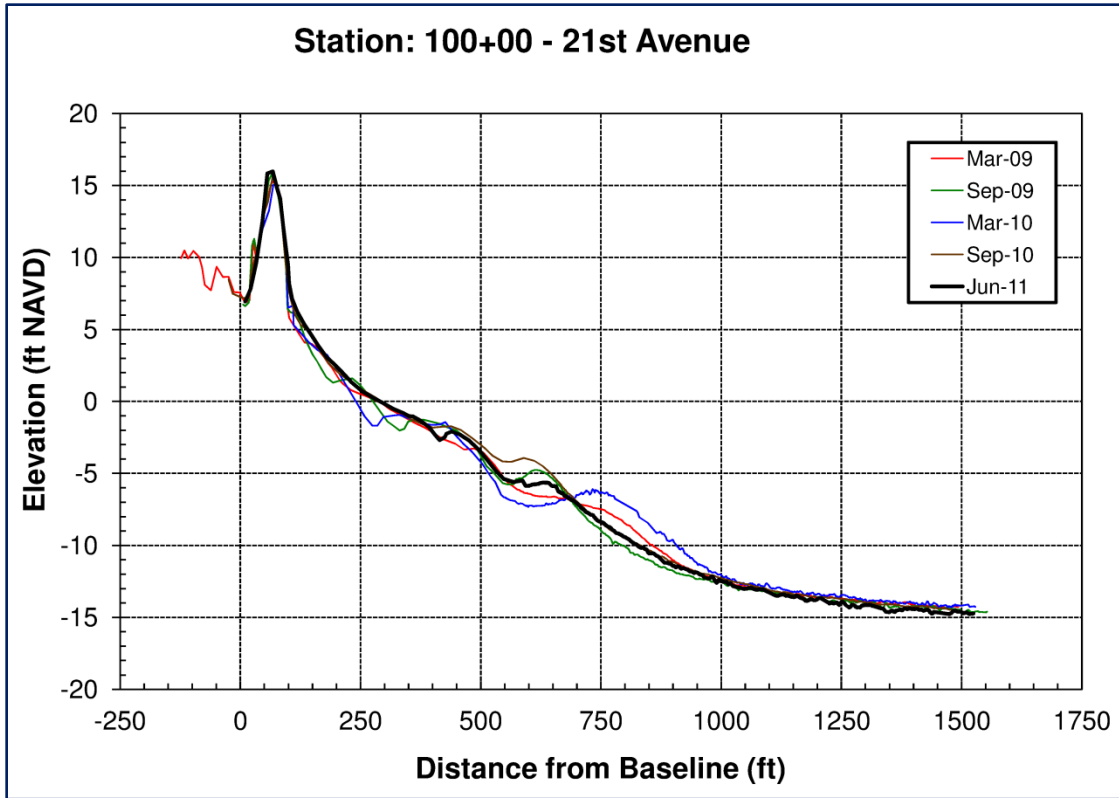
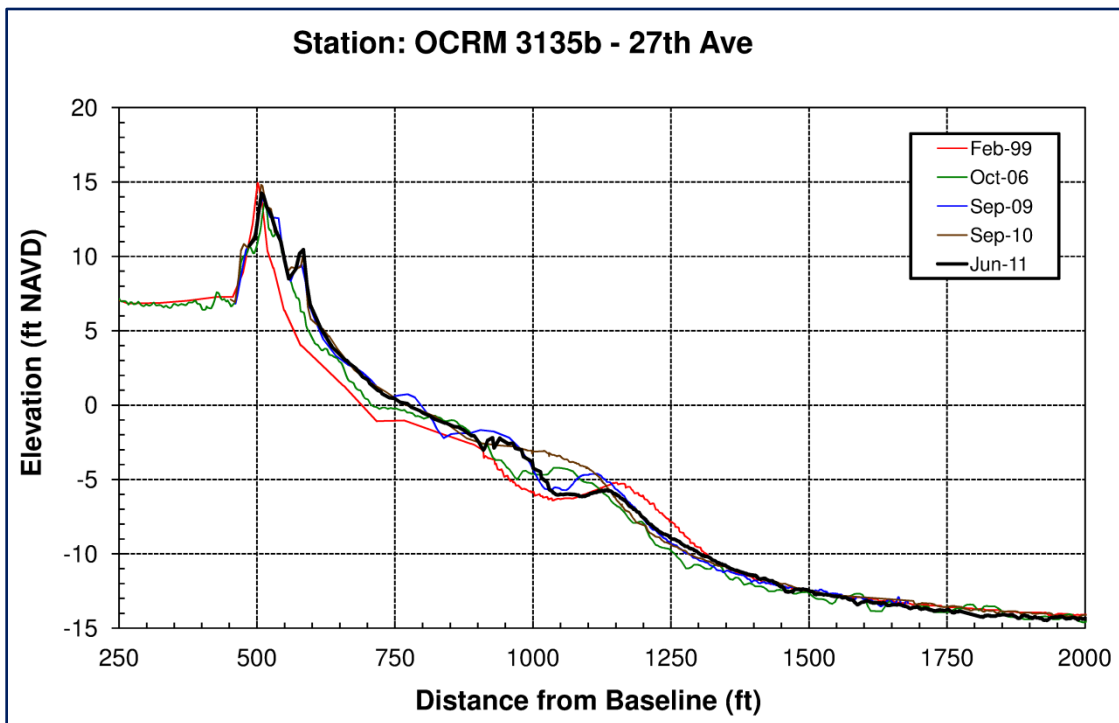
FIGURE 3.24. Profiles from station 100+00 (upper) and OCRM station 3135b (lower), showing long-term accretion since 1999. Protective dunes reach to +15 ft NAVD in this area and have been building since 1998. [Profiles prior to March 2009 courtesy SCDHEC-OCRM.]

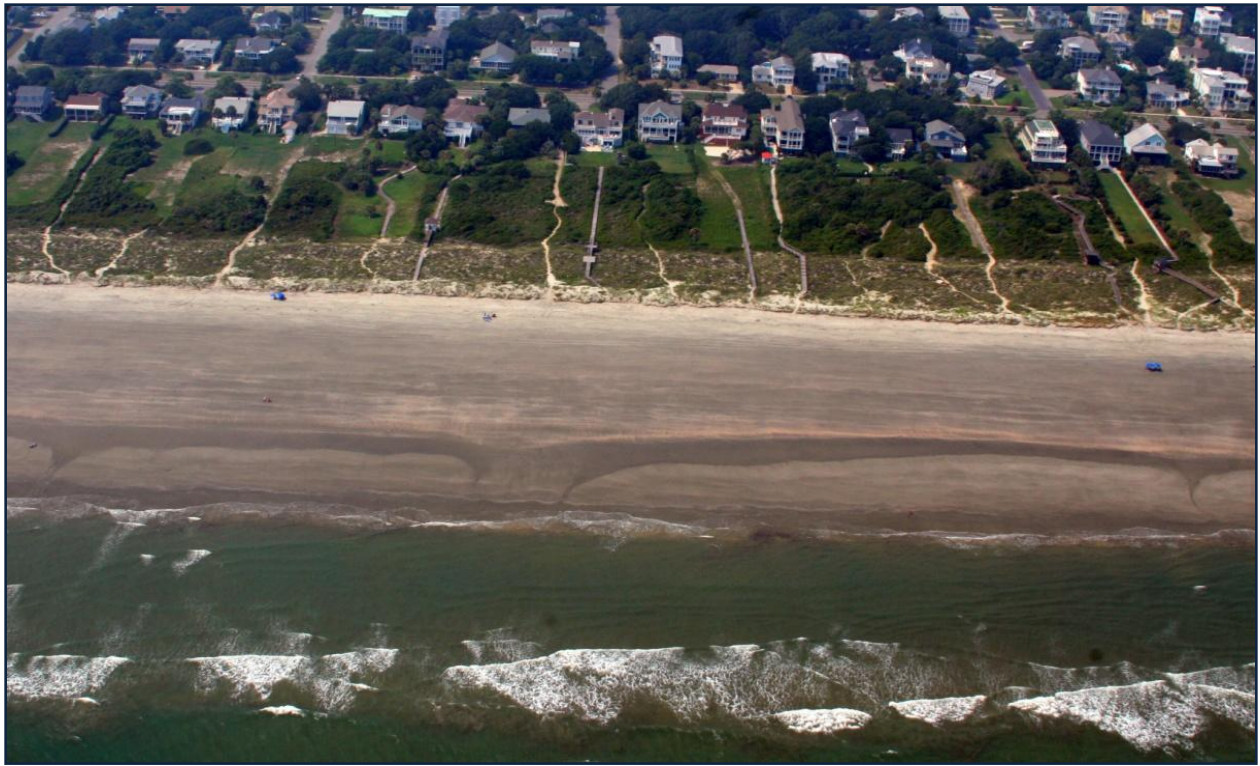
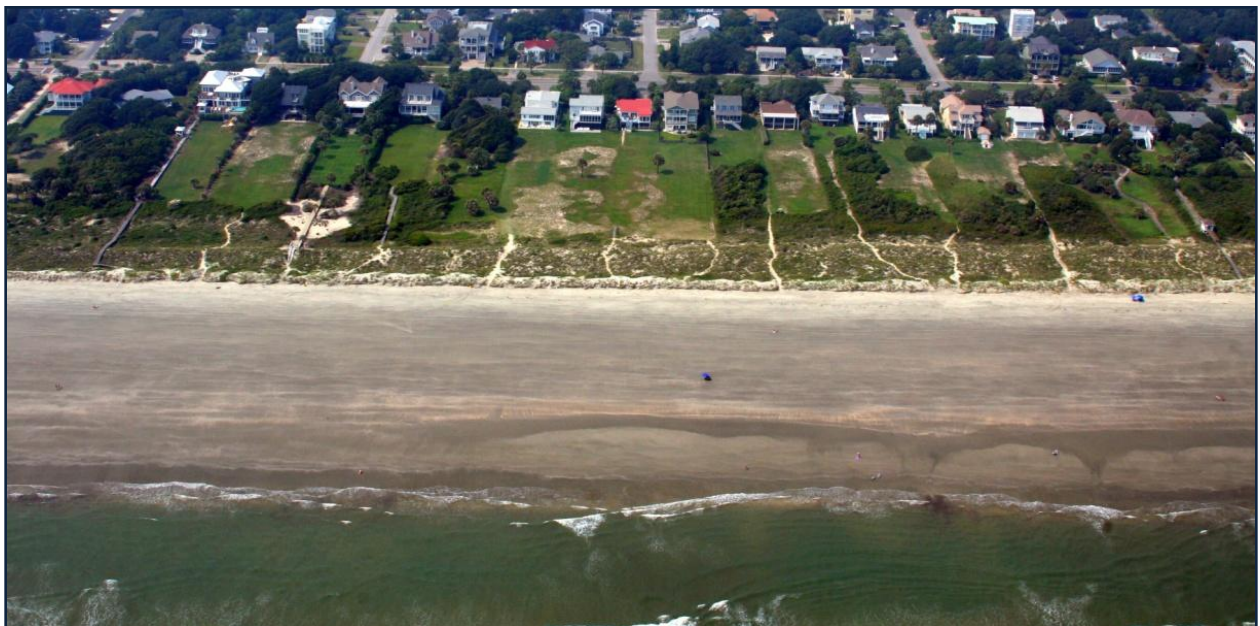
FIGURE 3.25. Aerial views along 27th Avenue to 30th Avenue (upper) and 25th Avenue to 29th Avenue (lower) after passage of Hurricane *Irene* in August 2011.

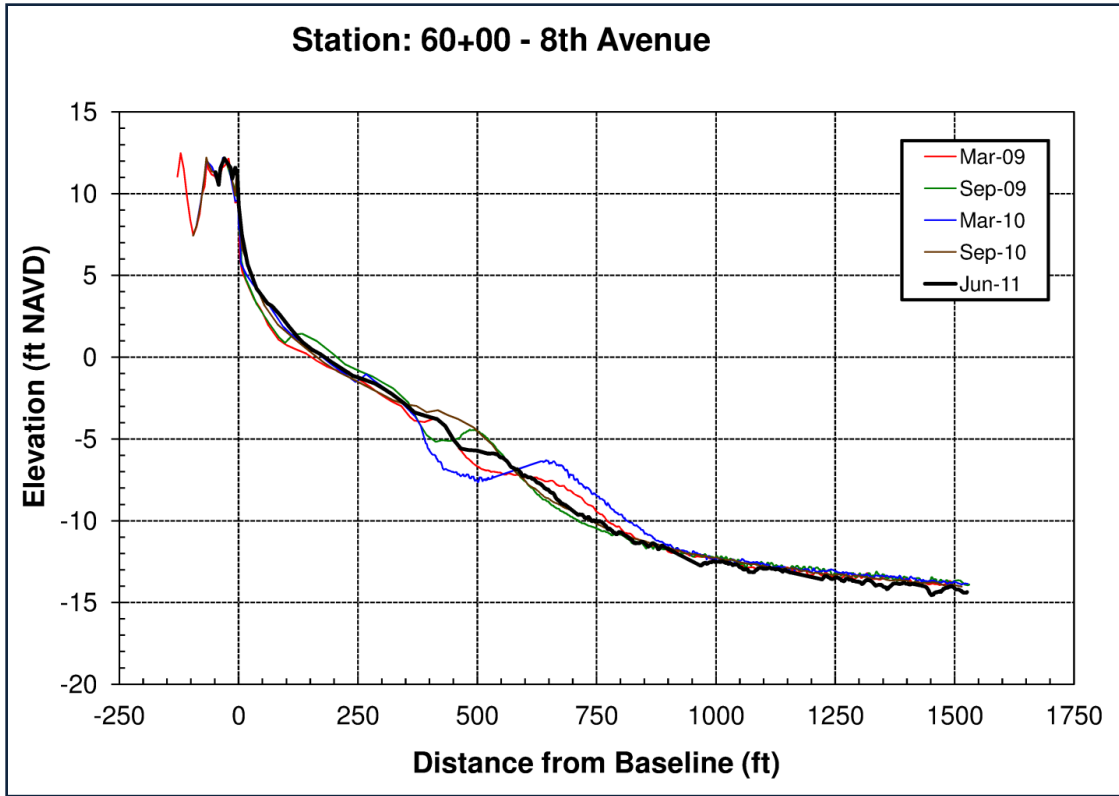
FIGURE 3.27. Profiles from station 60+00 (8th Avenue, upper) and station 80+00 (12th Avenue, lower). Reach 2 has remained generally stable since September 2010.

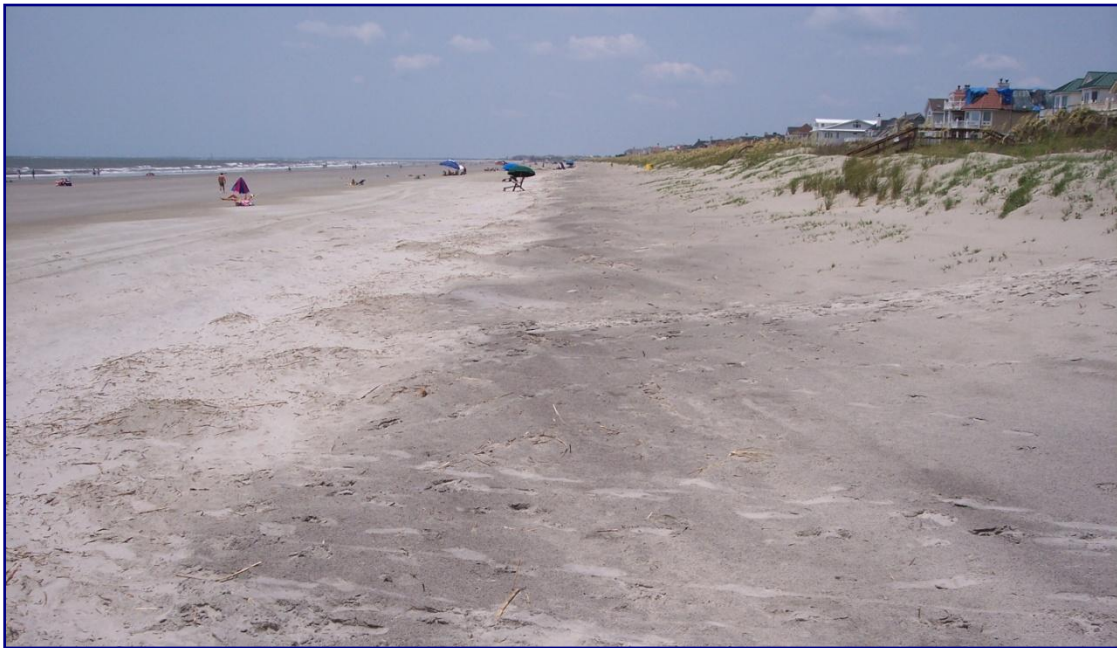
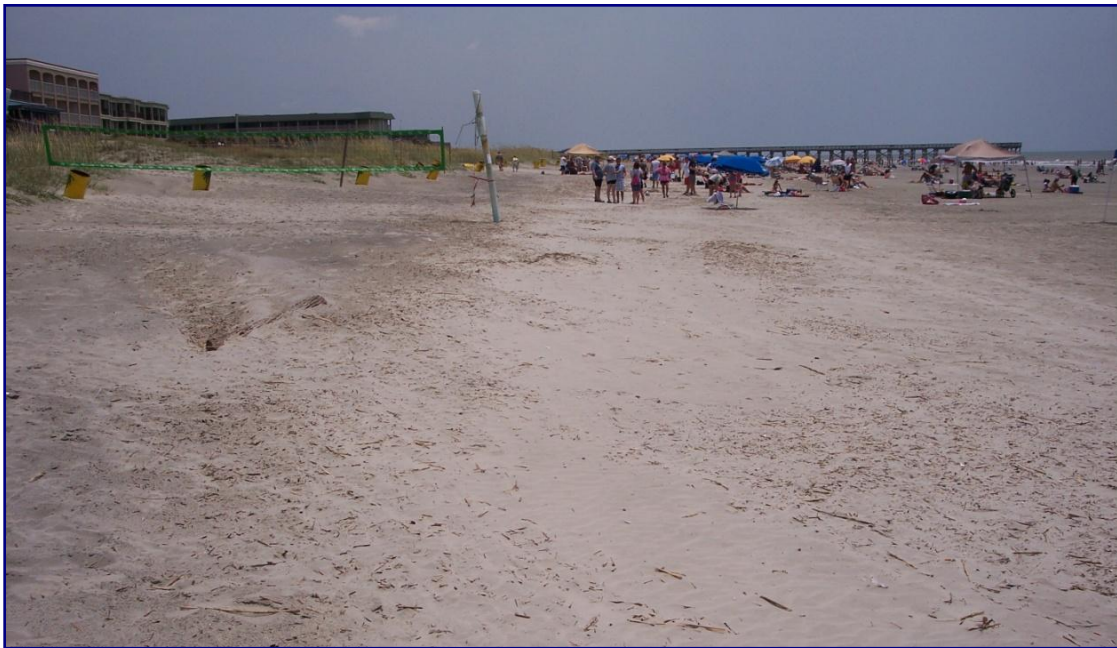
FIGURE 3.28. June 2011 photos from (upper) 8th Avenue (station 7542) and (lower) in front of the Windjammer (station 7549, just south of the pier).
