**2008 BEACH RESTORATION PROJECT
ISLE OF PALMS SOUTH CAROLINA**

**Monitoring Report No 3
November 2011**

YEAR 3 MONITORING REPORT

Coastal Science & Engineering (CSE)
PO Box 8056 Columbia SC 29202-8056

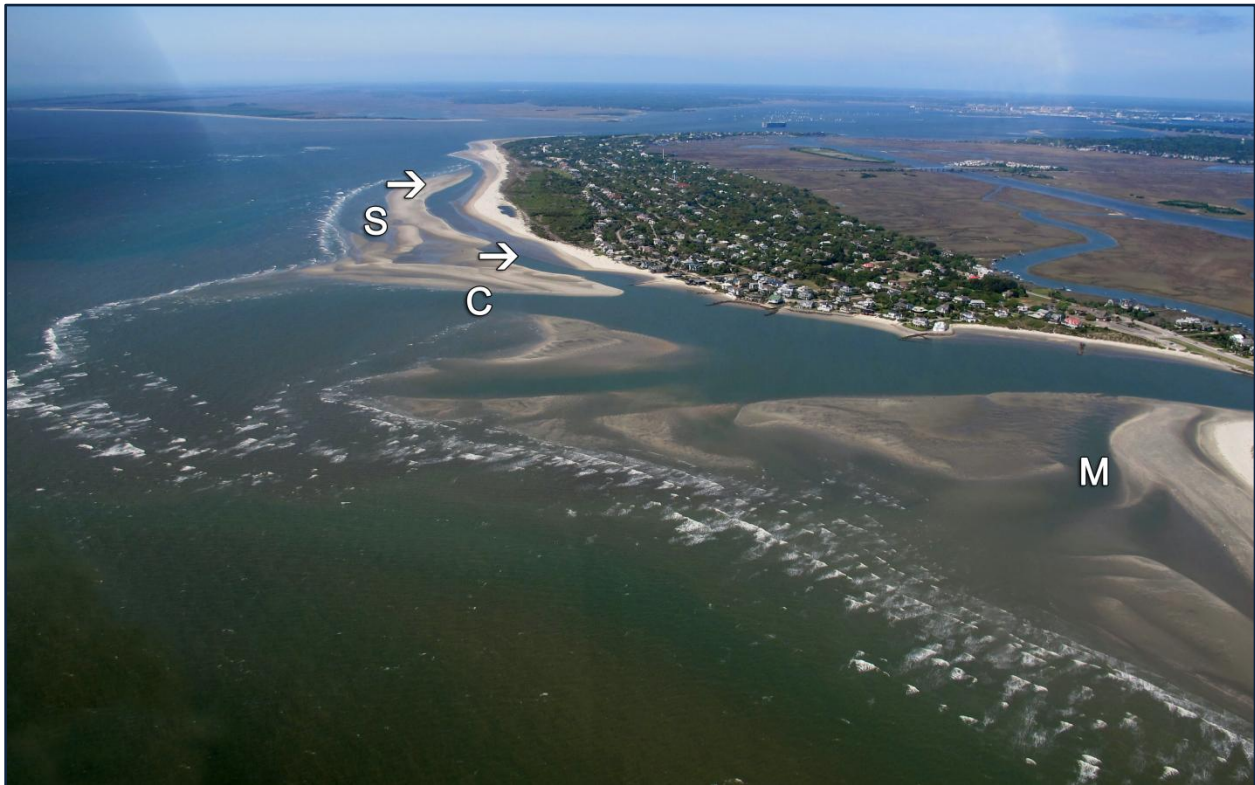
FIGURE 3.32. Aerial image of Breach Inlet taken 15 April 2011 (TW Kana). A channel (C) avulsion has triggered a large shoal-bypass event on Sullivan’s Island (S). The new main channel is oriented more perpendicular to the shoreline. Only a minor remnant of a marginal flood channel (M) was present on the Isle of Palms side when this photo was taken.

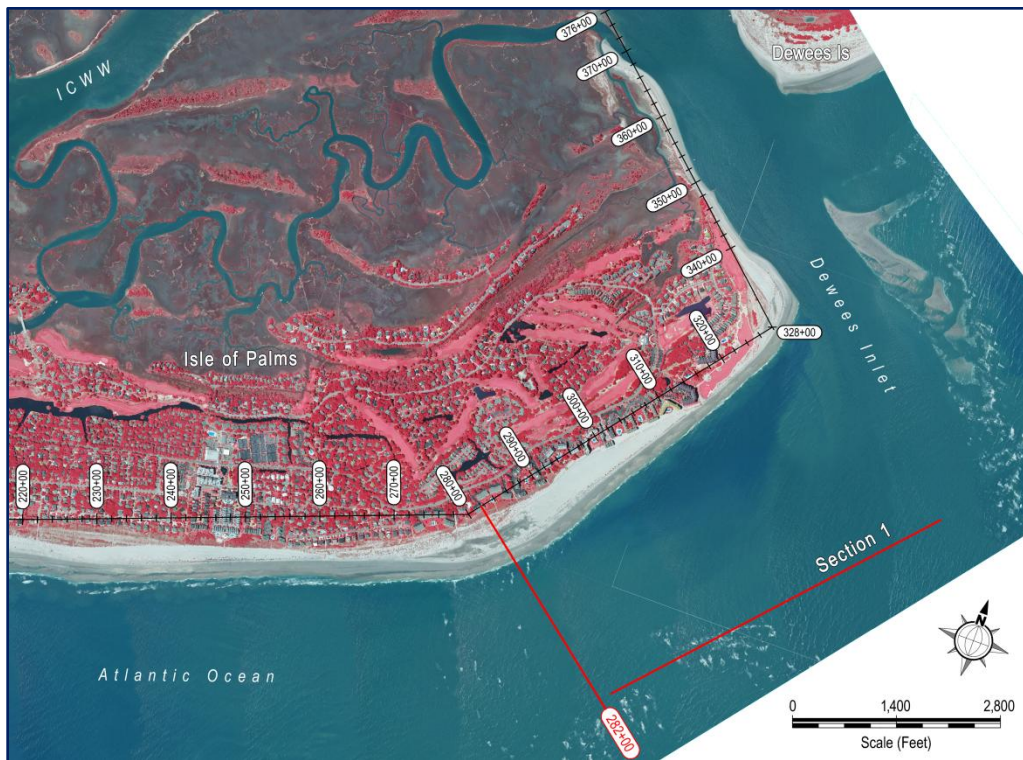
FIGURE 3.34. [UPPER] July 2011 aerial image of the northeastern end of Isle of Palms. No shoal was present as of August 2011. Section 1 indicates the location of the profile shown in Figure 3.39. **[LOWER]** Profiles from station 282+00 near the Wild Dunes POBH show the landward migration of shoals since 2007. Note the “2006” shoal (red line) attached to the shoreline with an ephemeral lagoon in July 2007 and completely welded to the beach in July 2008 (green line). The “2008” shoal attached in September 2009 (blue line). The 2010 shoal was much smaller than the previous two and essentially attached in September 2010 (brown line). The beach has receded since September 2010; however, collapse of the ebb-tidal delta of the old shoal is leading to buildup of sand ~3,000 ft from the beach. This sand will eventually migrate onshore. Note 0 ft NAVD is approximate mean sea level.

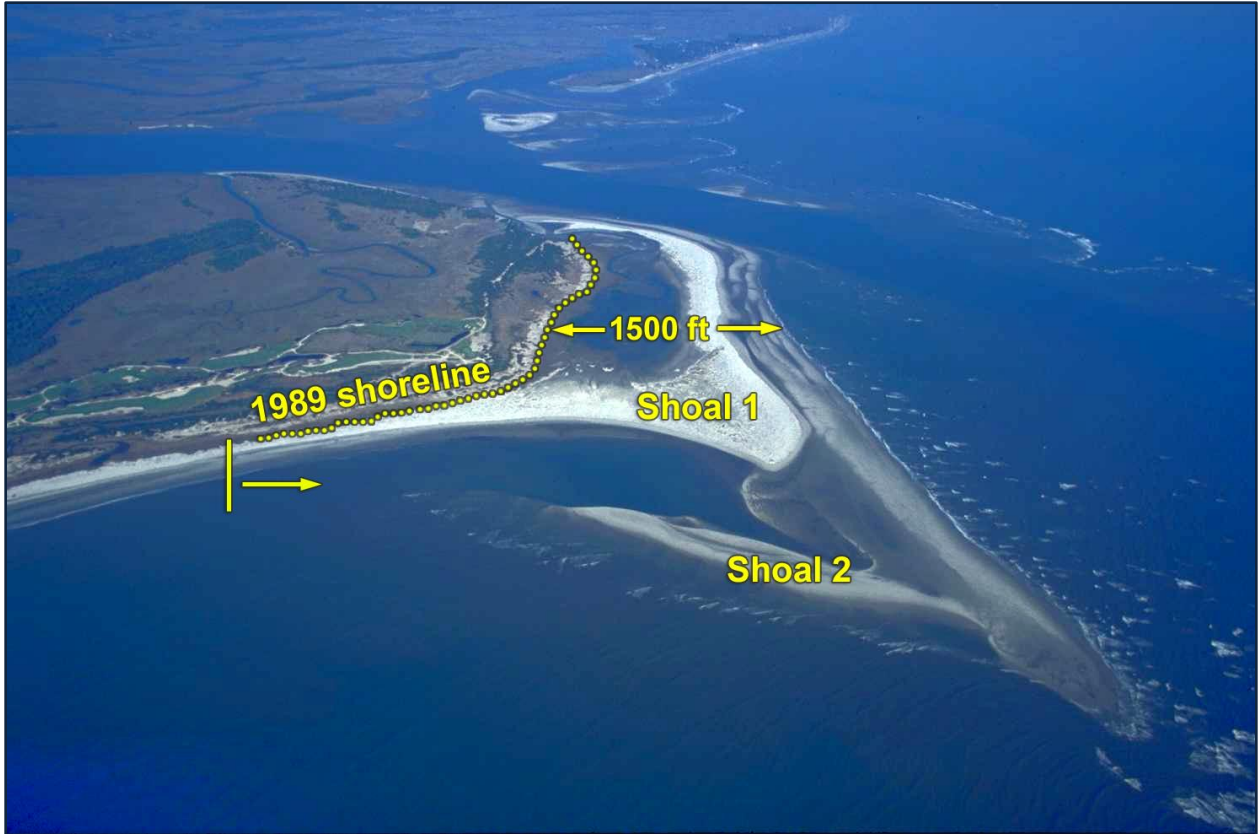
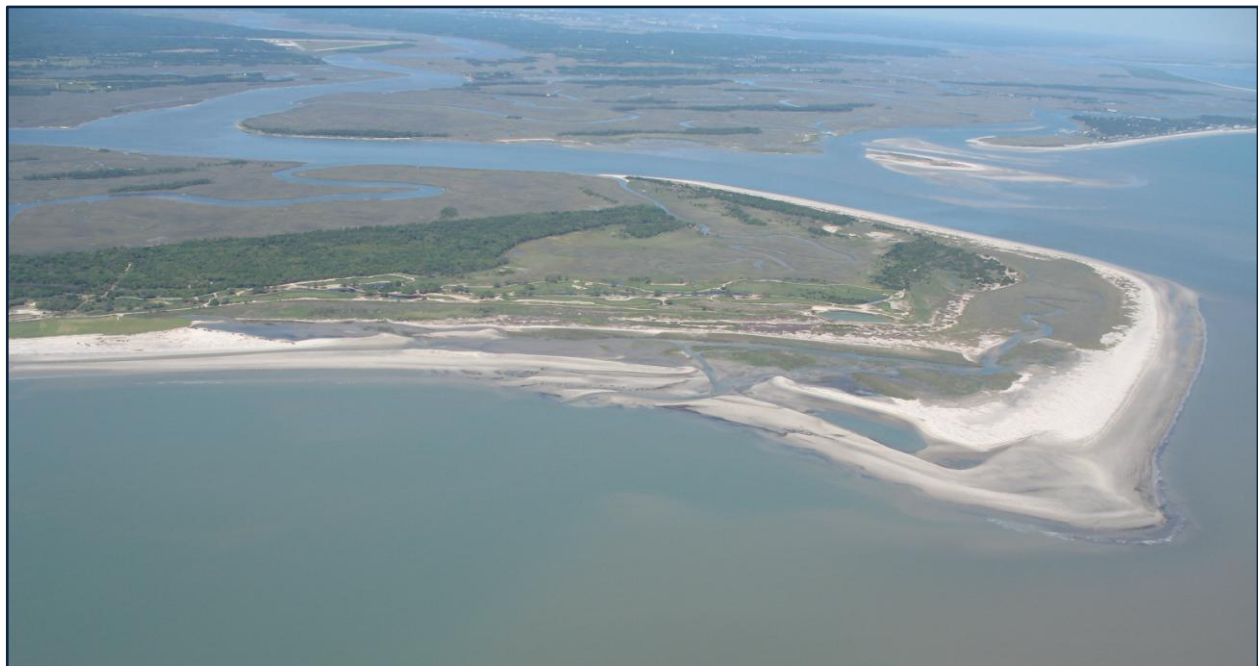
FIGURE 3.43. Shoal-bypass events at Kiawah Island. The upper image from 1998 shows two shoals estimated to contain ~5 million cubic yards of sand. Shoal 1 was attached and had built a barrier beach ~1,500 ft seaward of the original shoreline. A marsh was forming in the created lagoon. The second shoal was attached at the north end, but still in Stage 2 of the bypass cycle at the south end. The lower image is the same area in April 2010. By this time the second shoal had completely attached and was in the process of forming a new outer beach. Marsh had developed throughout the lagoon, leaving a network of tidal creeks flushing the new system. [Source: CSE 2007, 2010]

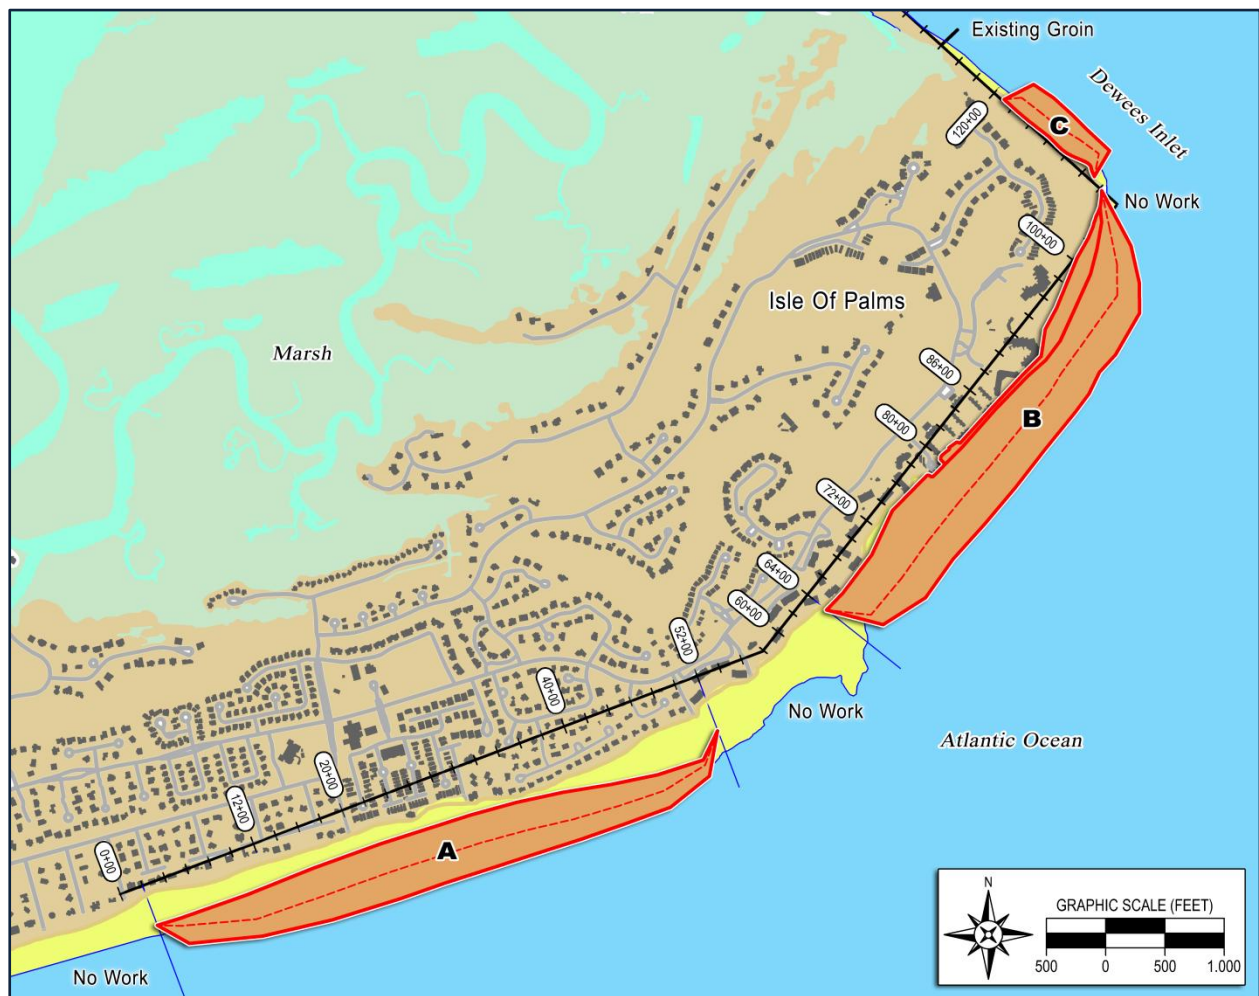
FIGURE 3.41. Reaches for the 2008 nourishment project. The graphic shows the project baseline with 0+00 located at 53rd Avenue (monitoring station 222+00).

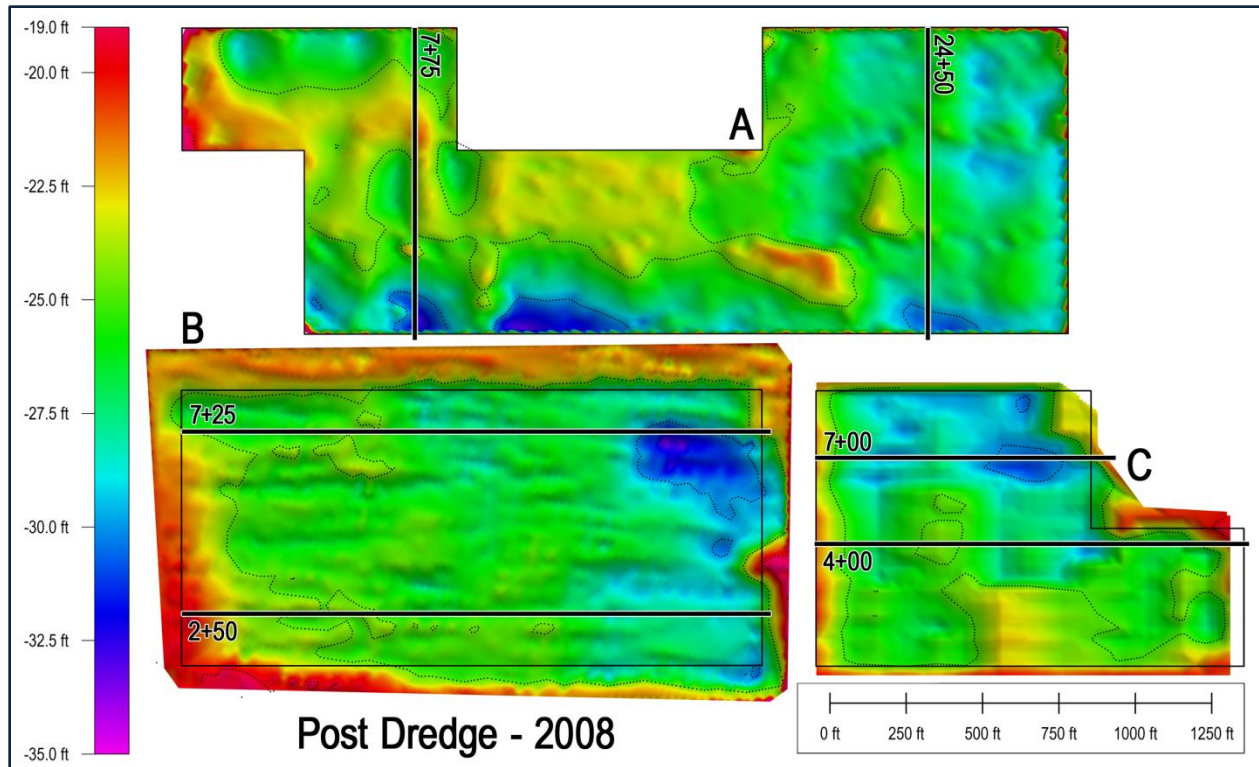
FIGURE 3.44. DTM models of borrow areas after nourishment in May 2008. [Solid black lines are the locations of sections in Figure 3.47.]

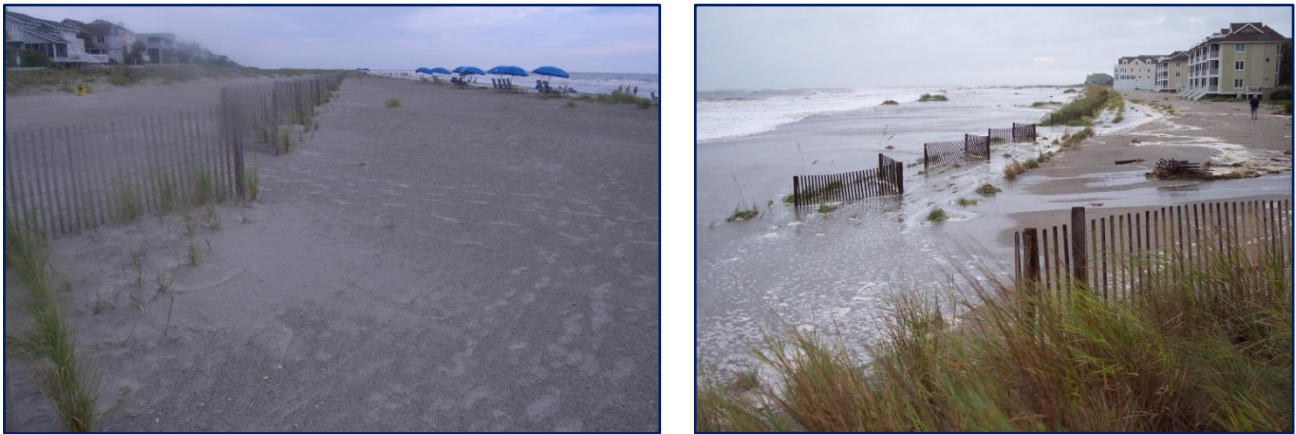
FIGURE 3.52. [LEFT] Sand fencing in Reach 5 in June 2011. There is less dune growth in this area than in Reach 6. [RIGHT] Sand fencing and vegetation in Reach 6 from Ocean Club in August 2011 during Hurricane *Irene*. The +6-ft NAVD berm was overtopped; however, only the dune near the Ocean Club boardwalk showed any damage. The +8-ft NAVD storm berm was not overtopped.

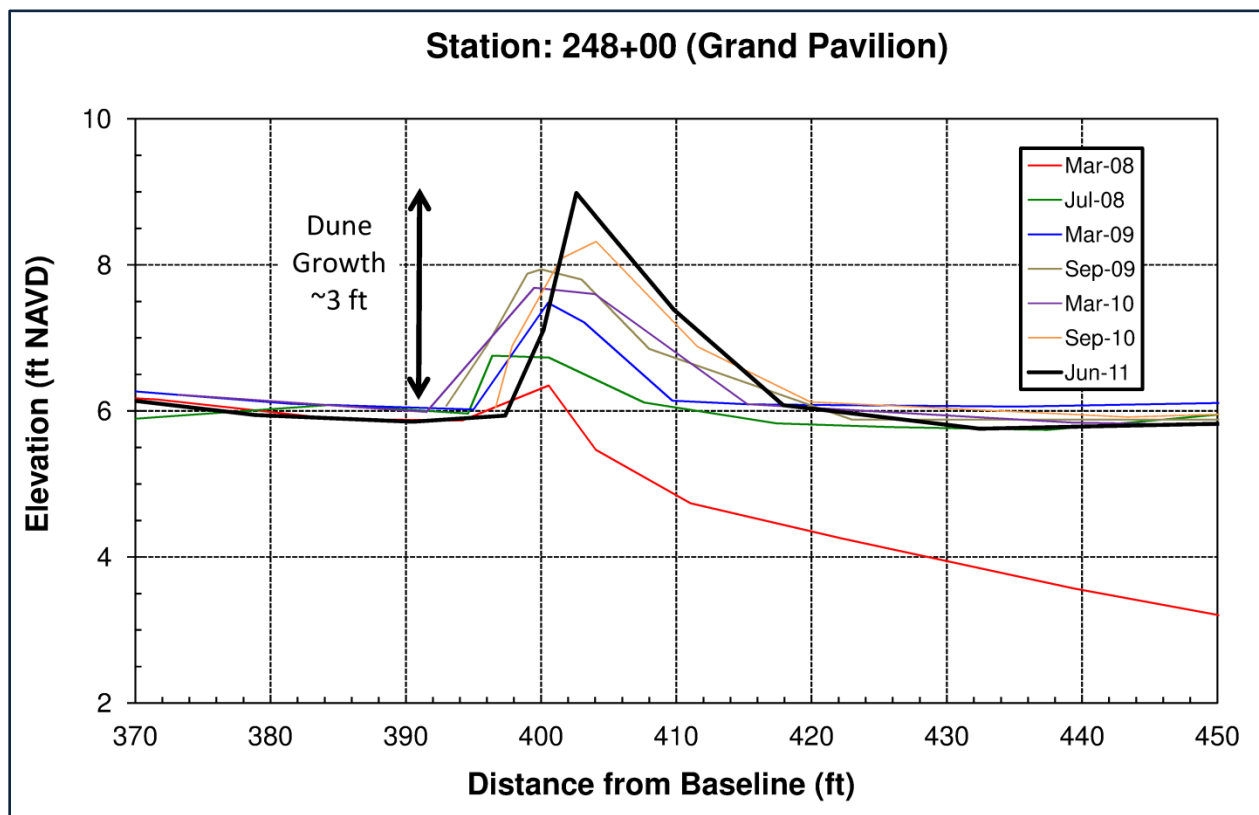
FIGURE 3.53. Evidence of dune growth at station 248+00 (adjacent to the Wild Dunes Grand Pavilion) following nourishment (May-June 2008). Elevation of the dune has increased ~3 ft naturally since the pre-project condition. Dune growth may slow in this area as the dune further seaward (at the sand fencing) becomes larger, intercepting more sand.
