**2008 BEACH RESTORATION PROJECT
ISLE OF PALMS SOUTH CAROLINA**

**Monitoring Report No 5
December 2013**

YEAR 5 MONITORING REPORT

Coastal Science & Engineering (CSE)
PO Box 8056 Columbia SC 29202-8056

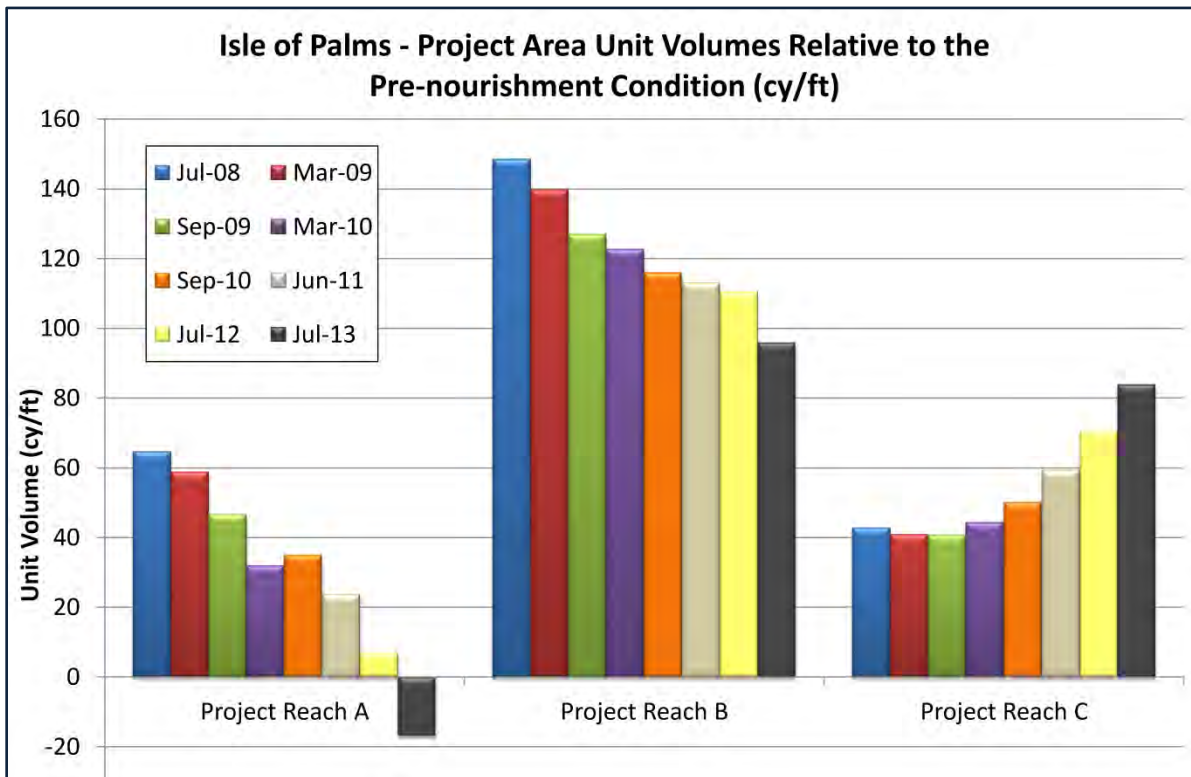
FIGURE A. Percent of nourishment volume remaining in project areas as of July 2013.

- Reach C (a 1,000-foot length of Dewees Inlet shoreline adjacent to the 17th hole and 18th tee of the Wild Dunes Links Course) retains ~196.0 percent of the nourishment volume (Fig A), gaining ~13,250 cy over the past year.

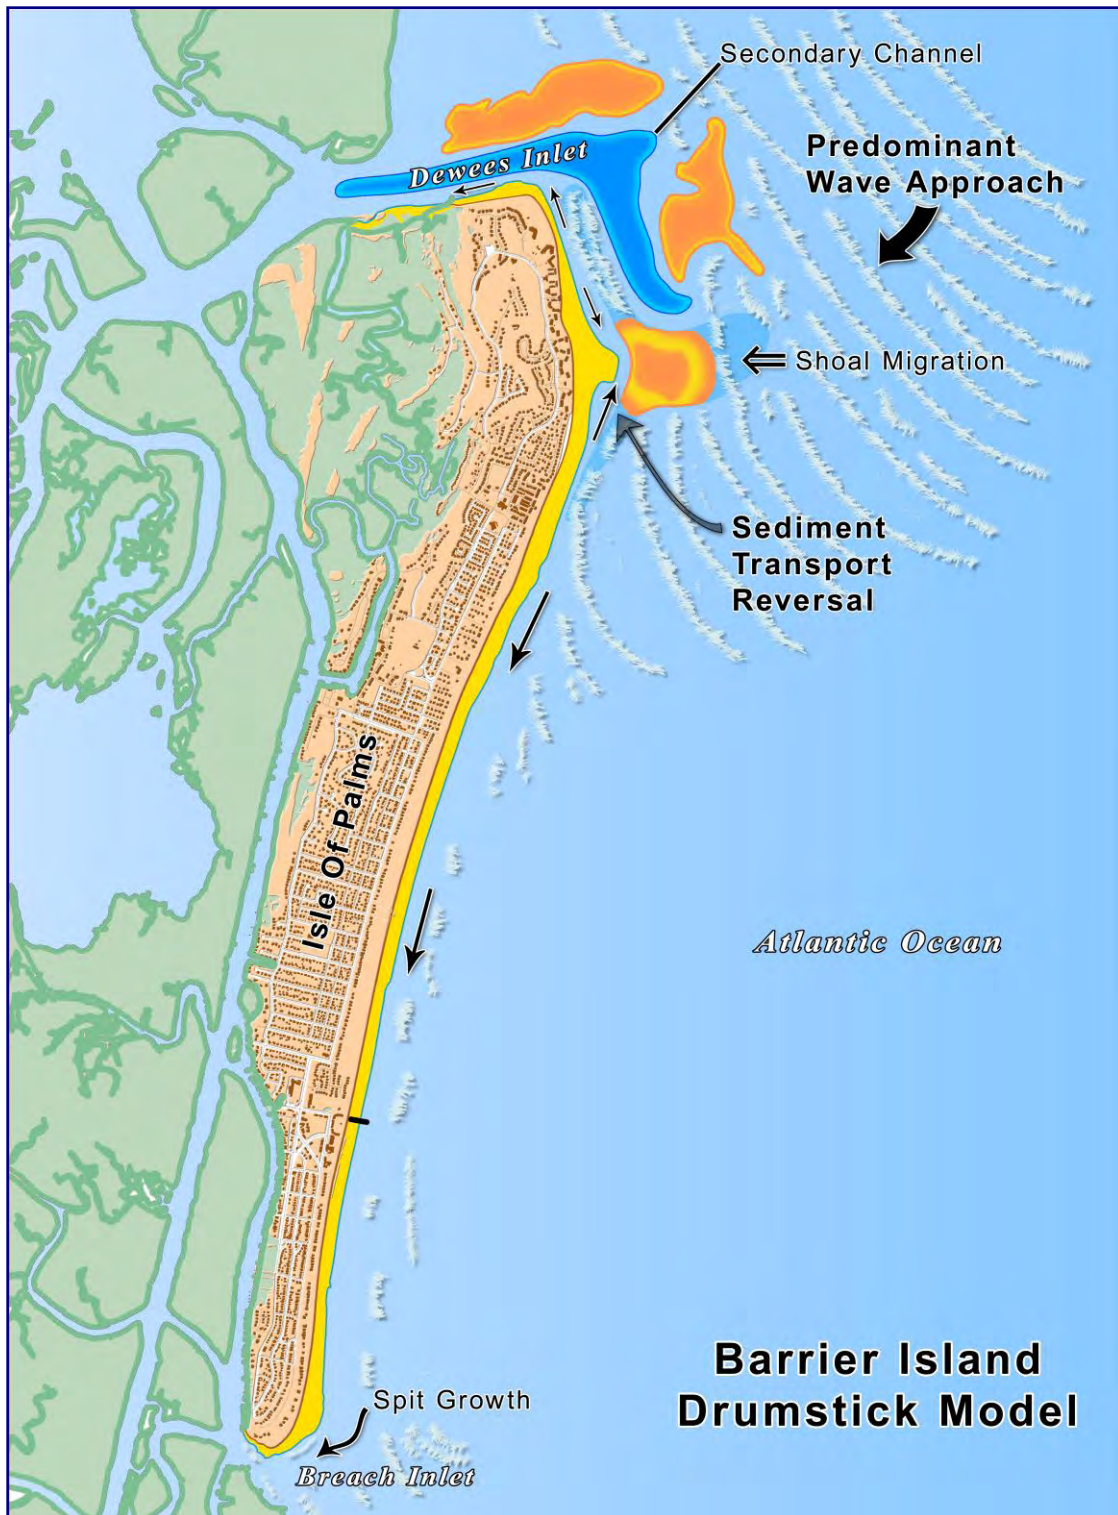
FIGURE 1.1. Isle of Palms is a typical “drumstick” barrier island (after Hayes 1979), where the upcoast end is wider due to sediment accumulation through shoal-bypass events, and the downcoast end usually forms a growing recurve spit. Other examples of drumstick barrier islands along South Carolina are Bull Island, Kiawah Island, and Fripp Island. Zones of sediment transport reversal generally occur in the lee of delta shoals which are situated offshore. Upon shoal attachment to the beach, transport directions in the vicinity of the shoal switch, spreading sand away from the attachment point (see for example — Fig 1.2).

The wider end of the island is influenced by shoal bypassing, a process whereby sand is periodically released from the inlet delta and moved onshore through wave action. This process occurs at somewhat regular intervals (average interval between events from 1941 to 1997 is 6.6 years, Gaudiano 1998) and contributes to the overall health of the island. However, it also can cause focused erosion in areas adjacent to the shoal attachment zone (Kana et al 1985).

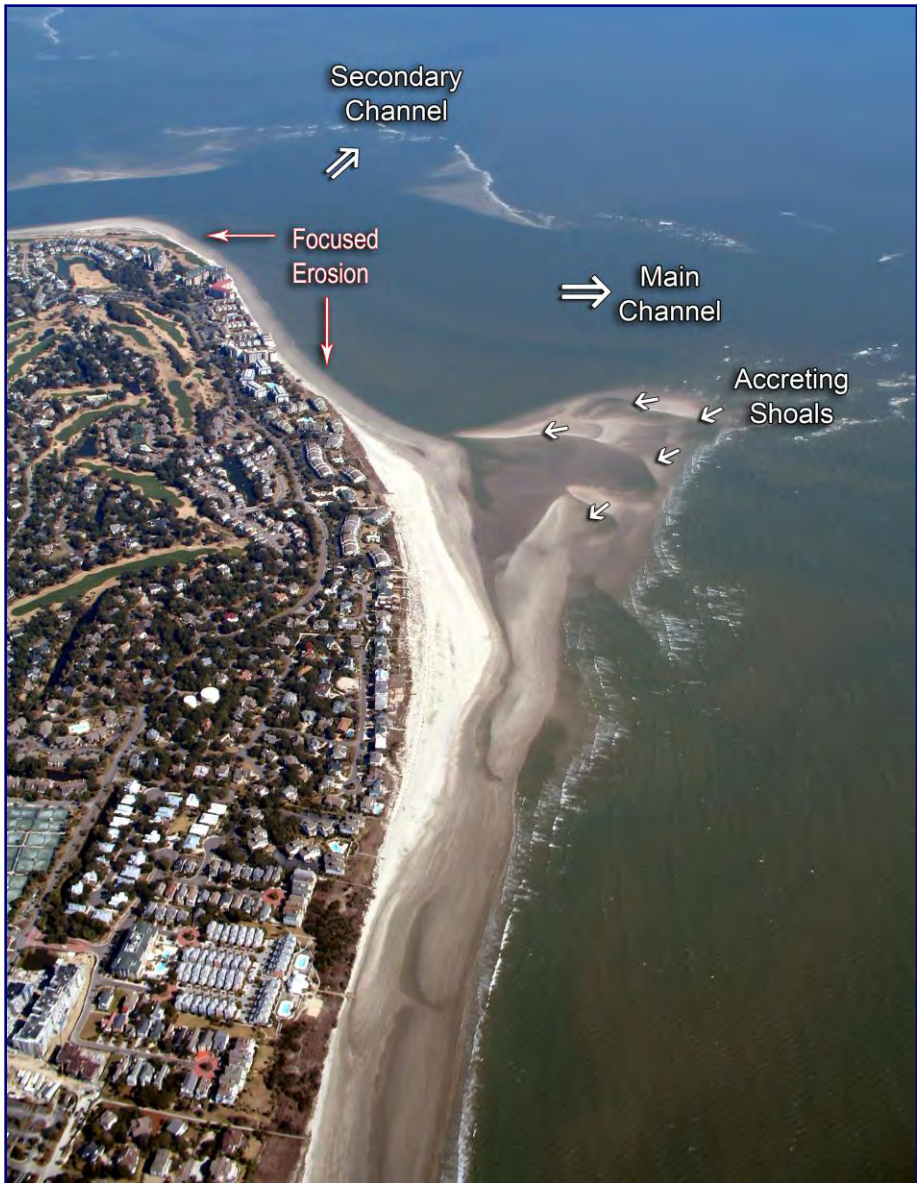
FIGURE 1.3.

Prior to the 2008 project, little to no beach was present at low tide near the Ocean Club condominiums.

Prior to nourishment in June 2008, most of Reach 6 was severely eroded with profile volumes seaward of development well below an ideal condition. Property owners had piled sand bags against buildings for protection, and little or no dry beach was present (see Fig 1.3). The condition was beginning to improve just before the nourishment as the shoal attaching at the western end of the reach was in Stage 3 of the bypass cycle. Sand was moving from the shoal toward Dewees Inlet, but not quickly enough to restore the beach along most properties north of the Wild Dunes Property Owners Beach House (WDPOBH).

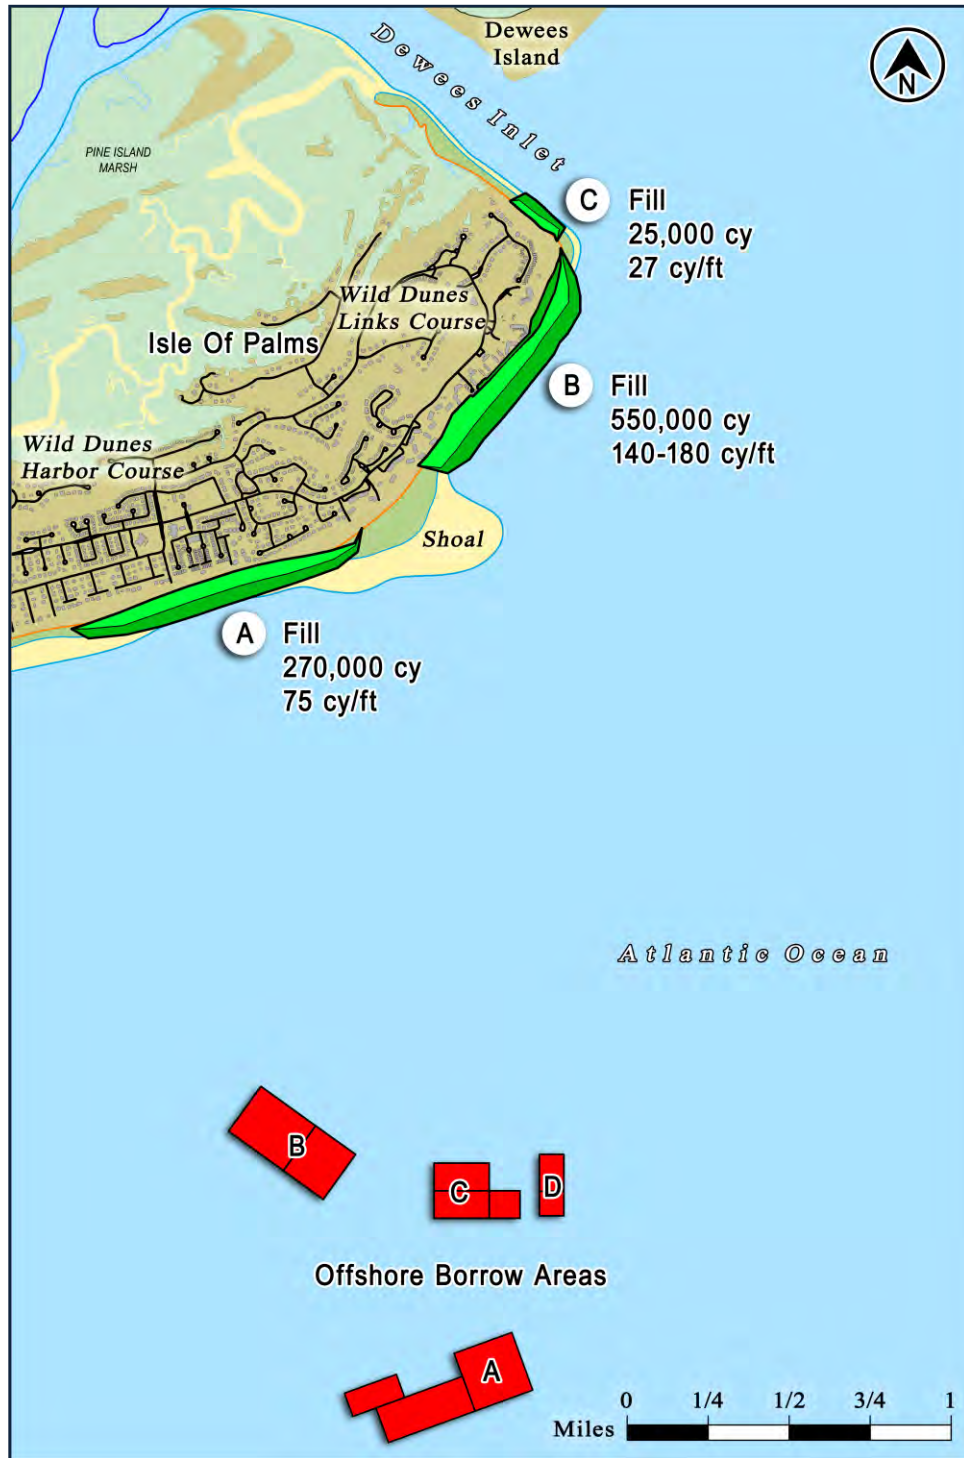
FIGURE 1.4. Project map of the 2008 IOP restoration project. The project was designed to nourish sections of the beach and provide sufficient sand to offset losses associated with long-term erosion as well as an ongoing shoal-bypass event. Borrow areas were located 2-3 miles offshore. Area D was not dredged.

The final volume added to the beach calculated from Weeks Marine's surveys was 933,895 cy, which was ~10 percent greater than the design volume of 847,400 cy. The overage of 86,495 cy was not a pay quantity as stated in the contract; therefore, the City was only required to pay for the contract volume of 847,400.

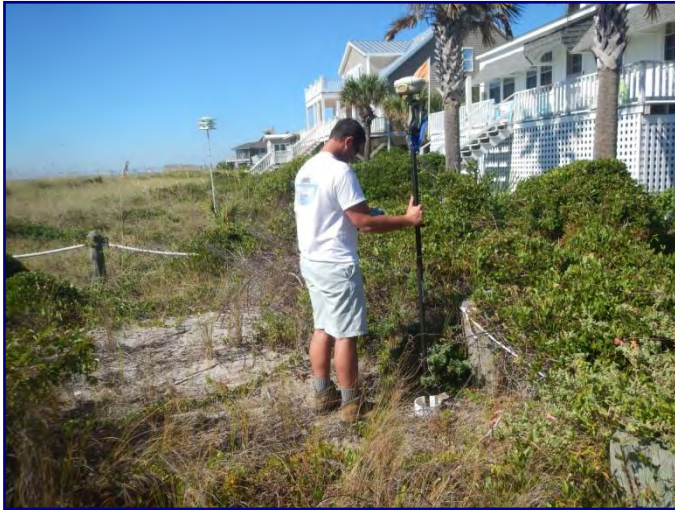
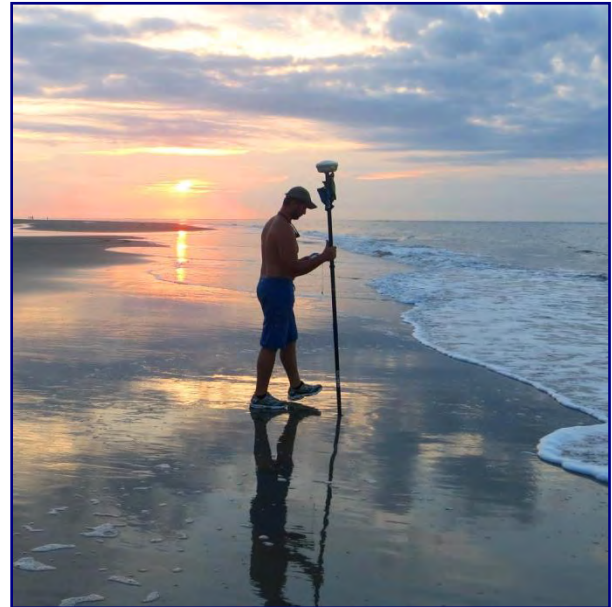
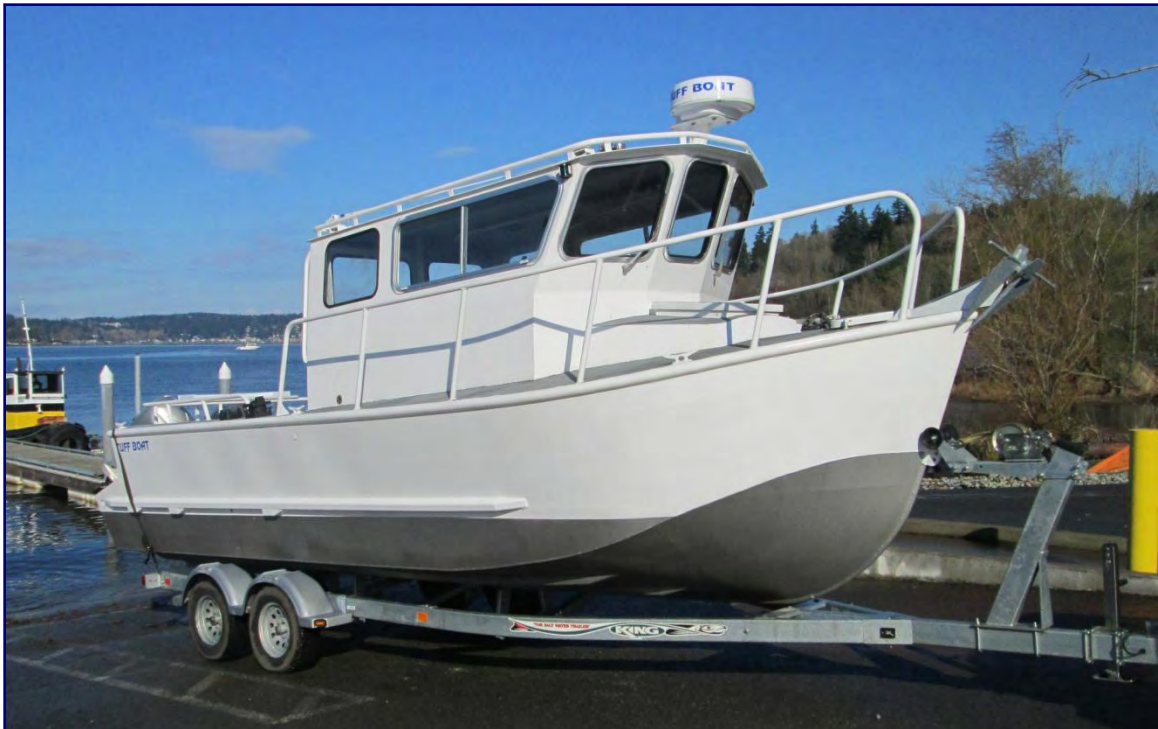
FIGURE 2.2. CSE beach monitoring methods include land-based data collection using Trimble™ RTK GPS from the backshore to low-tide wading depth and over-water work using RTK GPS linked to a precision echosounder aboard CSE's survey boat (RV *Southern Echo*).

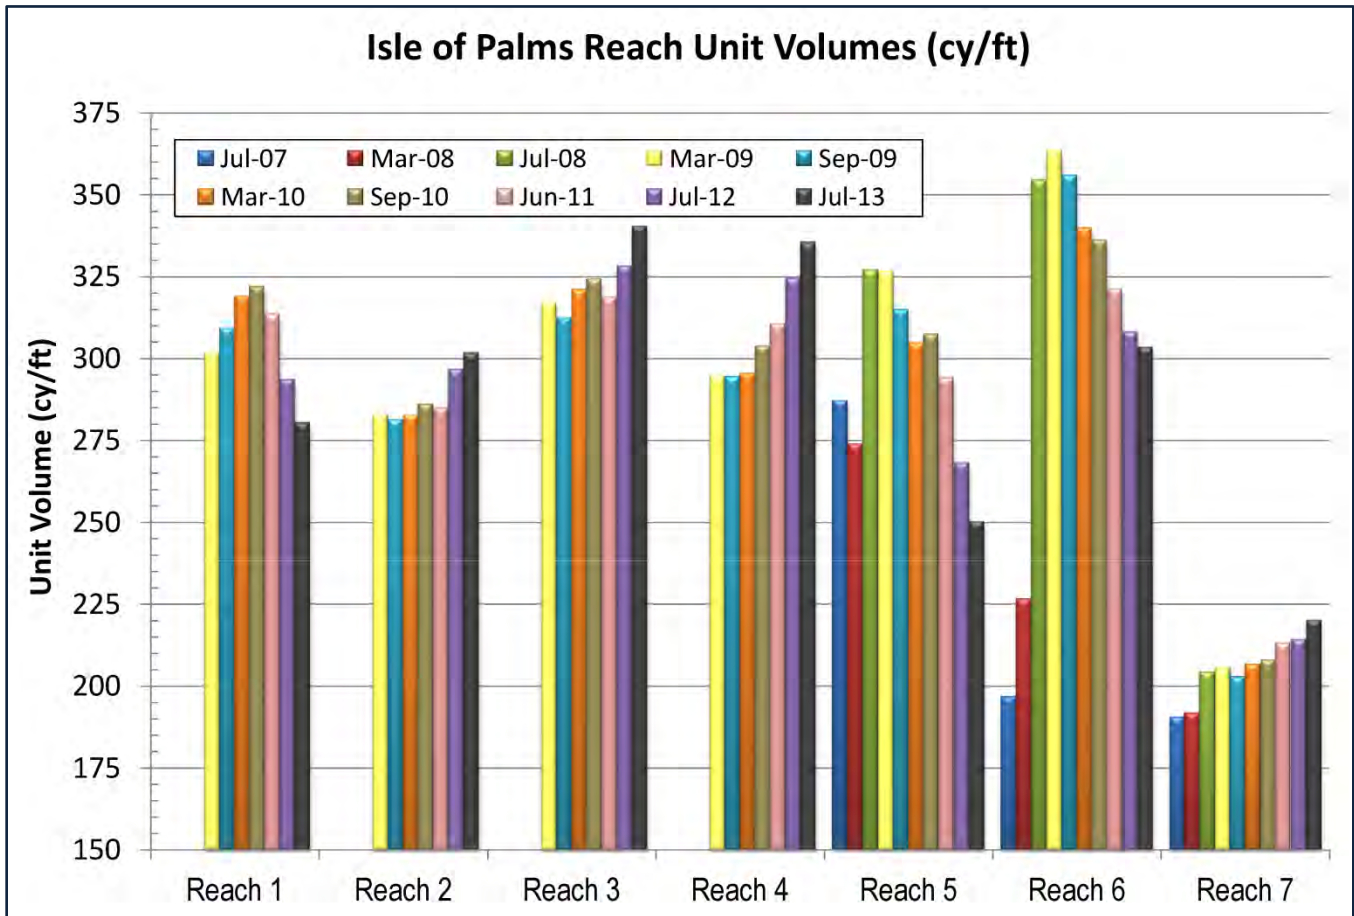
FIGURE 3.1. Average unit-width volumes for each monitoring reach at Isle of Palms. See Figure 2.3 for reach boundaries. Unit volumes were calculated from the primary dune to a profile-specific depth, generally between -9 ft and -13 ft NAVD for the beachfront. Nourishment occurred prior to the July 2008 data collection in Reaches 5, 6, and 7. Design-fill unit volumes for full sections were ~75 cy/ft in Reach 5, ~140-180 cy/ft in Reach 6, and ~27 cy/ft in Reach 7. See Figure 2.1 for beach nourishment locations.

The results of the 2013 monitoring survey show that the island gained ~11,200 cy (0.3 cy/ft) of sand from July 2012 to July 2013. Reaches 1, 5, and 6 were erosional; however, each lost less sand than the previous year. The central portion of the island continues to gain sand, while portions of the eastern end (Beachwood East/Dunecrest and near Ocean Club) and the area near Breach Inlet are the most erosional. Significant accretion was observed near Beach Club Villas and Mariners Walk, in the lee of an attaching shoal. Volume change data for each monitoring station and reach are given in Figure 3.1, and Tables 3.1 and 3.2.

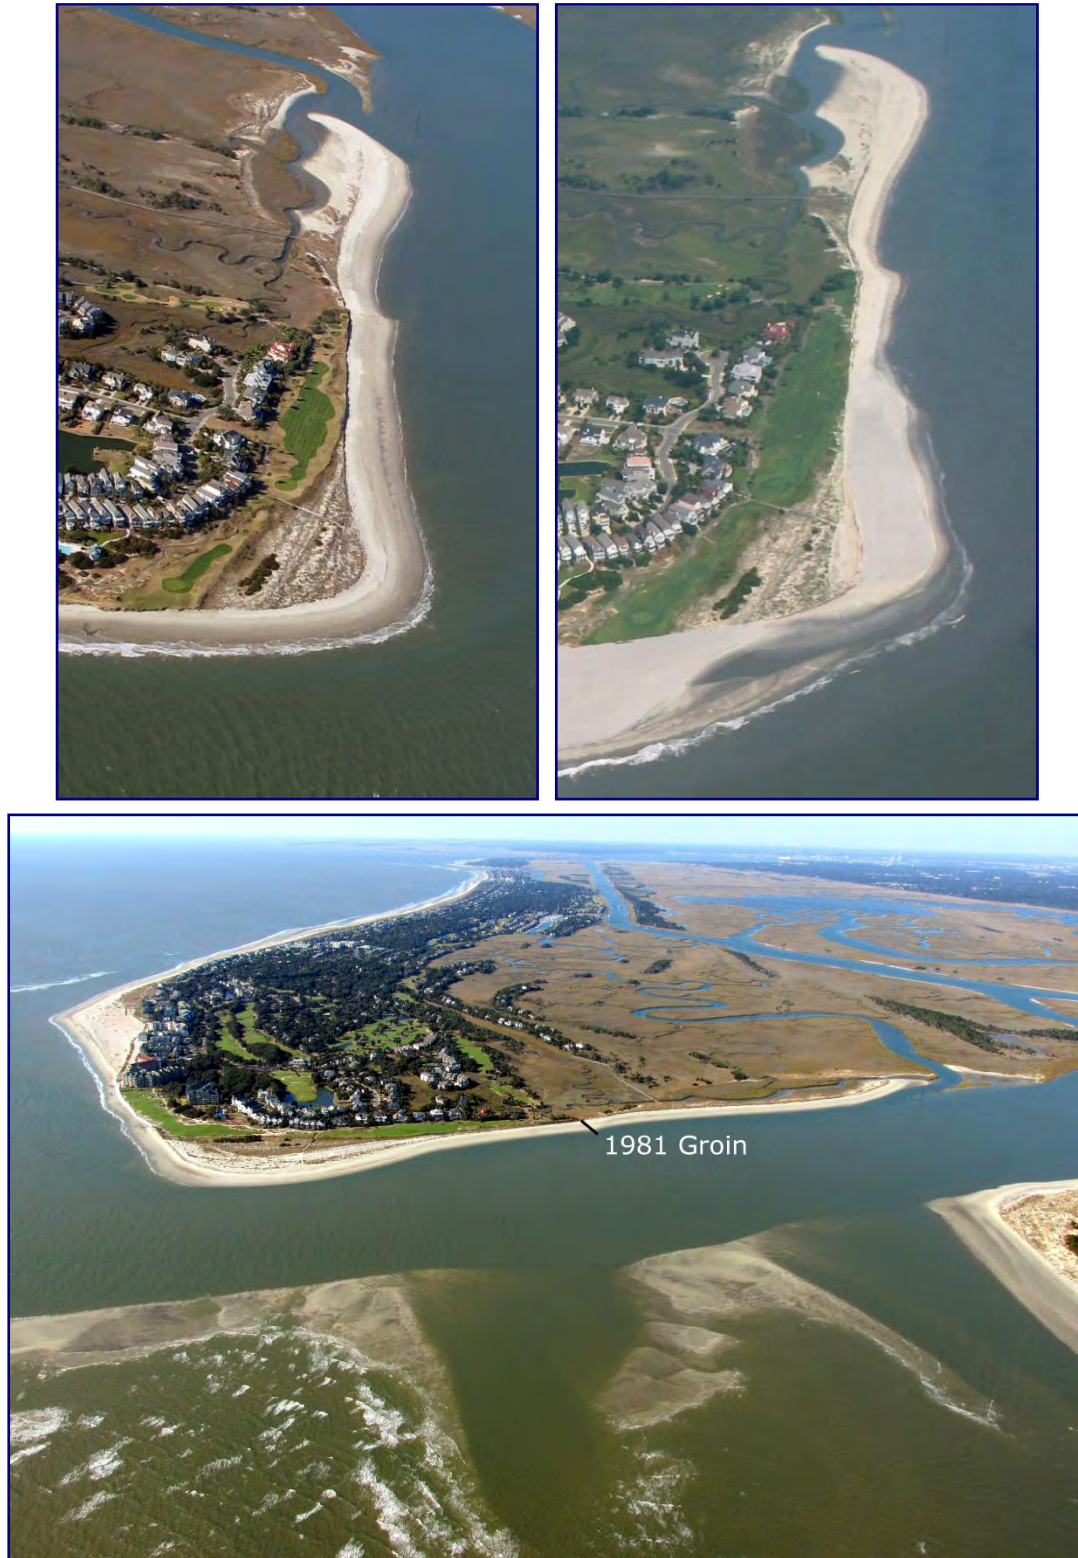
FIGURE 3.2. [UPPER LEFT] Reach 7 in December 2007. [UPPER RIGHT] June 2008 near the end of the project. [LOWER] November 2013. [Upper images by TW Kana] [Lower image by S Traynum]

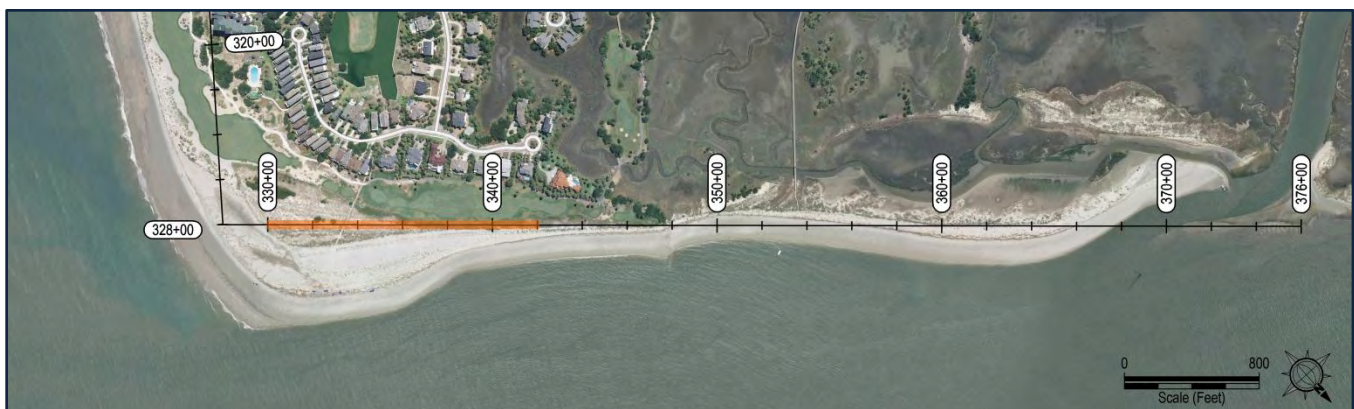
FIGURE 3.3. Station map of the Dewees Inlet area (Reach 7). Reach 7 spans from station 330+00 near the 18th tee to station 368+00 near Cedar Creek spit. The approximate limits of Reach C nourishment are identified by the orange-highlighted bar. The 1981 low profile groin is positioned near station 348+00. [July 2011 aerial image by Independent Mapping Consultants Inc]

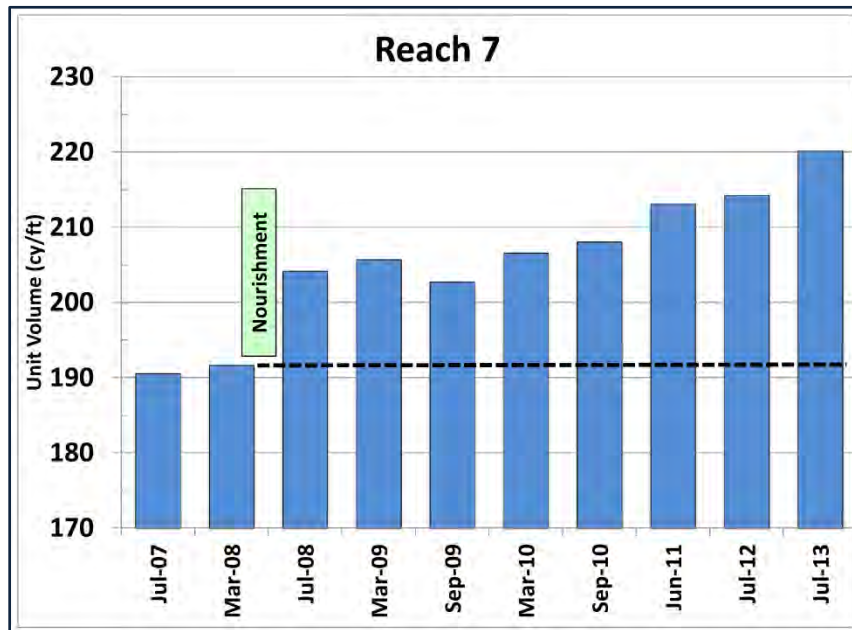
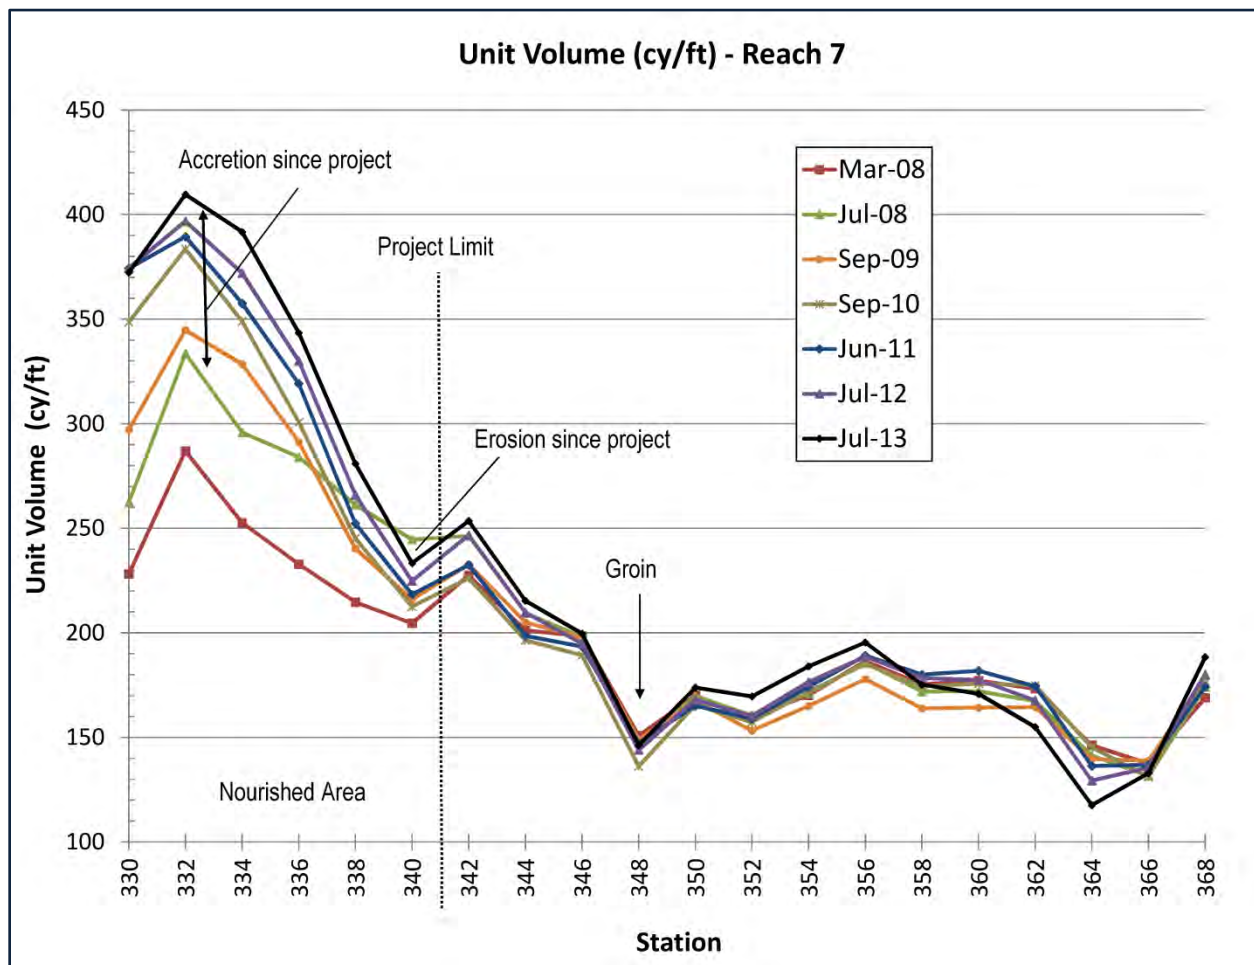
Reach 7 has consistently gained sand since 2007 (Fig 3.4, upper), with most of the accretion being focused near the seaward end of the reach (17th green and 18th tee area). The area seaward of the groin (station 348+00 near the 17th tee) has gained ~61,750 cy of sand since nourishment in 2008 (most of which was gained between stations 330+00 and 338+00). Of note is that erosion which occurred rapidly following the project at stations 338+00 – 342+00 has recovered and the beach is healthier than the post-nourishment condition at all but station 340+00. The beach inland of the groin has been relatively stable, showing a net gain of ~2,100 cy. Within this subreach, stations 348+00 thru 356+00 accreted an average of 6.4 cy/ft while stations 358+00 thru 366+00 eroded an average of 7.4 cy/ft over the past year.

FIGURE 3.4. [UPPER] Cumulative unit volumes for Reach 7 from 2007 to 2013. [LOWER] Unit volumes for stations in Dewees Inlet. Profiles in the southwestern portion of the reach (17th green – 18th tee) have accreted following the project, while the remaining stations have been stable or have eroded. The difference between 2013 (black line) and post-nourishment (green line) shows the volume change since nourishment.

Overall, the reach gained 23,650 cy (5.9 cy/ft) of sand over the past year. As of July 2013, the reach contains 114,100 cy (28.5 cy/ft) more sand than the pre-nourishment condition. Wave action directed towards and into the inlet moves sand from the front beach to the inlet shoreline, leading to the observed accretion. Once the sand reaches Cedar Creek Spit, or is moved below the influence of wave action, tidal currents in Dewees Inlet carry it offshore, building the delta system. Over the last few years, a significant sandbar, termed a trailing ebb spit, has formed just offshore of the point (see Fig 3.17 in this section). Sand lost from the front beach, some of which may be cycled through Reach 7, is likely the source of sand for this growing feature.

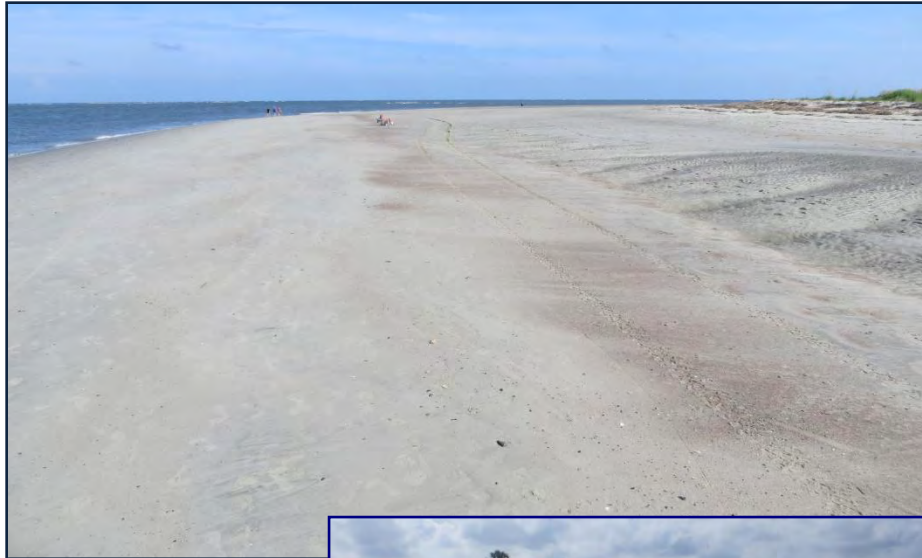
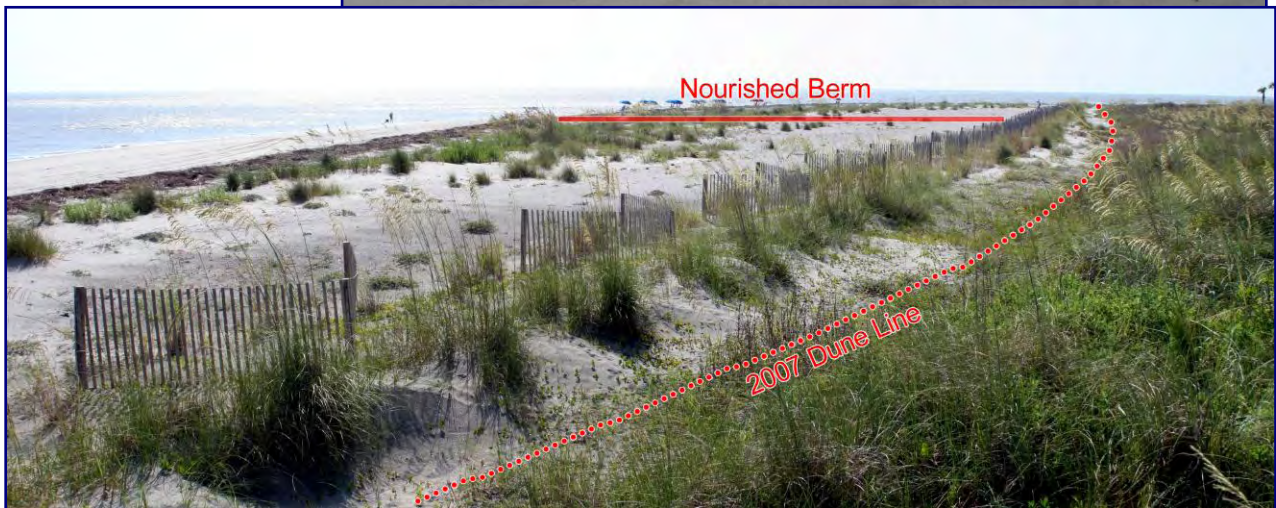
FIGURE 3.6. [UPPER] View looking south from station 332+00 in July 2013; the sand visible in this image has accreted since nourishment. [MIDDLE] Northwest view in July 2013 from station 344+00 ~400 ft seaward of the groin. A small scarp is visible; however, a dry berm separates the high waterline from the dune. [LOWER] View seaward of the nourished area of Reach 7 in July 2012. Vegetation has become well established seaward of the sand fencing. The pre-project dune line (red dotted line) is the dense vegetation ~25 ft to the right of the fencing in the image. [Photos by D Giles and S Traynum]

The seaward end of the reach has accreted (station 332) since nourishment, while the central and inland portions of the reach have remained fairly stable.

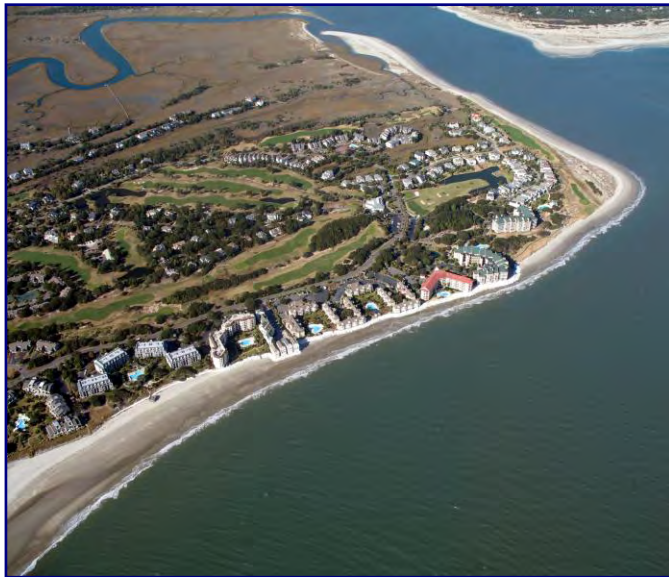
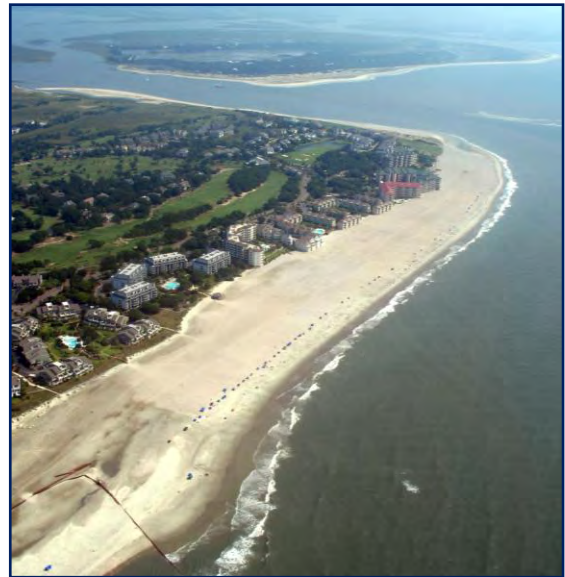
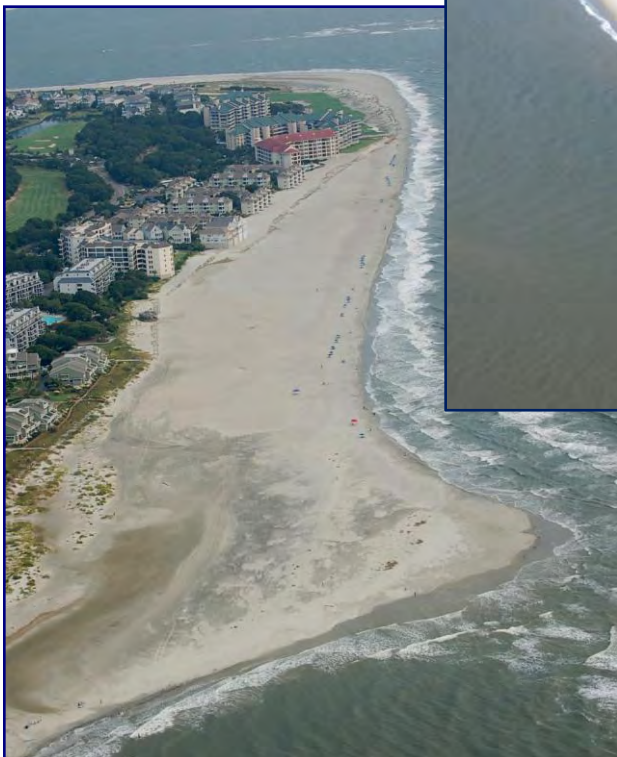
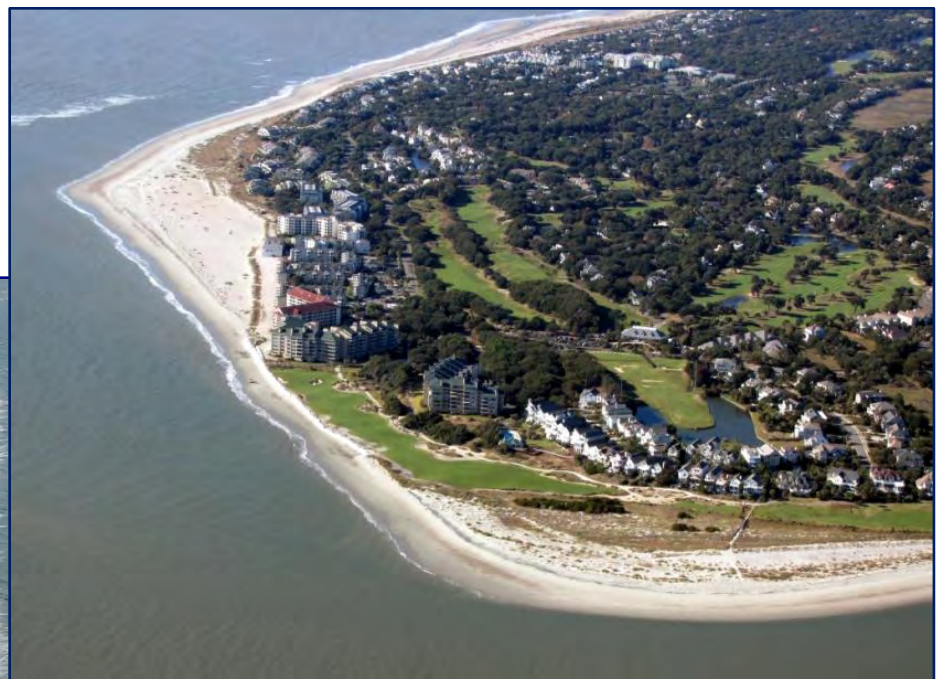
FIGURE 3.7. Reach 6 in December 2007 (upper left), June 2008 near the end of the project (upper right), September 2009 (lower left) and November 2013 (center right).

Reach 6 (Fig 3.7, previous page) extends from the Wild Dunes Property Owners Beach House ~4,900 ft northeast to the 18th fairway, where the beach turns into Dewees Inlet (station 280+00 to station 328+00, Fig 3.8). Shoal-bypassing events have highly impacted this area since the island's formation. Depending on the location and timing of the bypass events, the shoreline can change hundreds of feet over a period of several months (Kana et al 1985, Gaudio 1998). As was the case in 2007-2008, the shoreline may encroach on development in this reach when shoal-bypass events are prolonged.

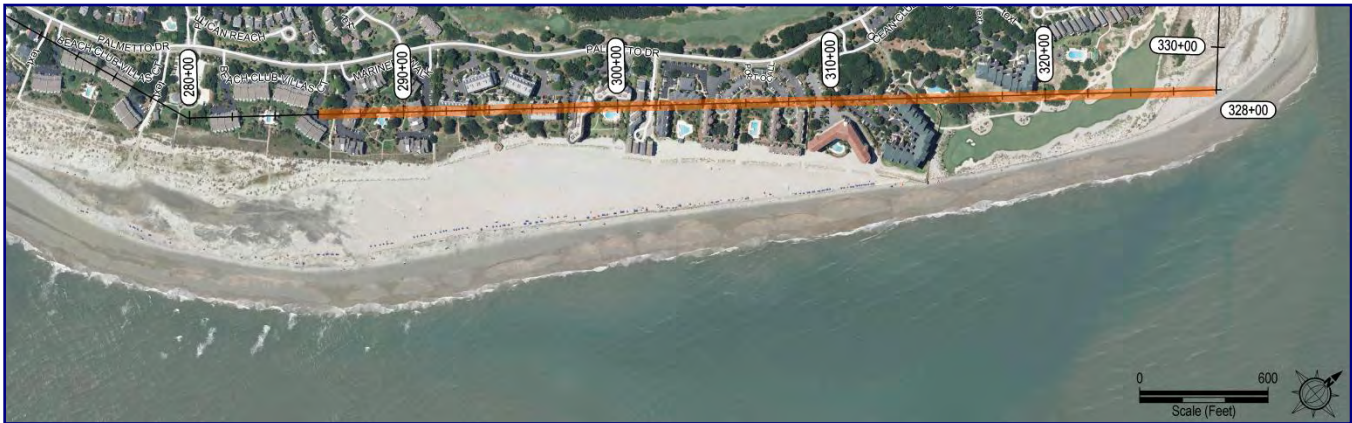
FIGURE 3.8. Reach 6 spans from the Wild Dunes Property Owners Beach House (station 280+00) to the 18th fairway of the Wild Dunes Links Course (station 328+00). The approximate limits of nourishment Reach B are identified by the orange-highlighted bar. [July 2011 aerial image by Independent Mapping Consultants Inc]

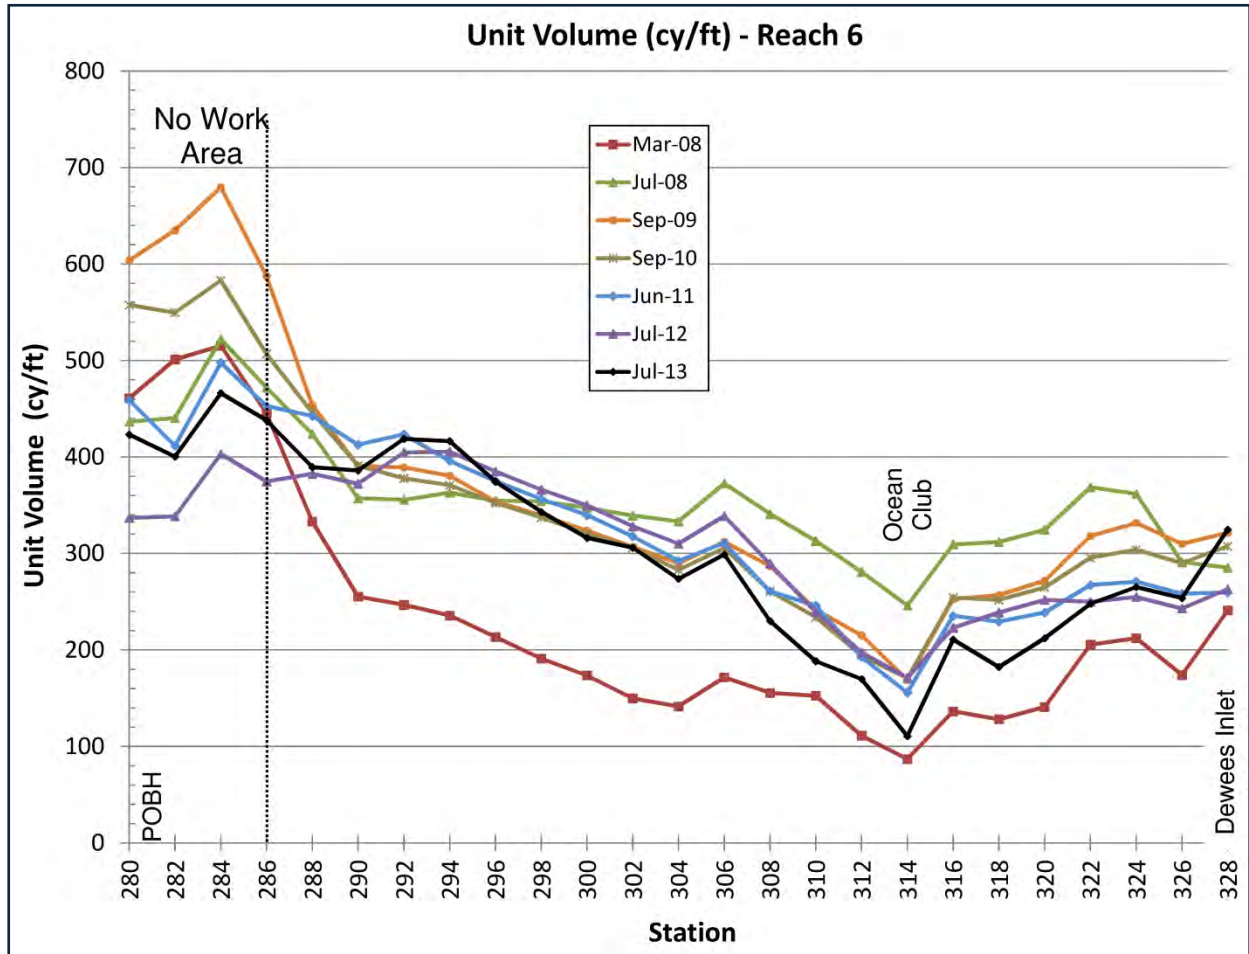
Additional sand was needed to supplement the natural sand transport condition. Between March and July 2008, ~628,000 cy of sand were added to the reach through nourishment and natural spreading of sand from the shoal (the design volume for this reach was 550,000 cy). Average profile unit volumes increased from 226 cy/ft to 355 cy/ft (calculated to -10 ft NAVD) (Fig 3.9, upper).

FIGURE 3.9. [UPPER] Bar graph showing beach unit volumes calculated to -10 ft NAVD in Reach 6. Overall, this reach has over 100 cy/ft more sand in July 2012 than in July 2007 (prior to shoal attachment and nourishment). **[LOWER]** Profile unit-width volumes for stations in Reach 6. Erosion has dominated the ends of the reach. The beach was much more stable from 2009 to 2012; however, erosion increased along the eastern portion of the reach over the past year.

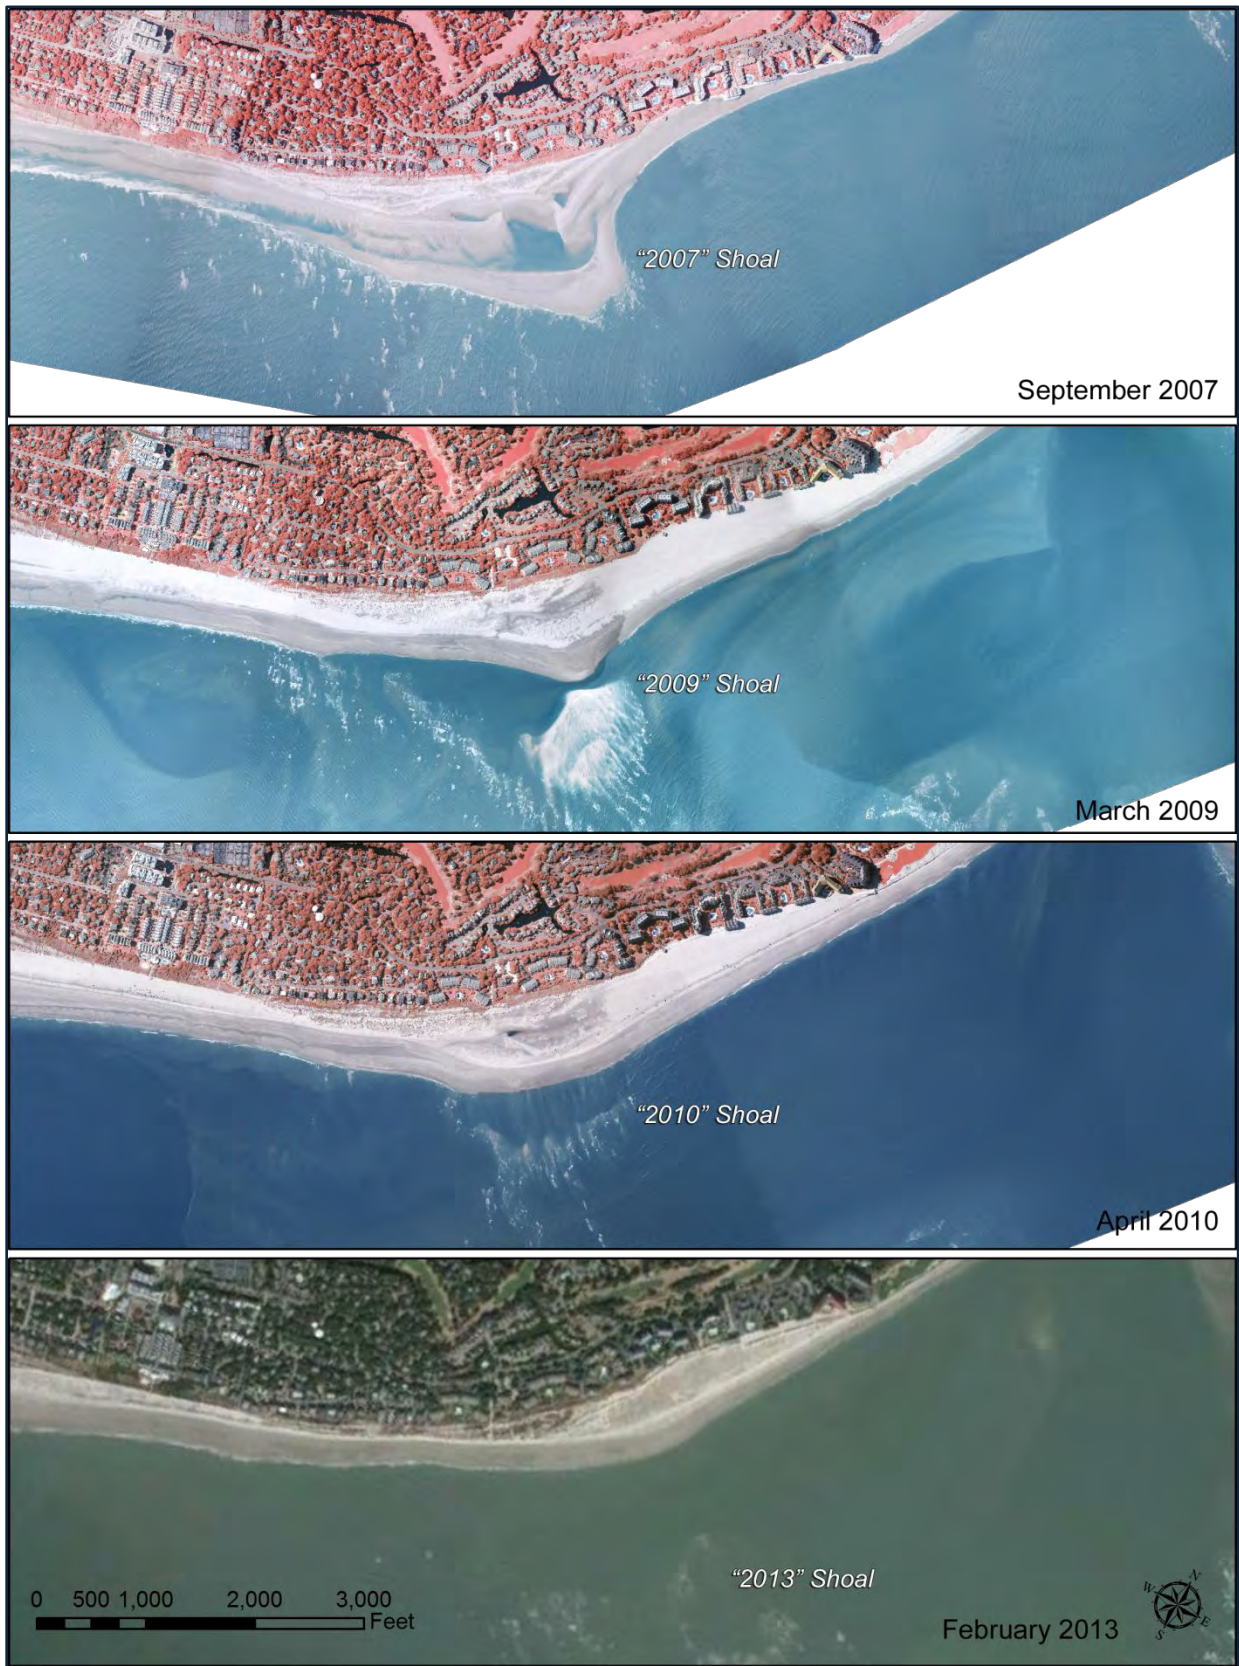
FIGURE 3.10. Sequence of aerial photographs showing four distinct shoal-bypass events occurring between 2007 and 2013. The 2009 and 2010 events were of much smaller scale than the 2007 event or the present event. The first three images were obtained by Independent Mapping Consultants (IMC, Charlotte NC); the fourth image was obtained from Google Earth (2013).
