**2008 BEACH RESTORATION PROJECT
ISLE OF PALMS SOUTH CAROLINA**

**Monitoring Report No 5
December 2013**

YEAR 5 MONITORING REPORT

Coastal Science & Engineering (CSE)
PO Box 8056 Columbia SC 29202-8056

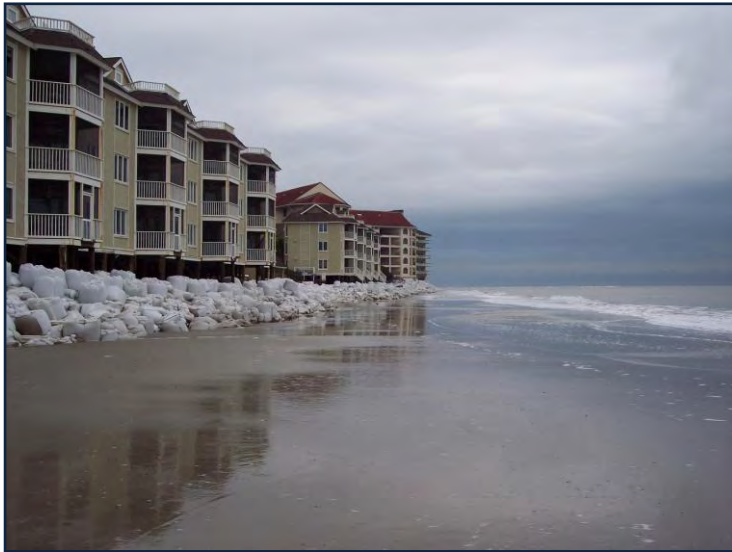
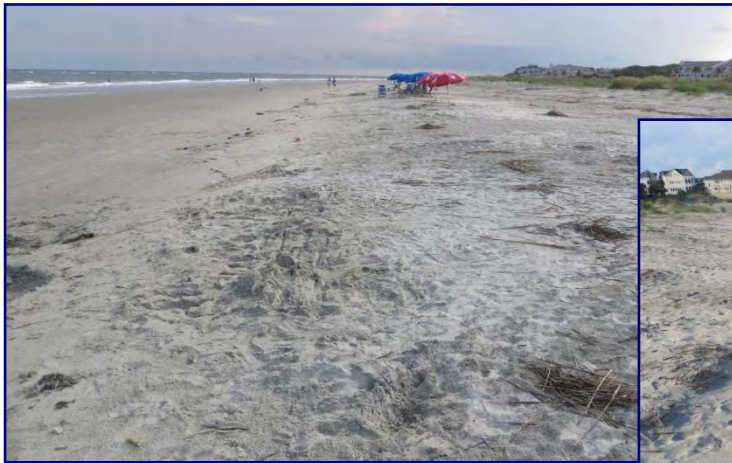
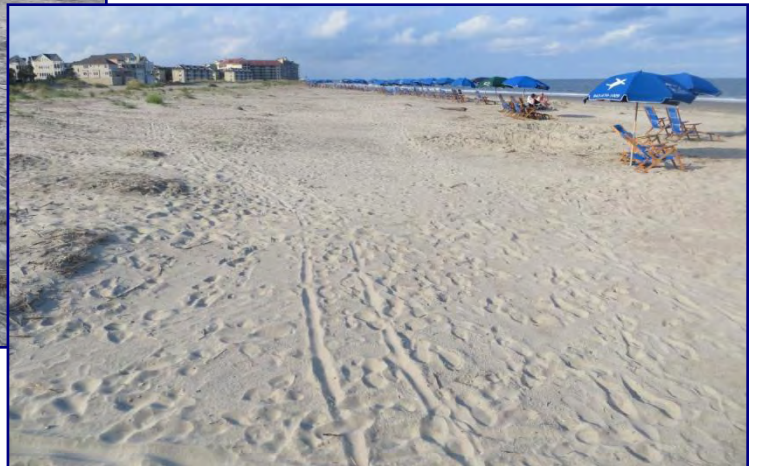
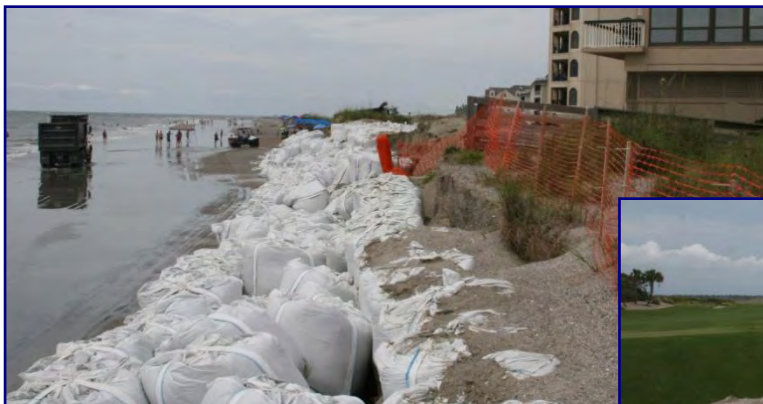
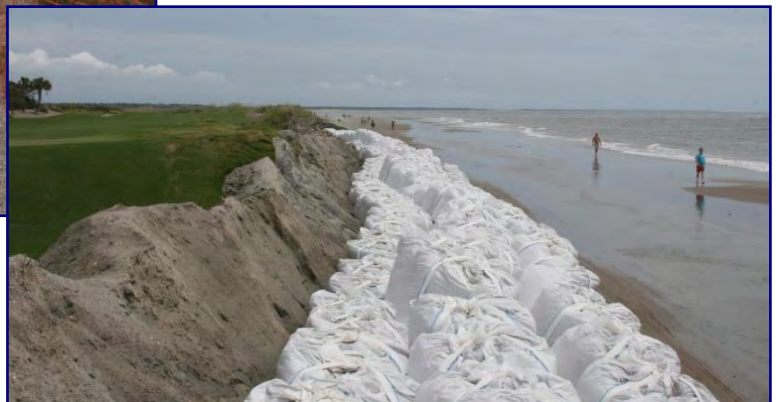
FIGURE 3.12.

[UPPER LEFT] View north in December 2007 near Summer Dunes Lane prior to the nourishment project.

[LOWER LEFT] Station 314+00 looking west (July 2013).

[LOWER RIGHT] Station 314+00 looking east (July 2013).

Station 314+00 eroded rapidly the first year after the 2008 project and continues to be an erosion hotspot.

A shoal management project was conducted in March of 2012 which placed ~87,000 cy of sand between stations 306+00 and 320+00; however, most of the dry berm created during the project had eroded by July 2012 (more details of the 2012 shoal management project and current plans for additional work are given in Section 3.2).

Erosion has increased from Port O'Call to the 18th fairway over the past year. Stations 306+00 thru 320+00 lost an average of 43.3 cy/ft from 2012 to 2013, which is less than the rate observed following the project but higher than typical rates over the past several years, and is spread over a greater distance along the beach. Hurricane *Sandy*, passing the area in October 2012, caused significant dune recession and likely contributed to the increase in erosion observed over the past year. Profiles show an ~50-ft recession of the berm crest and a steeper beach along most of this area. The increase in erosion is believed to be in response to the approaching shoal west of the area as it is now in Stage 2 of the shoal-bypass cycle. The eroded area is the characteristic erosional arc commonly present adjacent to shoal-attachment sites. Erosion is expected to continue until the main body of the shoal attaches and sand begins to spread, or a management project is completed.

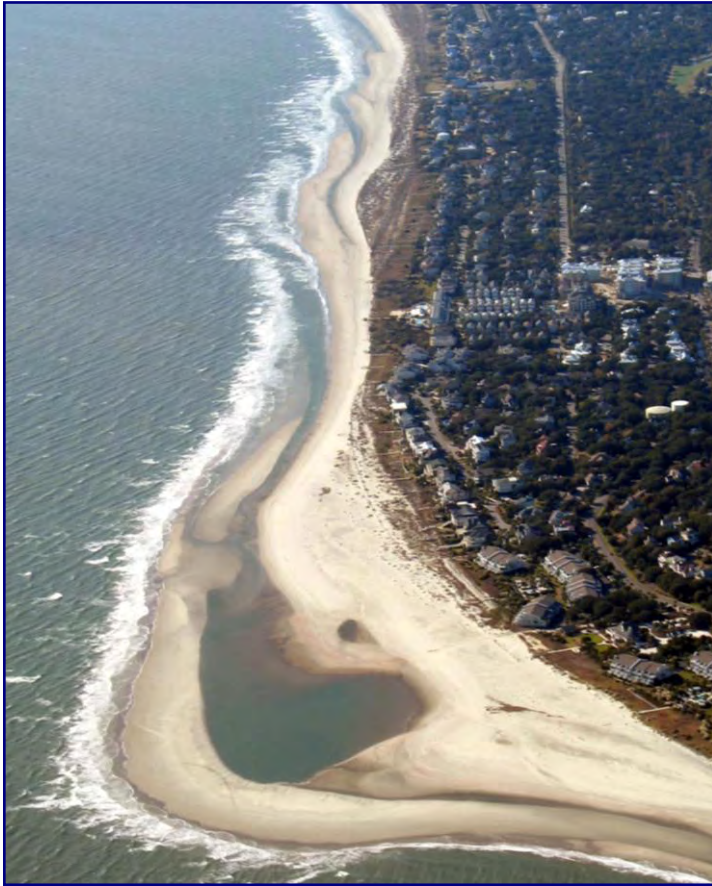
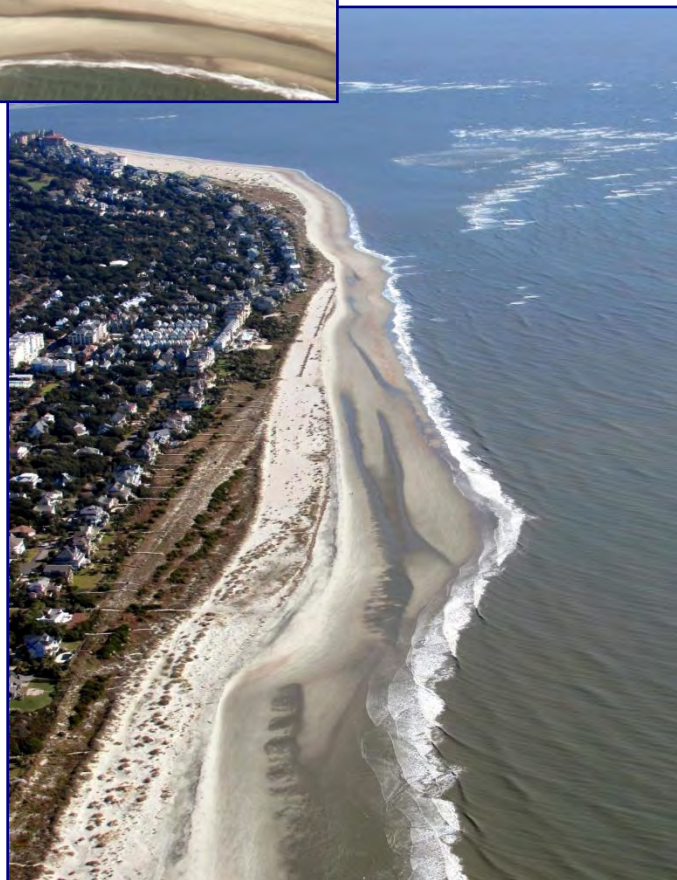
FIGURE 3.13.

[LEFT]
Reach 5 in December 2007.
[Photo by TW Kana]

[RIGHT]
Reach 5 on 15 November 2013.
[Photo by S Traynum]

Reach 5 (Fig 3.13, previous page) spans ~6,000 ft between 53rd Avenue and the Wild Dunes Property Owners Beach House and encompasses project Reach A (Fig 3.14, stations 222+00 thru 280+00). Like Reach 6, this area is greatly influenced by shoal-bypass events, especially at the northern end of the reach where the majority of shoals attach to the beach.

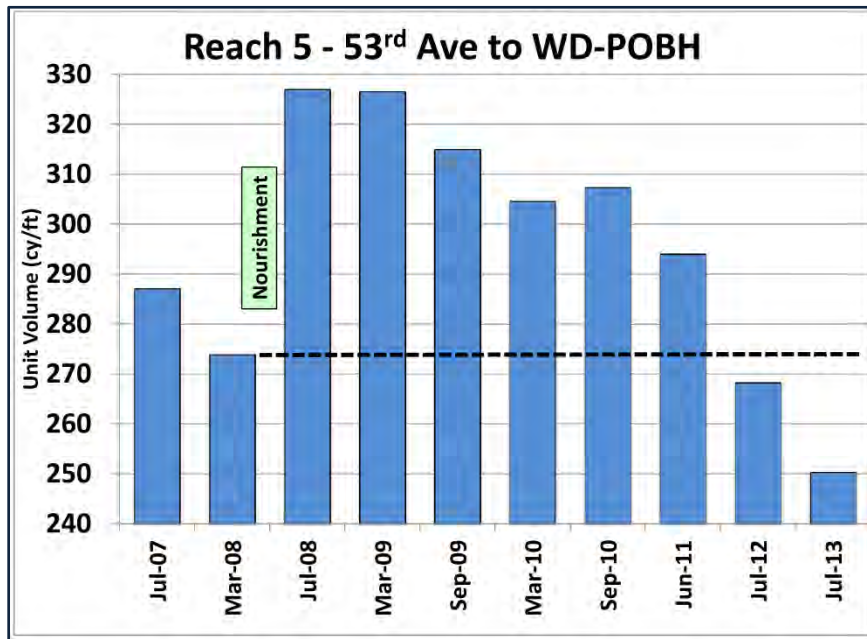
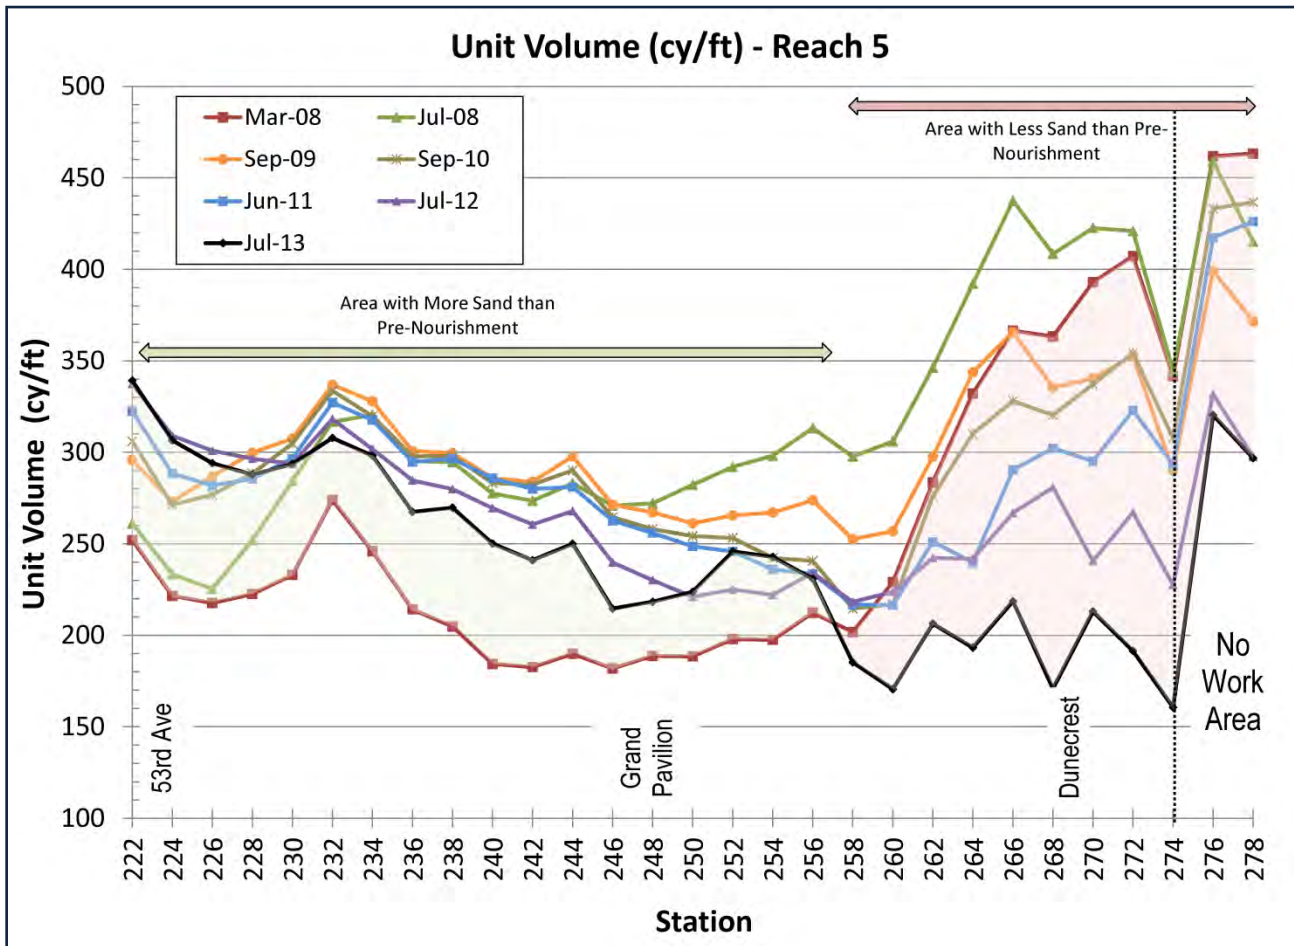
Reach 5 gained ~318,000 cy (128.1 cy/ft) of sand between March and July 2008; this included nourishment and natural accretion from the shoal attachment (Fig 3.15, upper). The design volume was 270,000 cy, and CSE estimates ~340,000 cy of sand were added to the project area between March and July 2008. [Note the project reach limits differ from the monitoring reach, producing the difference in accretion numbers.] Design fill unit volumes were ~75 cy/ft throughout area A, decreasing in the taper sections. Dry beach width increased up to ~225 ft in this reach. The northern portion of Reach 5 was highly erosional prior to the nourishment project, losing up to 45 cy/ft between July 2007 and March 2008 (Fig 3.15, lower). The rest of the reach was more stable, gaining sand at most stations.

FIGURE 3.15. [UPPER] Bar graph showing beach unit volumes calculated to -10 ft NAVD in Reach 5. While the 2013 average sand volume is less than the pre-nourishment condition, stations 222–258 (3,600 ft of a total of 6,000 ft of Reach 5) still hold ~184,100 cy (51.1 cy/ft) more sand than the pre-nourishment condition. [LOWER] Profile unit-width volumes for stations in Reach 5. Erosion has dominated the northern part of the reach (stations 250–278) and is associated with excess sand spreading from shoal attachment events in 2006, 2009, and 2010 and shoal-induced erosion from the present event.

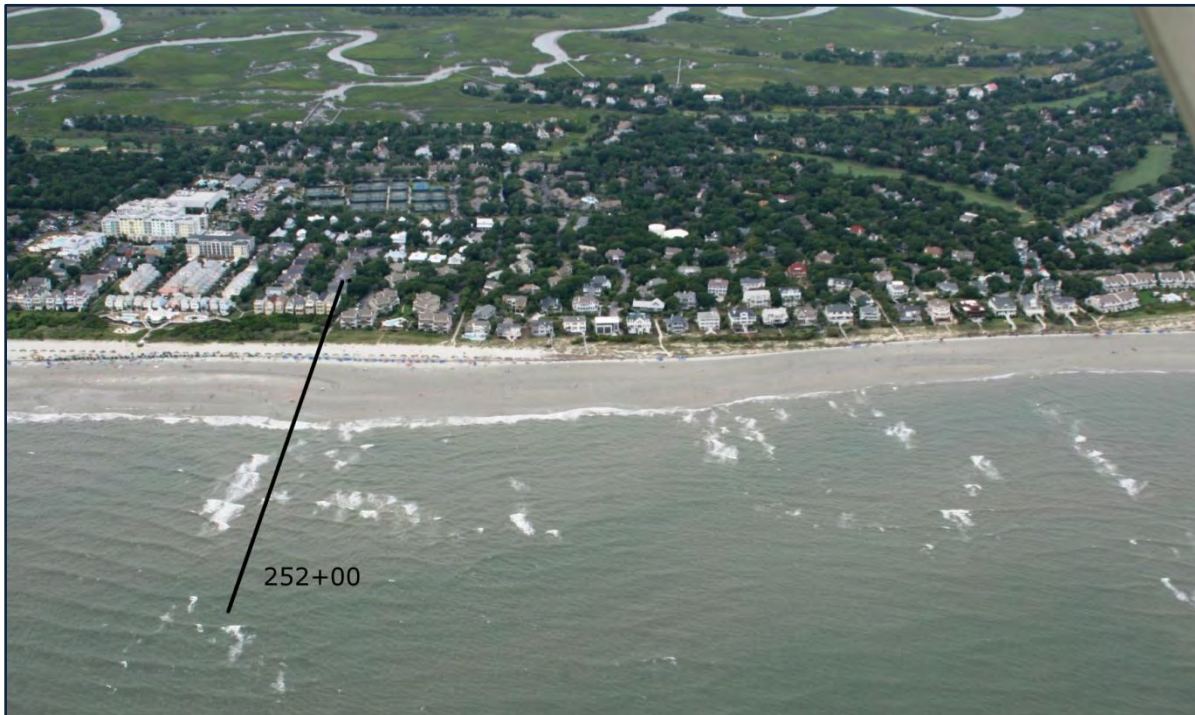
FIGURE 3.16. [UPPER] July 2013 aerial image of the area from the Wild Dunes Grand Pavilion to Beachwood East showing isolated sand bars (areas with breaking waves) attached or near the beach. [LOWER] Profiles from station 252+00 showing a sandbar attached to the beach. These bars are formed from remnants of the pre-2007 inlet channel delta fan, which collapsed following the channel avulsion event and is migrating toward the beach.

A July 2013 aerial image of the bar and profiles from station 252+00 are shown in Figure 3.16. The sand attaching to the beach is a remnant of the westernmost portion of the 2007 ebb-tidal delta, which was abandoned when the inlet channel relocated to the east. The sand, which was spread over a large area offshore of the WDPOBH in 2007, has condensed into isolated shoals near stations 250+00 through 264+00 and into the linear shoal visible in Figure 3.17 west of the subaerial shoal off of Shipwatch.

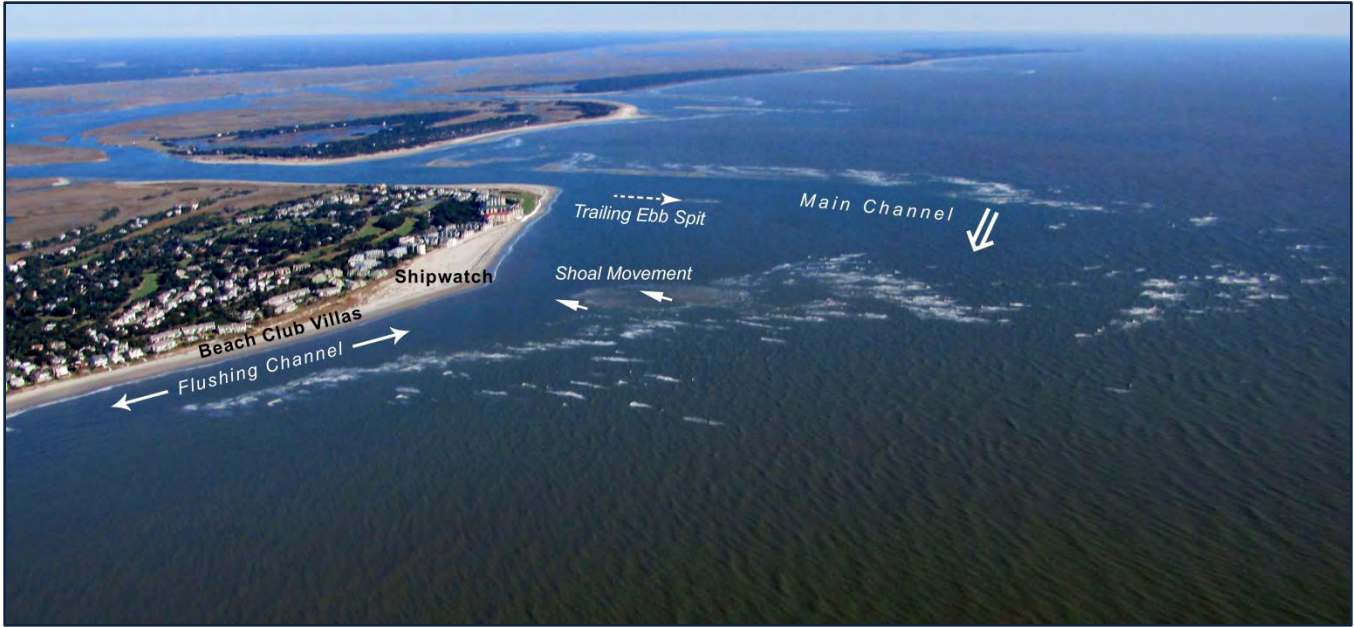
FIGURE 3.17. November 2013 oblique aerial image of the northeastern end of Isle of Palms. Several events are occurring simultaneously, all of which have an impact on the beach condition. CSE expects the beach will evolve rapidly over the next year due to the current shoal-bypass event.

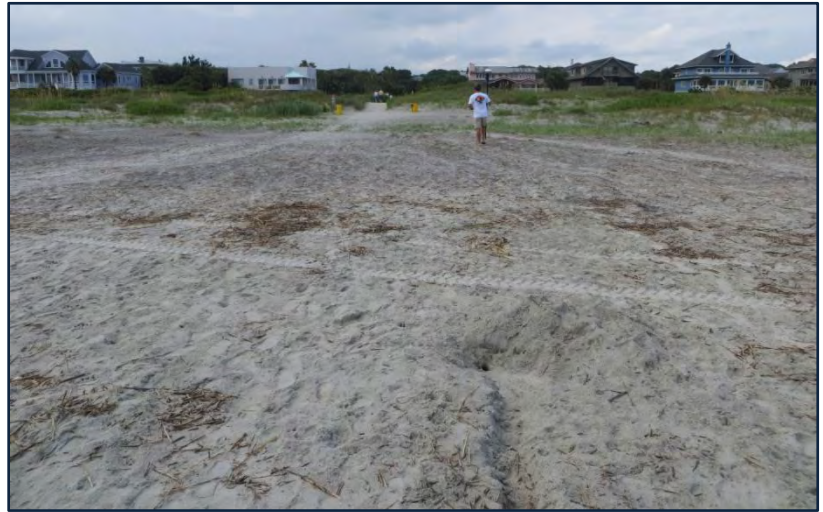
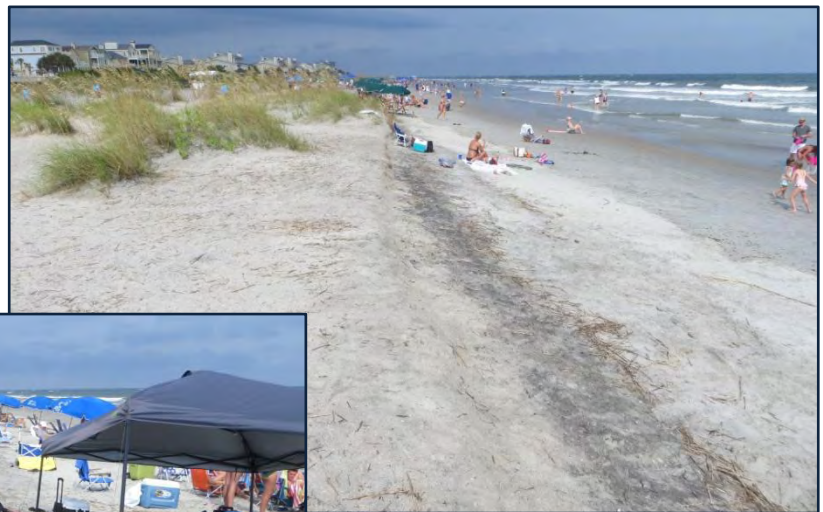
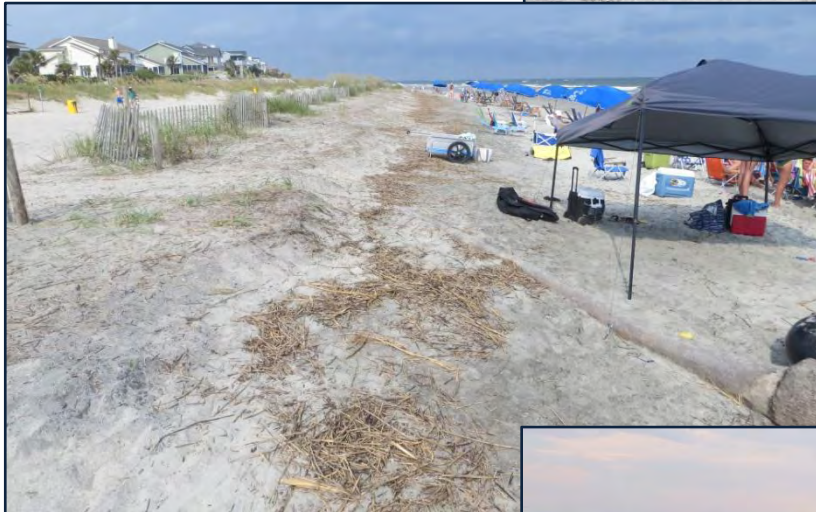
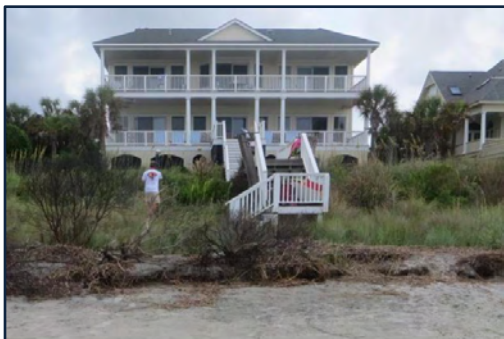
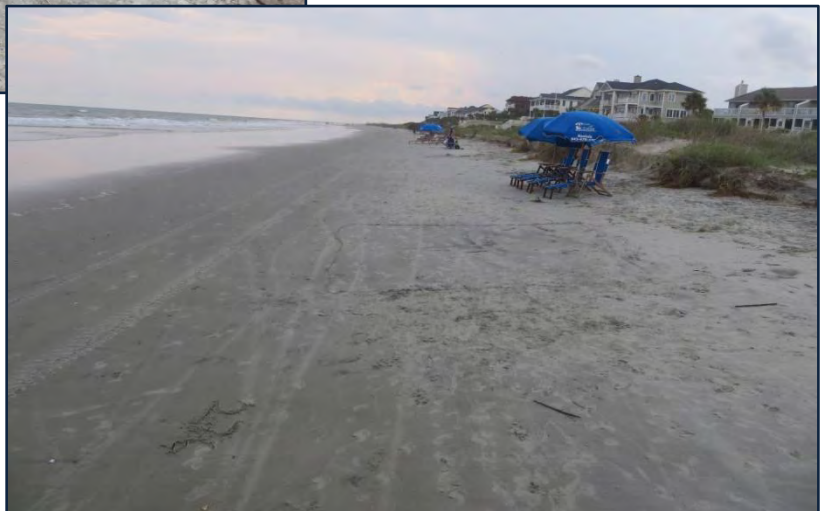
[4th RIGHT] Looking west from station 276+00 (Beach Club Villas I) into the eastern erosional arc. Erosion has caused substantial berm recession, leaving little protection for some houses (left bottom photo).

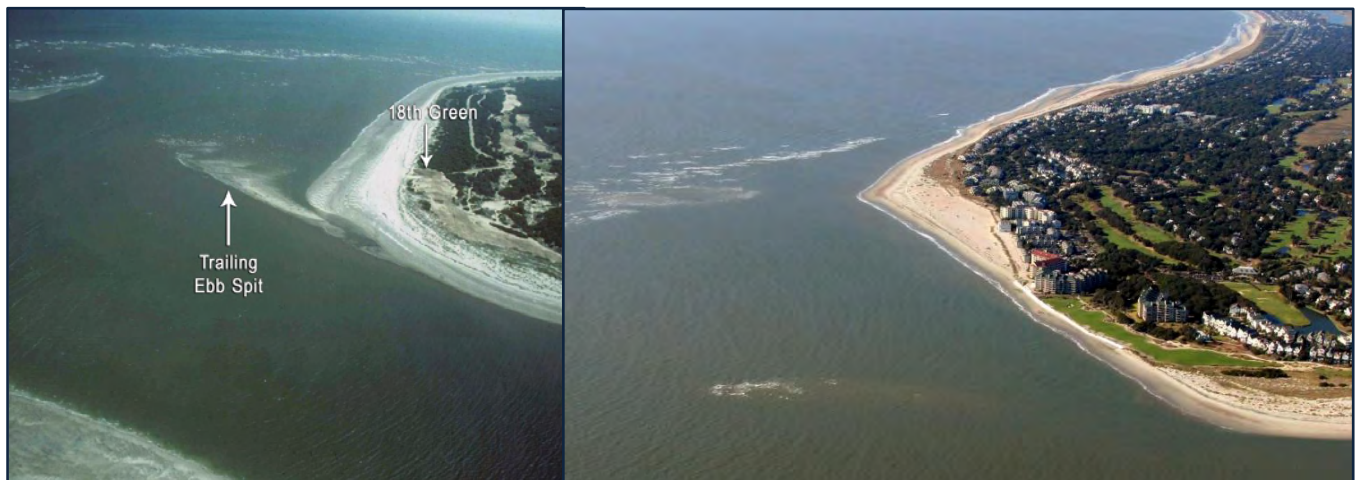
FIGURE 3.20. [RIGHT] November 2013 aerial image of a trailing ebb spit (breakers at bottom left of photo) at the northeastern end of Isle of Palms. [LEFT] A similar, but more developed, trailing ebb spit was present in 1980 (photo by TW Kana).

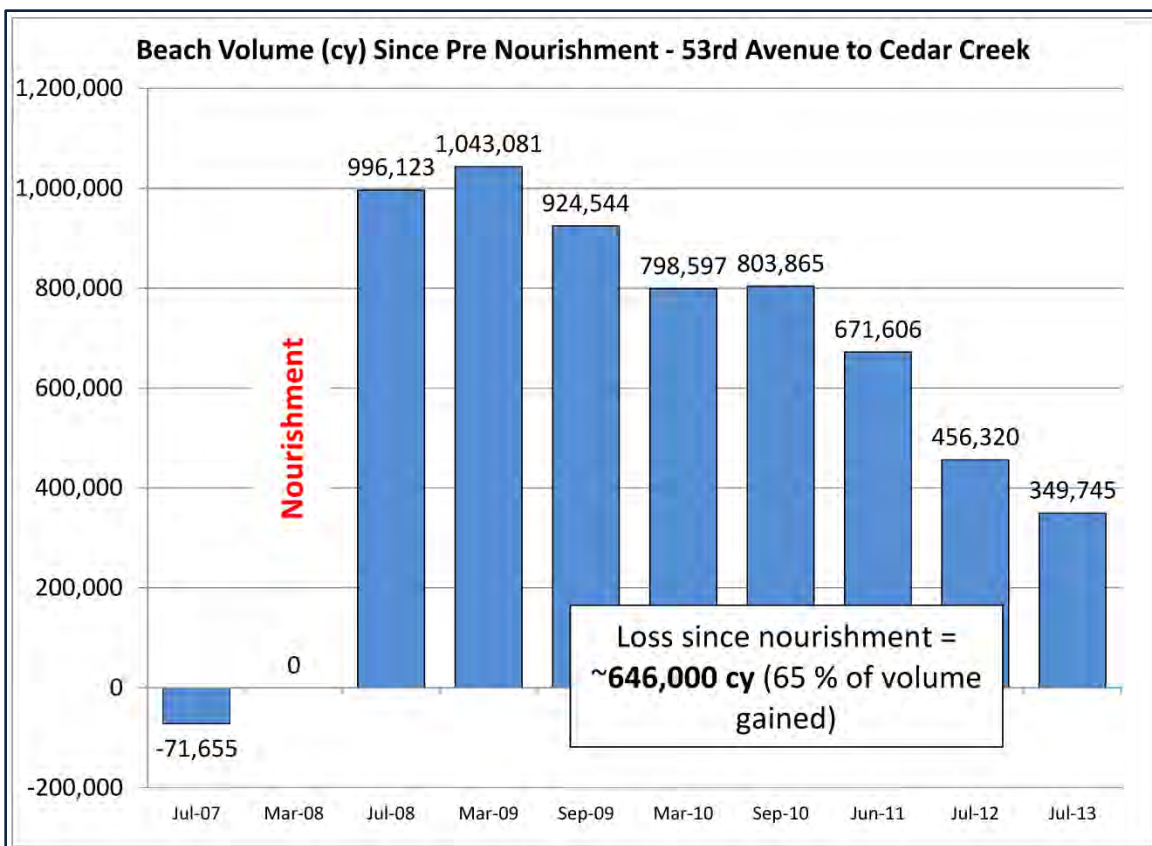
Overall, Reaches 5–7 lost 106,575 cy from July 2012 to July 2013 (Fig 3.21). This compares to losses of ~215,000 cy from July 2011 to July 2012, and 152,000 cy from September 2010 to June 2011. All subreaches within Reaches 5–7 showed less erosion (or more accretion) than the previous year. Reaches 5–7 still retain ~350,000 cy (23.5 cy/ft) more sand than the pre-nourishment condition. The Wild Dunes area of Isle of Palms has lost ~646,000 cy (43.4 cy/ft) since July 2008 (post-nourishment condition), which equates to an average annual loss of 8.7 cubic yards per foot year (cy/ft/yr). Presently 54 out of 75 stations in Reaches 5–7 (72 percent) retain more sand than the pre-nourishment condition.

FIGURE 3.21. Beach volume relative to March 2008 (pre-nourishment). The values shown include all areas (both nourished and non-nourished) and do not account for sand accumulated at the turn in the baseline at the northeastern point, which is estimated to have gained over 50,000 cy since March 2008. These volumes do not include ~1.6 million cubic yards of sand in the bypassing shoal which is poised to weld along Wild Dunes in the next couple of years.

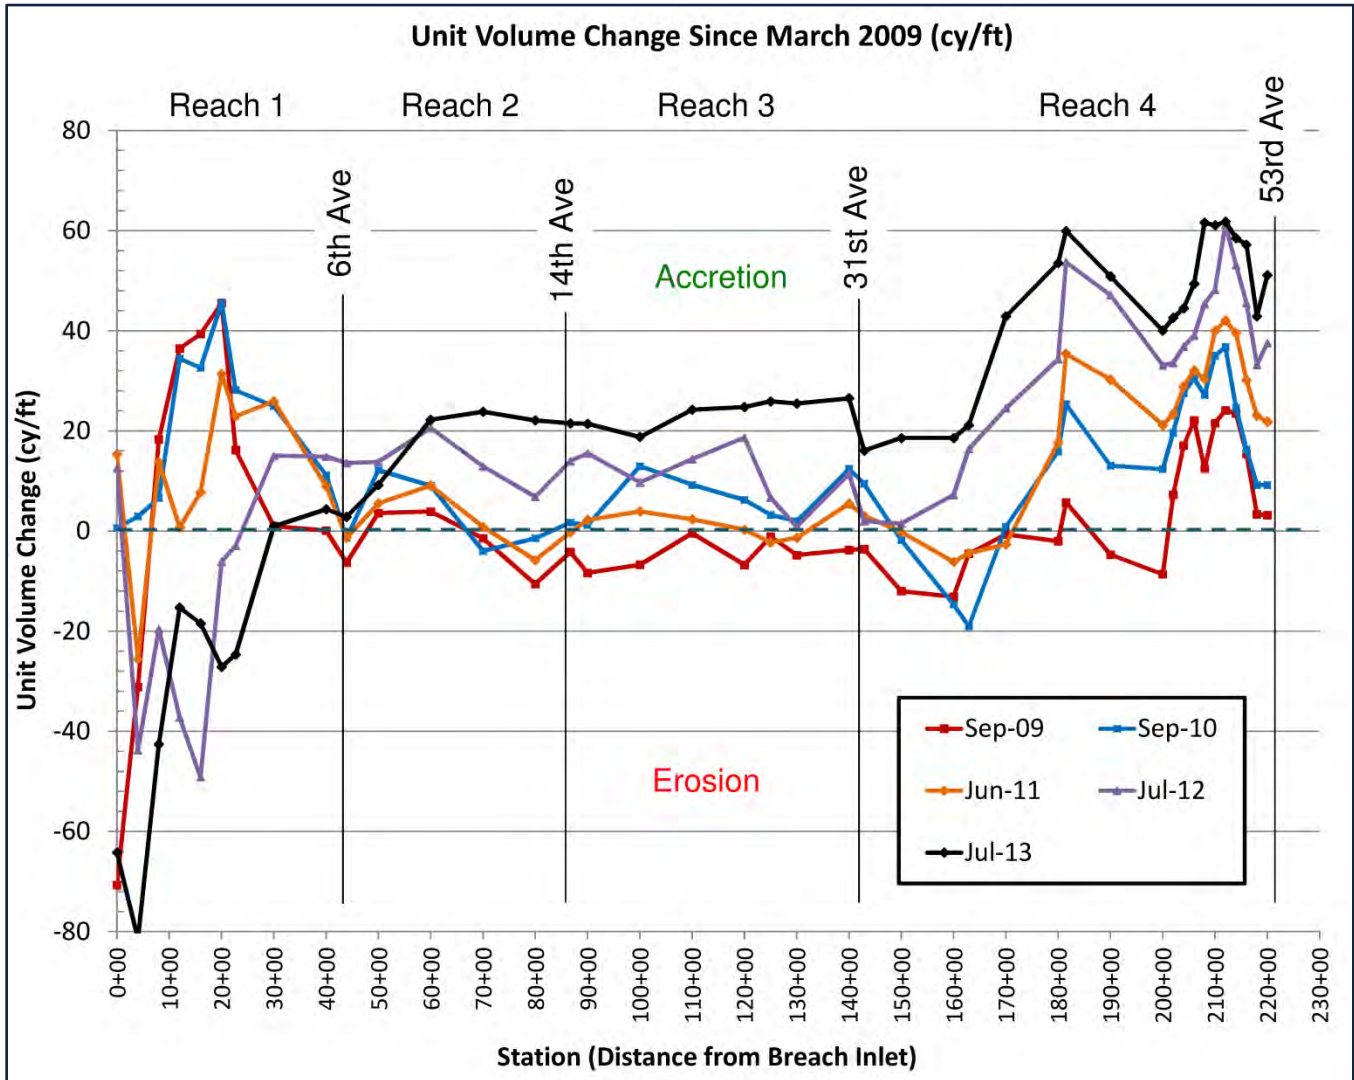
FIGURE 3.23. Profile unit-width volume change (cy/ft) between March 2009 and later dates for Reaches 1–4. CSE established and surveyed profiles spaced 1,000 ft apart within the Isle of Palms reaches and reoccupied monuments surveyed annually by SCDHEC-OCRM. Historically, these reaches have been accretional; however, between March and September 2009, most stations outside of the influence of the inlet or project were erosional. Since September 2009, most stations have shown accretion and are currently healthier than the March 2009 condition (ie – where the black line is greater than zero). The higher rates and westward sequence of accretion along Reach 4 illustrate the downcoast spread of nourishment sand from Reach 5. [Volumes are relative to the March 2009 condition.]

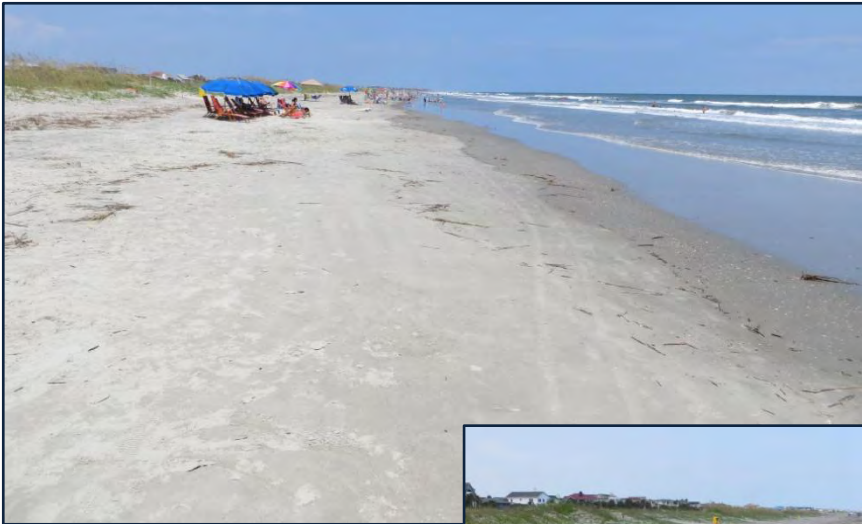
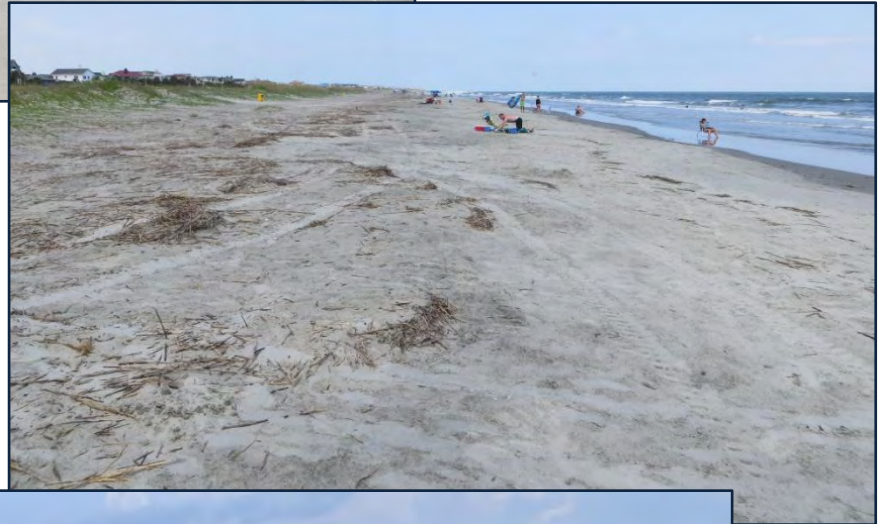
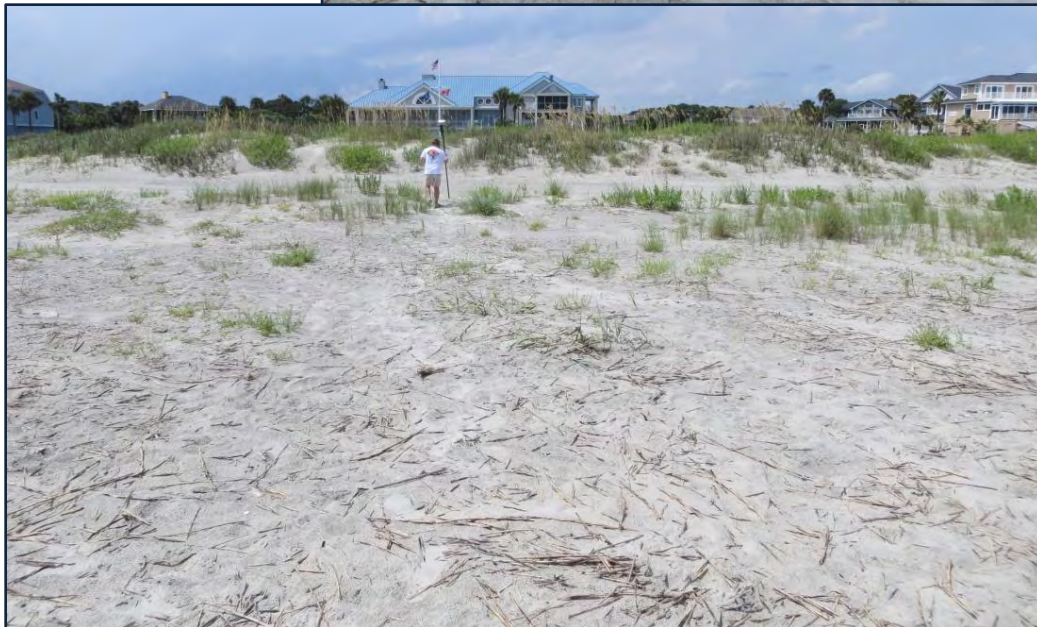
FIGURE 3.26. July 2013 photos from Reach 4. **[TOP]** View east from station 3140 (31st Avenue) showing a narrow, but growing, dry beach and stable dune. **[CENTER]** View east from station 3145 (36th Avenue) showing a wide dry beach and healthy dune system. **[BOTTOM]** Inland view of station 202+00 (Citadel Beach House) showing vegetation propagating across a stable dry berm. The 2008 dune line is the high dune landward of the surveyor. In the 1980s, the Citadel Beach House lacked a dry-sand beach, and the property was protected by an exposed seawall. [Photos by S Traynum]

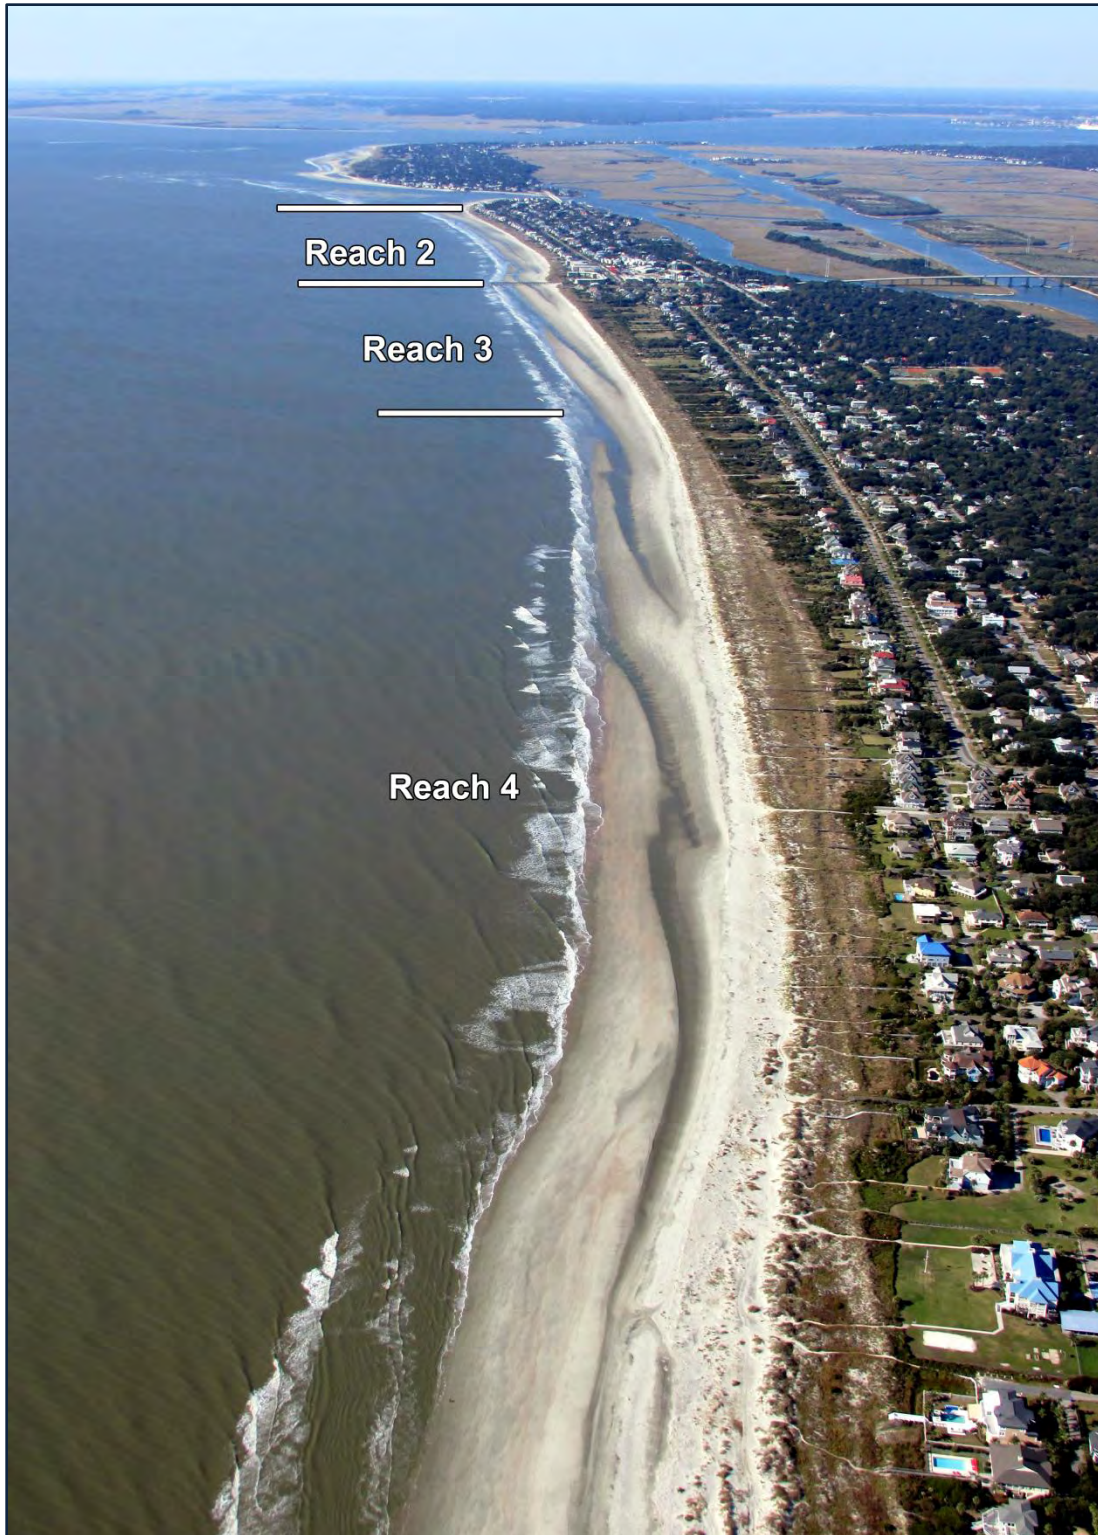
FIGURE 3.27. November 2013 aerial image of the central portion of Isle of Palms. Steady long-term accretion has resulted in wide vegetative buffers and protective dunes. Note oblique low-tide bars and troughs (“runnels”) along the beach, which form under the influence of waves from the northeast. [Photo by SB Traynum]

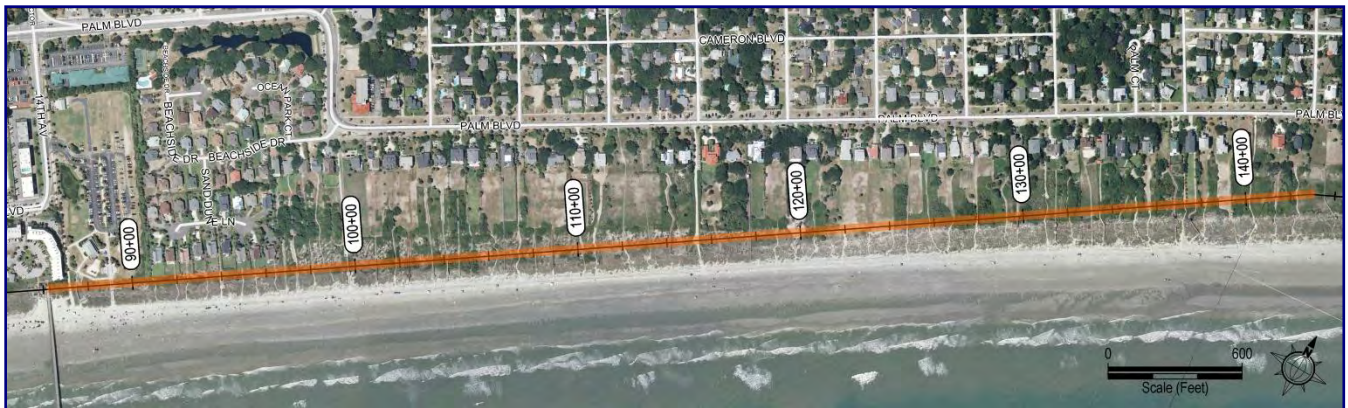
FIGURE 3.28. Reach 3 spans from station OCRM 3125 (pier) to station OCRM 3140 (31st Avenue) — noted by the orange-highlighted bar.

Reach 3 spans the oceanfront from the Sea Cabins Pier to 31st Avenue (OCRM monuments 3125 to 3140, Fig 3.28). Like Reach 4, the long-term trend in this area is stable to accretional. Profiles from OCRM station 3135 (near 27th Avenue) show the beach has gained ~40 ft in width at the +5-ft NAVD contour (Fig 3.29) over the past ten years. A similar trend is evident at OCRM station 3125 (14th Avenue) with dune growth and beach widening over the past ten years.

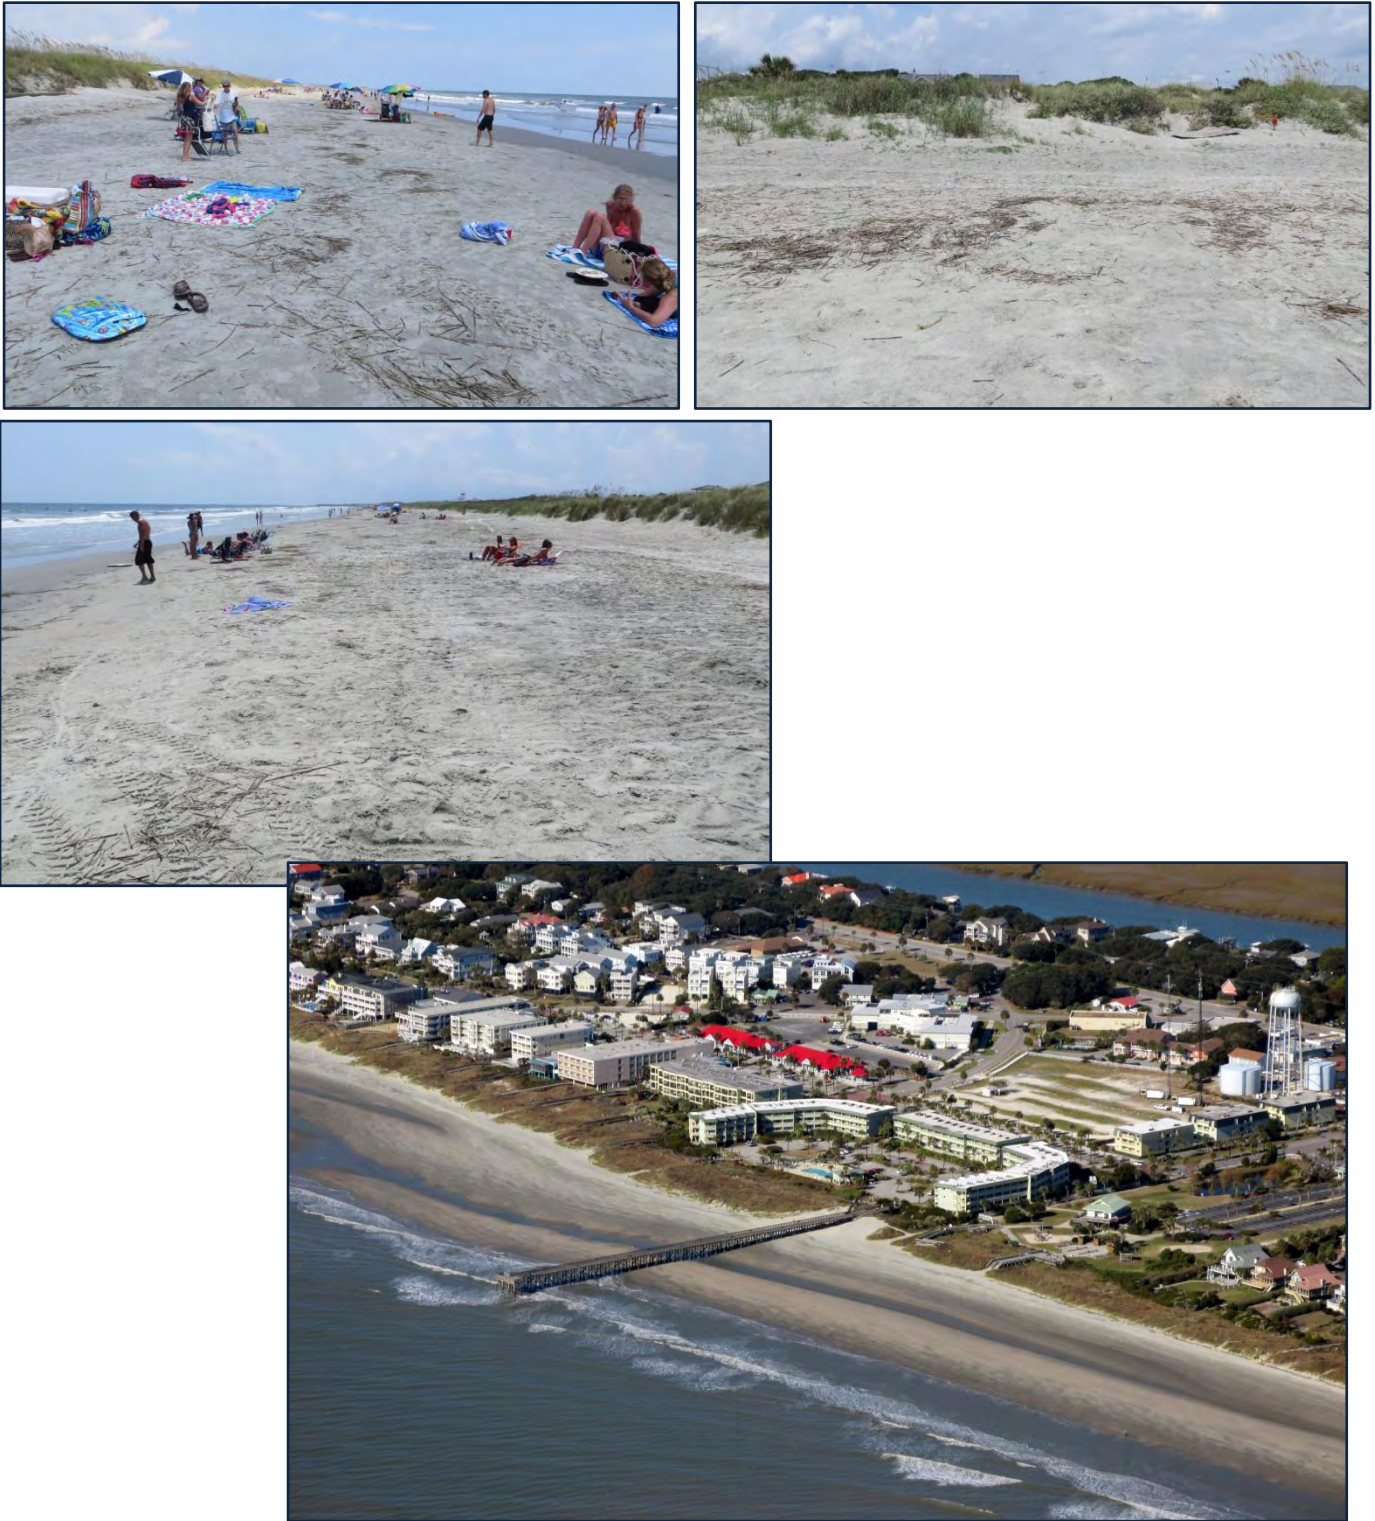
FIGURE 3.30. [UPPER LEFT] Station 100+00 (21st Avenue) looking east in July 2013. Note the healthy dune and various wrack lines representing high-tide swash lines at various tidal stages. (Spring tide is near the dune while the neap tide is ~30 ft seaward.) [UPPER RIGHT] Station 120+00 (26th Avenue) shows a healthy, but relatively low, dune. Winter storms typically cause minor dune erosion along this area, which usually heals during the calmer summer months. [CENTER LEFT] Station 140+00 (30th to 31st Avenue) looking west. A significant dry beach is present in July 2013. [LOWER RIGHT] November 2013 aerial image of the area around Sea Cabins Pier (separating Reach 2 and Reach 3). [Photos by S Traynum]

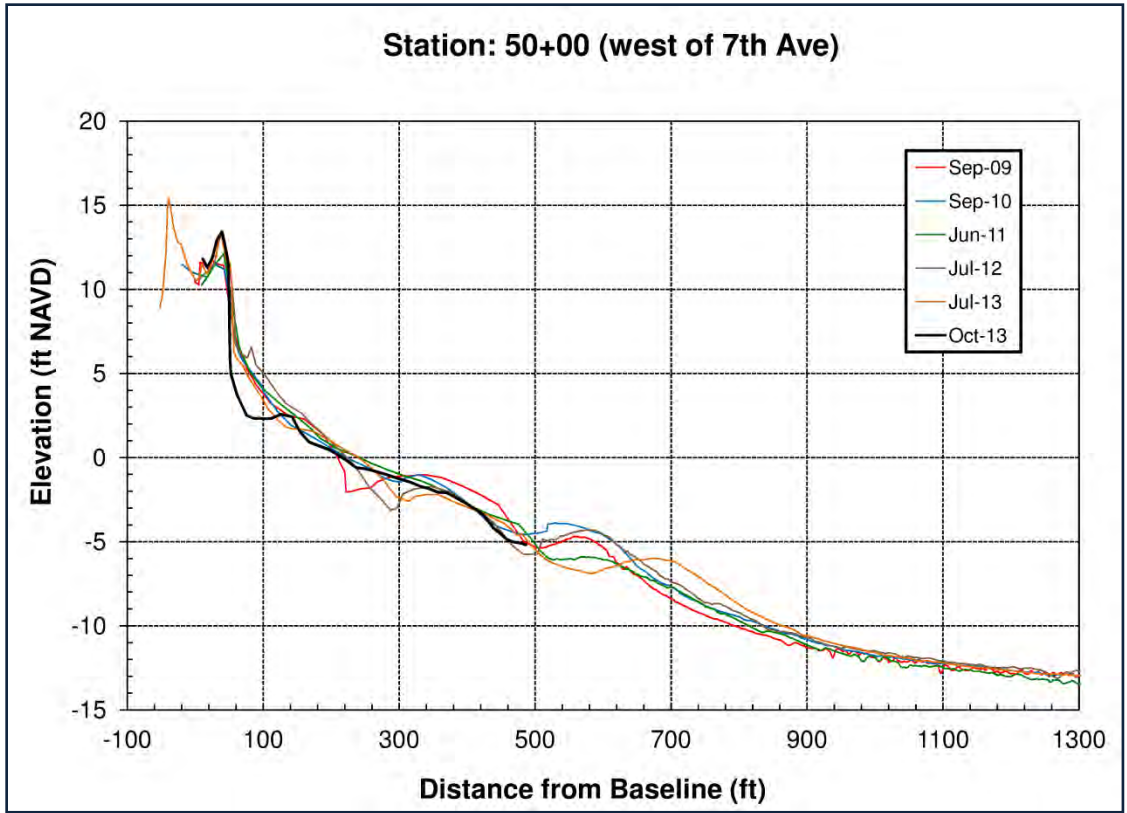
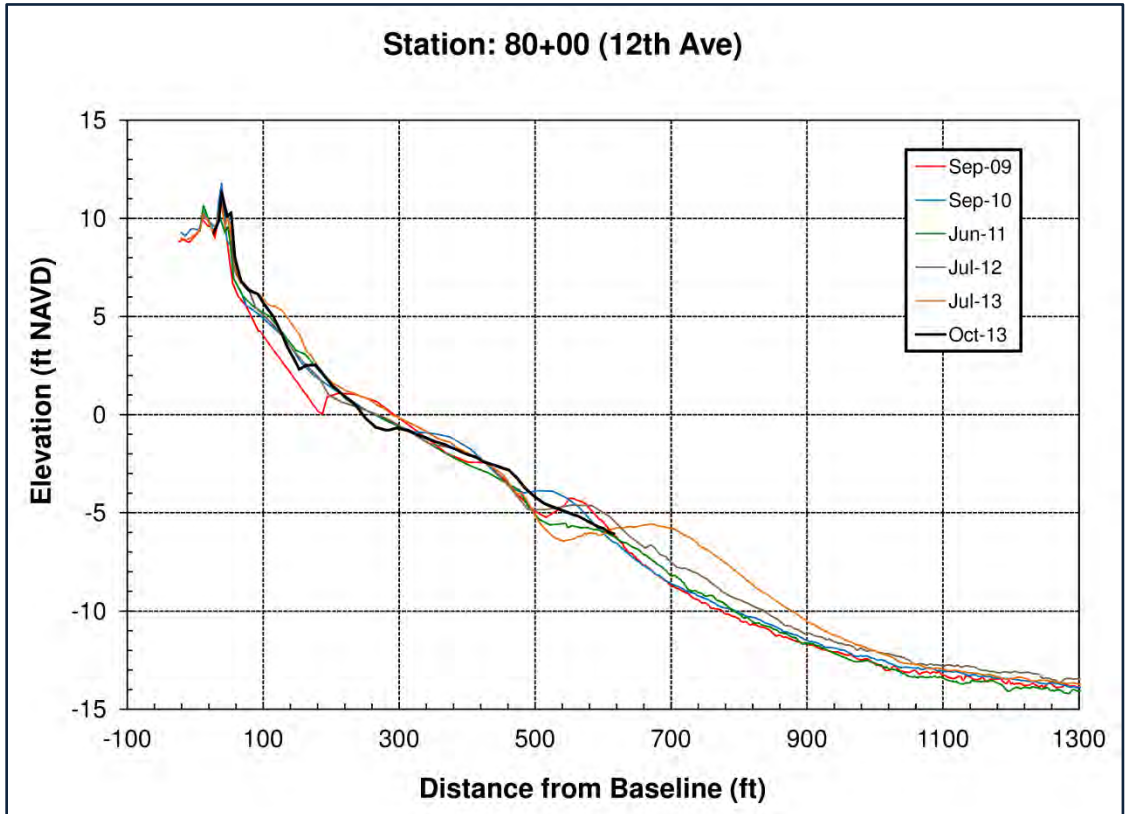
Reach 2 has gained ~80,000 cy (18.7 cy/ft) of sand since March 2009, an average annual accretion rate of 4.3 cy/ft per year. Profiles show relative stability or seaward growth of the dune compared to 2009 (Fig 3.33). Similar to reaches 3 and 4, accretion was observed in the underwater portion of the profile (–5 to –10 ft NAVD) along all stations in Reach 2.

FIGURE 3.33. Profiles from station 50+00 (7th Avenue, upper) and station 80+00 (12th Avenue, lower). An erosional arc is centered at station 50+00, causing significant dune recession at this location.
