**2008 BEACH RESTORATION PROJECT
ISLE OF PALMS SOUTH CAROLINA**

**Monitoring Report No 5
December 2013**

YEAR 5 MONITORING REPORT

Coastal Science & Engineering (CSE)
PO Box 8056 Columbia SC 29202-8056

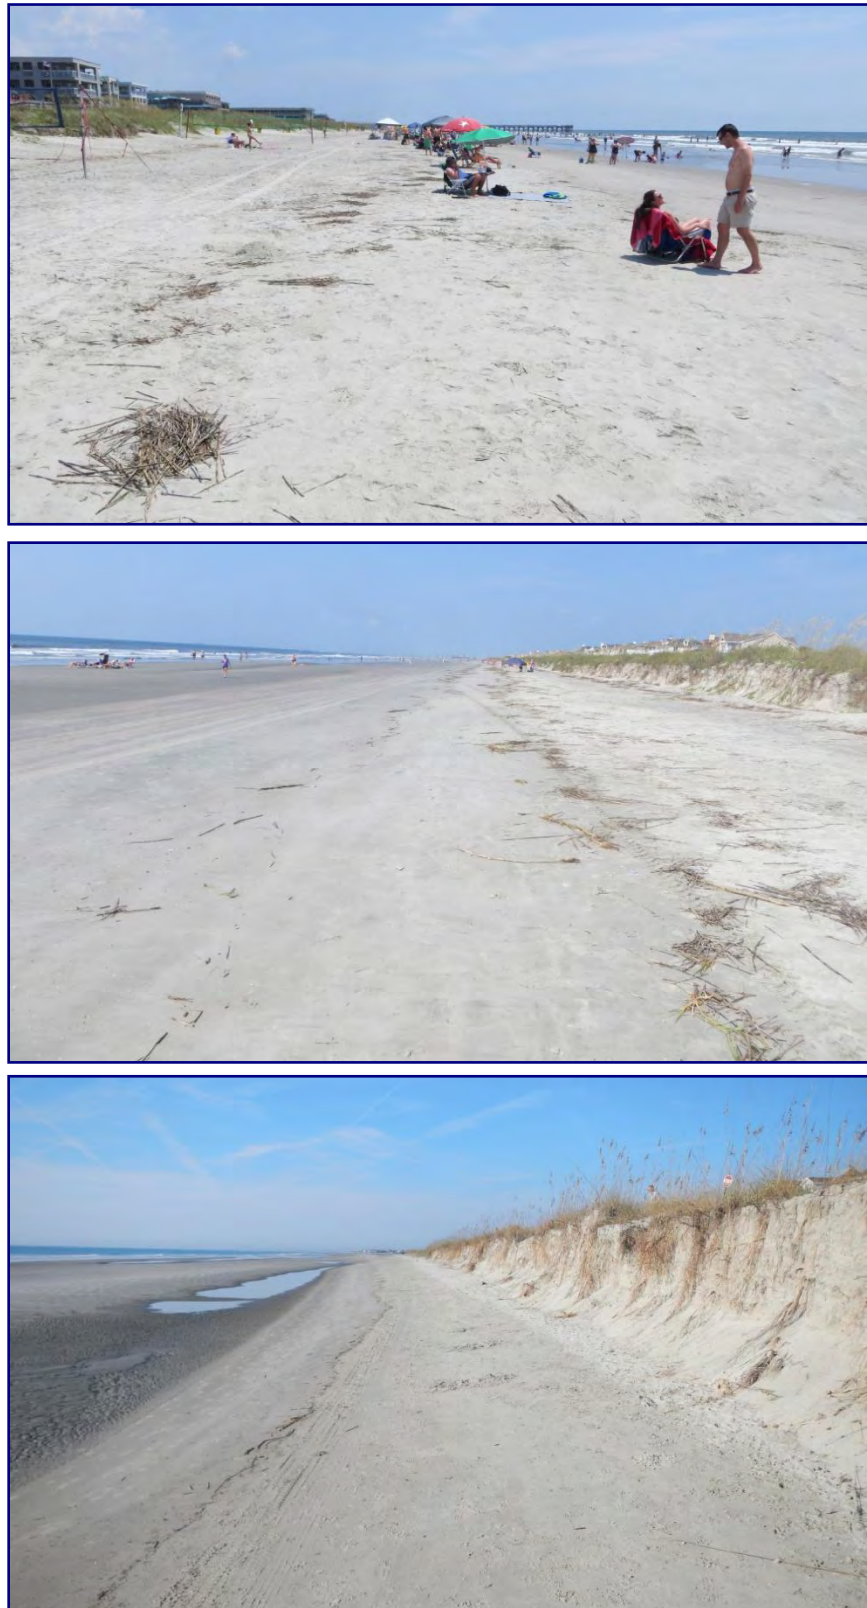
FIGURE 3.34. [UPPER] View looking east from station 70+00 (10th Avenue) in July 2013 showing a wide dry-sand beach for volleyball nets and recreation. [MIDDLE] View looking west from station 50+00 (west of 7th Avenue) in July 2013 showing a scarped dune. An erosional arc was centered near this station in July and October 2013. [LOWER] View west from station 50+00 in October 2013. Erosion from July to October was limited to this station only. Adjacent stations showed stable dunes and gained volume (to -6 ft NAVD).

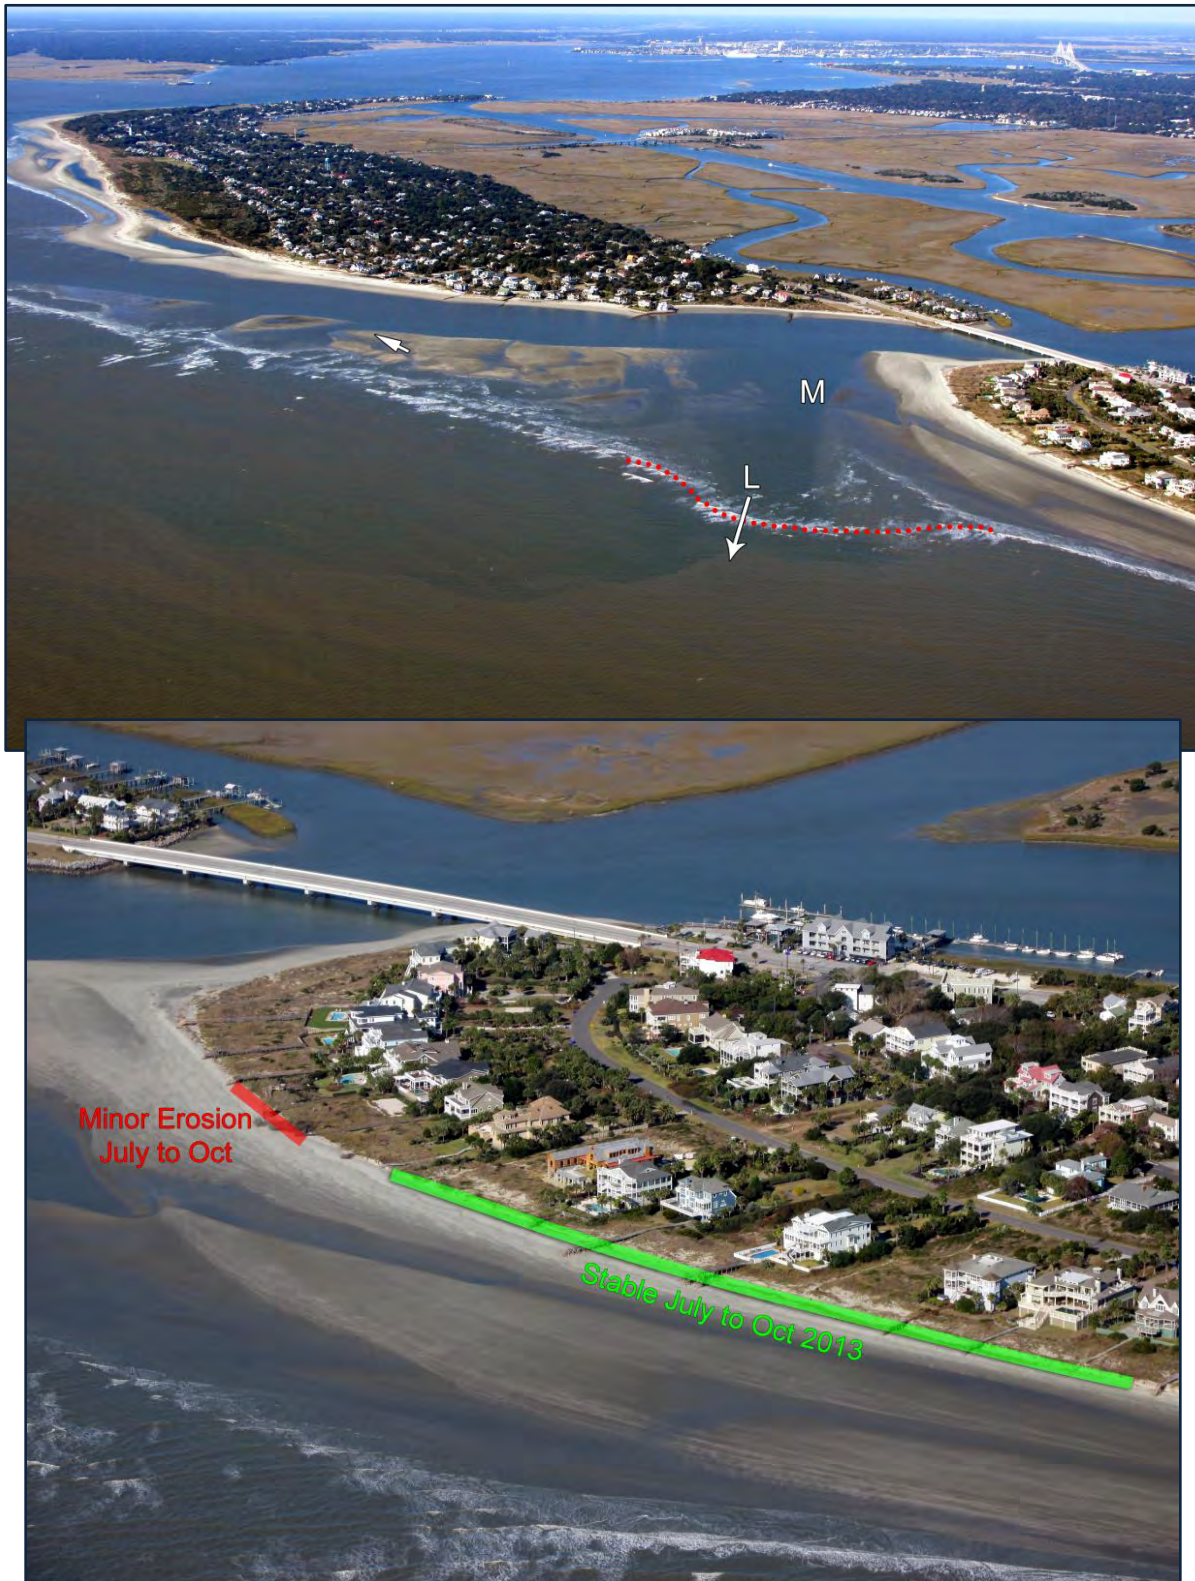
Dune recession in Reach 1 provided evidence of ongoing erosion and generated concern among property owners in the area. In subsequent discussions with the City, CSE provided an opinion that the erosion was temporary and likely a result of cyclical changes in the delta of Breach Inlet. Based on historical trends and ebb-tidal delta morphology, CSE expects Reach 1 to rebuild naturally without intervention. Nevertheless, CSE recommended additional monitoring be conducted to document short-term volume and contour changes. Additional assessments provide quarterly updates on the beach condition and give the City information for planning mitigation efforts should they be warranted. CSE completed the first quarterly monitoring event in October 2013. Results showed that all areas other than station 50+00 gained sand and had stable dunes between July and October 2013 (Fig 3.37). A summary letter from the October assessment is included in Appendix B.

FIGURE 3.37. November 2013 aerial images of Breach Inlet area. [UPPER] View of the Breach Inlet delta, which extended southwest (toward Sullivan’s Island) from 2012 to 2013, likely drawing sand off the IOP beach. The marginal flood channel (M) migrated toward the beach and developed a terminal lobe (L) through the delta shoal. [LOWER] View of the western tip of Isle of Palms showing areas which were stable or erosional between July and October 2013. While a small area showed minor dune recession, all stations in this view gained sand from July to October 2013 (measured to -6 ft NAVD). [Photos by SB Traynum]

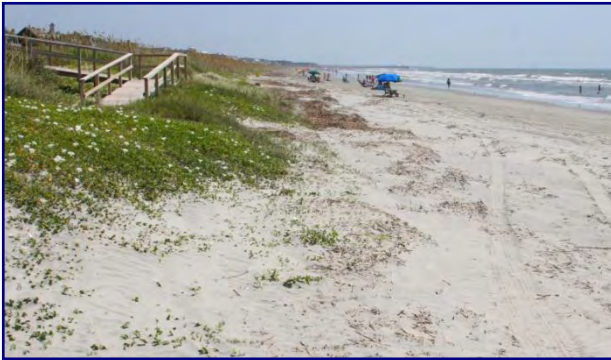
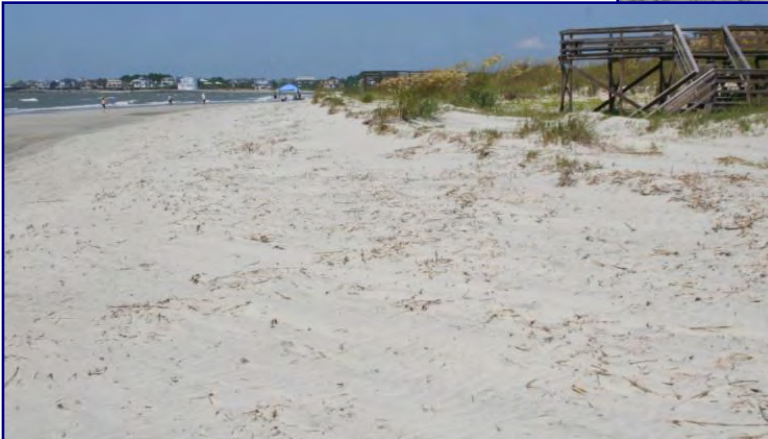
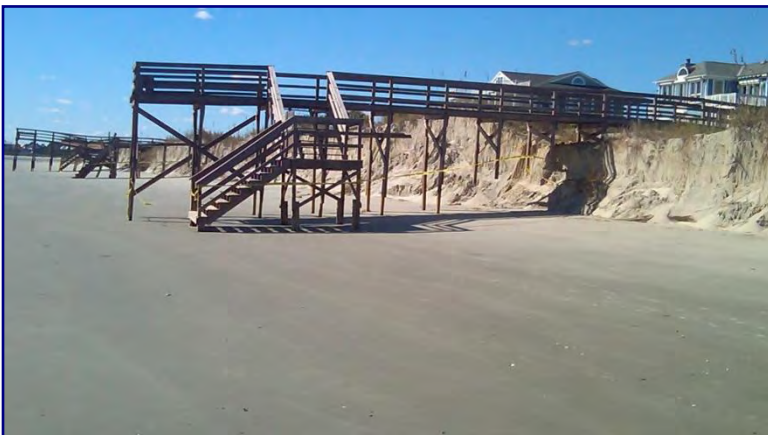
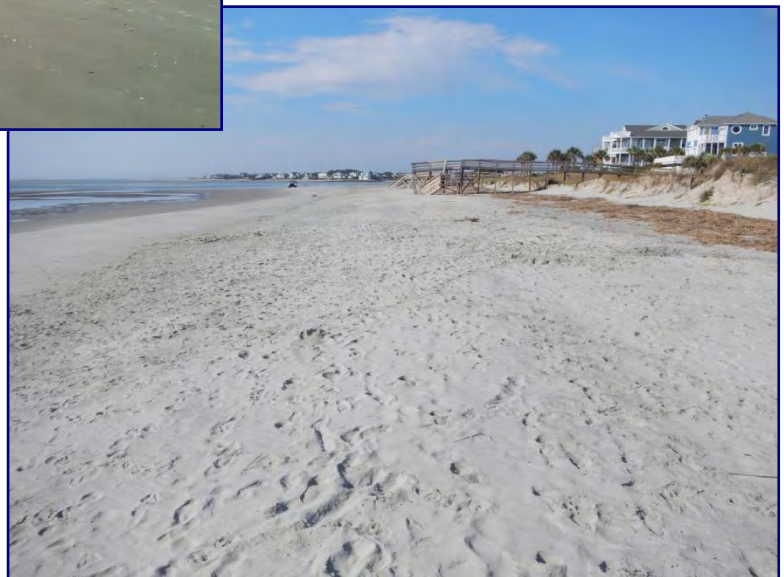
FIGURE 3.39.

[UPPER LEFT] 4th Avenue (10 July 2012).

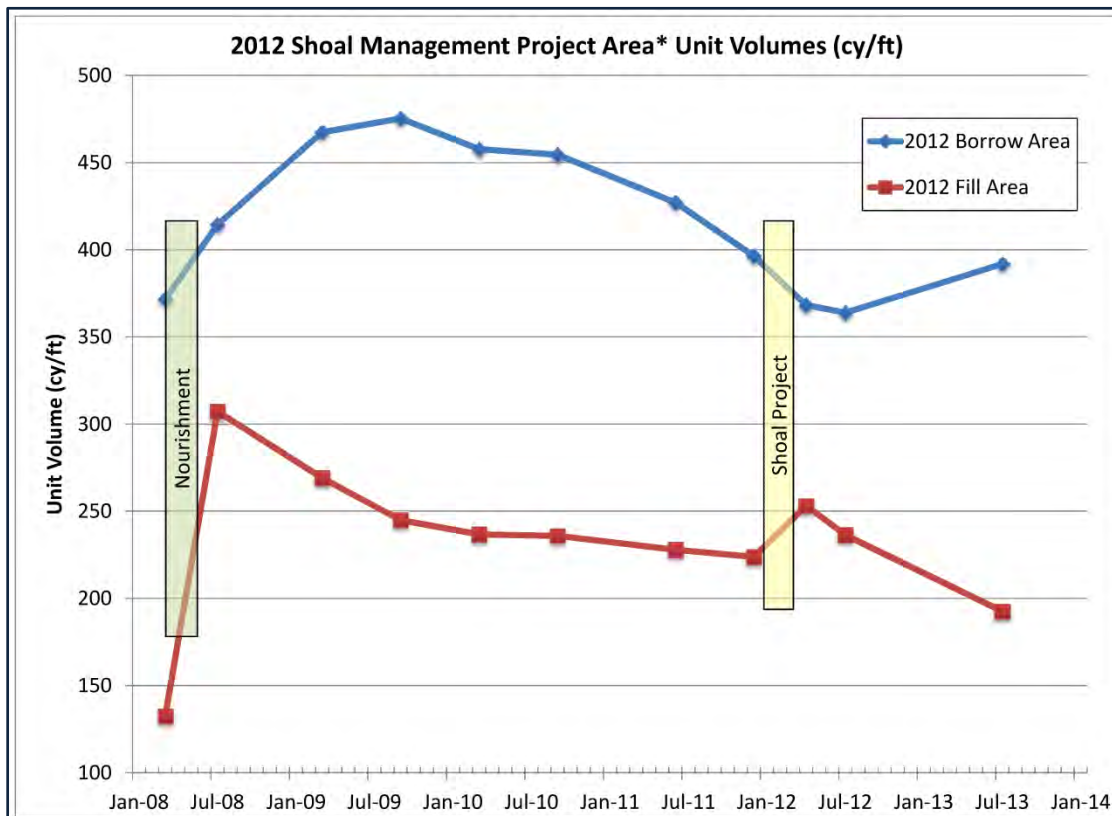
FIGURE 3.40. Unit volumes for the 2012 shoal management project borrow area (*blue, stations 276–298) and fill area (*red, stations 306–320). The fill area eroded rapidly after placement and had lost all of the project sand following passage of Hurricane *Sandy* (October 2012). The erosion rate increased over the past year compared to the 2009–2012 rate.

Erosion increased over the past year with the area within the fill limits losing ~61,308 cy (43.8 cy/ft), leaving it with an average of 60.1 cy/ft more sand than the 2008 pre-nourishment condition. Much of the erosion over the past year appears to have occurred during Hurricane *Sandy* (27 October 2012), although the area has continued to lose sand since then. Property owners have placed approximate cubic-yard-sized sand bags along the dune escarpment to protect the remaining berm until another shoal management project can be performed.

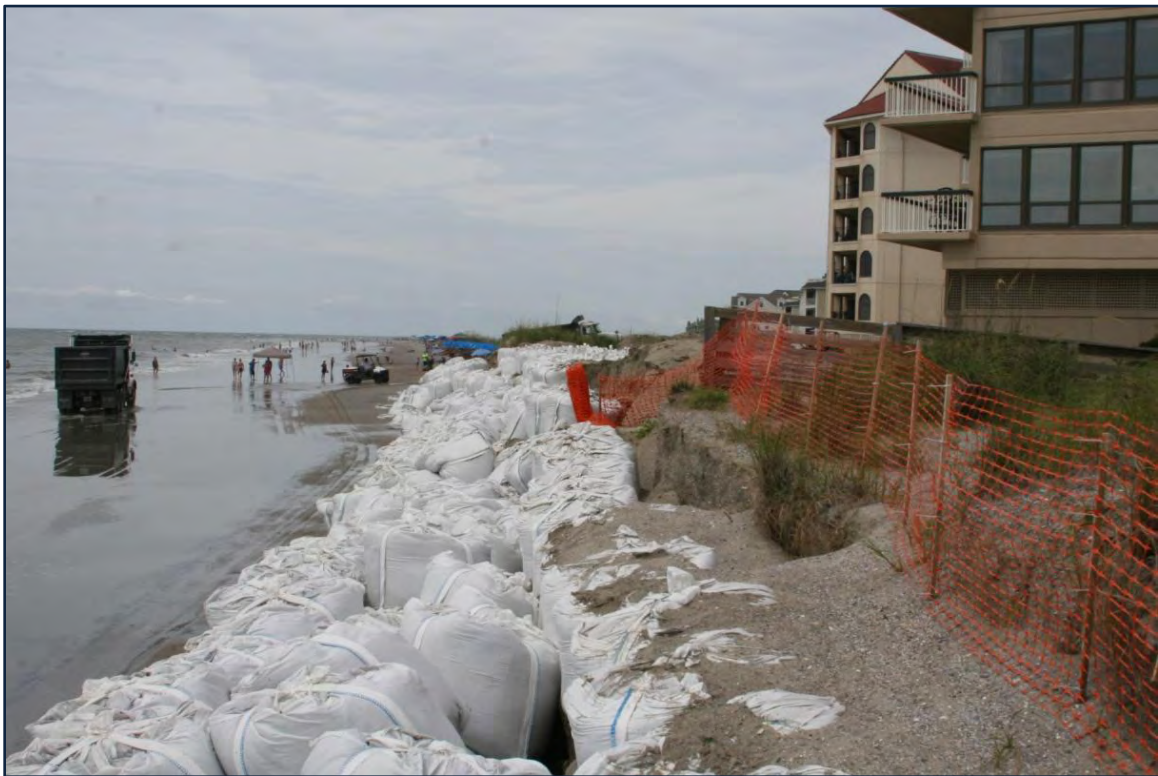
FIGURE 3.41. July 2013 photo of the temporary sandbag revetment placed by property owners along the critically eroded portion of Wild Dunes.

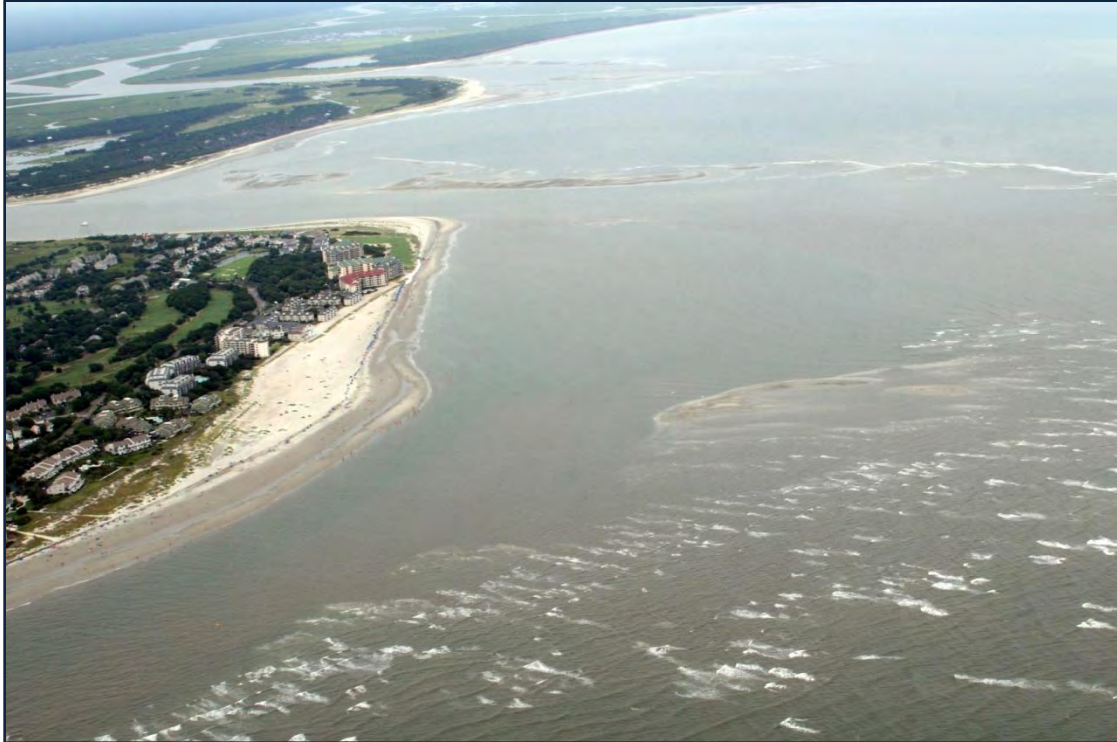
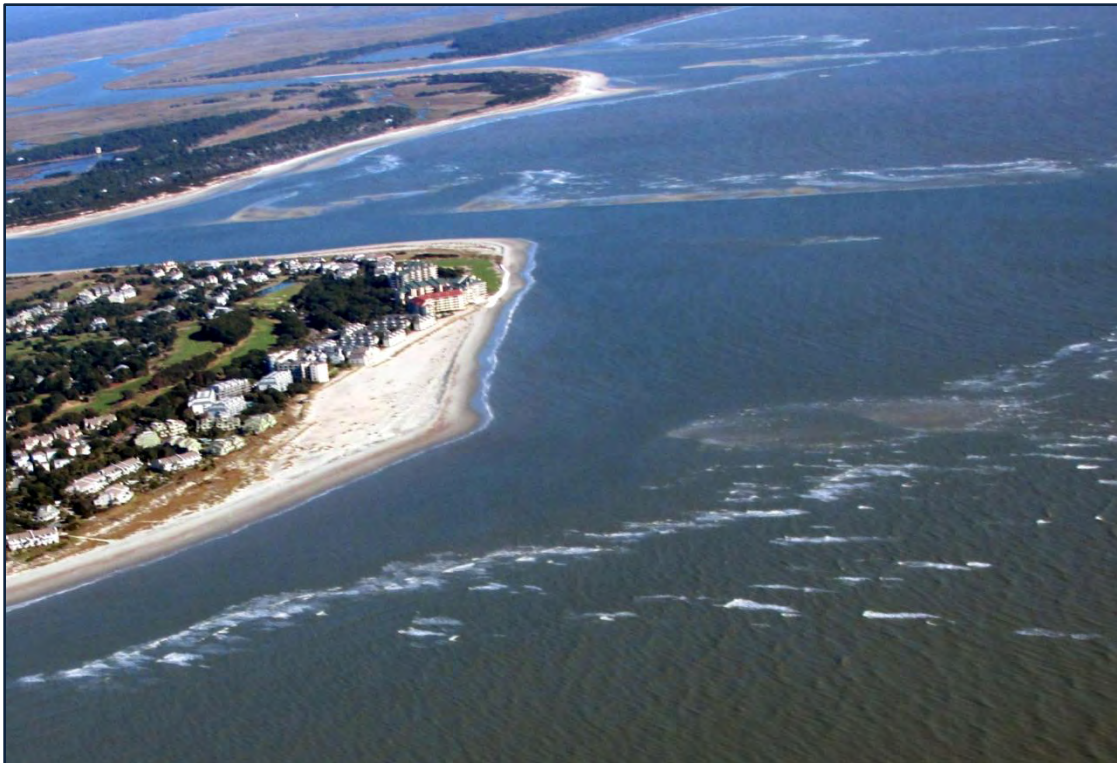
FIGURE 3.44. July 2013 (upper) and November 2013 (lower) aerial images of the ongoing shoal-bypass event at the northeastern end of Isle of Palms. It is apparent that the main body and western area of the shoal have migrated closer to the beach since July (date of survey data). [Note the November image was taken at a slightly higher tidal stage, reducing the extent of the breakers and area of exposed sand.]

The leading edge of the shoal migrated between 500 ft and 750 ft closer to the beach from July 2012 to July 2013. Oblique aerial images from July and November 2013 show even further landward migration as the leading edge appears to be ~400 ft from the beach near Mariners Walk (Fig 3.44). The elevation of the crest of the shoal has increased along all profiles, which leads to continual wave-breaking and more rapid migration. The main body of the shoal offshore of Mariners Walk has a maximum elevation of (~)-1.5 ft NAVD, and is now above the MLLW elevation at the site. The shoal is separated from the beach by an ~500-ft-wide area which allows flushing of water between the ocean on the eastern and western sides of the shoal. As the shoal moves closer to the shoreline, currents in this gap may increase as water attempts to flow from one side of the shoal to the other (especially when waves are oblique to the shoreline). This may lengthen the time it takes to attach as higher currents will sweep away some sediment. A similar, but smaller-scale, flushing channel was present in March 2009 just prior to attachment of a smaller shoal (cf – Fig 3.10).

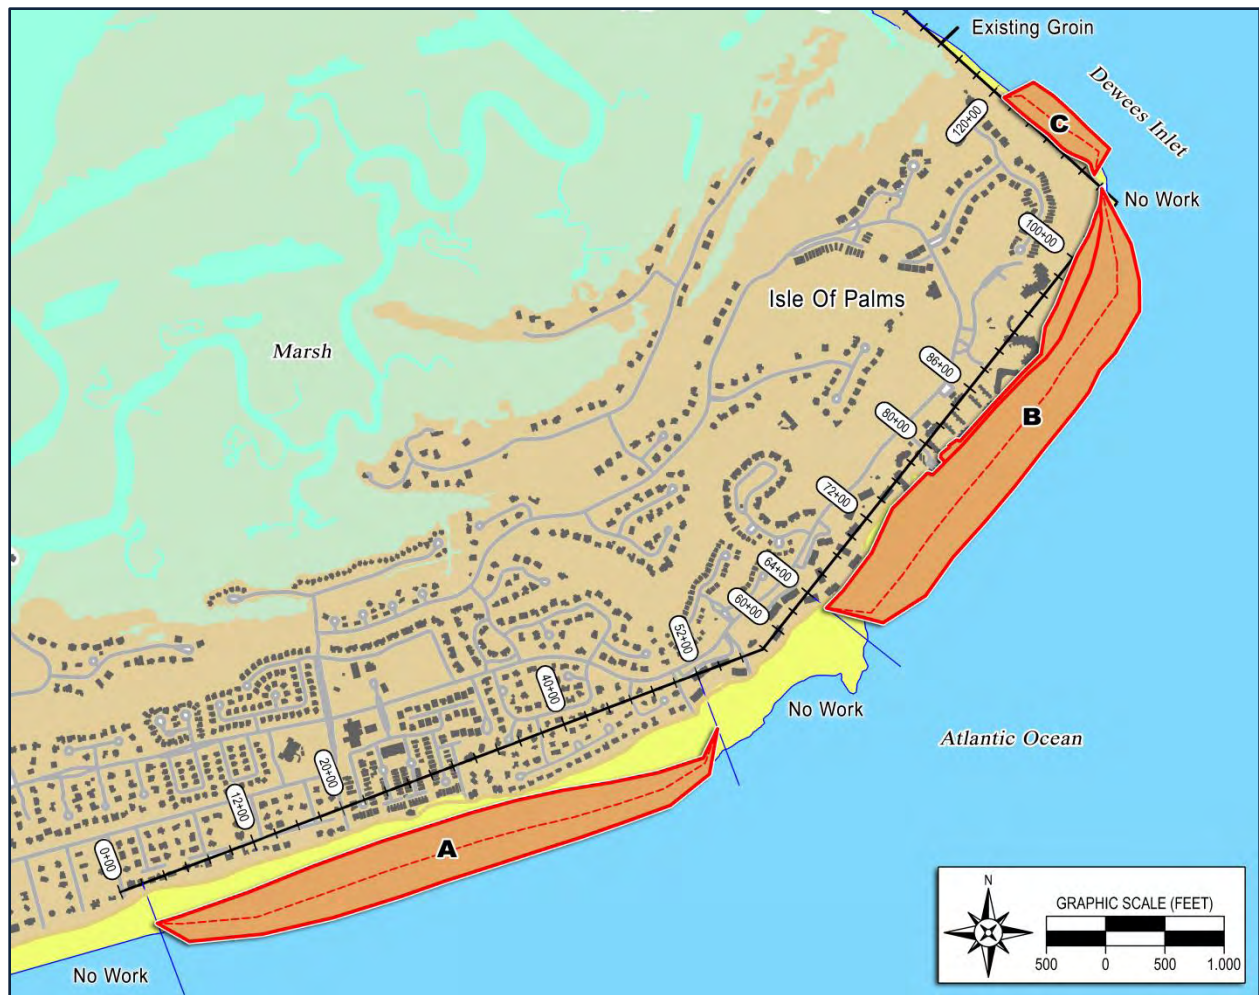
FIGURE 3.45. Reaches for the 2008 nourishment project. The graphic shows the project baseline with 0+00 located at 53rd Avenue (monitoring station 222+00).

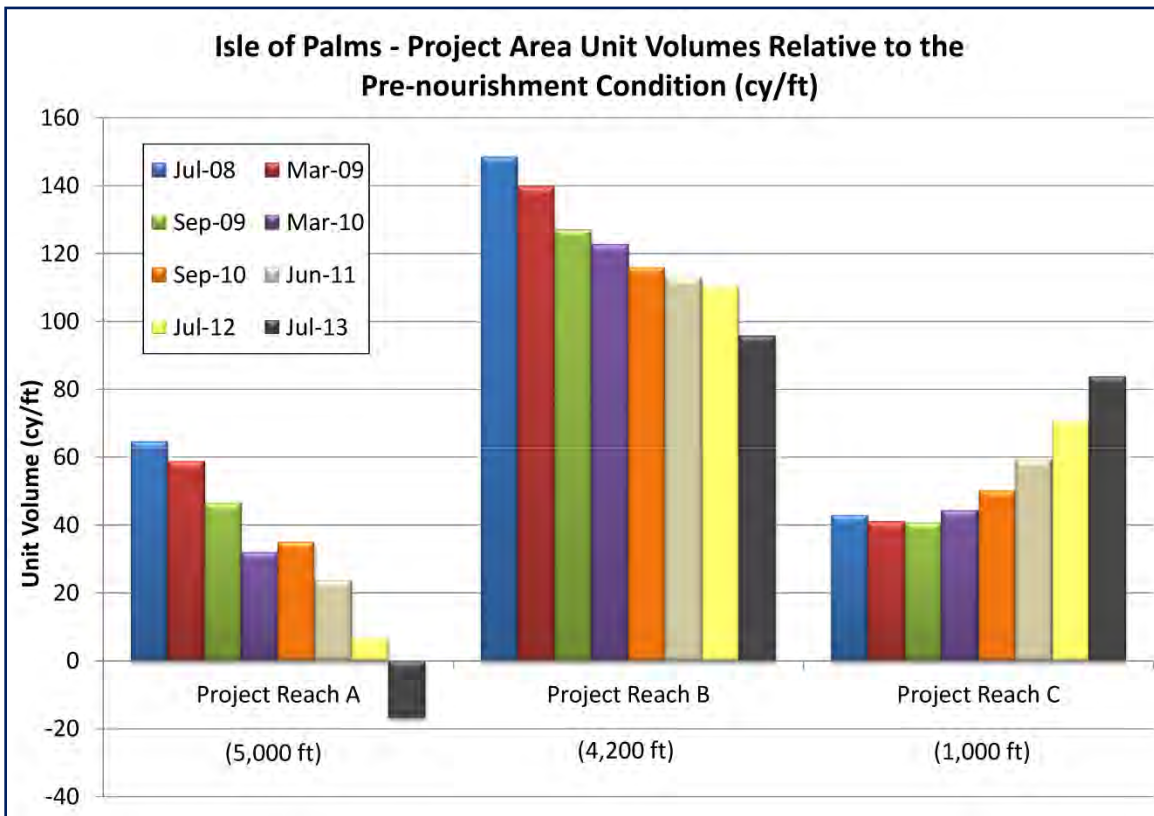
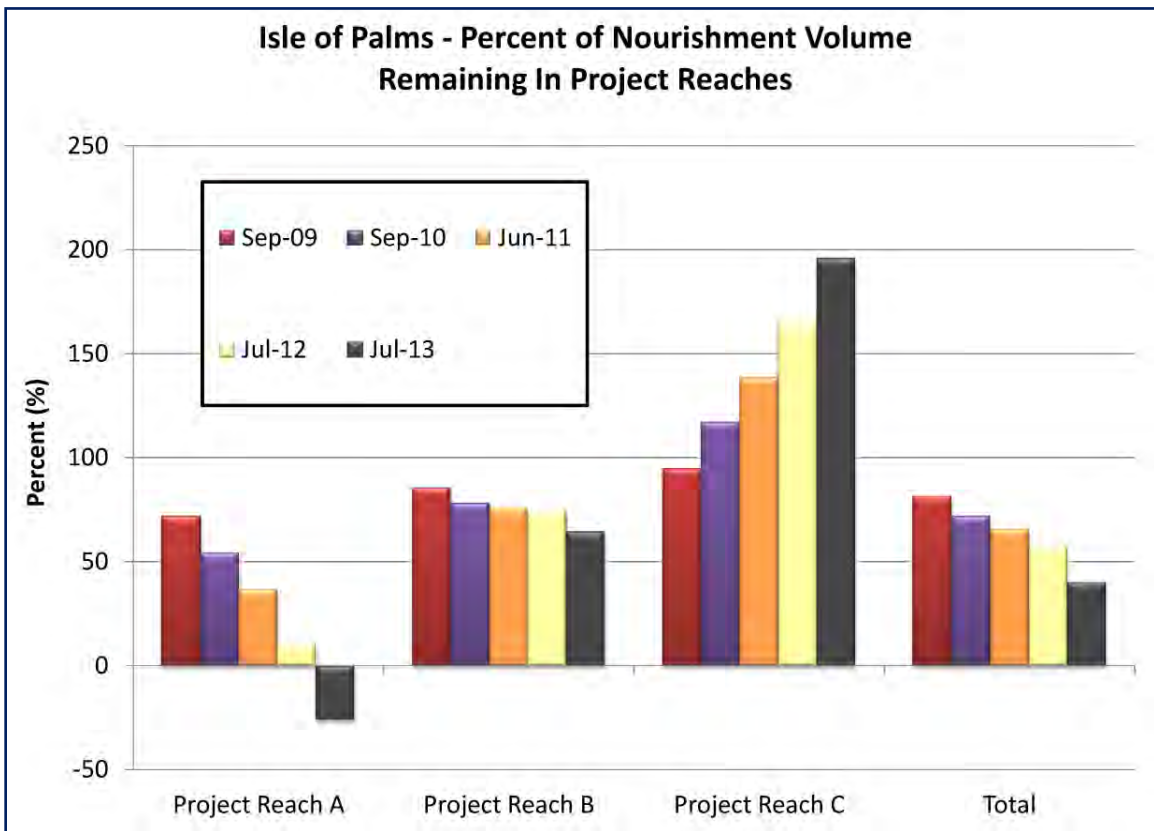
FIGURE 3.46. [UPPER] Project area unit volumes relative to the pre-nourishment (March 2008) condition, which is zero on these graphs. [Note that the project area limits differ from monitoring reach limits.] [LOWER] Percent of nourishment volume remaining in each project area.

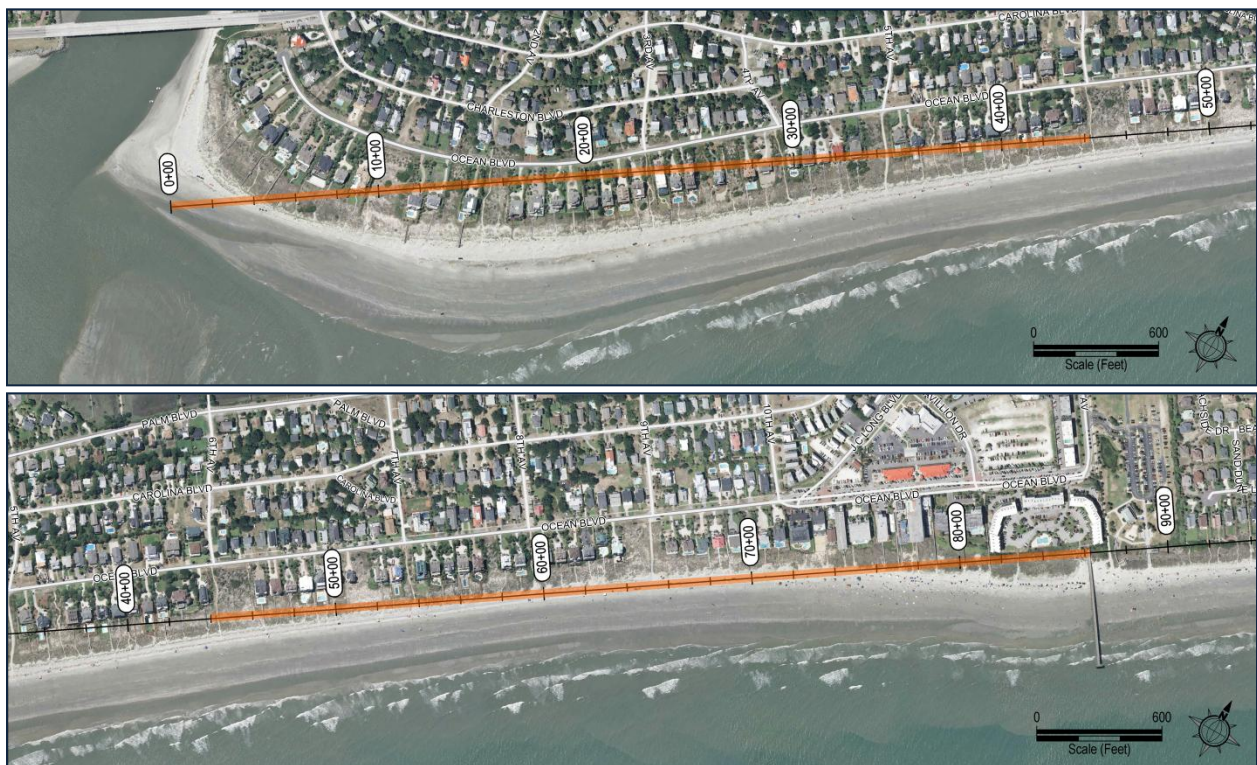
FIGURE 1. Monitoring baseline in Reach 1 (upper) and Reach 2 (lower). The highlighted areas show the reach limits.

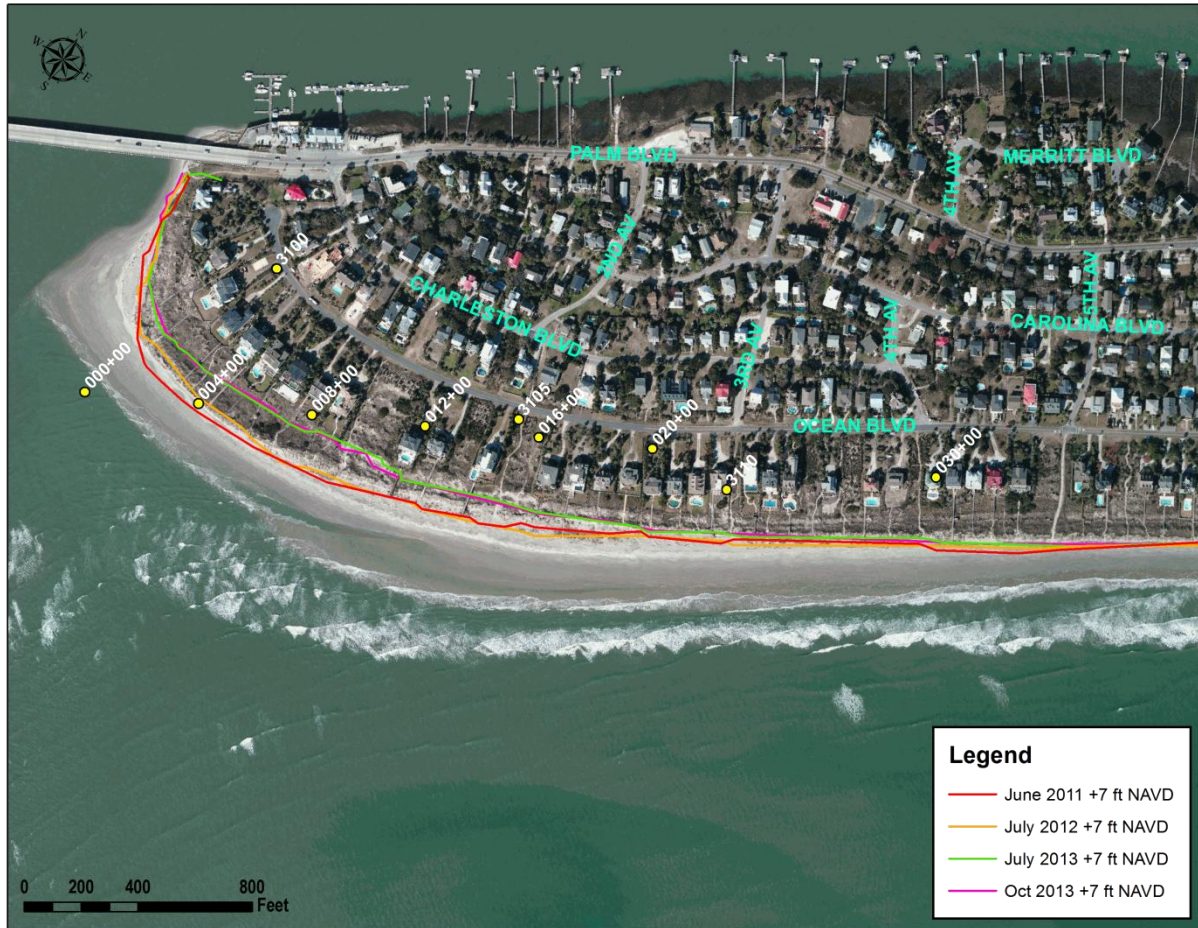
FIGURE 2. Contour map showing the location of the +7-ft NAVD contour, which is approximately the toe of the dune of the escarpment line.

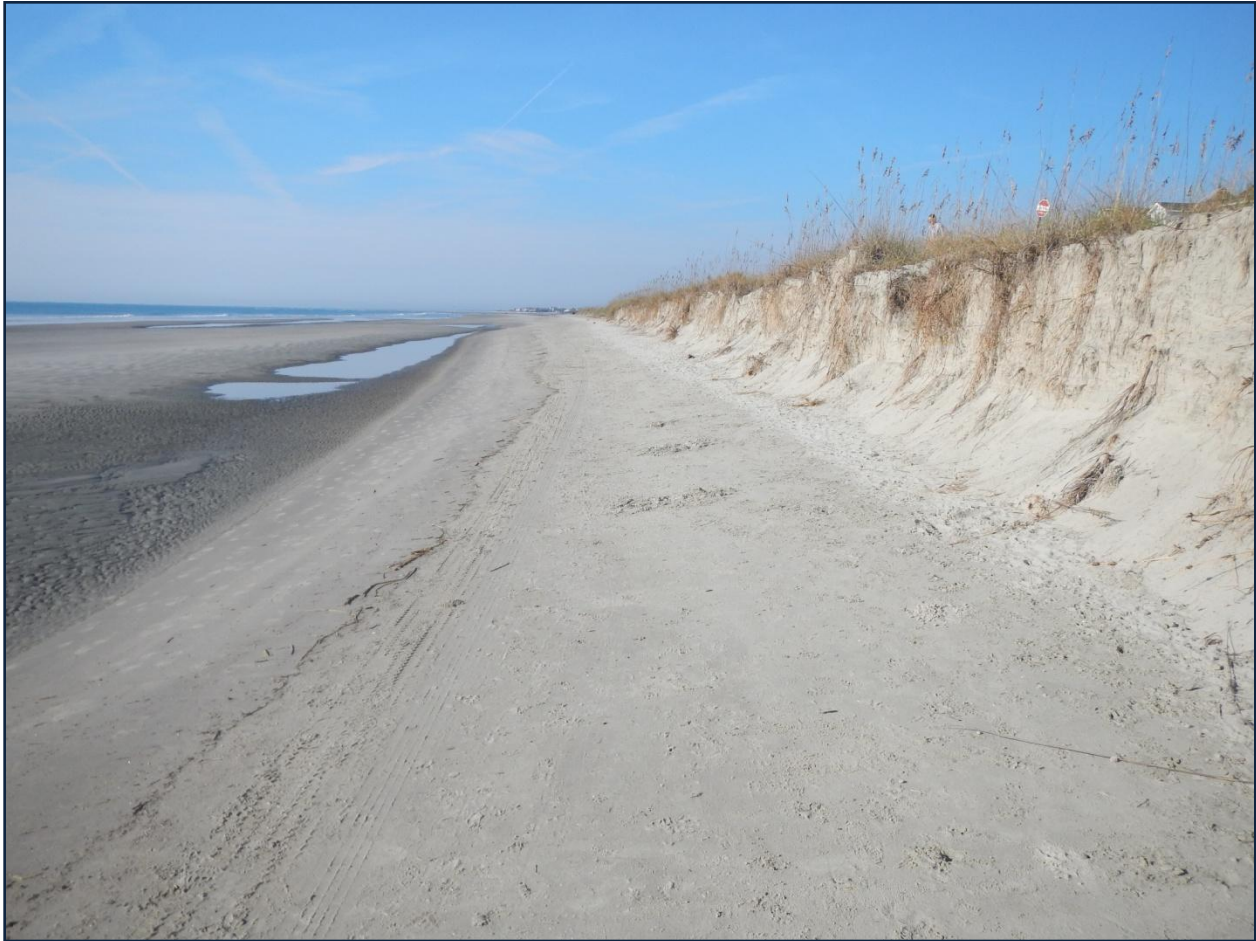
Looking west from Station 50+00 (near 7th Ave). This was the only area showing an active escarpment in October 2013. There was a small erosional arc centered at this station.

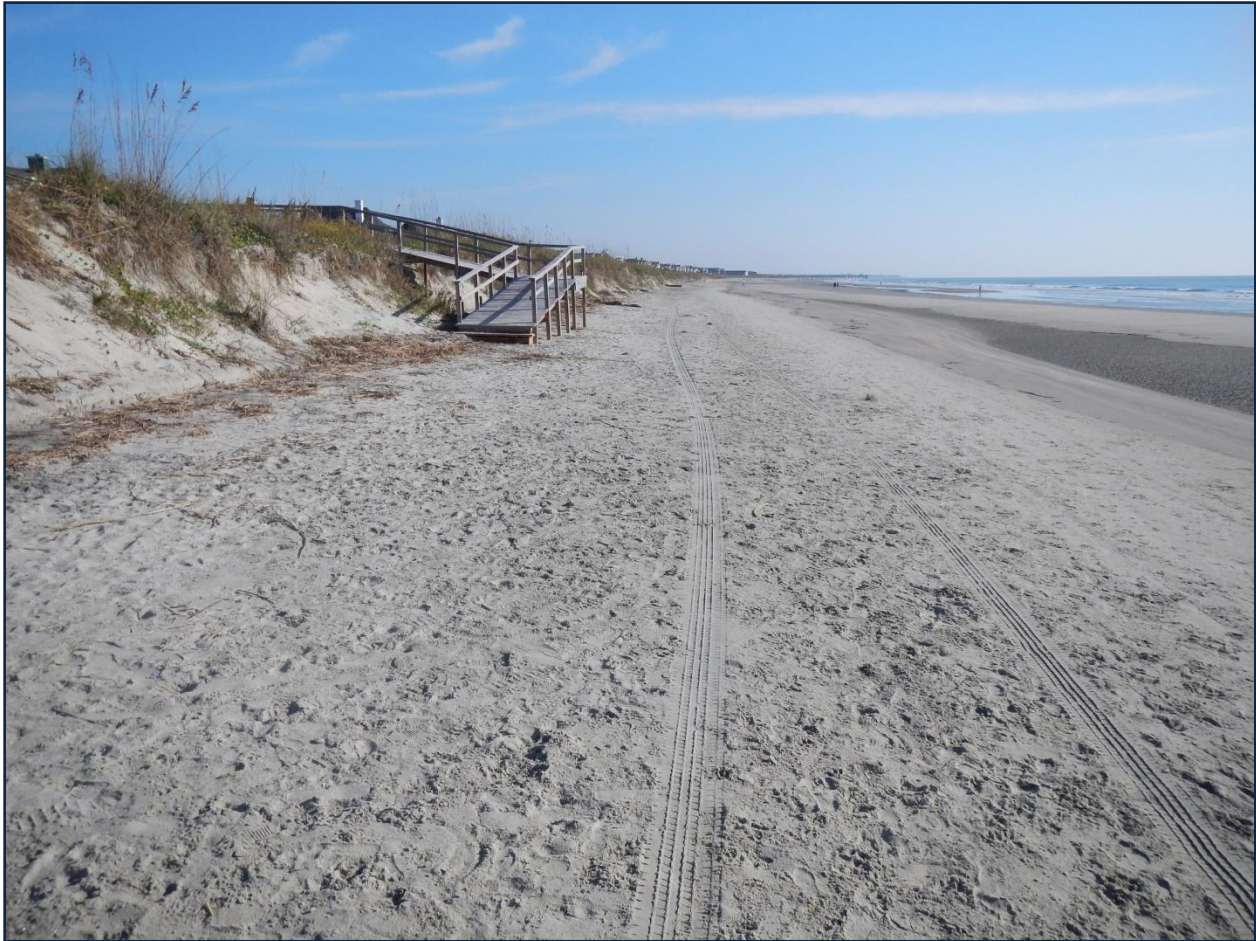
Looking east from station 30+00. Wind-blown sand has accumulated at the base of a recent escarpment, suggesting stability and dune recovery at this location.

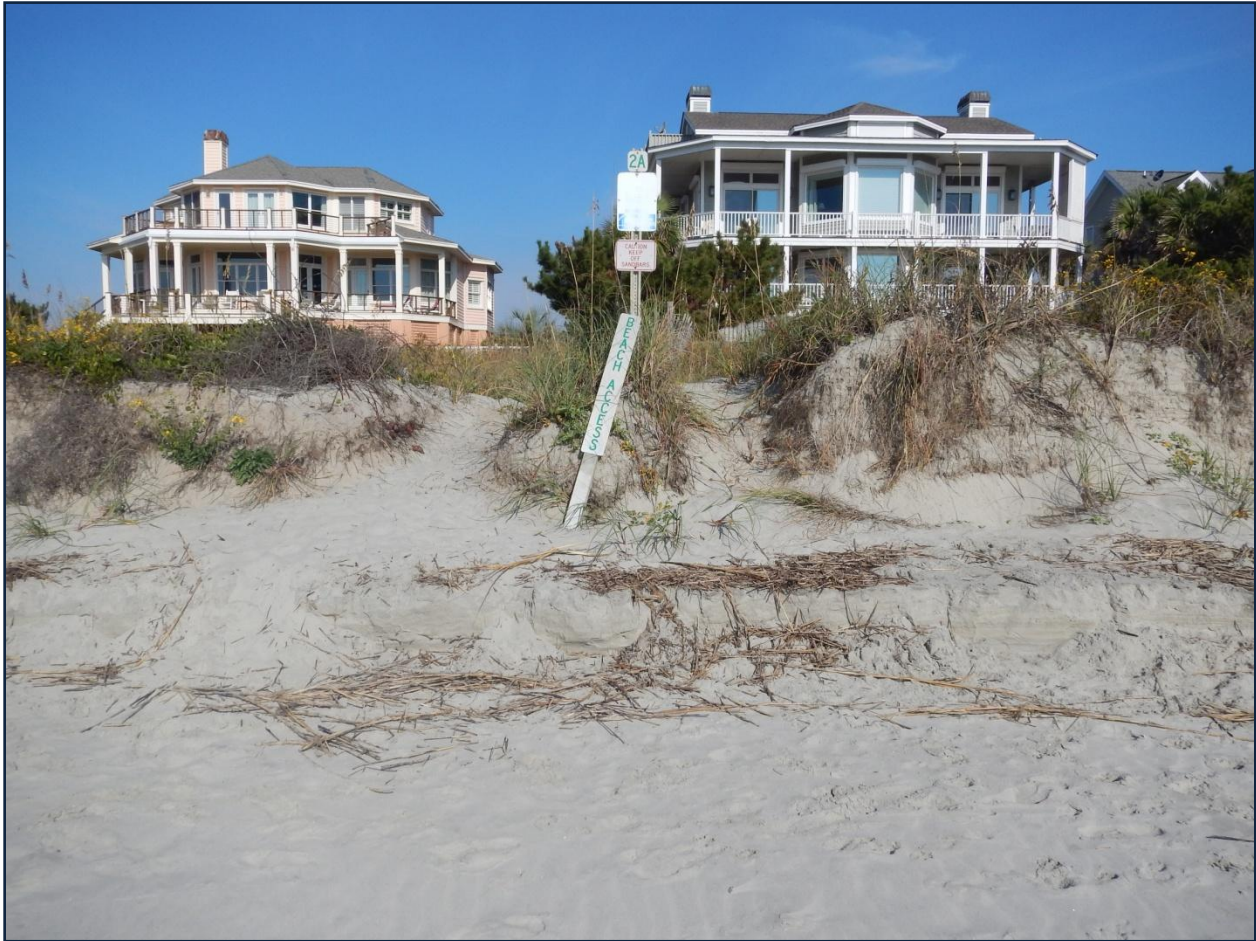
Dune at station 20+00. An old scarp has recovered, although a new, smaller scarp in the berm is evident.

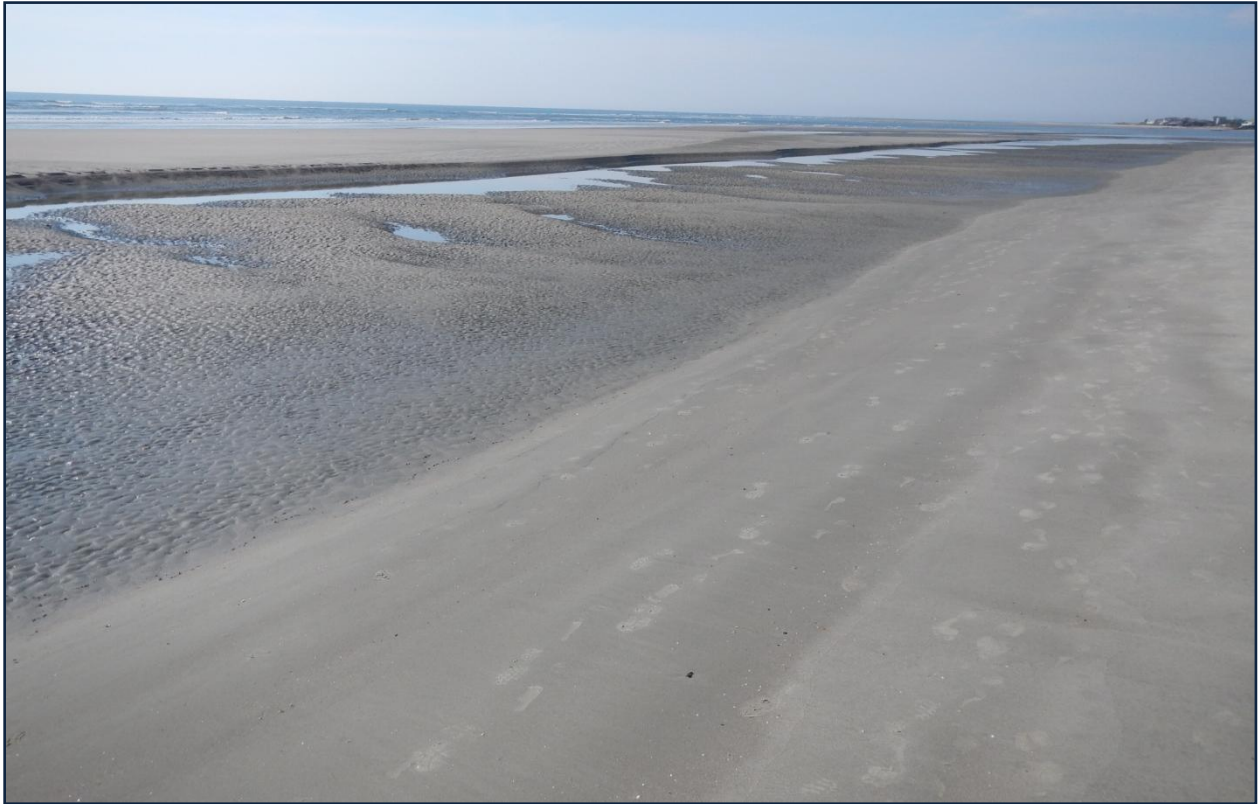
A large ridge and runnel (shown here at station 20+00) is usually evidence of an accretional pattern, which was also reflected in positive volume changes between July and October 2013.

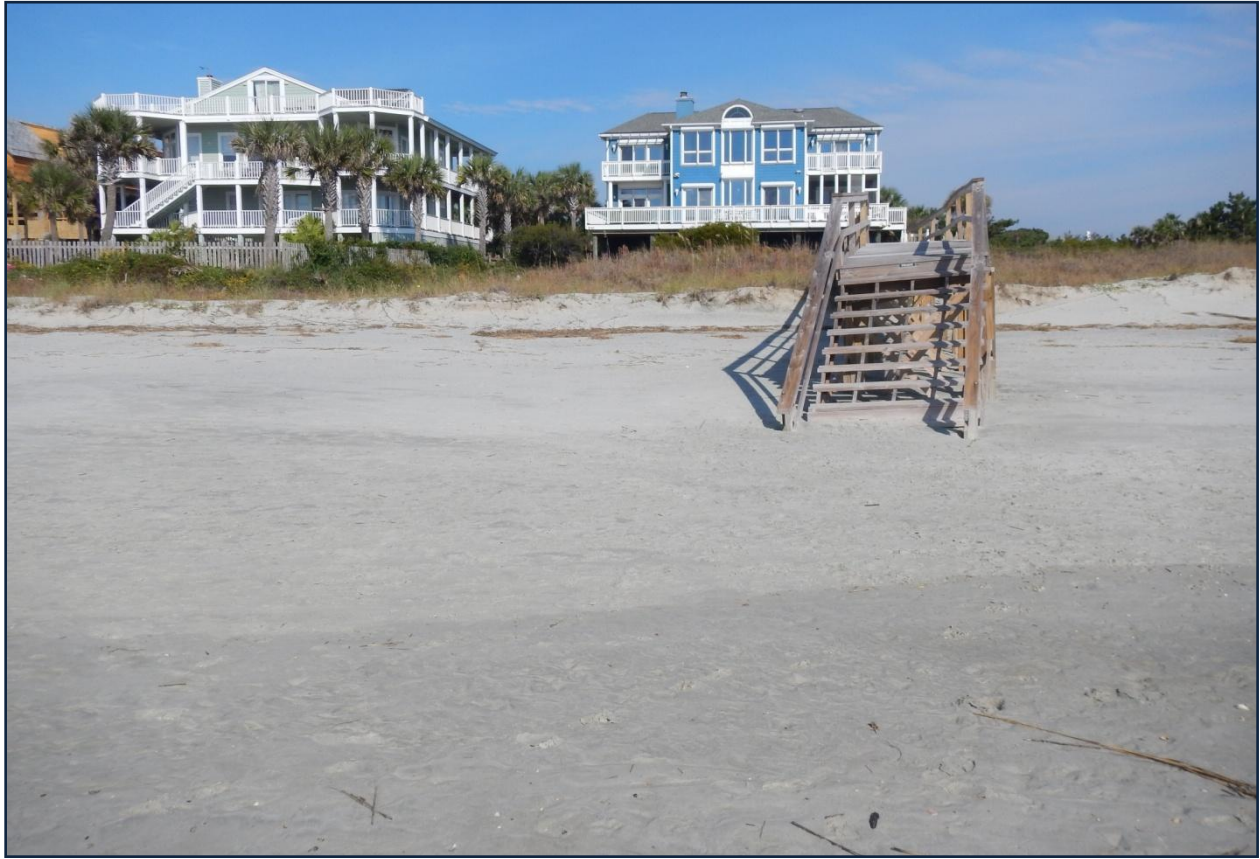
Landward view at station 12+00 showing low dunes lacking sufficient elevation to offer significant storm protection. This area had eroded heavily from July 2012 to July 2013 but was accretional from July 2013 to October 2013.
