2008 BEACH RESTORATION PROJECT  
ISLE OF PALMS SOUTH CAROLINA

Monitoring Report No 7  
June 2016

## YEAR 7 (2015) MONITORING REPORT

### Annual Beach and Inshore Surveys

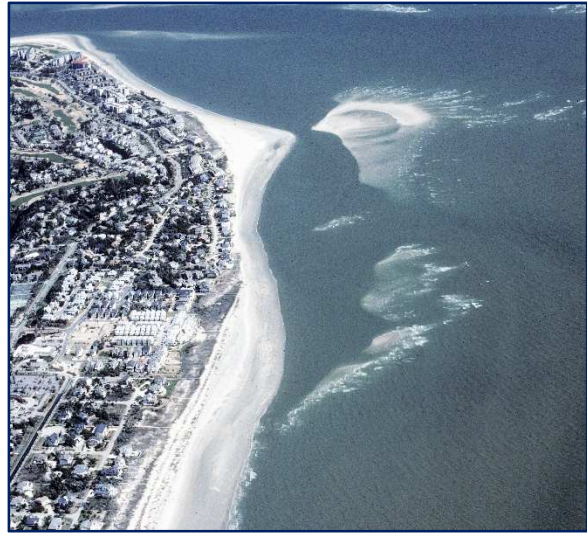
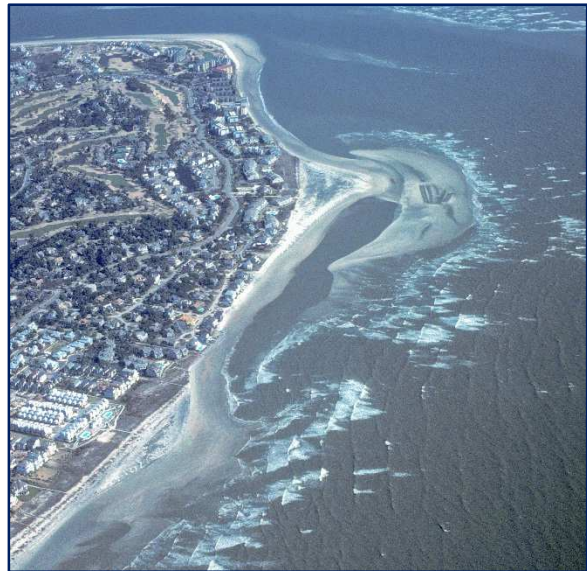
FIGURE 1.2. Shoal-bypassing at IOP.

**FIGURE 1.3.** Schematic of the sediment transport pathways at Isle of Palms (SC). The island is a typical “drumstick” barrier island (after Hayes 1979), where the upcoast end is wider due to sediment accumulation through shoal-bypass events, and the downcoast end usually forms a growing recurve spit. Other examples of drumstick barrier islands along South Carolina are Bull Island, Kiawah Island, and Fripp Island. Zones of sediment transport reversal generally occur in the lee of delta shoals which are situated offshore. Upon shoal attachment to the beach, transport directions in the vicinity of the shoal switch, spreading sand away from the attachment point (see for example Fig 1.2).

Another bypass event occurring in the mid-1990s led to critical erosion (see Fig 1.2), and sand was transferred from the attaching shoal to erosional areas (quantities are uncertain) in a similar fashion as recent shoal-management projects.

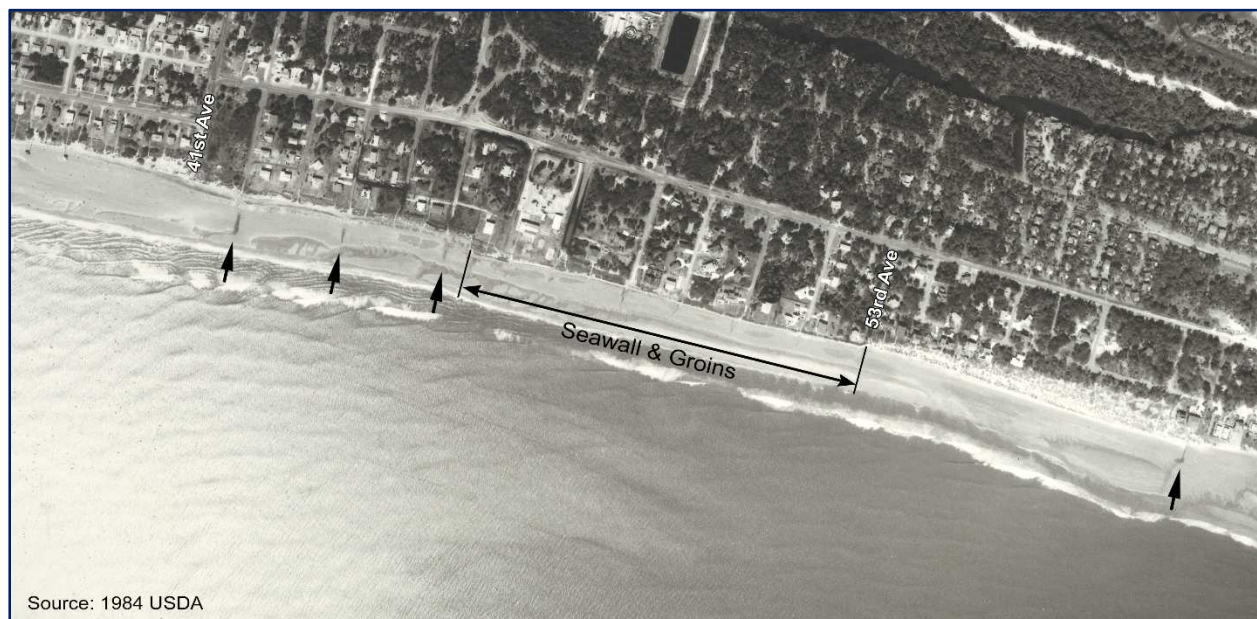
**FIGURE 1.4.** 1984 aerial image of Isle of Palms between 39th Avenue and 57th Avenue showing groins and a seawall installed along the beach. Groins are indicated by the arrows.

The earliest known, engineered erosion control efforts at Isle of Palms were installation of a seawall in the vicinity of the Citadel Beach House from 46<sup>th</sup> Avenue to 53<sup>rd</sup> Avenue and a series of groins from 42<sup>nd</sup> Avenue to 53<sup>rd</sup> Avenue. These were in place by 1973 in response to narrow setbacks in the area and are shown as they existed in 1984 in Figure 4. The structures remained visible through 1994 and were removed or buried by the late 1990s as the beach in this area accreted.

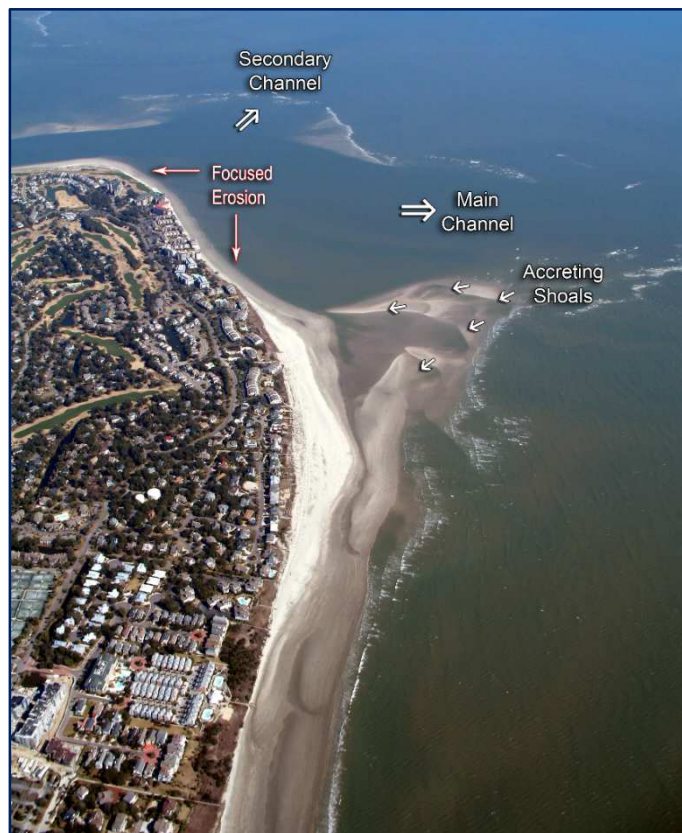
FIGURE 1.5. 2007 aerial image of the northeast end of Isle of Palms, showing a large shoal event attached to the beach.

The event leading to the present monitoring effort was a large shoal-bypass event which began to impact the shoreline along Wild Dunes by 2003. This event was one of the largest observed shoal-bypassing events observed at Isle of Palms (Gaudio & Kana 2001) and resulted in an extended period of extreme erosion on either side of the shoal. On the north side, erosion was so severe that all properties north of Mariners Walk had to place sandbags to prevent damage to structures (Fig 1.5). The 18<sup>th</sup> hole of the links course eroded after sandbags proved too costly to maintain. In 2007, CSE completed an erosion assessment and provided a feasibility study to the Wild Dunes Community Association recommending a nourishment project using an offshore sand deposit to restore the existing sand deficit and provide advanced nourishment for future erosion. The City then led the effort to implement an ~900,000 cy nourishment project in the late spring of 2008, which added sand to the erosional areas in three reaches as shown in Figure 1.6.

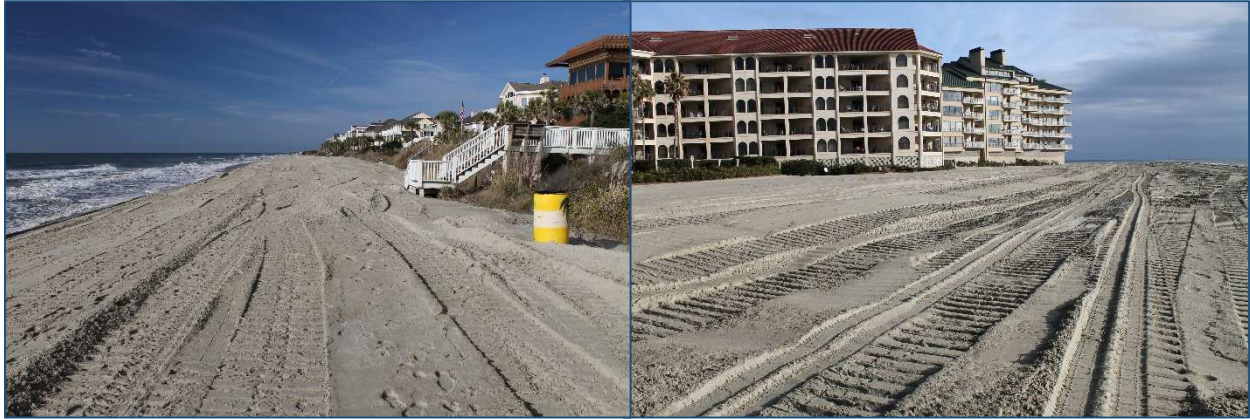
**FIGURE 1.7.** Post-construction photos of the 2014–2015 shoal management project. [LEFT] The area fronting Dunecrest Lane. [RIGHT] The area fronting Seascape and Ocean Club.

By late 2014, an approaching shoal was nearing attachment to the beach, and a portion of the shoal was accessible to equipment for harvesting. The City implemented another shoal management project (Fig 1.7) which moved ~240,000 cy of sand to the two erosional areas: ~70,000 cy were placed in along the area between Seagrove and Dunecrest Lane, and 170,000 cy were placed between Port O Call and the 18<sup>th</sup> Hole. Near the time of the project, erosion accelerated along the western area and continued during and after the project, resulting in rapid loss of the sand placed along that length of beach. The eastern area performed much better, retaining a dry sand buffer until Hurricane *Joaquin* in early October 2015.

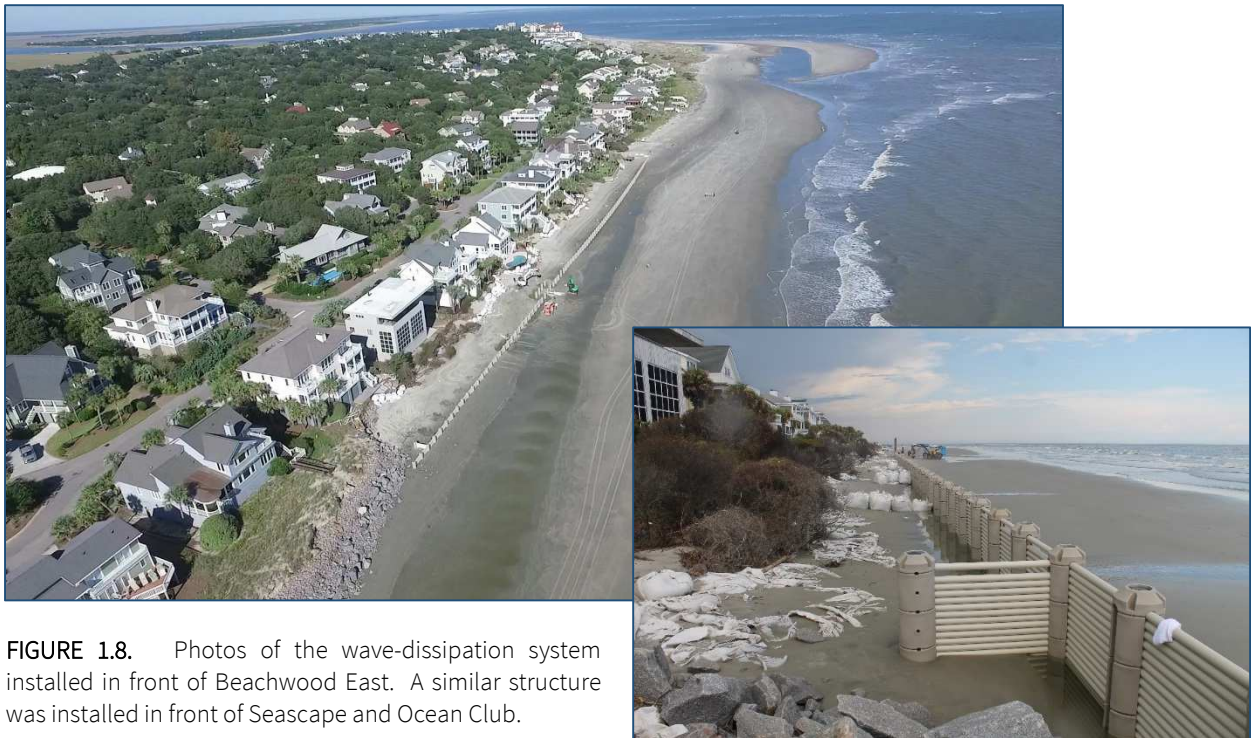
**FIGURE 1.8.** Photos of the wave-dissipation system installed in front of Beachwood East. A similar structure was installed in front of Seascape and Ocean Club.

Following the 2014/2015 shoal management project, a Wave Dissipation System (WDS) was installed by homeowners along Beachwood East in hopes of preventing additional loss of upland sand (Fig 1.8). A system was also installed in front of Ocean Club. These systems and the permits allowing the systems were not coordinated by the City, but conditions of the permits prevent sand from being placed seaward of the structures. In a meeting with homeowners in the erosional areas, the homeowners indicated to the City that they preferred to leave the WDS systems in place rather than allow the City to attempt another shoal management project in the fall of 2015. Presently, the City is in the initial phases of obtaining a permit for another large-scale beach nourishment project using an offshore borrow source.

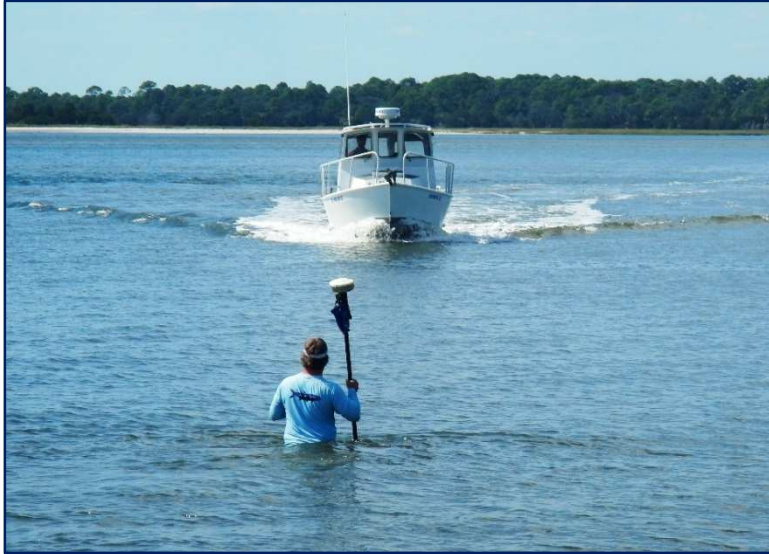
FIGURE 2.2.

Surveying beach profiles involves collection of land-based data at low-tide and hydrographic data collection overlapping the land-based work.

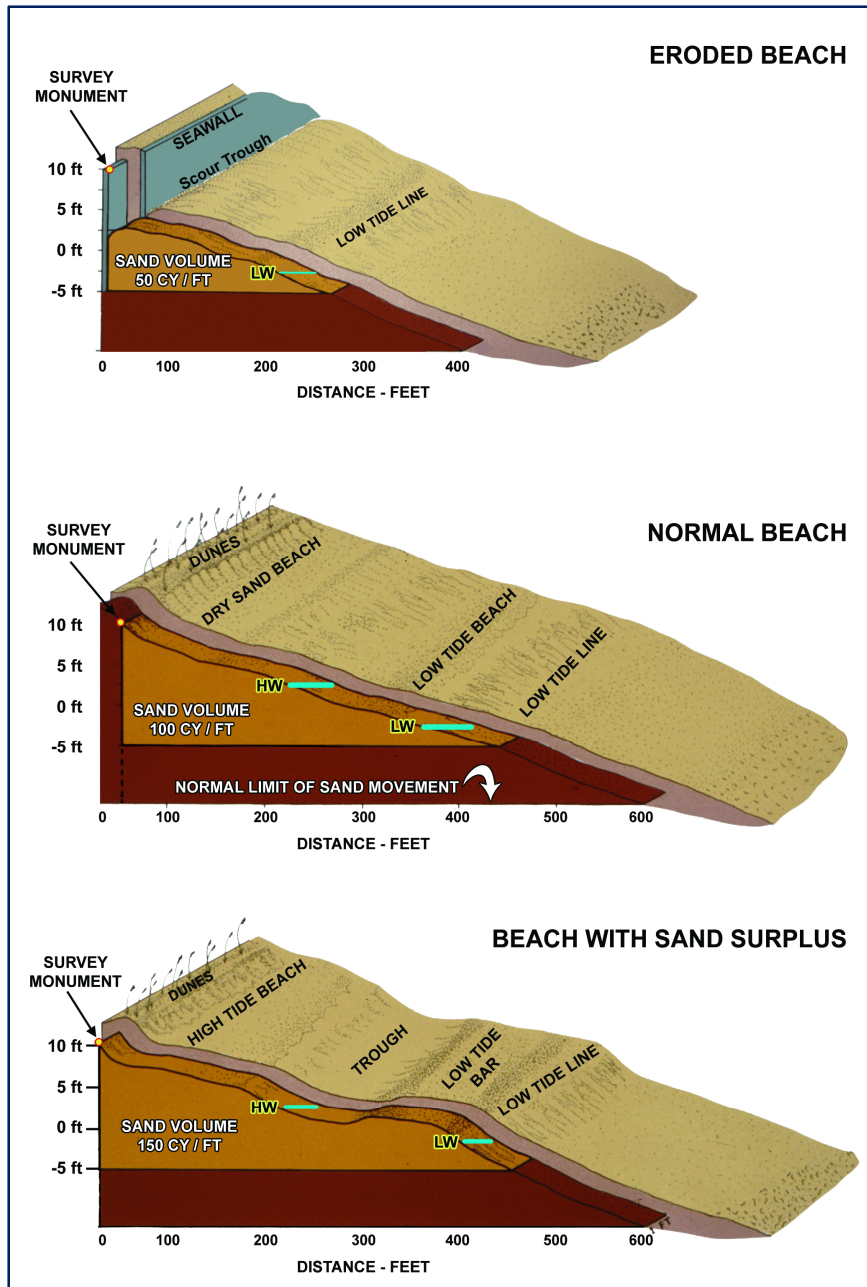
FIGURE 2.4. Illustration of the profile volume concept.

To determine changes in beach volume along Isle of Palms, beach profile data were entered into CSE's in-house custom software, Beach Profile Analysis System (BPAS), which converts 2D profile data in x-y (distance-elevation) format to 3D volumes. The software provides a quantitative and objective way of determining ideal minimum beach profiles and how the sand volume per unit length of shoreline compares with the desired condition. It also provides an accurate method of comparing historical profiles—as the volume method measures sand volumes in the active beach zone rather than extrapolating volumes based on single-contour shoreline position (ie – from aerial photography). Unit-volume calculations can distinguish the quantity of sediment in the dunes, on the dry beach, in the intertidal zone to wading depth, and in the remaining area offshore to the approximate limit of profile change (closure depth).

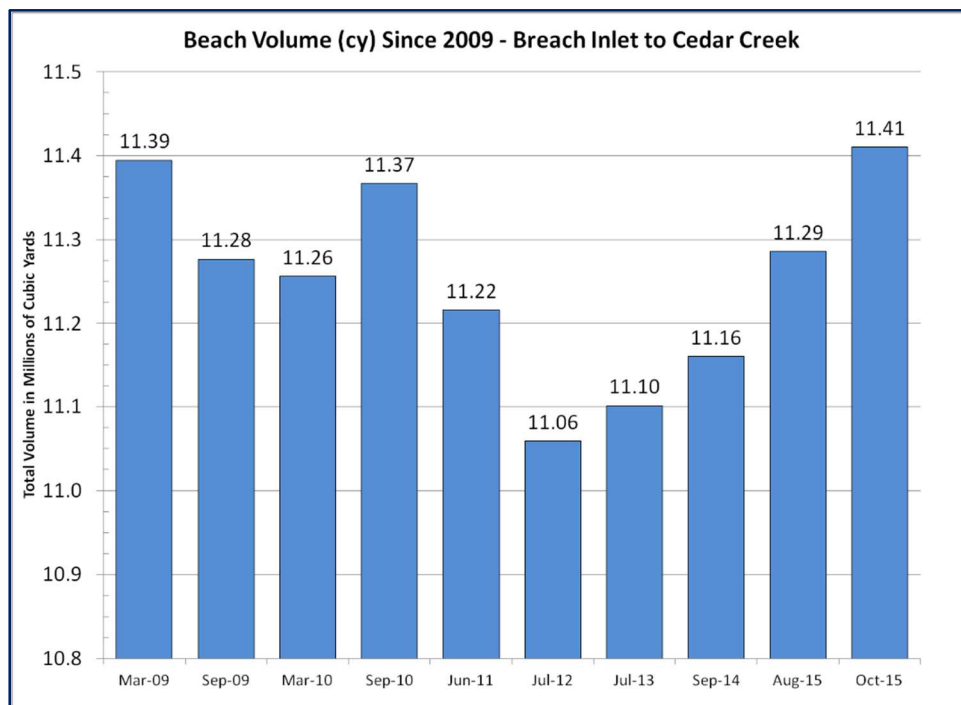
FIGURE 3.1. Total beach volume along Isle of Palms for the period 2009–2015.

Isle of Palms gained 125,000 cy of sand between September 2014 and August 2015 (Fig 3.1). Accretion was observed along the central portion of the island between 14<sup>th</sup> and 53<sup>rd</sup> Avenues (Reaches 3 and 4) and east of the Wild Dunes Property Owners Beach House (Reaches 6 and 7). Erosion was observed in the area between 4<sup>th</sup> Avenue and the Sea Cabins Pier (Reach 2), and from 53<sup>rd</sup> Avenue to the Wild Dunes Property Owners Beach House (Reach 5). Figure 3.2 shows the general volume change trends along the island between September 2014 and August 2015—with green and blue colors showing areas which accreted, and red and orange hues showing areas that eroded.

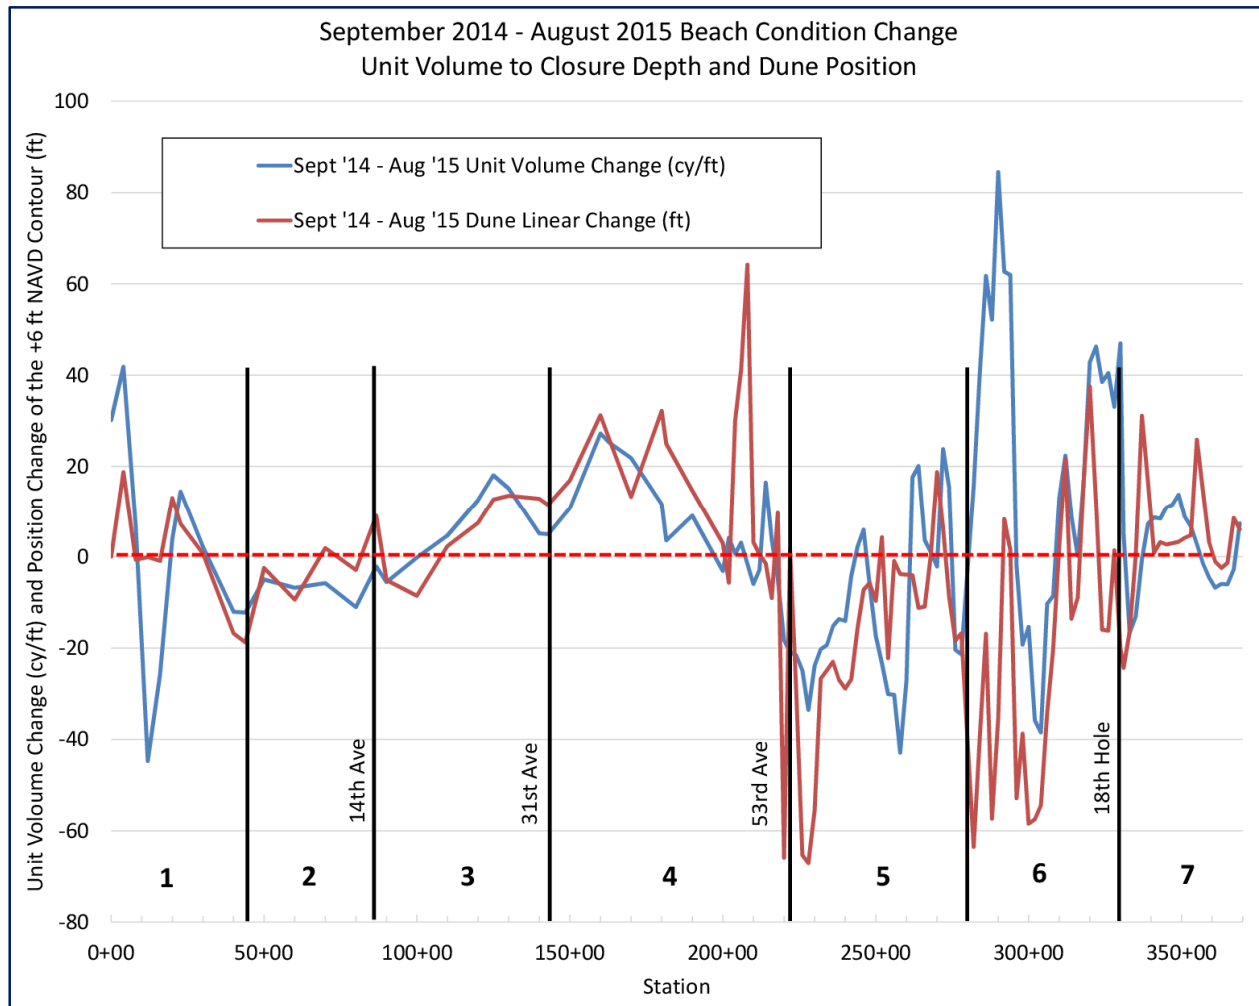
FIGURE 3.3. Erosion values (cy/ft) and linear change in the dune position (measured at the +6 ft NAVD contour) along Isle of Palms between September 2014 and August 2015.

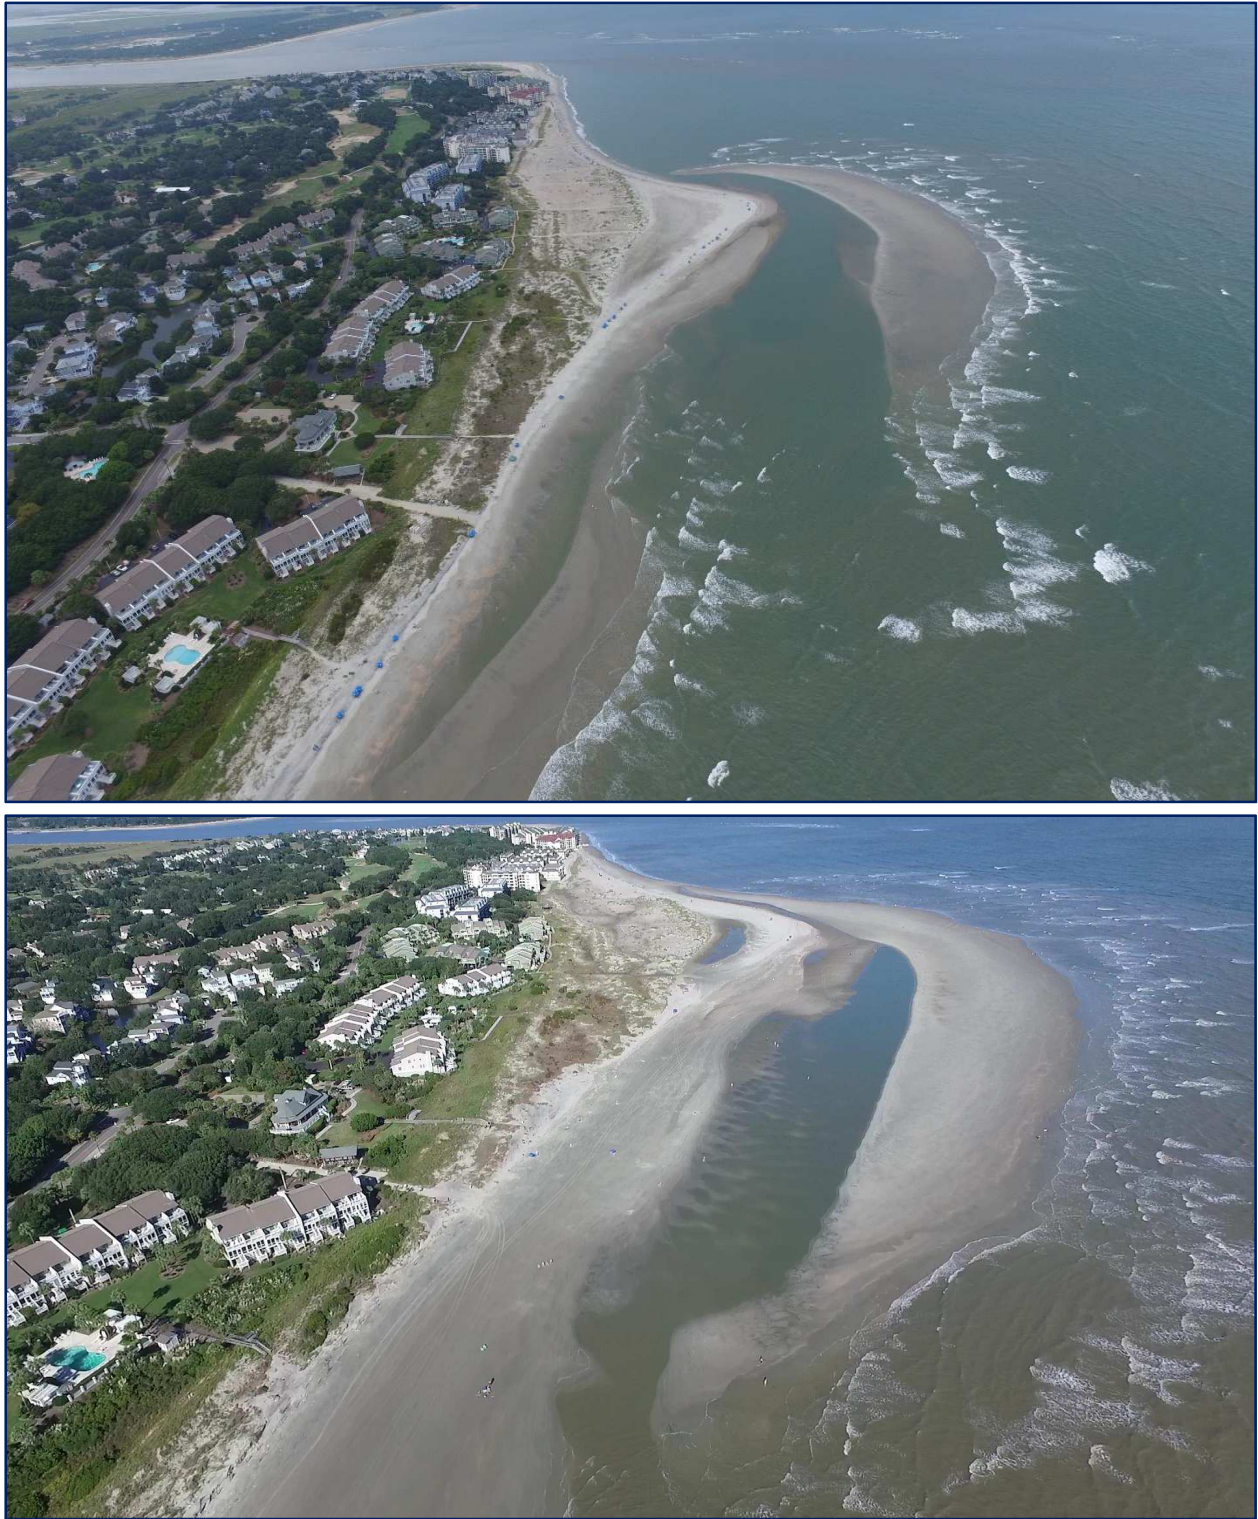
**FIGURE 3.5.** August 2015 (upper) and October 2015 (lower) aerial images of the attaching shoal at the northeast end of Isle of Palms. The center of the shoal (top of images) stalled between 2014 and August 2015, but moved onshore during Hurricane *Joaquin*.

Between the 2014 and 2015 beach monitoring efforts, the major change occurring in Dewees Inlet was continued onshore migration of the attaching shoal (Fig 3.5). The center of the shoal (at station 290+00, Fig 3.6) did not migrate landward between September 2014 and August 2015, but increased in elevation up to 5 ft along the leading edge. The beach landward of the shoal grew nearly 100 ft. Note that a shoal management project was completed between the two surveys, so the observed accretion was despite the removal of ~180,000 cy of sand from the shoal and the leeward beach. The channel separating the shoal and the beach also filled in, reducing the depth from ~8 ft at low tide to ~1 ft at low tide.

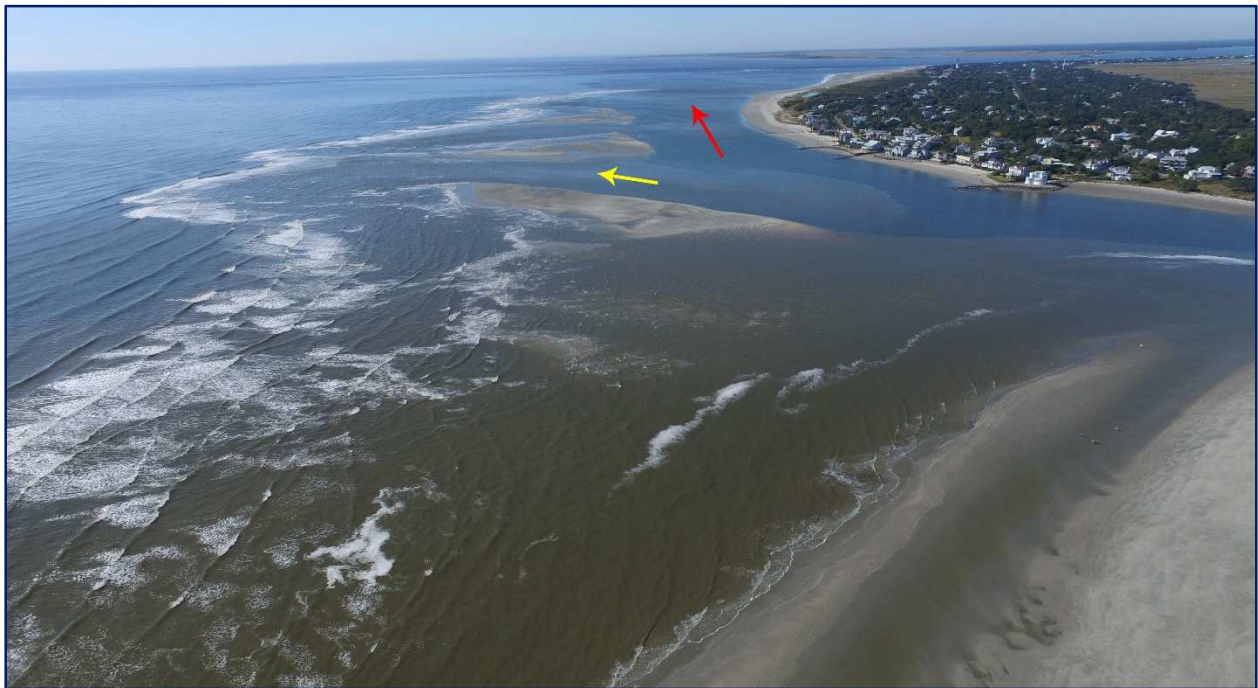
**FIGURE 3.9.** October 2015 aerial image of Breach Inlet. Arrows show the main (adjacent to Sullivan's Island) and secondary channels.

**Changes at Breach Inlet** — The beach condition near Breach Inlet is heavily influenced by currents and shoals. Net sediment transport to the west causes the main channel to migrate west, over-extending along the eastern portion of Sullivan’s Island. Much like Dewees Inlet at the eastern end of Isle of Palms, periodic breaks in the delta shoals allow the main channel to relocate further east, starting the migration process over again (Fig 3.9).

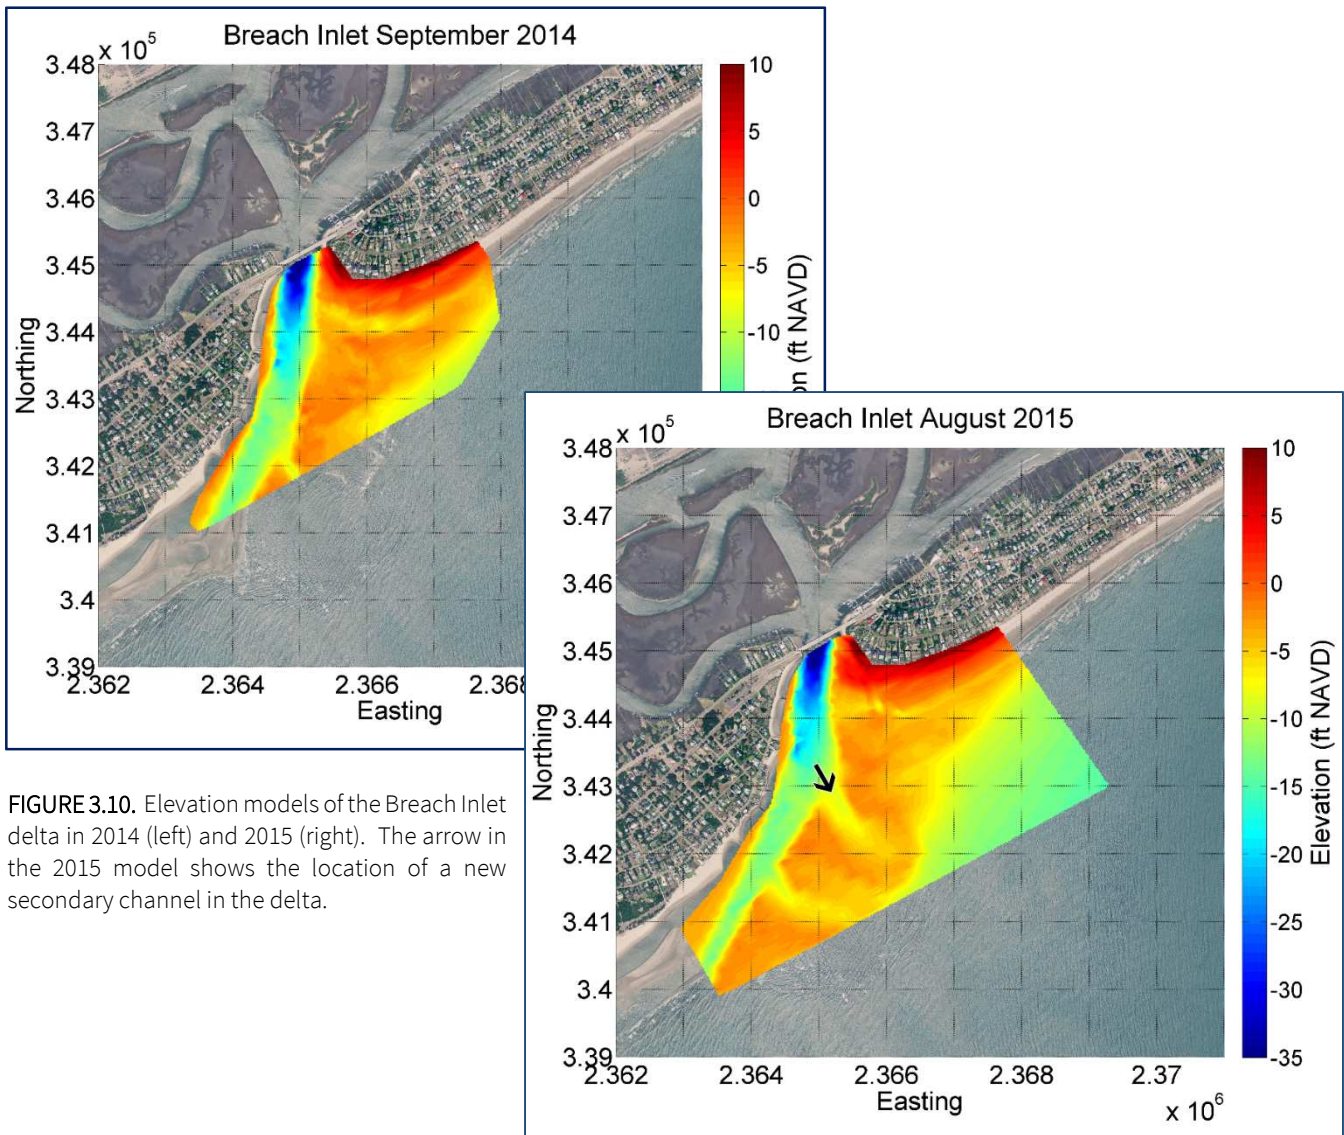
FIGURE 3.10. Elevation models of the Breach Inlet delta in 2014 (left) and 2015 (right). The arrow in the 2015 model shows the location of a new secondary channel in the delta.

A realignment event occurred between 2009 and 2011. Between 2013 and 2014, the seaward end of the inlet migrated away from Isle of Palms which caused the delta shoals to shift southwest, likely drawing off sand from the beach near Breach Inlet. Between 2013 and 2014, the Isle of Palms side of the Breach Inlet delta was fairly stable. The marginal flood channel was also relatively stable, which is favorable for stability of the beach. From 2014 to 2015, the major change observed in the delta was the formation of a new secondary channel in the center of the northern shoal, positioned ~2,500 ft south of the center of the bridge (Fig 3.10).

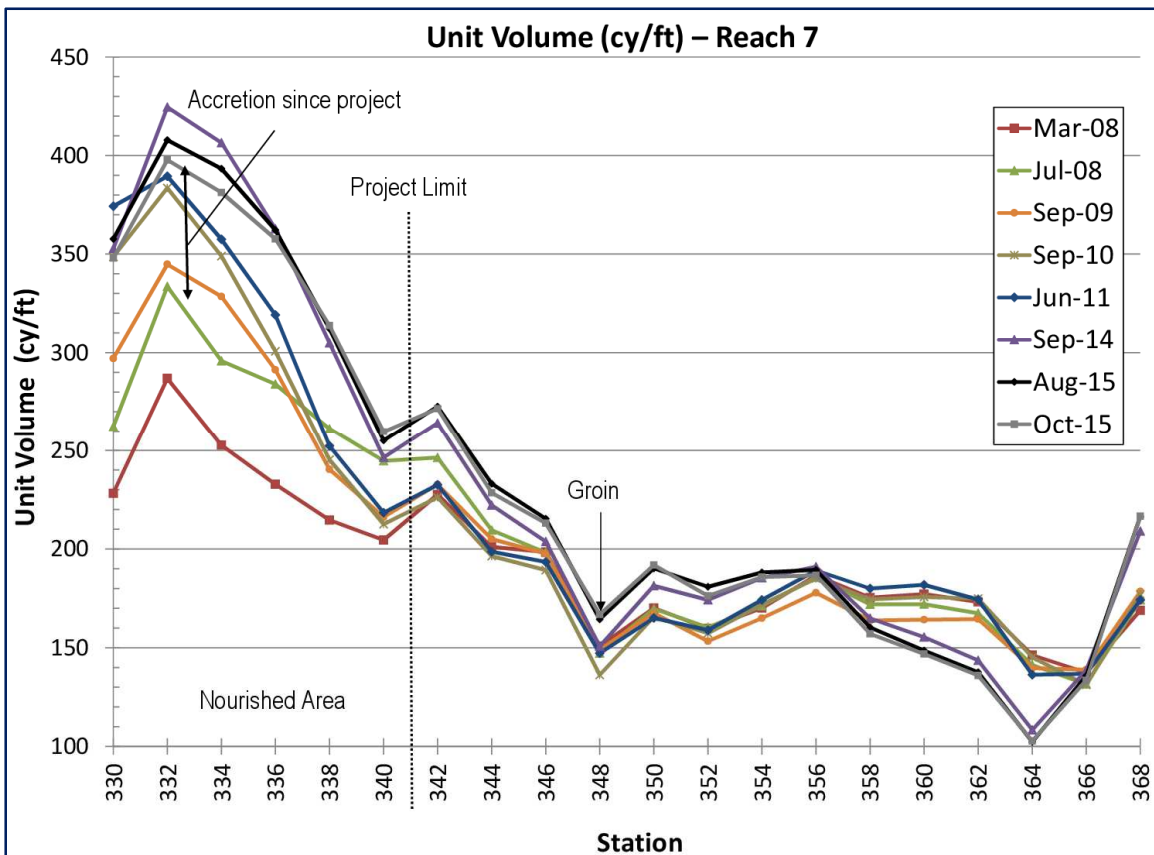
FIGURE 3.12. Beach volumes for Reach 7 showing overall volume change (upper) and change for each line (lower).

Between September 2014 and August 2015, Reach 7 gained 7,750 cy of sand (1.9 cy/ft). The majority of the gain occurred between stations 338+00 and 352+00 (between the 17<sup>th</sup> fairway and the boardwalk for the Seagrass Lane properties). The seaward end of the reach eroded with stations 332+00 and 334+00 losing ~15 cy/ft; however, this area remains much healthier than the post-project condition (Fig 3.13). The landward end of the reach near Cedar Creek spit also eroded moderately, although most of the sand loss occurred beneath the low waterline. Dunes in the area appeared stable despite the narrow and steep beach (Fig 3.14).

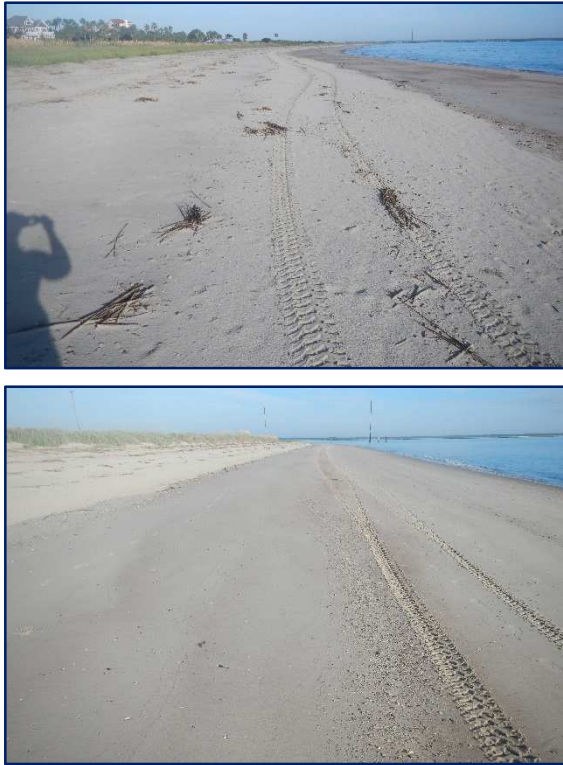
FIGURE 3.14.

August 2015 ground photos of Reach 7: upper photo is station 336+00; lower photo is station 356+00.

Profiles are shown for stations 332+00, 358+00, and 342+00.

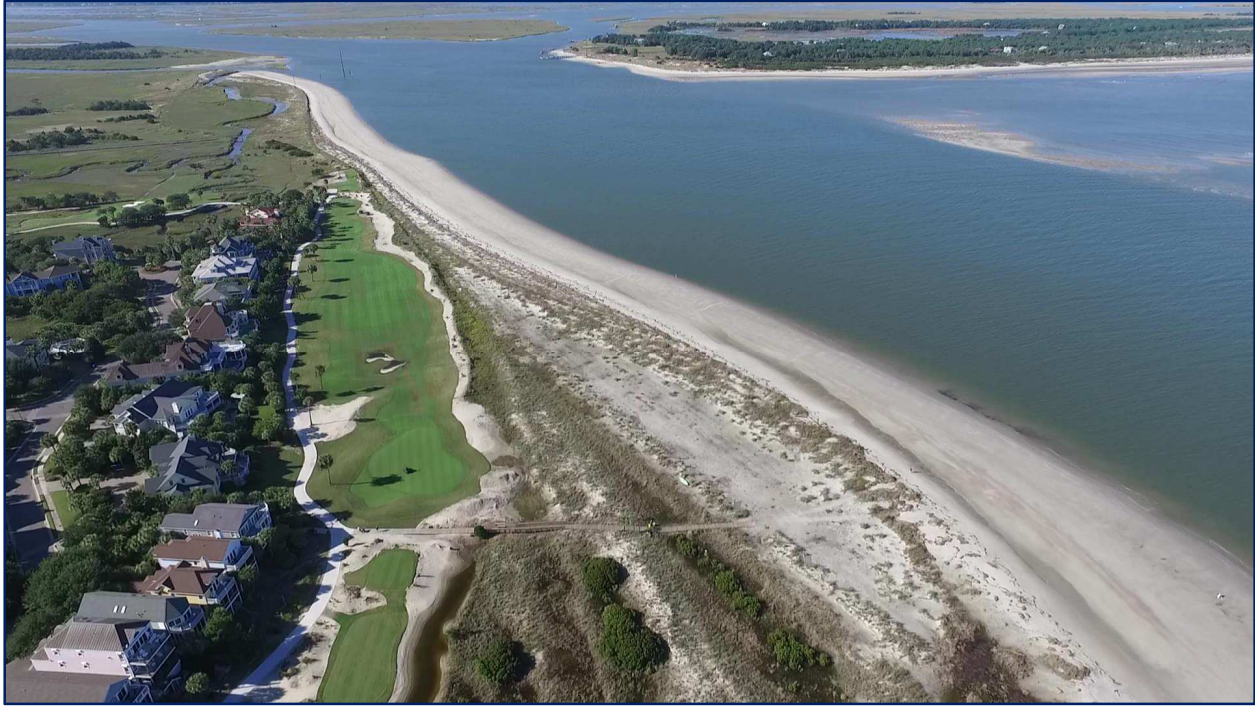
FIGURE 3.15. October 2015 aerial image of Reach 7 showing the nourished area in the foreground.

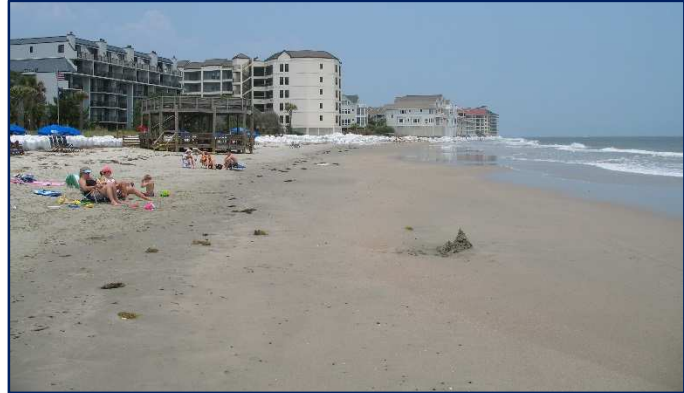
FIGURE 3.17. Sandbags were installed in front of most of the condominium units prior to the 2008 restoration project.

In 2007, The central and eastern ends of Reach 6 were critically eroded due to a very large shoal-bypass event, which was attaching at the western end of the reach. A temporary sandbag revetment was in place, extending from Summer House to the 18<sup>th</sup> Hole (Fig 3.16). A significant portion of the reach had no dry beach fronting condominium structures and a very narrow wet-sand beach. Approximately 628,000 cy of sand were added via nourishment in 2008, which was the highest fill density of any area during that project. The largest fill sections received nearly 200 cy/ft of sand, which increased the beach width by up to 350 ft. Additional details of the pre- and post-project condition are provided in the nourishment project final report (CSE 2008) and in the previous monitoring report (CSE 2014).

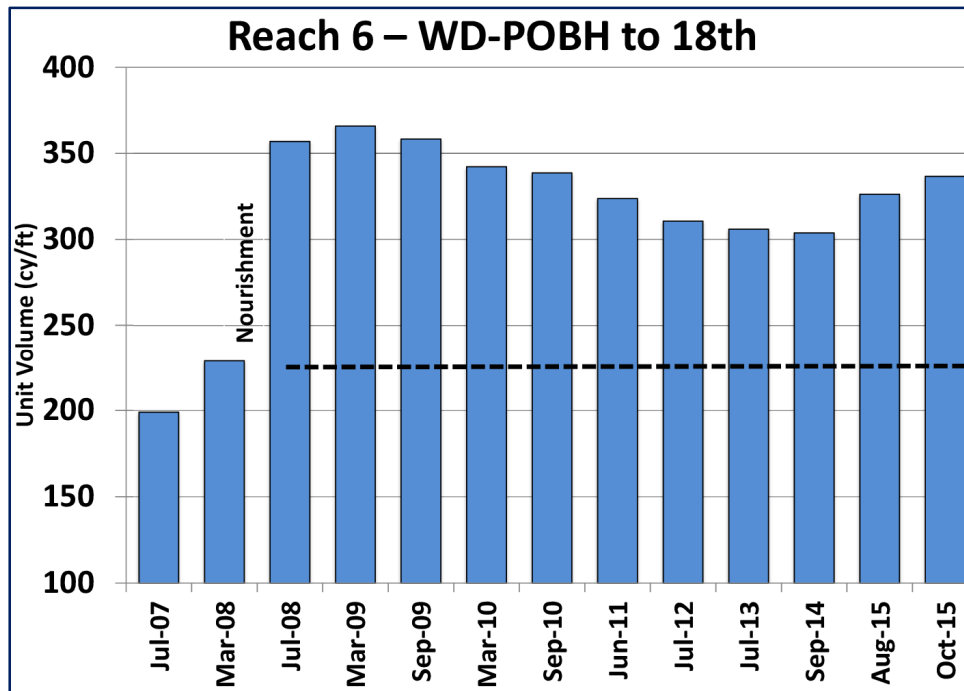
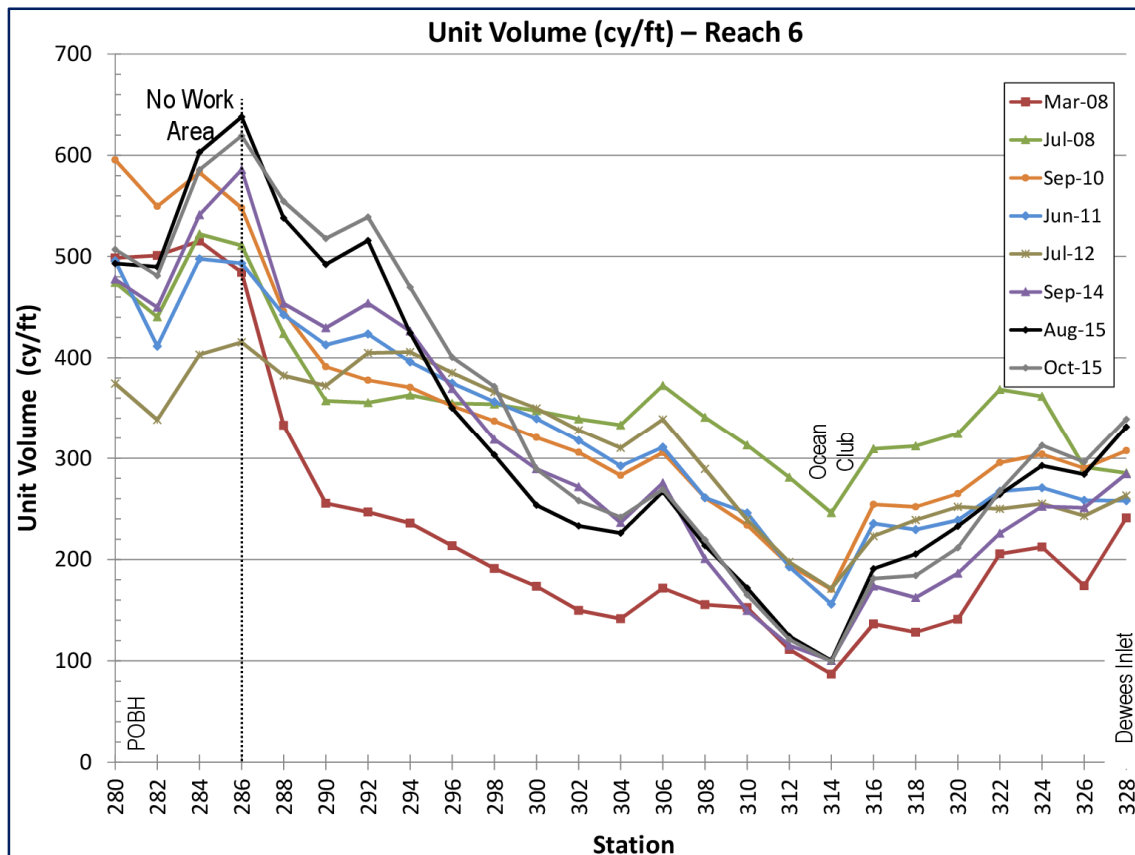
FIGURE 3.18. Beach volumes for Reach 6.

As the large shoal-bypass event approached the beach, the western end of the reach began to build as sand was deposited in the lee (sheltered area landward) of the shoal. By 2014–2015, the reach was showing a net gain of sand, gaining ~110,000 cy (22.5 cy/ft, Fig 3.17). Some of this volume was the result of the last shoal management event, which expedited sand movement from the shoal to the eastern end of the reach; however, most of the accretion is attributed to attachment of the shoal. Figure 3.17 shows the beach volume along the reach for selected surveys dating to 2008.

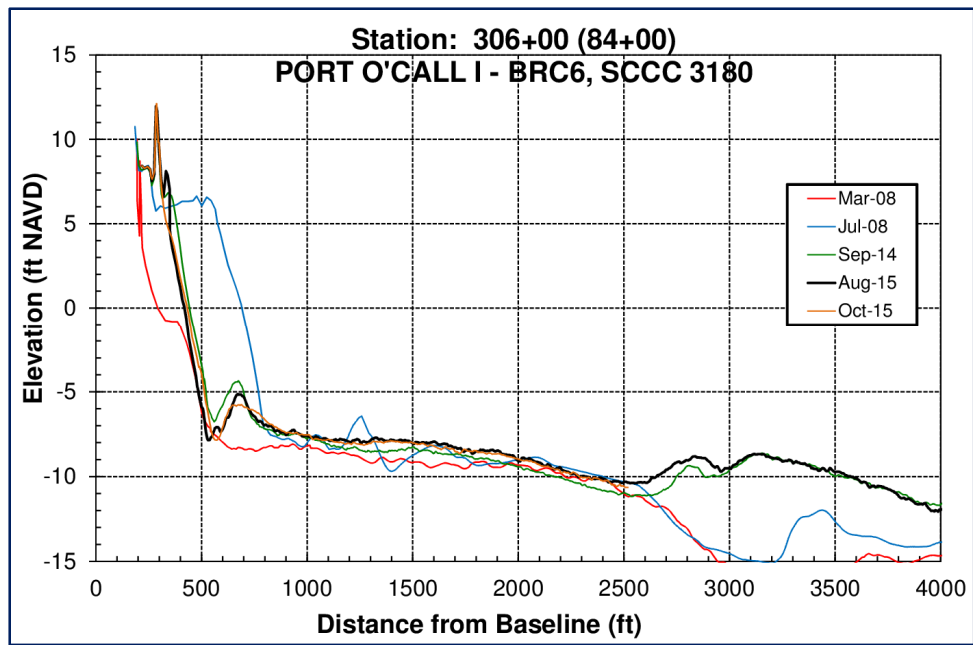
FIGURE 3.19. Profiles from Reach 6 showing beach profile changes since 2008. Station 286+00 is near the shoal attachment site and shows the shallow sand platform extending nearly a mile from the dune. Infilling of the old Dewees Inlet channel is evident at the seaward end of the profile from station 306+00.

Overall, the western third of the reach (west of Summer House) has been accretional since 2008 (compare black and green lines). As of August 2015, all stations held more sand than the pre-2008 nourishment condition, although the span from stations 310+00 through 314+00 are very close to the pre-nourishment condition. The reach presently contains 477,092 cy more sand than the March 2008 condition. Aerial photos in Figure 3.19 show the condition of Reach 6 at various periods over the past year.

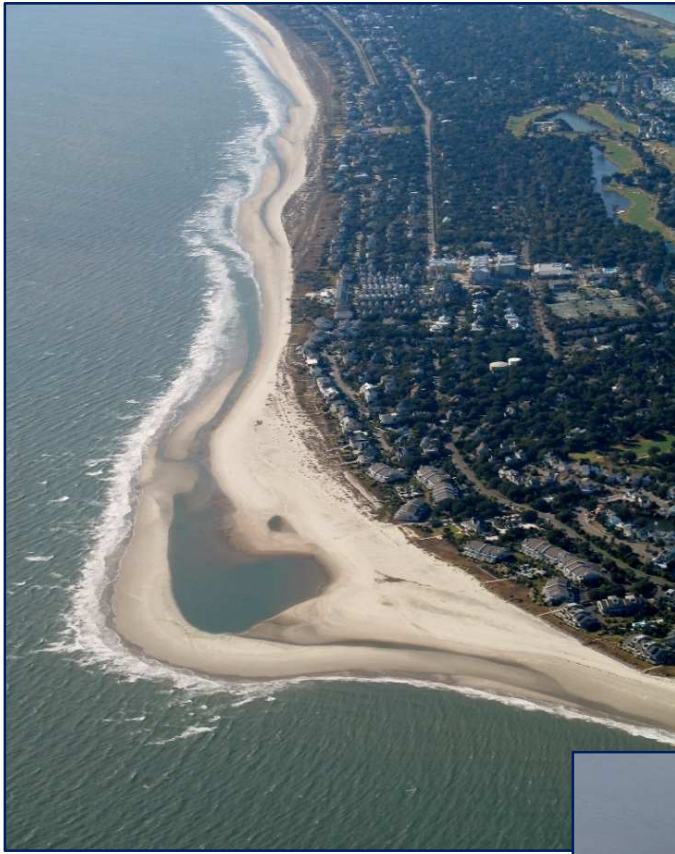
**FIGURE 3.22.**

[UPPER] Reach 5 in 2007 showing the bulge created from the recent shoal attachment and an erosional arc down-drift (center of photo).

[LOWER] January 2016 aerial view of Reach 5.

Since 2008, Reach 5 has been the most erosional area of the island. Most of the erosion occurred between 2008 and 2012, and was due to spreading of the bulge created by the 2007 shoal. Between 2008 and 2012, the reach lost nearly 400,000 cy (Fig 3.22, upper). Since 2012, erosion has continued, but has been the result of wave refraction around the new shoal-bypass event. The reach has lost ~187,000 cy since 2012, most of which was lost along the eastern half of the reach. The new shoal event is attaching to the beach further east than the 2007 event, which is causing the western erosional arc to form further east than the 2007 event (Fig 3.23).

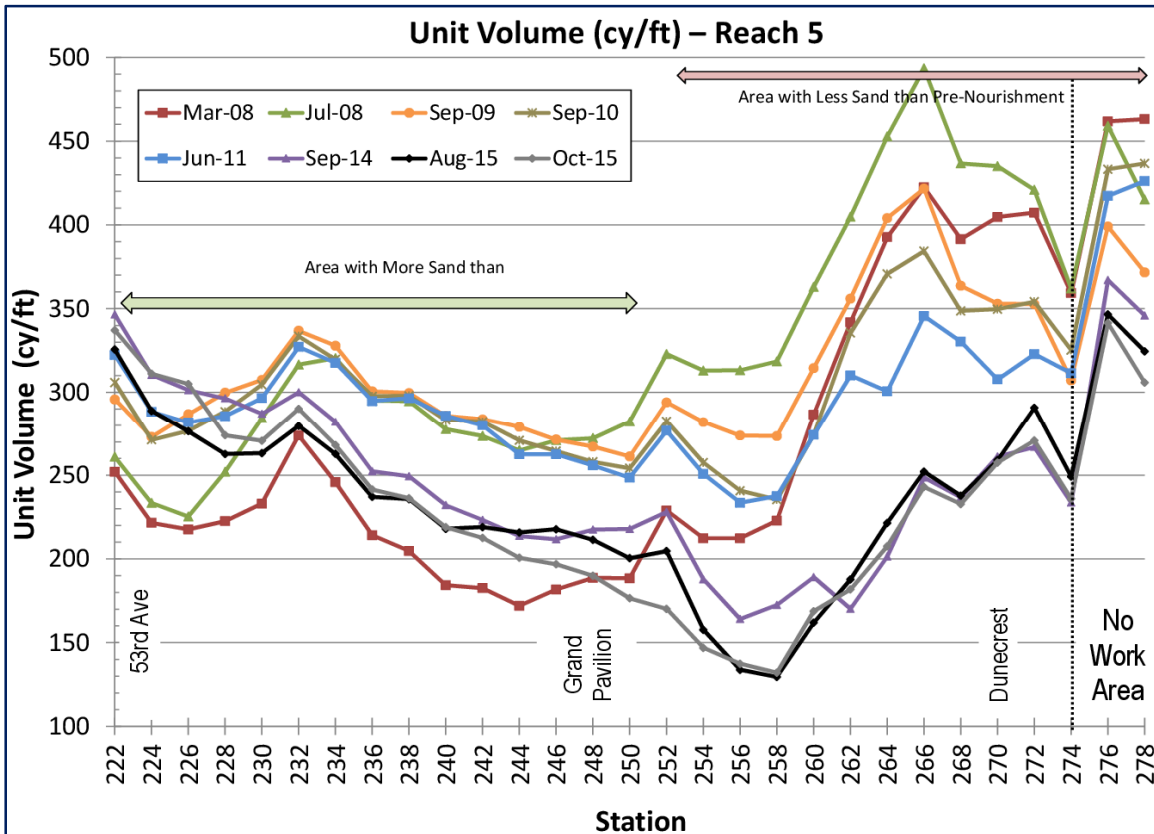
FIGURE 3.22. Beach volumes for Reach 5.

Figure 3.22(lower) shows the beach volume along Reach 5 and highlights the erosional trends since 2008. The eastern half of the reach has been highly erosional since the post-project condition (green line). As of August 2015, the area between station 248+00 and station 278+00 has lost an average of 156 cy/ft since nourishment with a maximum of 250 cy/ft at station 266+00. The western end of the reach has lost an average of 20.6 cy/ft over the same time with the erosion rate decreasing to the west. Stations 222+00-228+00 still contains more sand than the post-project condition, and stations 222+00 through 250+00 held more sand than the pre-project condition (as of August 2015).

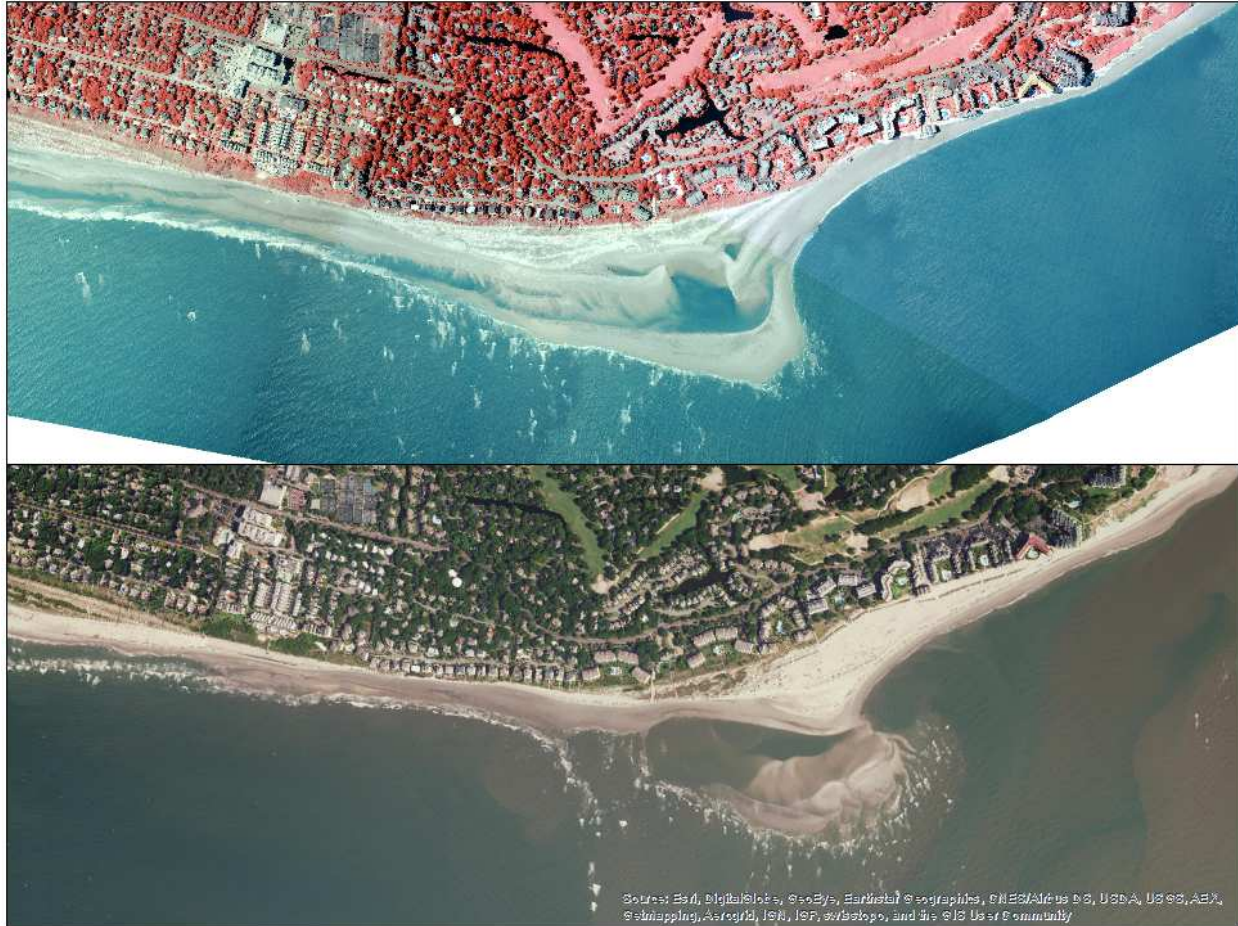
**FIGURE 3.24.** Aerial images of shoal attachments from 2007 and 2015. The 2015 event is attaching further east than the 2007 event, resulting in different portions of the beachfront experiencing focused erosion. [Upper image by IMC, Charlotte NC and lower image via ESRI World Imagery]
