2008 BEACH RESTORATION PROJECT  
ISLE OF PALMS SOUTH CAROLINA

Monitoring Report No 7  
June 2016

## YEAR 7 (2015) MONITORING REPORT

### Annual Beach and Inshore Surveys

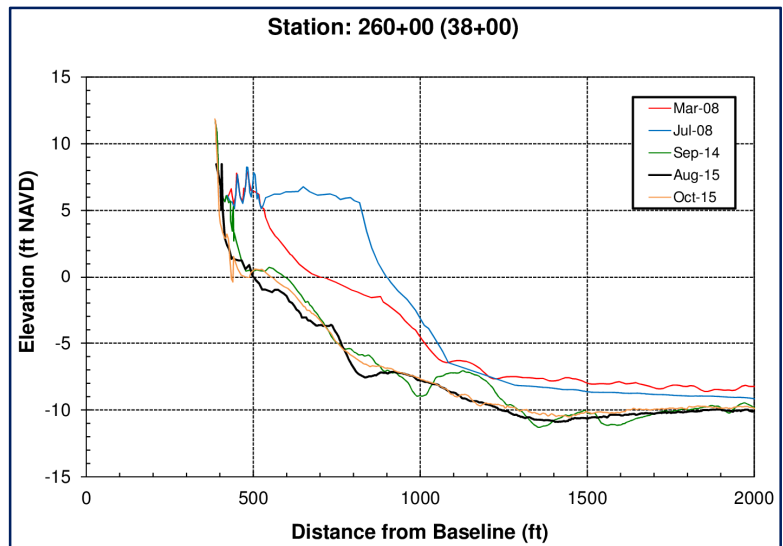
FIGURE 3.24.

Profiles from Reach 5 showing the variation in beach condition from one end of the reach to the other.

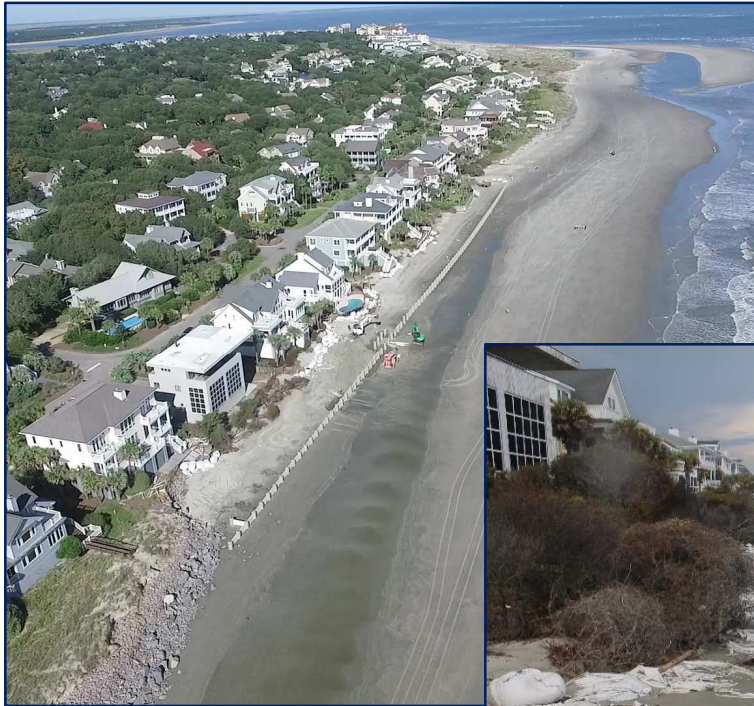
**Figure 3.25.**

Photos of the experimental wave dissipation system installed in front of properties along Beachwood East. Another installation fronts two condos in Reach 6.

Following the 2014/2015 shoal management project, a Wave Dissipation System (WDS) was installed by homeowners along Beachwood East in hopes of preventing additional loss of upland sand (Fig 1.8). A system was also installed in front of Ocean Club. These systems and the permits allowing the systems were not coordinated by the City, but conditions of the permits prevent sand from being placed seaward of the structures. In a meeting with homeowners in the erosional areas, the homeowners indicated to the City that they preferred to leave the WDS systems in place rather than allow the City to attempt another shoal management project in the fall of 2015. Presently, the City is in the initial phases of obtaining a permit for another large-scale beach nourishment project using an offshore borrow source.

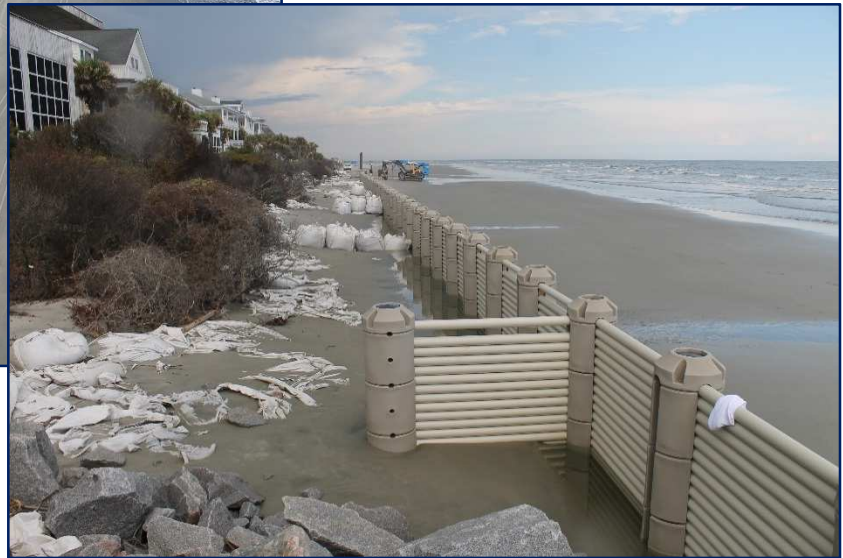
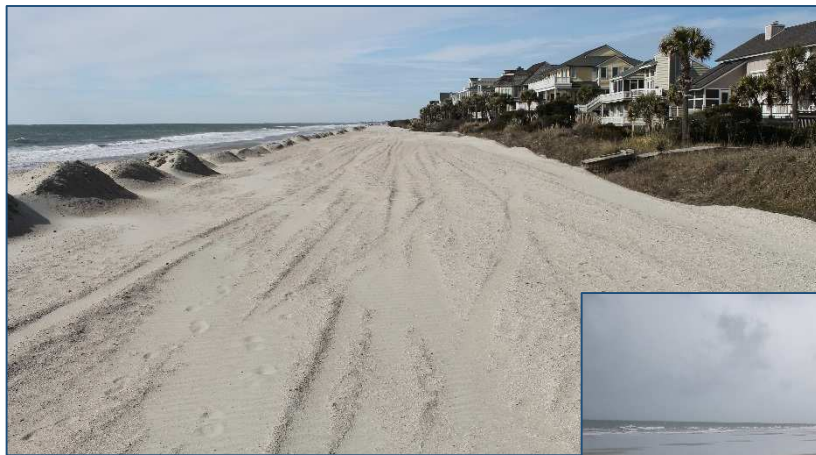
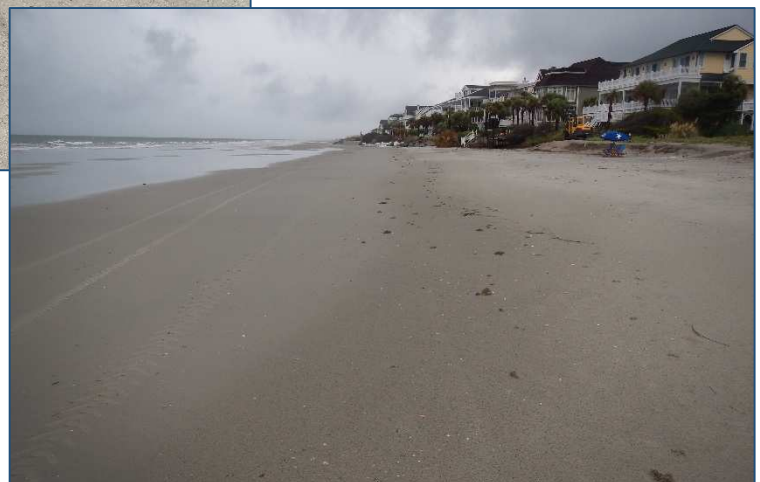
**FIGURE 3.26.**

Images of Reach 5, near station 270+00 from February 2015 following the shoal management project (left) and in August 2015 (right).

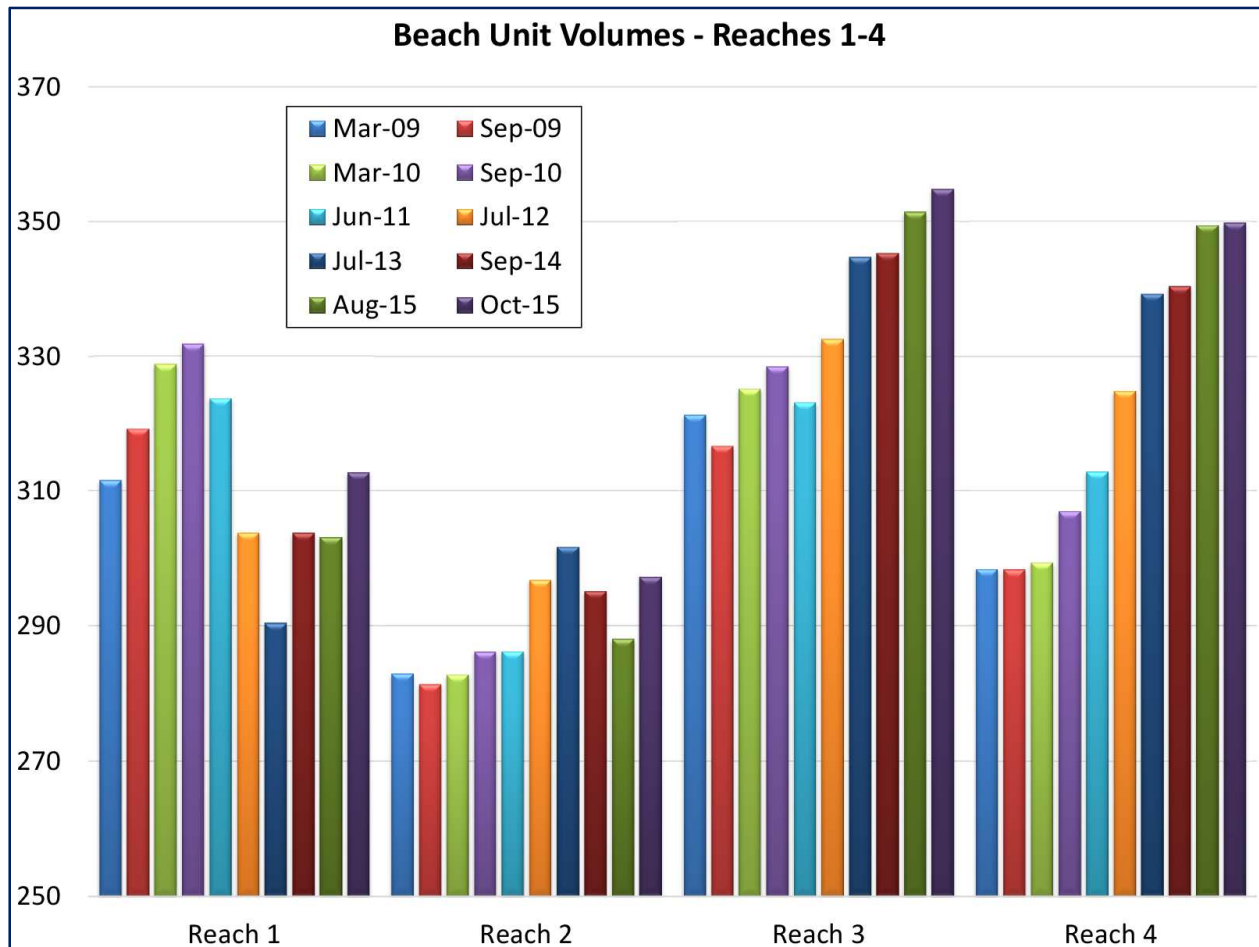
FIGURE 3.28. Beach unit volumes for Reaches 1-4 since March 2009.

Overall volume change for the downcoast reaches is shown in Figure 3.28.

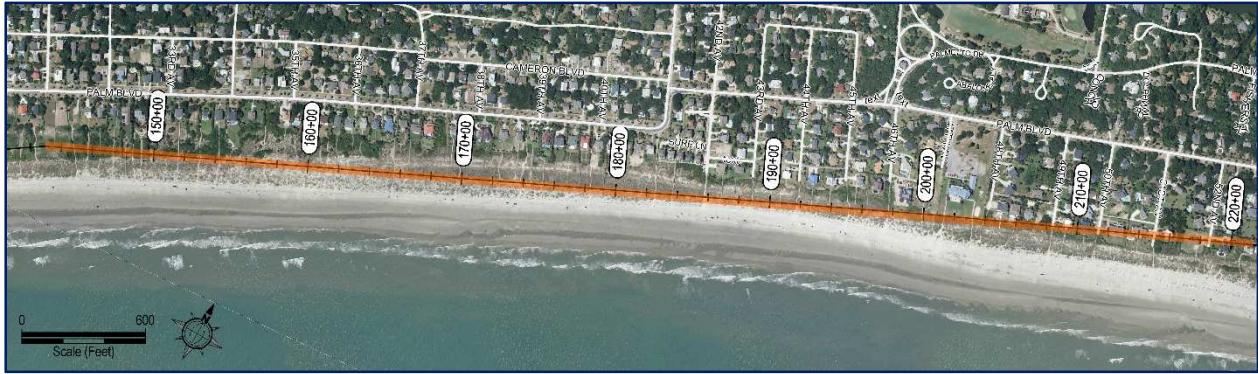
FIGURE 3.29. Baseline stationing map of Reach 4. Limits of Reach 4 are shown by the orange bar.

Reach 4 includes the length of beach between 31<sup>st</sup> Avenue and 53<sup>rd</sup> Avenue (stations OCRM 3140 to CSE 222+00 – Fig 3.29). This reach is ~7,910 ft long and immediately downdrift of the 2008 project area. It is also outside of the direct influence of Dewees Inlet and maintains a more typical and consistent beach profile shape. By being positioned downdrift of the 2008 project area, it receives nourishment sand spreading from the placement area as well as spreading shoal sand. The reach has gained sand every year since 2009.

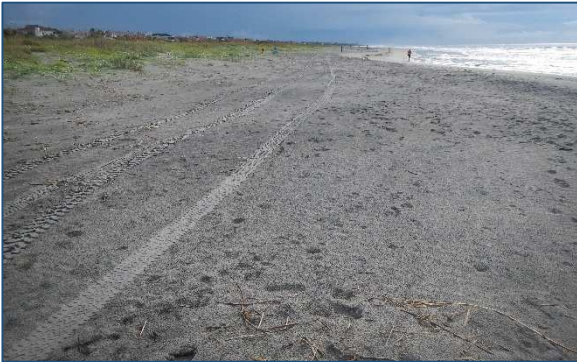
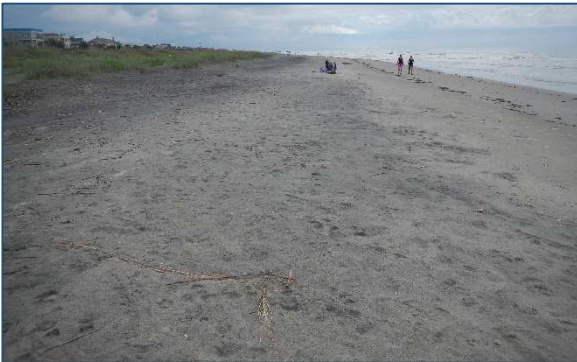
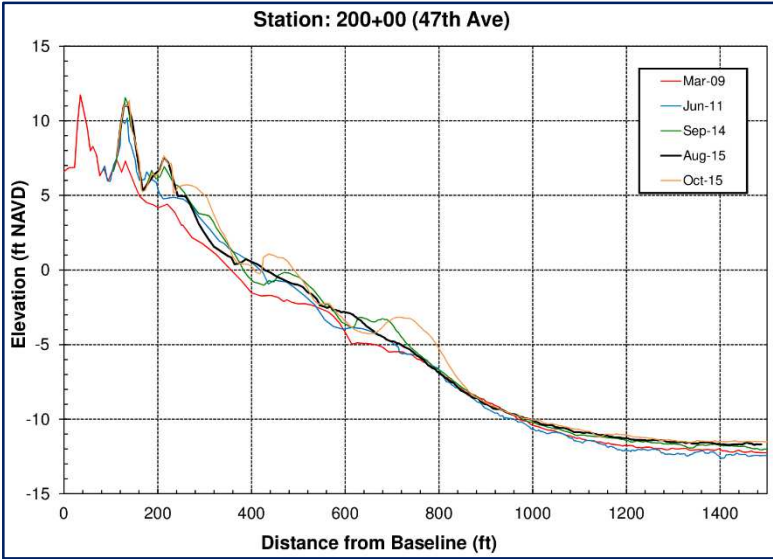
FIGURE 3.31. Profiles show the beach along Reach 4 has increased in width by 100–150 ft, and dunes have continued to grow in elevation and expand seaward.

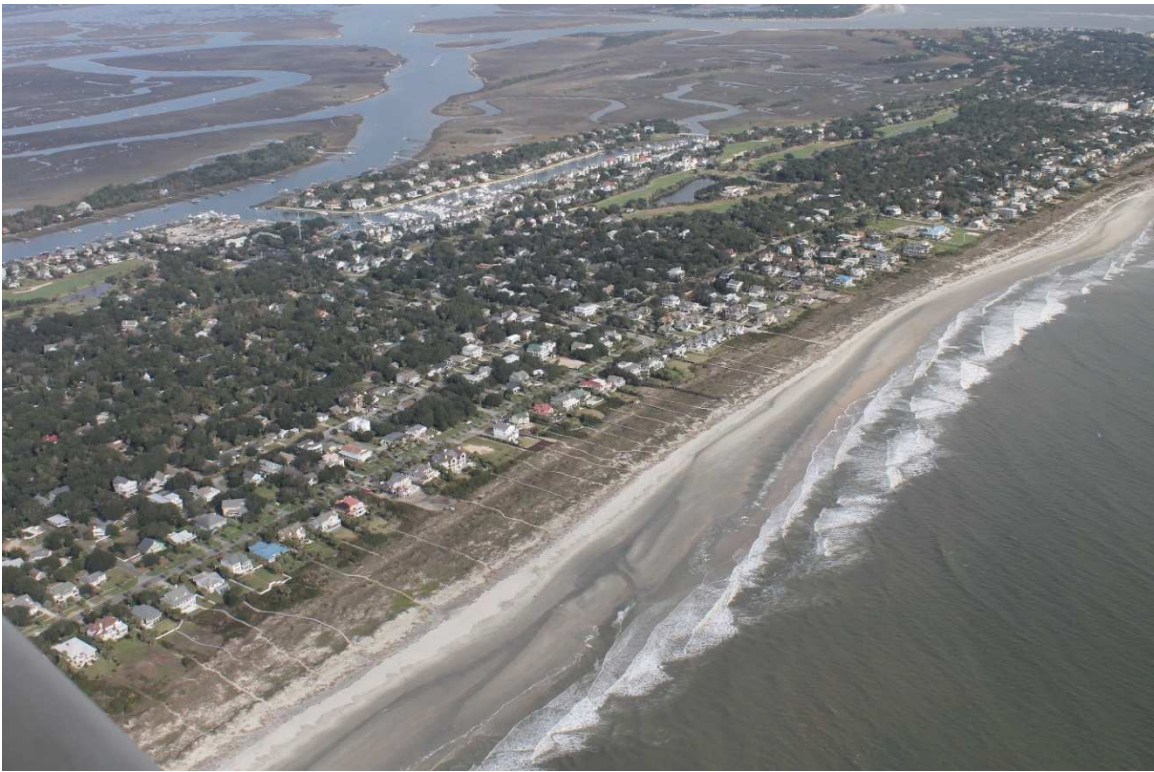
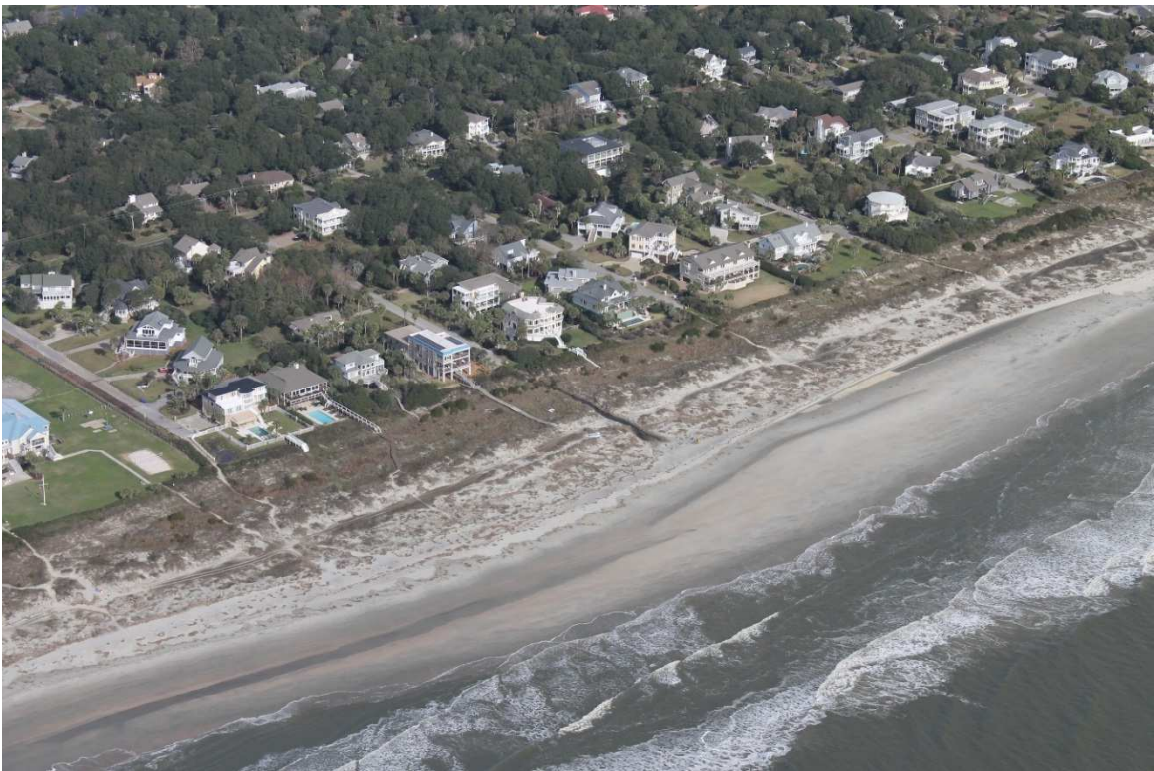
**FIGURE 3.32.** January 2016 photos of Reach 4. The lower photo shows the 49th Avenue beach access which was washed out during Hurricane *Joaquin*. The waviness of the dry-beach line reflects natural variations in the orientation, position, and width of intertidal sand bars. Sediment tends to move downcoast (right to left as viewed here) in “packages” rather than at a steady rate which would yield a straighter shoreline.

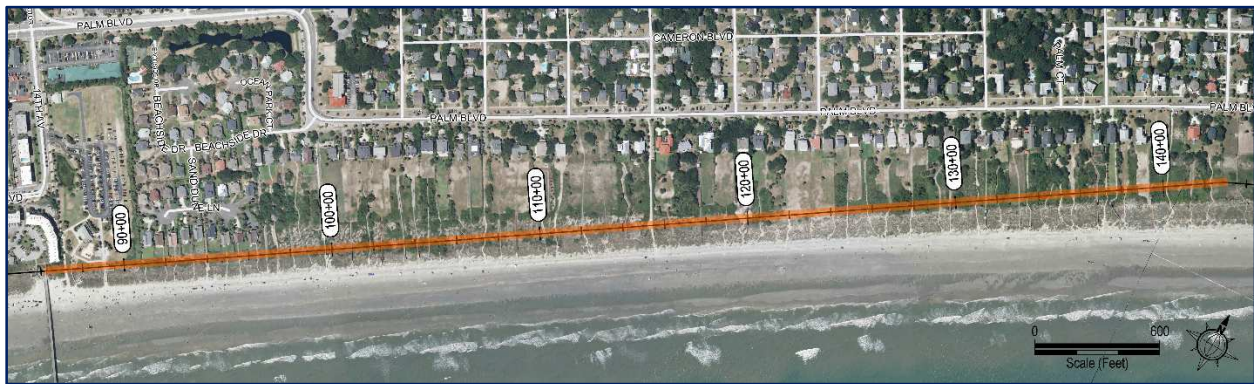
FIGURE 3.33. Baseline and stationing for Reach 3.

Reach 3 extends from the Sea Cabins Pier to 31<sup>st</sup> Avenue (OCRM monuments 3125 to 3140 – Fig 3.33). Like Reach 4, the long-term trend in this area is stable to accretional. Dwellings in the reach are generally well set back from the beach, generally between 400 ft and 500 ft except at the western end where Sand Dune Lane and the county park are set back ~150 ft. The reach has shown periods of erosion and accretion since CSE began island-wide monitoring in 2009. This is typical for stable to moderately accretional beaches as variations in wave conditions from year to year and temporary changes in sediment supply lead to minor fluctuations in yearly volume change. Over the long term, the trend is accretion. Profiles from stations within the reach show that the beach gained up to 50 ft of dune width between 2009 and 2015.

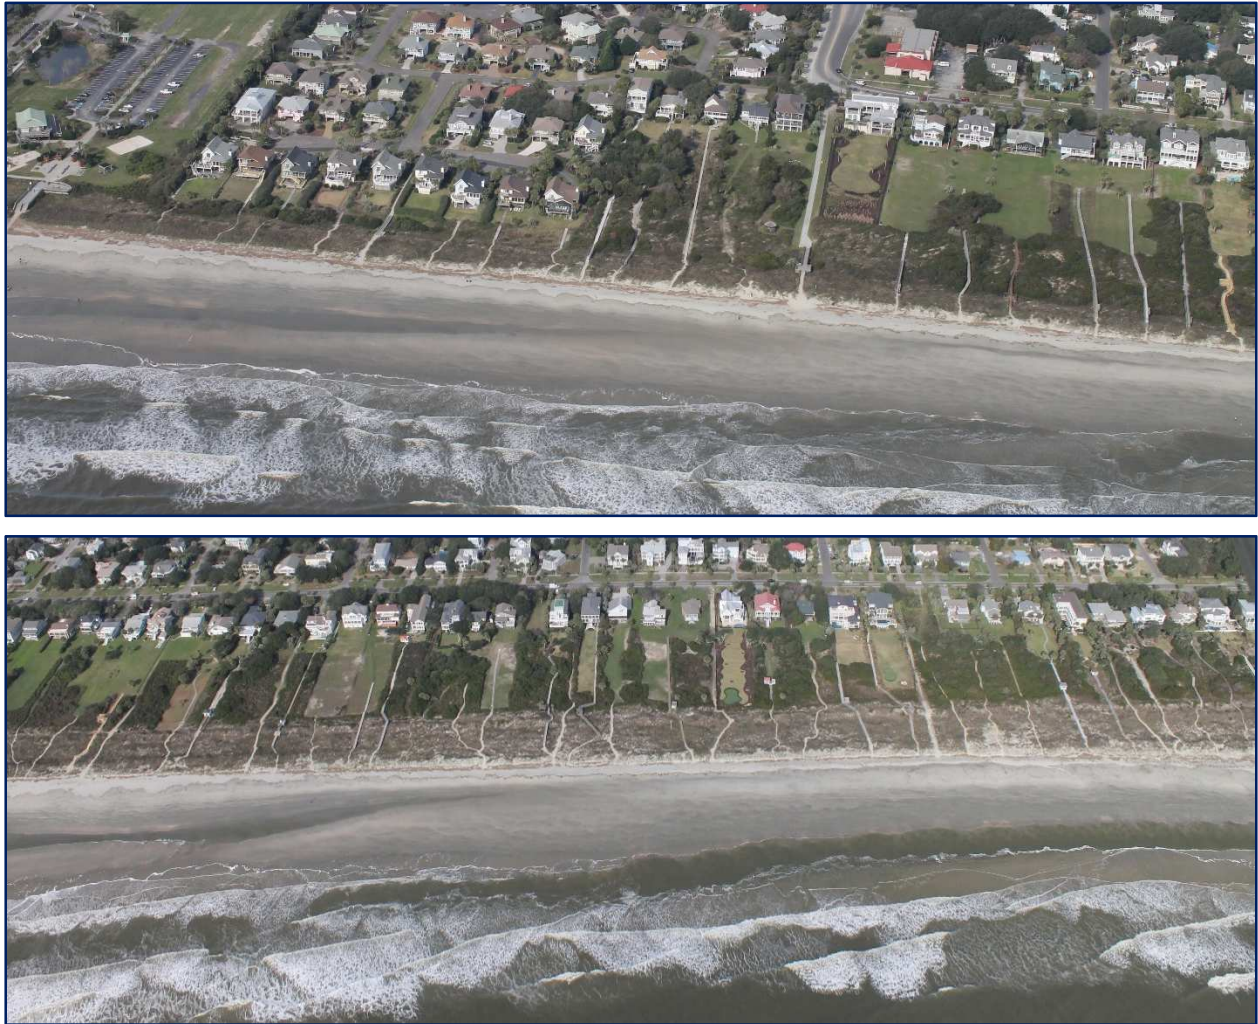
FIGURE 3.35. January 2016 aerial images of Reach 3. [UPPER] The area from the County Park to 22<sup>nd</sup> Avenue. [LOWER] Area between 27<sup>th</sup> Avenue and 33<sup>rd</sup> Avenue.

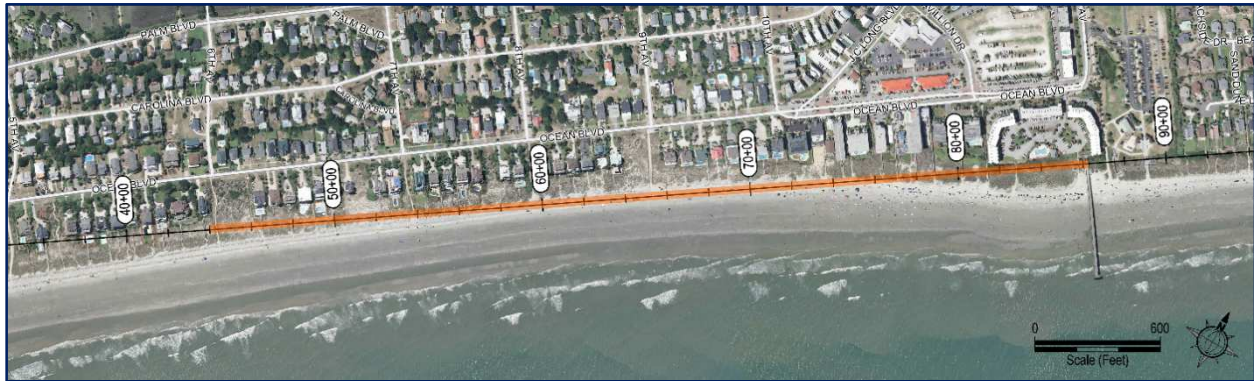
FIGURE 3.36. Baseline and stationing for Reach 2.

Reach 2 spans 4,280 ft between 6<sup>th</sup> Avenue and the Sea Cabins Pier (OCRM monuments 3115-2125 – Fig 3.36). It includes the Front Beach commercial area at the eastern end of the reach. Reach 2 shows an erosion/accretion pattern similar to Reach 3 with intermittent periods of accretion and erosion, and a long-term trend of accretion. Since monitoring began in 2009, Reach 2 has been the most stable reach, typically showing lower magnitudes of volume change compared to the other reaches.

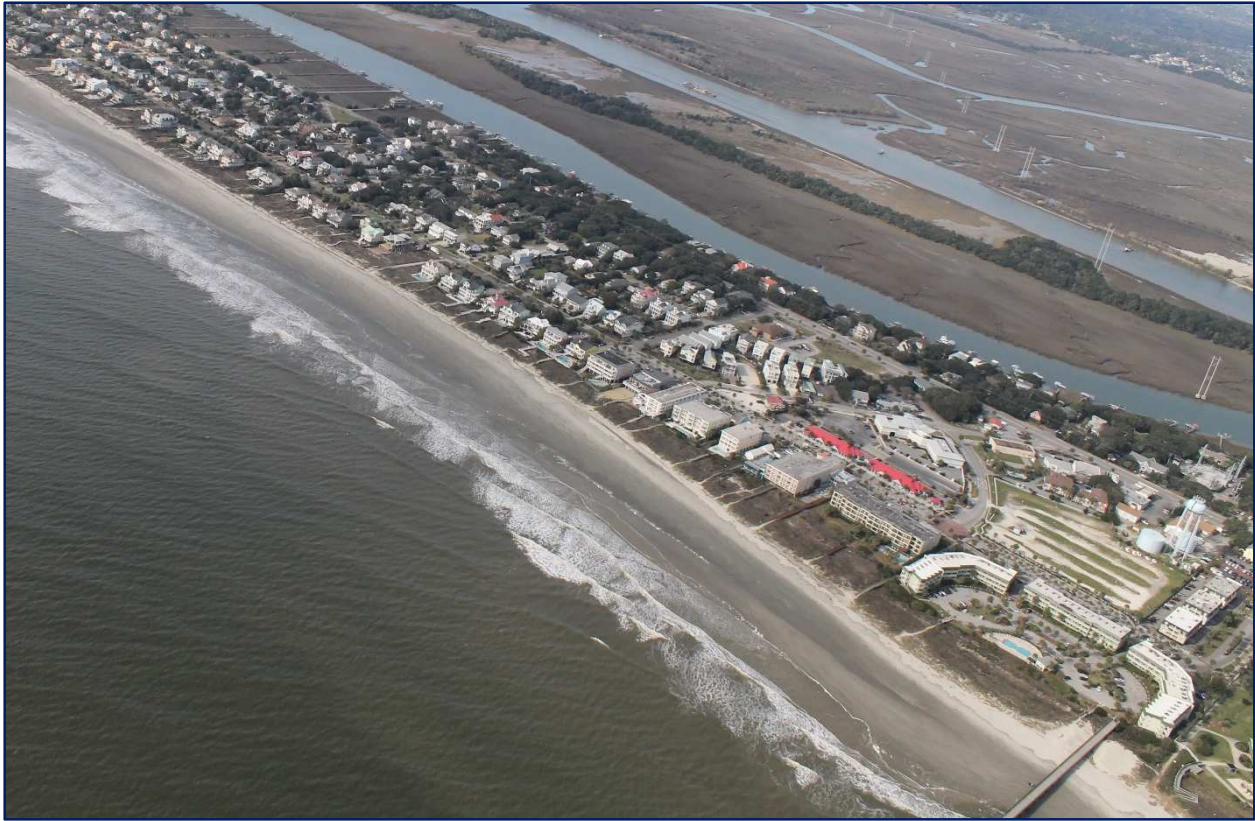
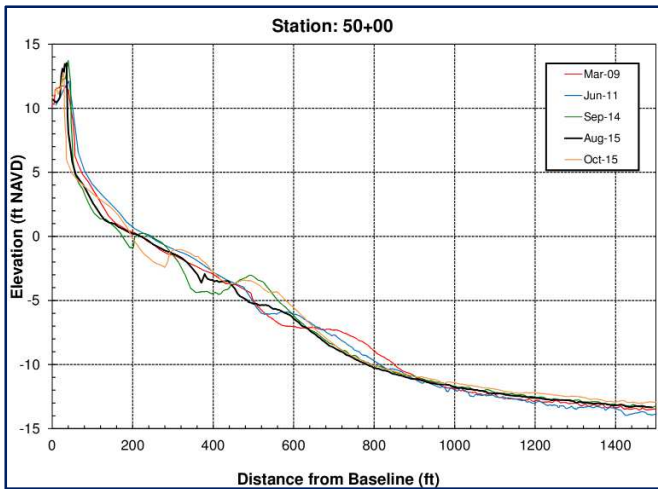
FIGURE 3.37. [UPPER] January 2016 aerial image of Reach 2. [LOWER] Profiles from Reach 2. This reach lost sand along the dune during Hurricane *Joaquin*, but has accreted overall since 2009.

Reach 2 lost ~30,200 cy (7.1 cy/ft) of sand between 2014 and 2015. This is the largest documented volume loss since monitoring began in 2009 and continues higher than normal erosion first observed in 2014 (when the reach lost 6.5 cy/ft). All five stations eroded during the monitoring interval, varying between 5.0 cy/ft and 12.2 cy/ft (see Fig 3.30). Along the western end of the reach, near 6<sup>th</sup> and 7<sup>th</sup> Avenues, erosion occurred to the dune, especially at station 50+00 which lost ~10 ft of dune between September 2014 and August 2015, and another 10 ft during Hurricane *Joaquin*.

Overall, Reach 2 has gained 21,900 cy (5.1 cy/ft) since 2009, which is an average annual accretion rate of 0.8 cy/ft/yr. Erosion occurring over the past two years has eliminated much of the accretion observed between 2009 and 2013 (Fig 3.38). As of August 2015, OCRM station 3115 and station 50+00 (near 6<sup>th</sup> Avenue) have less sand than the March 2009 condition (and a narrower dune). The remaining stations have a net increase in sand volume and dune width compared to 2009.

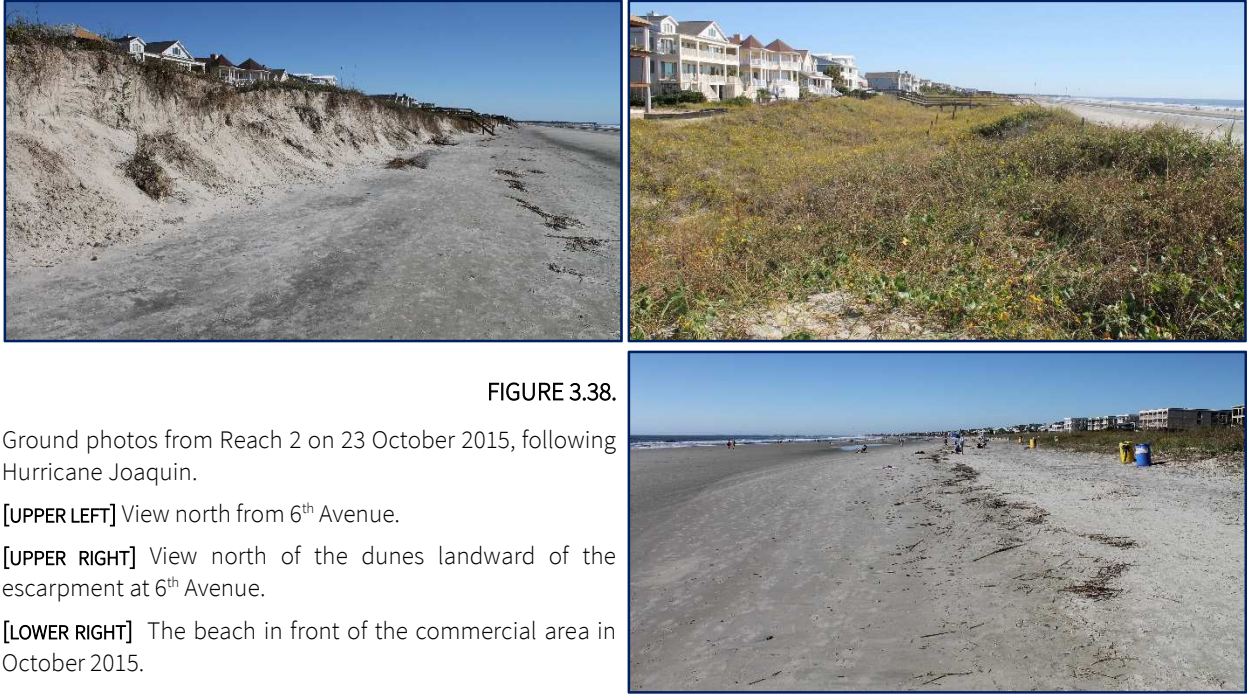
FIGURE 3.38.

Ground photos from Reach 2 on 23 October 2015, following Hurricane Joaquin.

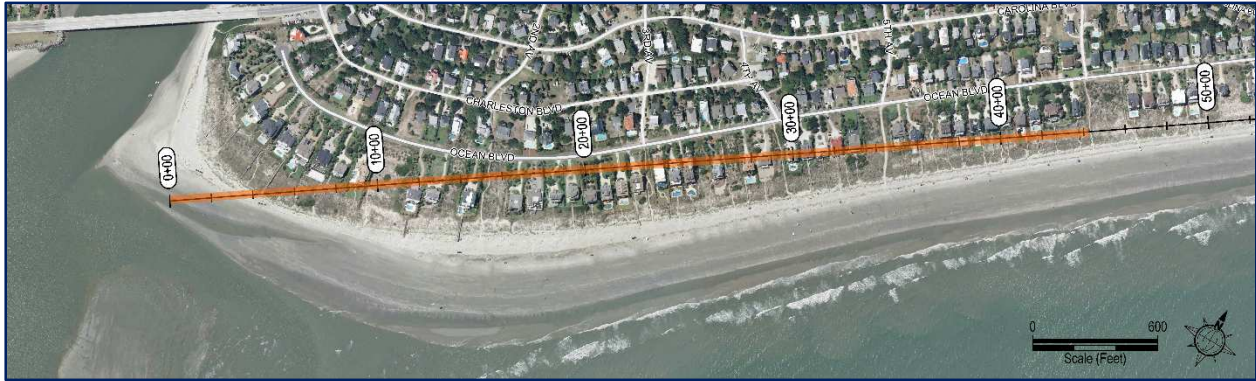
FIGURE 3.39. Baseline and stationing for Reach 1.

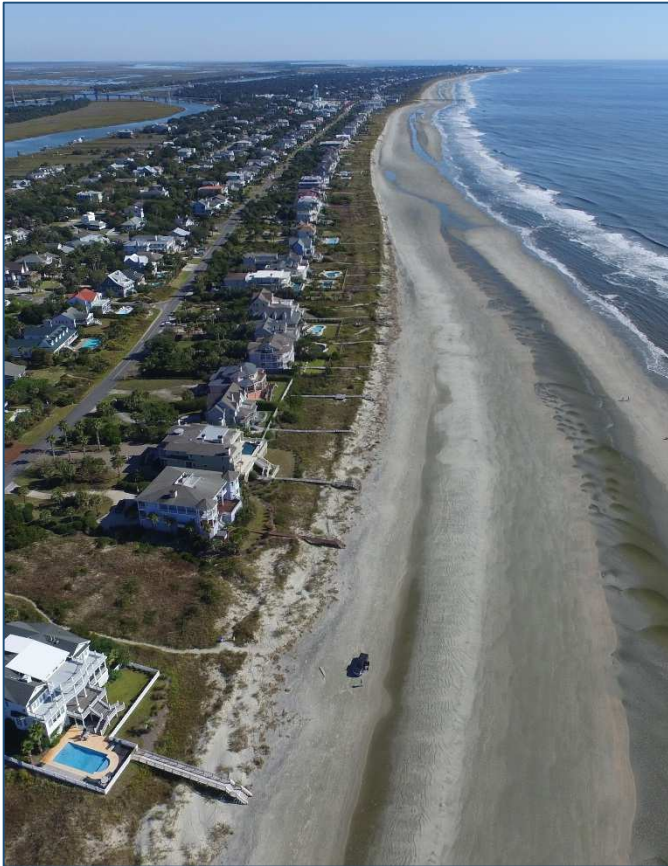
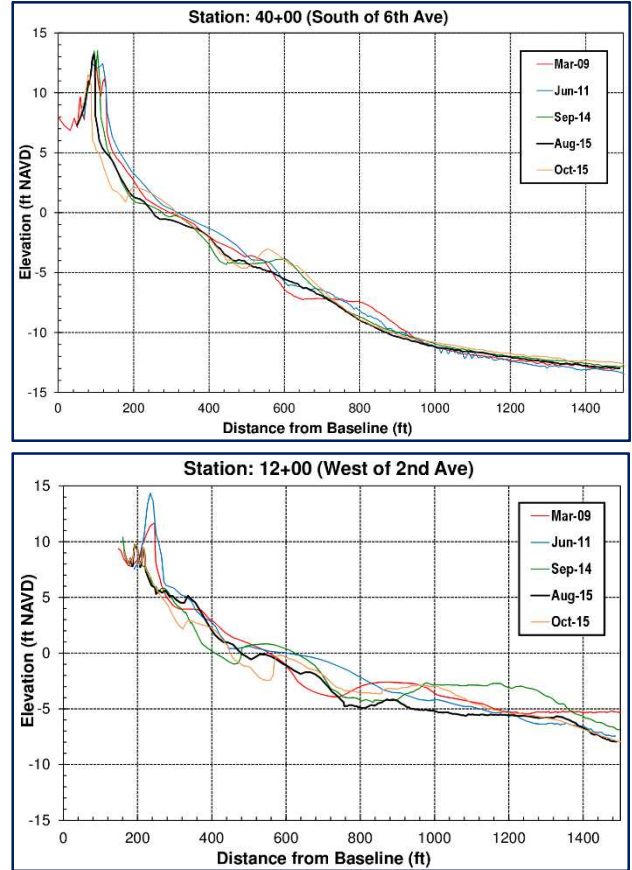
FIGURE 3.40. [LEFT] October 2015 aerial image of Reach 1 shortly after Hurricane *Joaquin*. [RIGHT] Profiles from Reach 1.

Station 40+00 continued an erosional trend observed since 2012, losing between 11.3 cy/ft and 13.7 cy/ft each year. The dune in this area has eroded ~60 ft since 2011. Fortunately, properties in this area are set back from the beach and are not presently threatened. In the 2014 monitoring report, CSE anticipated that erosion was likely in Reach 1 this year due to observed erosion in Reach 2. This proved to be the case with the low accretion rate. CSE continues to expect the erosional trend to reverse before structures are threatened due to the sand surplus in the upcoast reaches. Overall, the reach lost ~37,000 cy of sand between 2009 and August 2015; however, Hurricane *Joaquín* resulted in a gain of 42,800 cy for a total net change since 2009 of +5,800 cy.

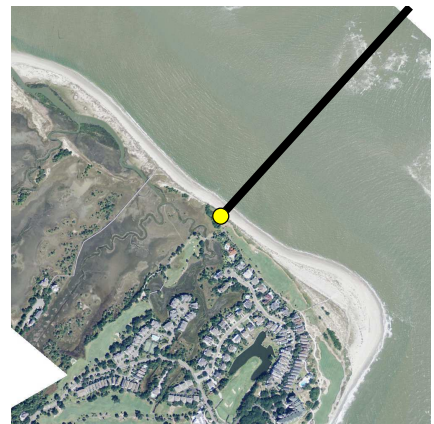
### Station: 348+00 (126+00)

Date	Unit Vol (cy/ft)
Jul 2007	142.7
Mar 2008	150.9
Jul 2008	147.2
Mar 2009	150.7
Sep 2009	149.0
Mar 2010	141.8
Sep 2010	136.2
Jun 2011	147.2
Jul 2012	144.0
Jul 2013	146.2
Sep 2014	150.7
Aug 2015	164.4
Oct 2015	166.8

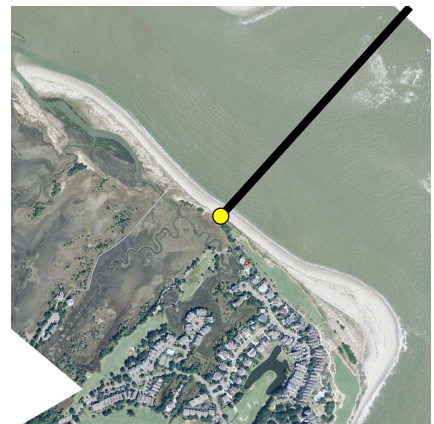
### Station: 350+00 (128+00)

Date	Unit Vol (cy/ft)
Jul 2007	171.6
Mar 2008	170.1
Jul 2008	169.7
Mar 2009	170.7
Sep 2009	167.5
Mar 2010	167.2
Sep 2010	165.5
Jun 2011	165.1
Jul 2012	168.0
Jul 2013	173.7
Sep 2014	181.4
Aug 2015	190.2
Oct 2015	191.9

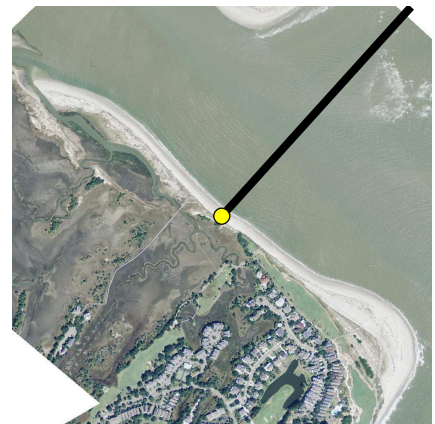
### Station: 352+00 (130+00)

Date	Unit Vol (cy/ft)
Jul 2007	164.0
Mar 2008	159.8
Jul 2008	160.4
Mar 2009	155.2
Sep 2009	153.3
Mar 2010	155.4
Sep 2010	157.3
Jun 2011	158.9
Jul 2012	160.2
Jul 2013	169.6
Sep 2014	174.2
Aug 2015	180.9
Oct 2015	176.2

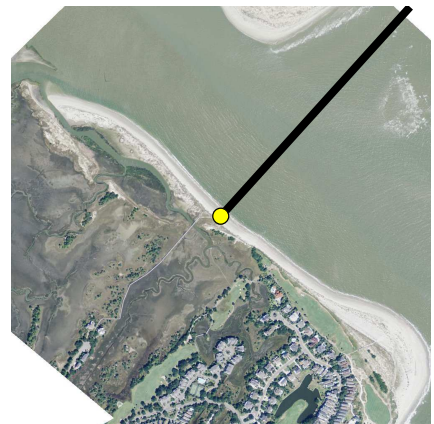
### Station: 354+00 (132+00)

Date	Unit Vol (cy/ft)
Jul 2007	177.0
Mar 2008	170.1
Jul 2008	171.1
Mar 2009	168.1
Sep 2009	165.0
Mar 2010	167.0
Sep 2010	171.8
Jun 2011	174.2
Jul 2012	176.5
Jul 2013	184.0
Sep 2014	185.4
Aug 2015	188.1
Oct 2015	185.8

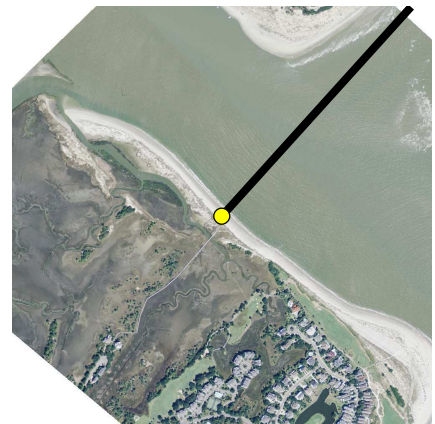
### Station: 356+00 (134+00)

Date	Unit Vol (cy/ft)
Jul 2007	193.1
Mar 2008	186.5
Jul 2008	185.6
Mar 2009	183.1
Sep 2009	177.9
Mar 2010	183.7
Sep 2010	185.1
Jun 2011	189.1
Jul 2012	188.6
Jul 2013	195.4
Sep 2014	190.9
Aug 2015	189.4
Oct 2015	186.6
