**City of Isle of Palms  
2018 Beach Restoration Project**

**2018  
FINAL REPORT**

[CSE-2453FR]

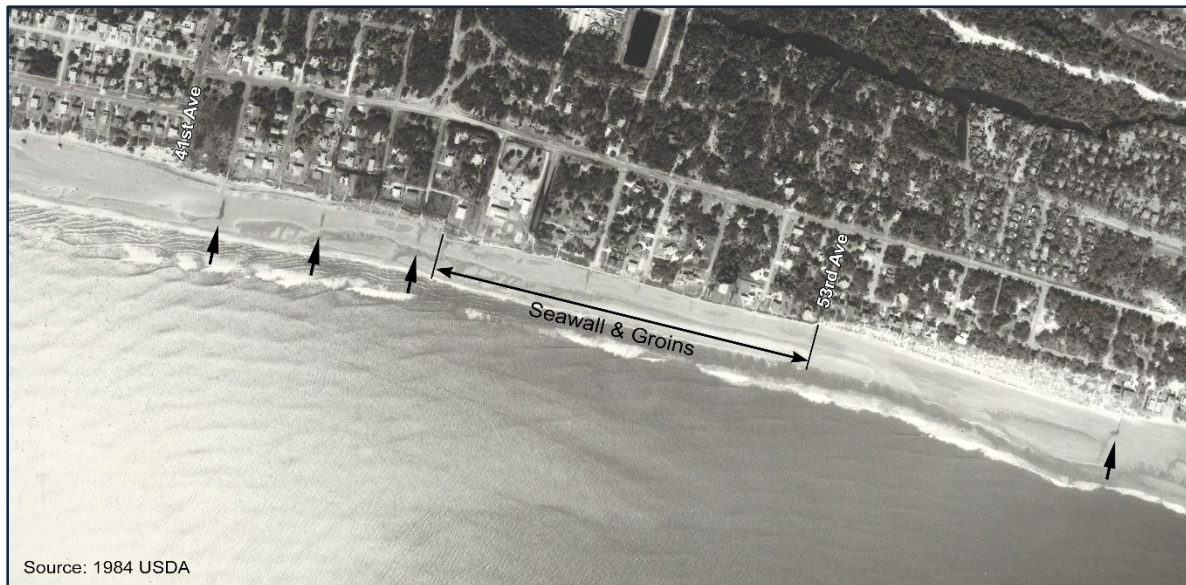
**FIGURE 2.4.** A seawall and groins were in place in 1984 between 46<sup>th</sup> Ave to 53<sup>rd</sup> Ave. Today, due to rapid accretion, these groins and seawalls have been buried.

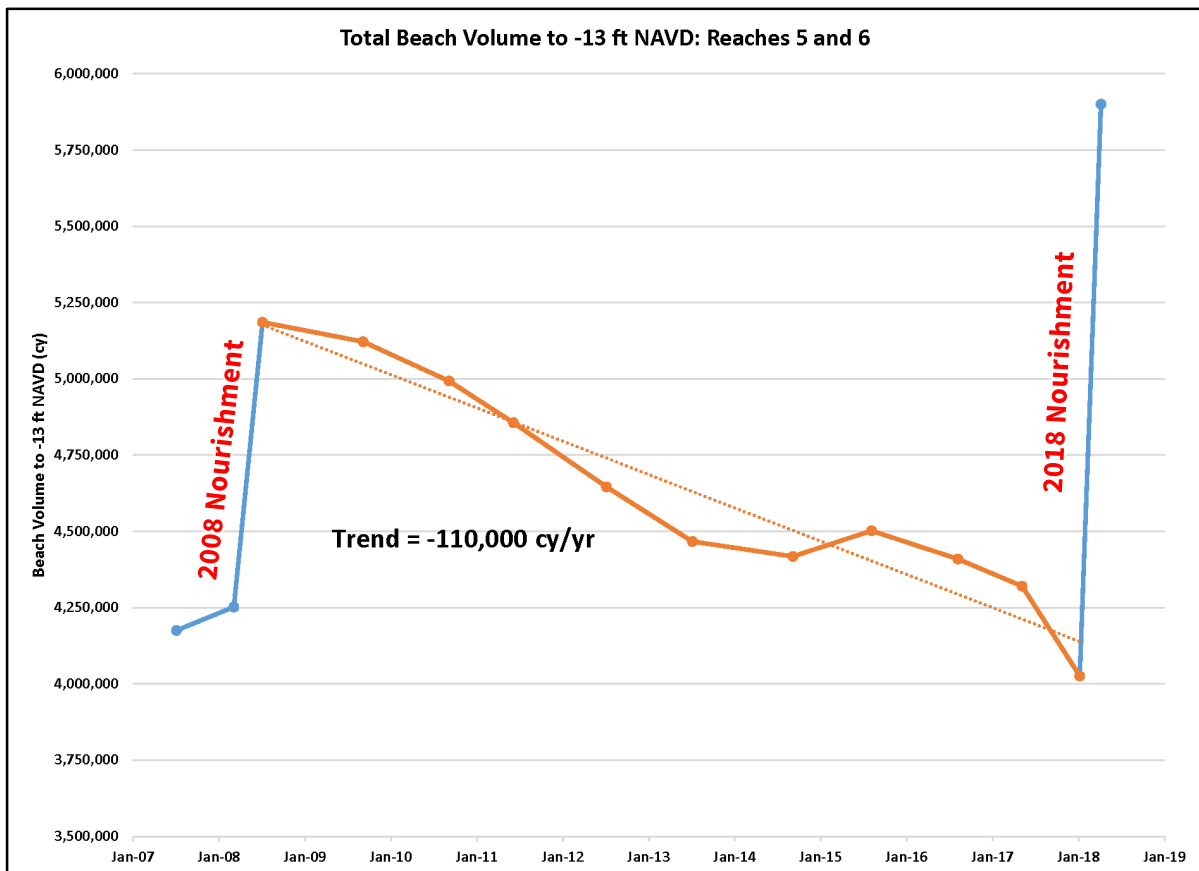
Figure 2.12 shows the cumulative beach volume for Reach 5 (53rd Ave to the Wild Dunes Property Owners Beach House — WDPOBH) and Reach 6 (WDPOBH to the 18th Fairway) from July 2007 to April 2018. The interval from July 2008 to January 2018 represents the post-2008 project volume change and is colored orange in the figure. The effects of the 2008 project on beach volume are visible in the 933,000 cy volume increase from Jan–July 2008. From 2008 to January 2018, the beach lost an average of 110,000 cy per year (or 10.1 cy/ft per year), with a maximum annual loss rate of ~194,000 cy observed from 2011–2012. Two time intervals indicated net accretion in reaches 5 and 6; 2007–March 2008, and Sep 2014 – Aug 2015. Both of these time periods coincide with stage three of shoal bypass cycles, where attached sand was spreading along the beach. The period from 2009 to 2013 was highly erosional, with annualized losses greater than 130,000 cy/ft per year between each monitoring event. The majority of the sand losses during this timeframe were losses from spreading of the shoal that attached in 2007 near the center of the project and losses associated with an erosional hotspot centered near the Ocean Club condominium unit. Overall, Reaches 5–6 lost a total of ~1,160,000 cy between July 2008 and January 2018.

**FIGURE 2.12.** The Total Volumes Chart illustrates the cumulative beach volume for Reach 5 (53rd Ave to the Wild Dunes Property Owners Beach House - WDPOBH) and Reach 6 (WDPOBH to the 18th Fairway) from July 2007 to April 2018.

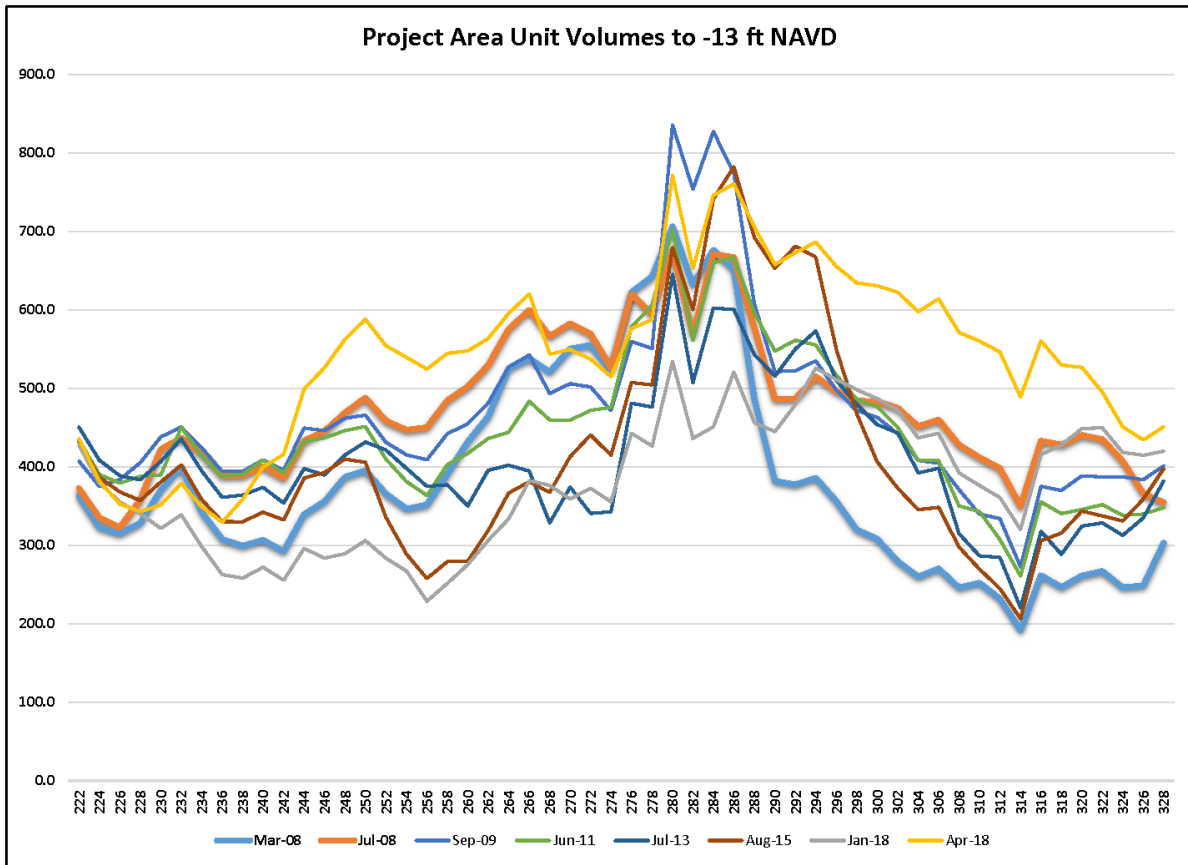
Figure 2.13 shows the profile volume for each station in Reaches 5 and 6, with the pre and post project values bolded. The 2008 project impacts are visible in the volume increase between the bold blue and orange lines, and erosion of the 2008 project is tracked in the thin weight lines over time. Details of volume change for individual years and portions of the beach were discussed in monitoring reports provided to the City (CSE 2009/2010/2011a–b/2012/2013/2015/2016a). Generally, along Reach 5, erosion increased from west to east between 2008 and 2014. At the eastern end of the reach (center of the project area), the beach eroded following shoal attachments and accreted during the attachments of 2007 and 2014. By 2014, the beach along Beachwood East was severely eroded, and the erosional signature migrated west through 2018, leaving the area between the Grand Pavilion and Beachwood critically eroded up until the 2018 project. Just before the 2018 project, there was some evidence of recovery along the eastern portion of Beachwood East and Dunecrest Ln; however, there was insufficient sand volume to indicate that a substantial beach would develop along the remainder of the reach.

**FIGURE 2.13.** Profile volume for each station in Reaches 5 and 6, with the pre and post project values bolded. The 2008 project impacts are visible in the volume increase between the bold blue and orange lines, and erosion of the 2008 project is tracked in the thin weight lines over time.

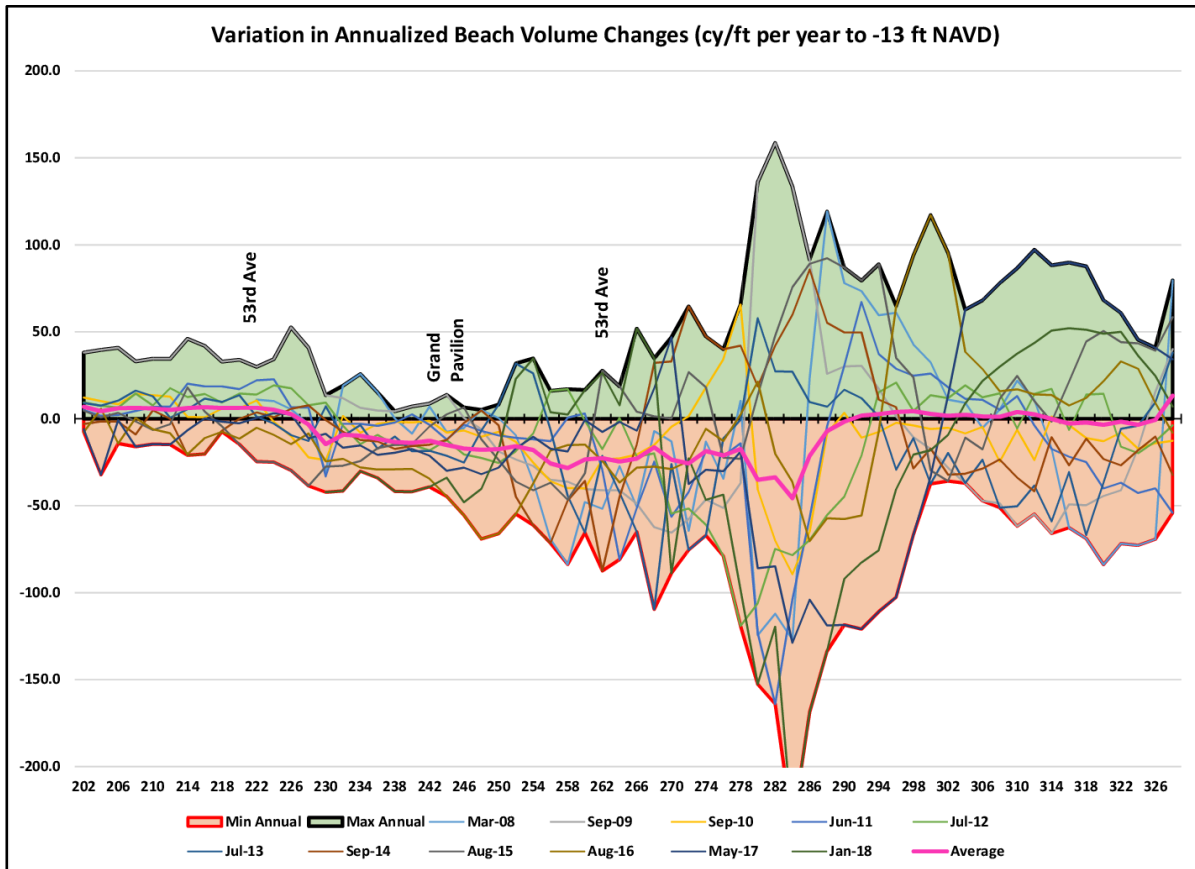
**FIGURE 2.15.** Annualized beach volume changes between each survey for the profiles in the project area. The lines represent the magnitude of profile volume gains or losses, and are scaled to a yearly rate to eliminate variations in time between surveys impacting the data. West of the 2008 project (stations 202-222), most of the data is in the positive range, meaning the beach has generally accreted.

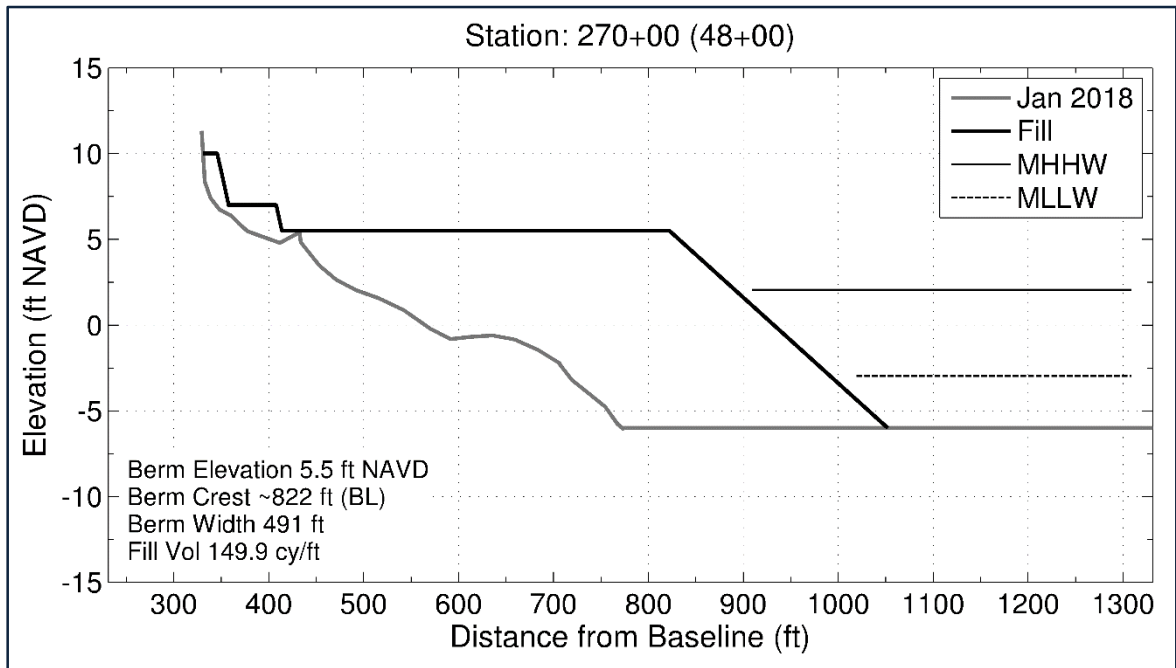
The design fill profile included a dune, storm berm, fill berm, and sloping section (Fig 2.18). The dune was included in all sections that lacked an existing dune and vegetated area, which included the areas fronting the Grand Pavilion, Seagrove, Beachwood East, and Port of Call to the Links Course. The dune height was set at +10 ft NAVD, which is ~4 ft higher than the typical dry beach elevation. The crest width was 15 ft. In these areas, a ~50 ft wide storm berm was also included in the design to prevent overwash during moderate storm events and extreme tide events from reaching the dune. The elevation of the storm berm was +7.5 ft NAVD, which is high enough to prevent swash from moderate storms and extreme tides from overtopping the berm.

**FIGURE 2.18.** The design 2018 fill profile which plans for a dune, storm berm, fill berm, and sloping section.

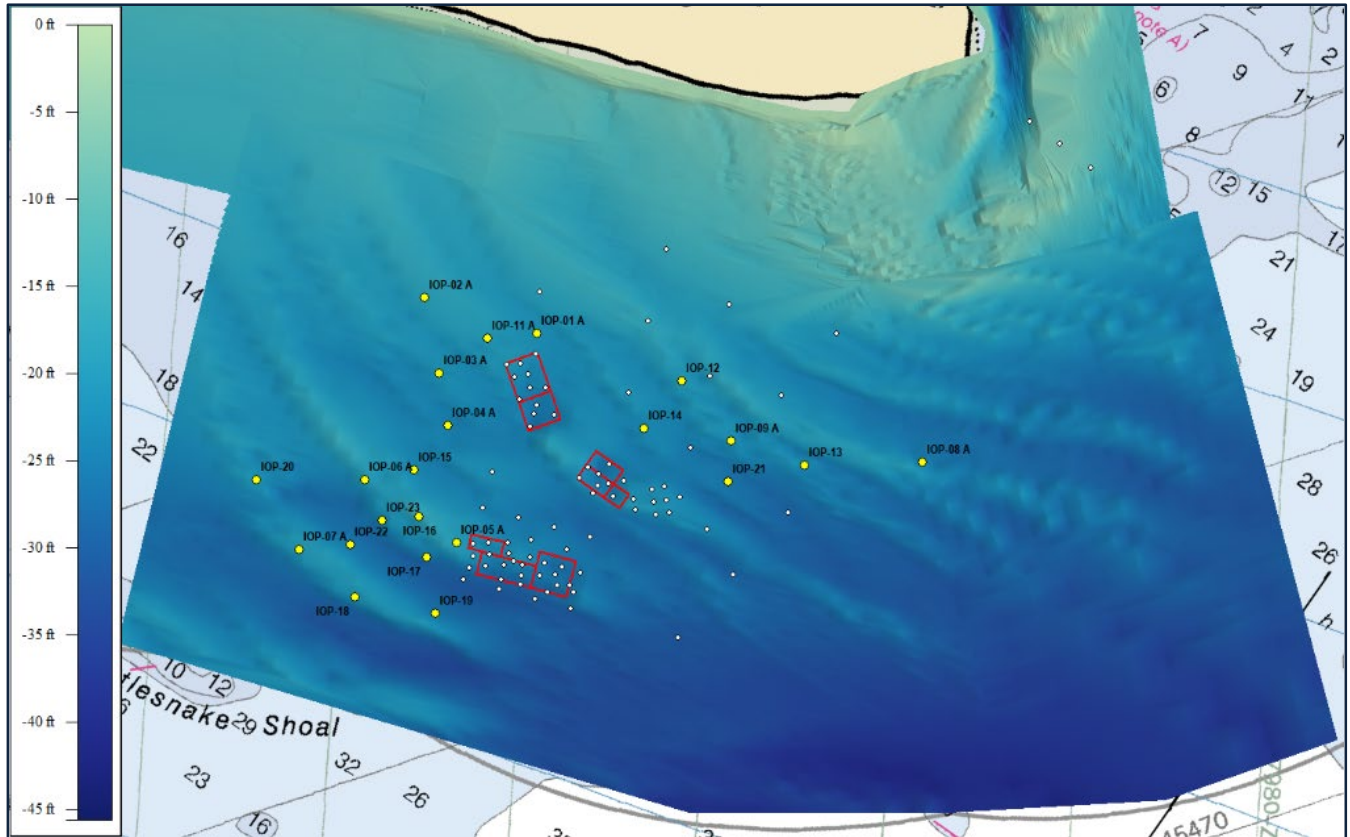
Following analysis of the first borings, CSE identified a preliminary borrow area situated west of the 2008 Borrow Area A. As part of the coordination with FEMA for post-disaster recovery funds, CSE was required to provide the SC State Historic Preservation Office (SHPO) with the preliminary borrow area spatial configuration. SHPO informed CSE that since the 2008 project, they received funding to study Civil War-era shipwrecks in the vicinity of Charleston Harbor, and located up to 13 wrecks associated with a blockade of the harbor. Referred to as the 2nd Stone Fleet, the wrecks were comprised of old whaling vessels filled with large stone and sunk around the shoals of the

harbor. SHPO indicated that they were seeking to designate a four square mile area offshore of Isle of Palms as a historic district and that no dredging would be allowed within the district (Fig 2.20). The area included the proposed borrow area identified by CSE, resulting in the need for additional geotechnical investigations to find an alternate borrow site(s).

**FIGURE 2.19.** Borrow areas used for the 2008 renourishment project (red boxes). Initial testing locations for the 2018 project are shown in the bold yellow dots. Borings for the 2008 project are shown as the small dots.

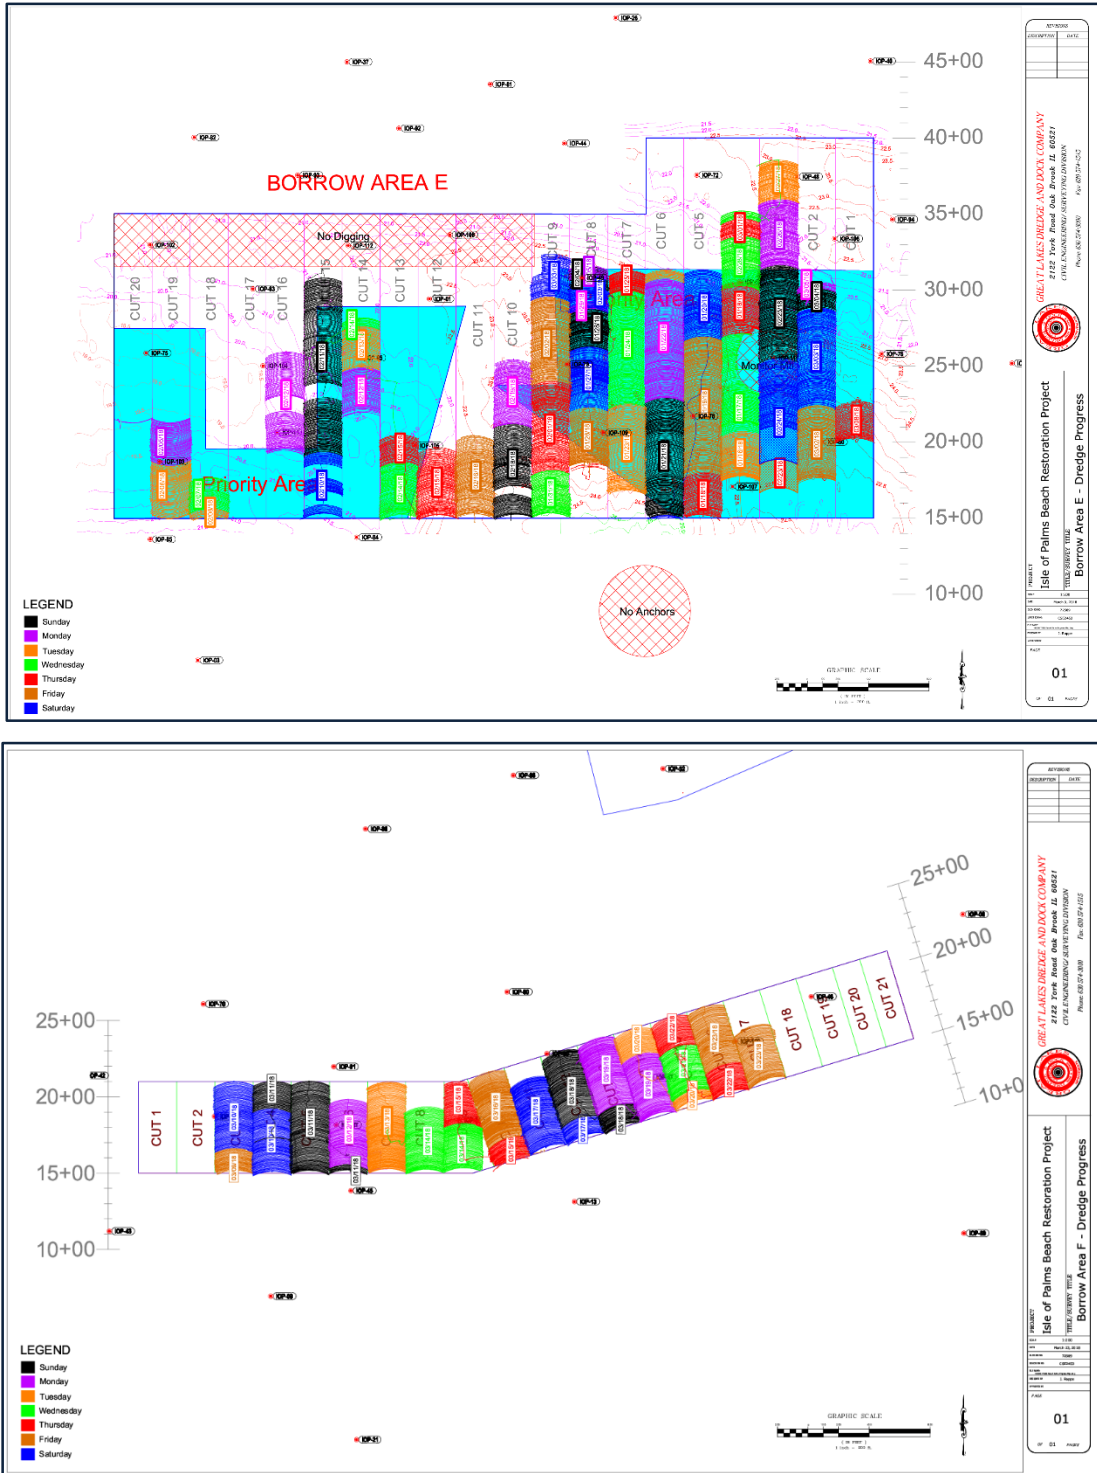
**FIGURE 3.3.** Dredge cut paths for Borrow Areas E & F. The colors represent the days the dredge was operating.

As the dredge approached the center portion of the borrow area, GLDD encountered pockets of material containing mud at a high enough concentration to leave “mud rollers” or thin layers of mud deposits on the beach. CSE and GLDD worked to alter the dredge plan to reduce the potential for lasting impacts through rigorous monitoring of the outflowing material and relocating the dredge to other portions of the borrow area. Note small gaps in the dredge track data in Figure 3.3 that show where the dredge moved forward along a cut in an attempt to find suitable material. After multiple attempts to find consistent sediment within the western portion of Area E, GLDD elected to focus on the remaining portion of Area E (eastern side) and Area F. The *Illinois* moved from Area E to Area F on 8 March 2018.

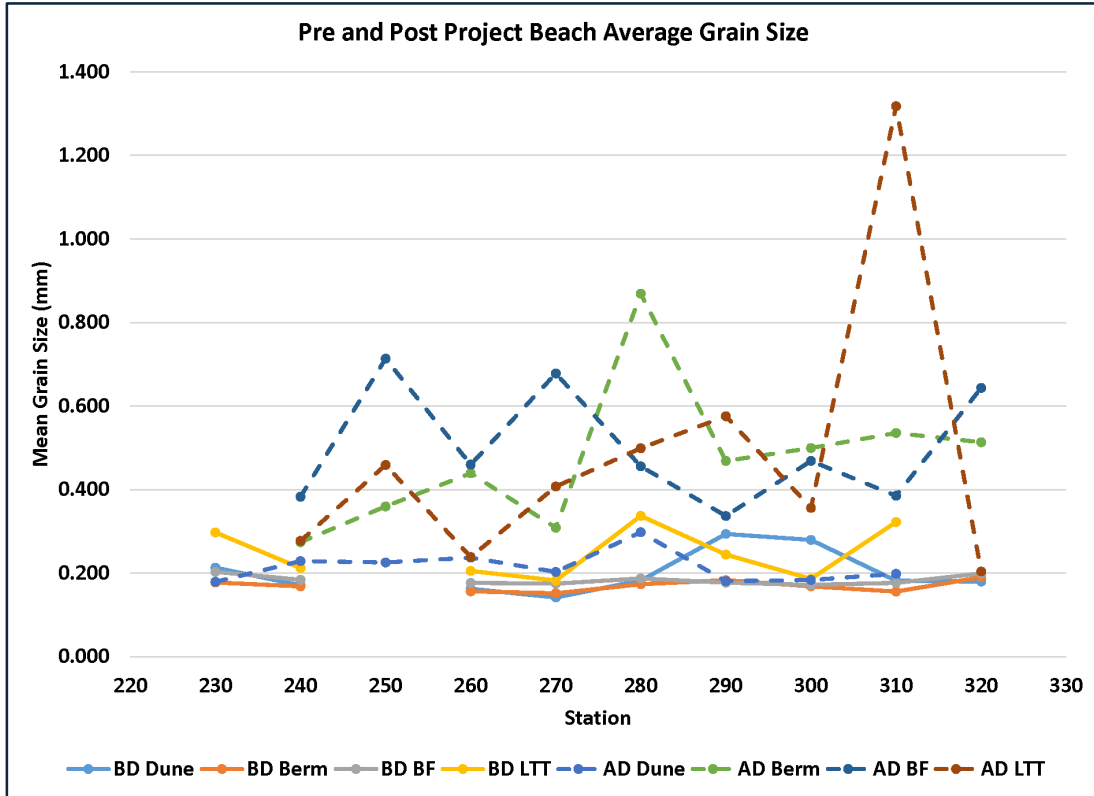
**FIGURE 3.10.** Beach sediment statistics for before and after the project. After dredge samples are indicated in dashed lines. Note the dune area remained a similar sediment size as the before dredge samples.

The average grain size and shell content increased for the post-project samples. This is a result of the coarser sediment present in the borrow area coupled with a higher percentage of shell fragments. While the shell content increased, the majority of the shell was very fine fragments (sand-sized). Figure 3.10 shows the beach sediment statistics for before and after the project, with the AD samples in the dashed lines. Of note is the dune area remained a similar sediment size as the BD samples. This is due to the quick accumulation of wind-blown sand along the dune line. CSE anticipates that the sediment grain size will decrease over time as more wind-blown sand accumulates along the berm, and sediment on the beach face and LTT sorts itself through wave reworking. It can take several months for wave action to sort the sediment into a typical configuration where coarser sand is present in the energetic wave breaking zone, and finer sediment is present along the dune and seaward of the breaker zone.

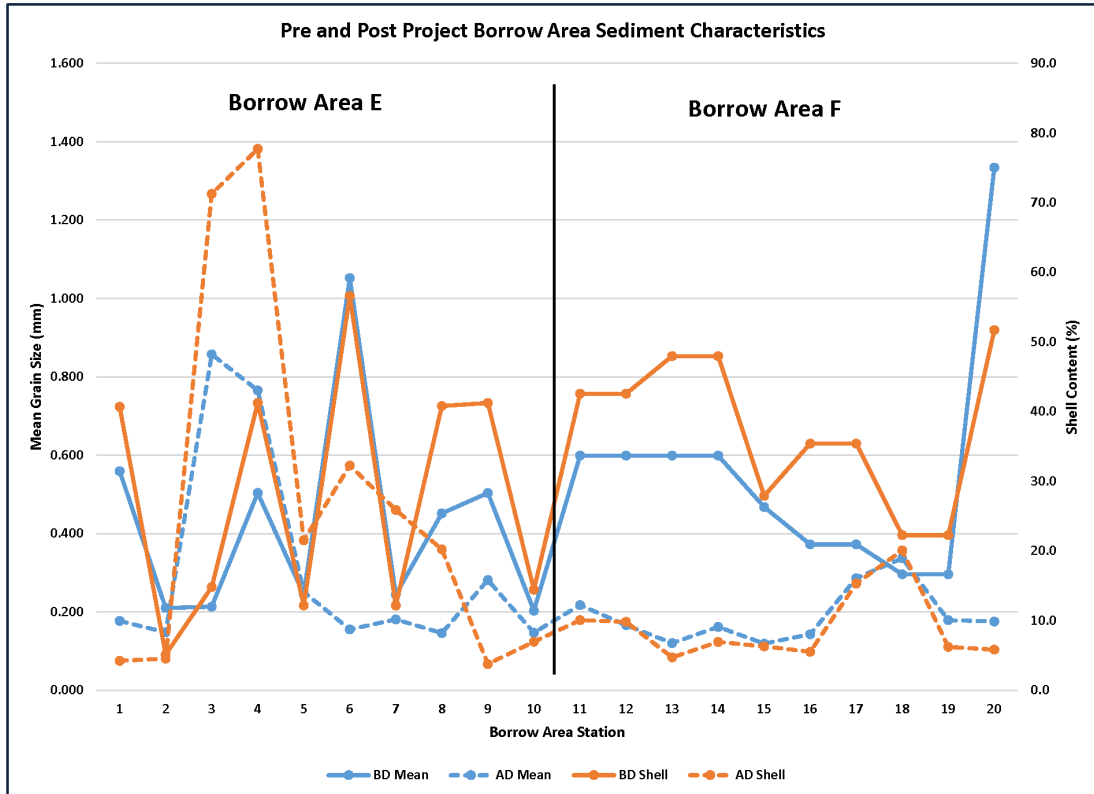
**FIGURE 3.11.** Graphed results for grain size and shell content for pre- and post-project. Overall, the post-project surface sediment was finer and had less shell content than pre project conditions.

In the borrow area, CSE compared surface samples from pre-project borings with surface grab samples collected in the excavated portions of the borrow area. Table 3.4 shows the borrow area sediment data, while Figure 3.11 graphs the results for grain size and shell content. In general, the post-project surface sediment was finer than the pre-project, with the mean grain size decreasing from 0.486 mm pre-project to 0.251 mm post project. Shell content also decreased from 32.8 % to 18.0 %. CSE noted that at a few locations, very fine sediment similar to pluff mud was present on the ocean bottom. At these locations (6, 7, 8, 9, and 16), CSE noted between 7 and 25 % of the sample was classified as mud (< 0.0625 mm). This deposit may be a result of localized exposure and settlement of silty and muddy sediment occurring during dredging as the cutterhead worked through the substrate. It is most likely not a result of the settlement of fine material from the surrounding waters, though there is the potential for that to occur over the next few years.
