**2018 Isle of Palms Restoration Project
Year 1 Monitoring Report**

2019
MONITORING REPORT

Year 1 (2019) Monitoring Report Annual Beach and Inshore Surveys

[2492YR1 — Monitoring Year 1]

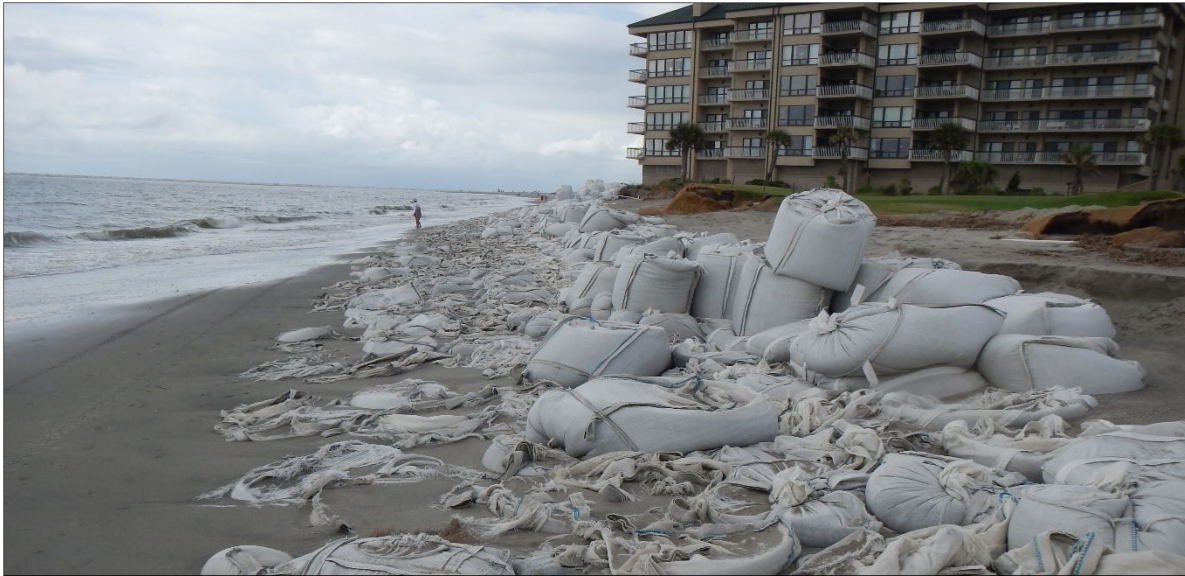
FIGURE 2.5. To prevent additional erosion, sandbags were installed along several structures from Shipwatch to Ocean Club from 2004 to 2007.

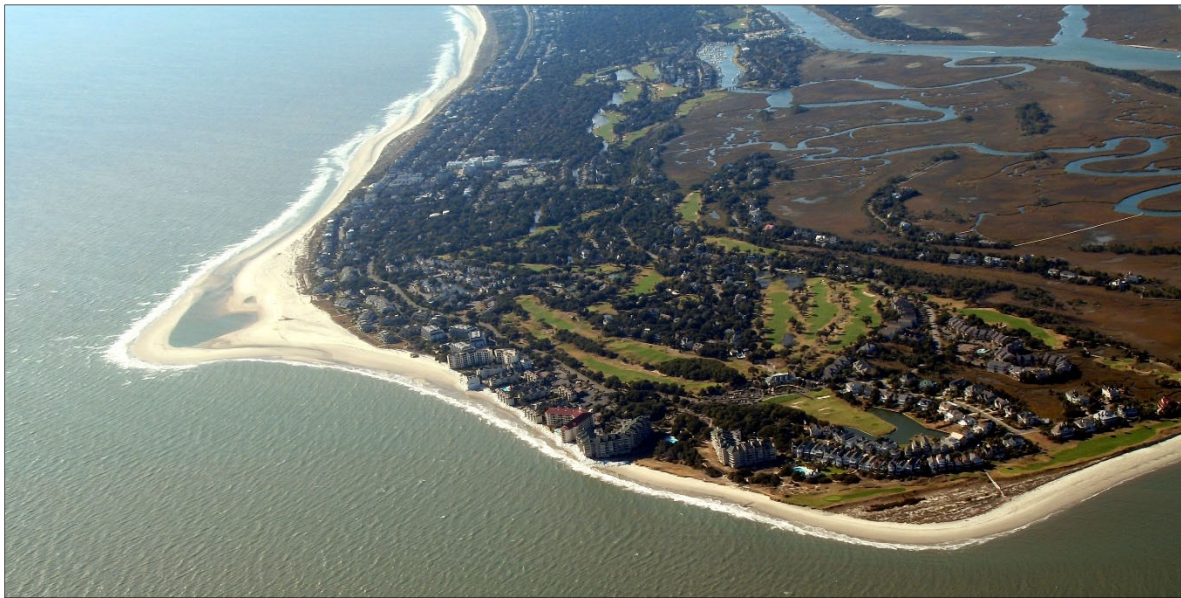
Erosion reached such a severe condition in 2007 that there was little-to-no beach along portions of the east end of the island, even at low tide (Figure 2.6). The Wild Dunes Community Association contracted with CSE to evaluate the causes of erosion and prepare a feasibility study outlining alternatives for restoration (CSE 2007). CSE recommended nourishing the beach using sand from an offshore borrow area and began the steps to obtain a permit for the work. The City of Isle of Palms then took ownership of the project and served as the applicant for the permits. Permits were obtained (P/N 2007-02631-2IG), and the City contracted with Weeks Marine for a project including nourishment of 847,000 cy of sand over 10,200 lf (linear feet) of beach. The project extended from 200 ft north of 53rd Avenue to the 17th green of the Links Course.

FIGURE 2.6. Isle of Palms in 2007 prior to beach nourishment.

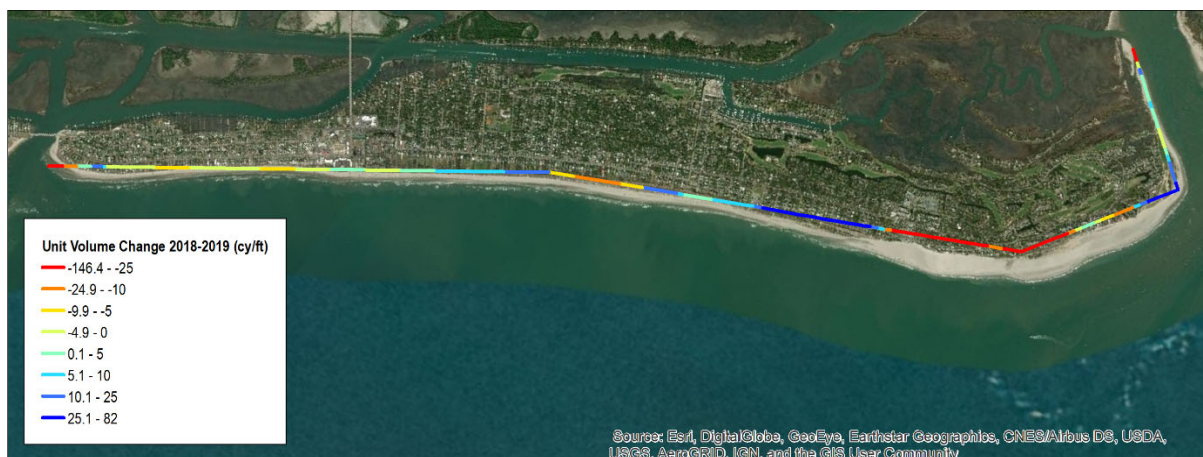
The Isle of Palm’s beach lost 234,583 cy of sand between April 2018 and June 2019. Figure 4.1 shows a map of the island with the distribution of volume change as colored lines. In the figure, warmer colors indicate erosion, while cooler colors show areas that gained sand. The image shows that there were erosional hotspots along the eastern end of the island and along the area from 3rd Ave to 12th Ave. Another erosional hotspot was present between 32nd and 38th Ave. Accretion was measured along most of the central portion of the island, especially just west of the 2018 project area and at the northeast corner of the island. Figure 4.2 provides a graph of the beach volume change for each profile line. Overall, the island holds 1,280,000 cy more sand than the 2017 pre-nourishment condition, and 1,165,000 cy more sand than in 2009 (Figure 4.3). Details of beach volume change for each reach of the island are discussed in the following sections.

FIGURE 4.1. Line map showing erosion and accretion patterns over Isle of Palms from 2018–2019.

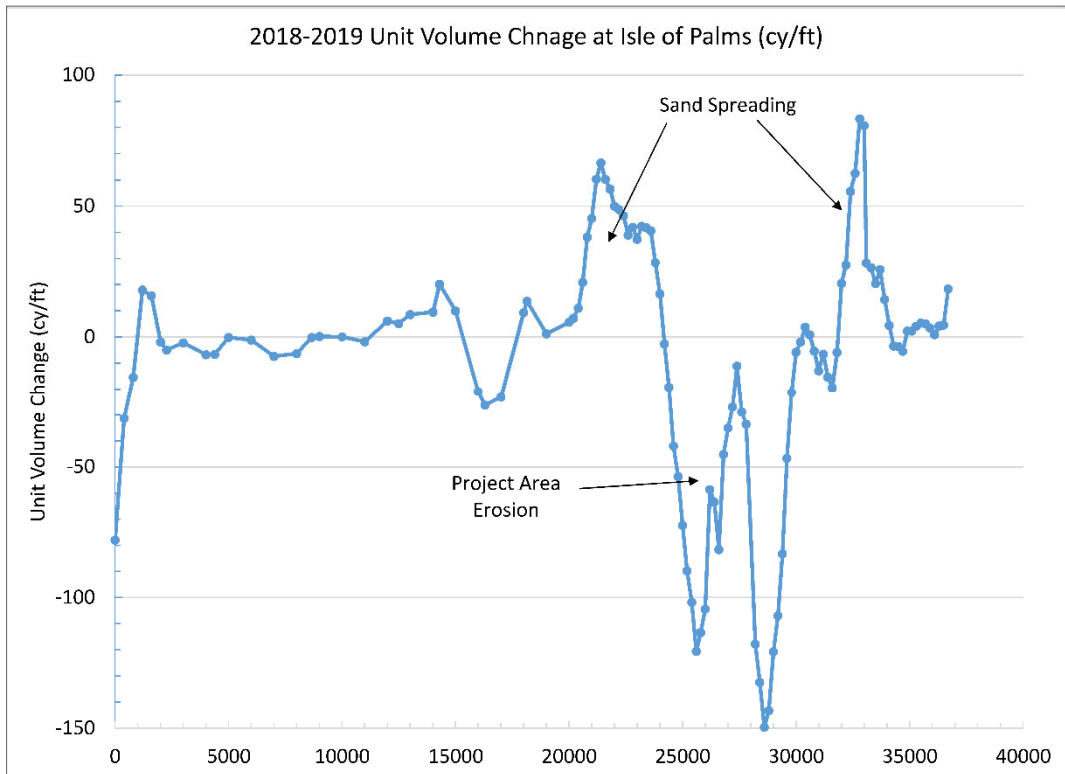
FIGURE 4.2. Beach unit volume change from 2018 to 2019 for each monitoring line at Isle of Palms. The X axis represents distance from Breach Inlet in feet. This graph highlights the erosion occurring in the project area and accumulation of spreading sand adjacent to the project area.

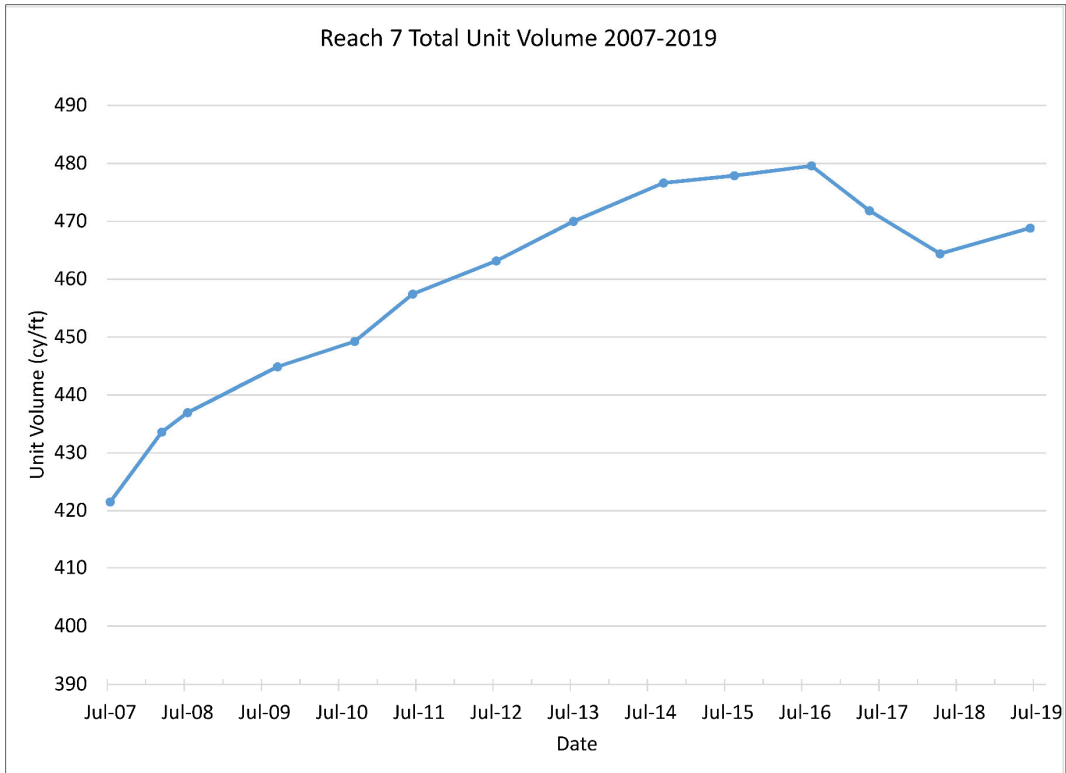
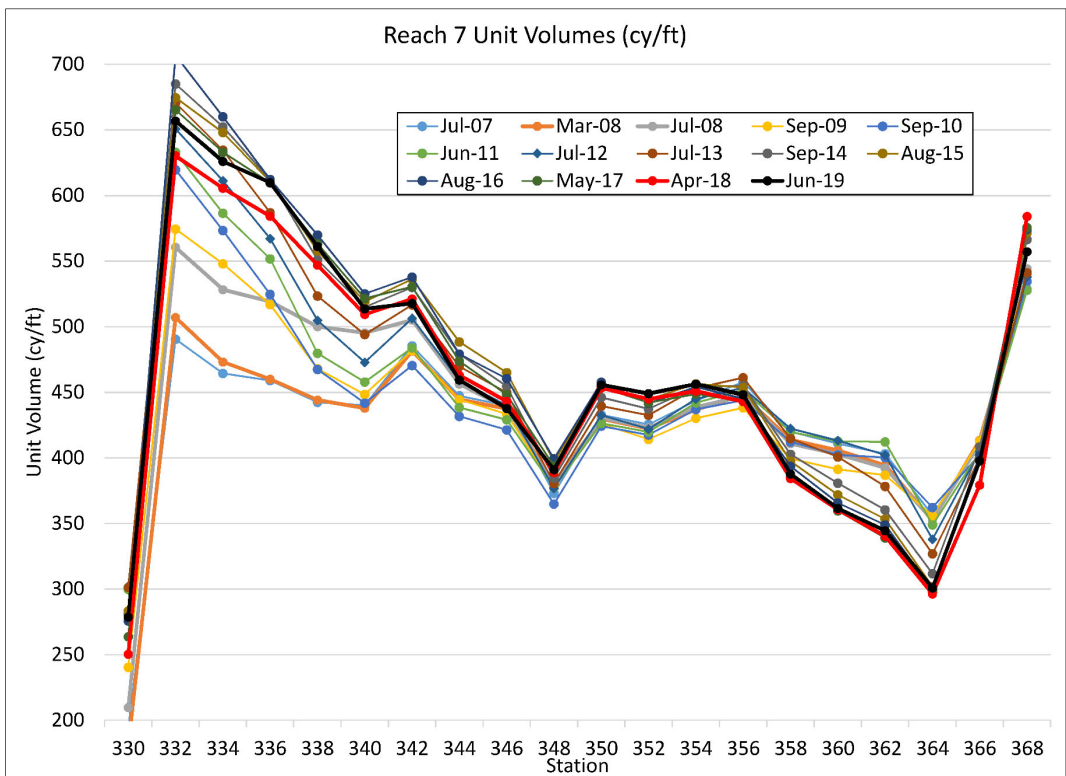
Reach 7 was accretional from 2018 to 2019, gaining 17,837 cy (4.5 cy/ft) of sand. The seaward end of the reach was highly accretional, with profiles gaining up to 28 cy/ft of sand due to spreading from the front beach. Only three profiles located just north of the groin at the 17th tee measured erosion. Figure 4.6 shows the beach volume trends for the reach since 2007, with the upper figure showing the total reach volume and the lower figure showing the volume history for each monitoring line. Figure 4.7 provides beach profiles and representative photos of the reach in 2019. Profiles from the seaward end of the reach (ie – Station 332) show substantial growth of the dry sand berm from 2018 to 2019, with the area gaining approximately 50 ft in width and increasing in elevation. Stations further inland were much more stable as shown in the profiles from Station 344. Ground photos

FIGURE 4.6. [UPPER] Total beach volume in Reach 7 since 2007. [LOWER] Profile unit volumes for each monitoring line in Reach 7.

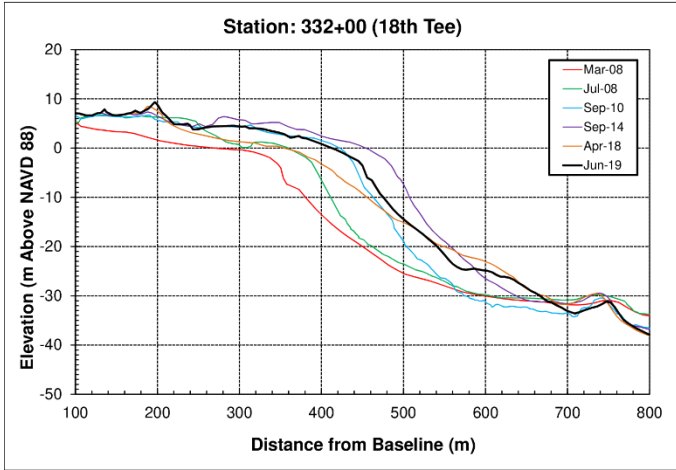
FIGURE 4.7. Beach profiles and ground photos from Reach 7. Photos are from stations 334 (left) looking seaward, 346 looking seaward (bottom left), and 346 looking landward (bottom right).

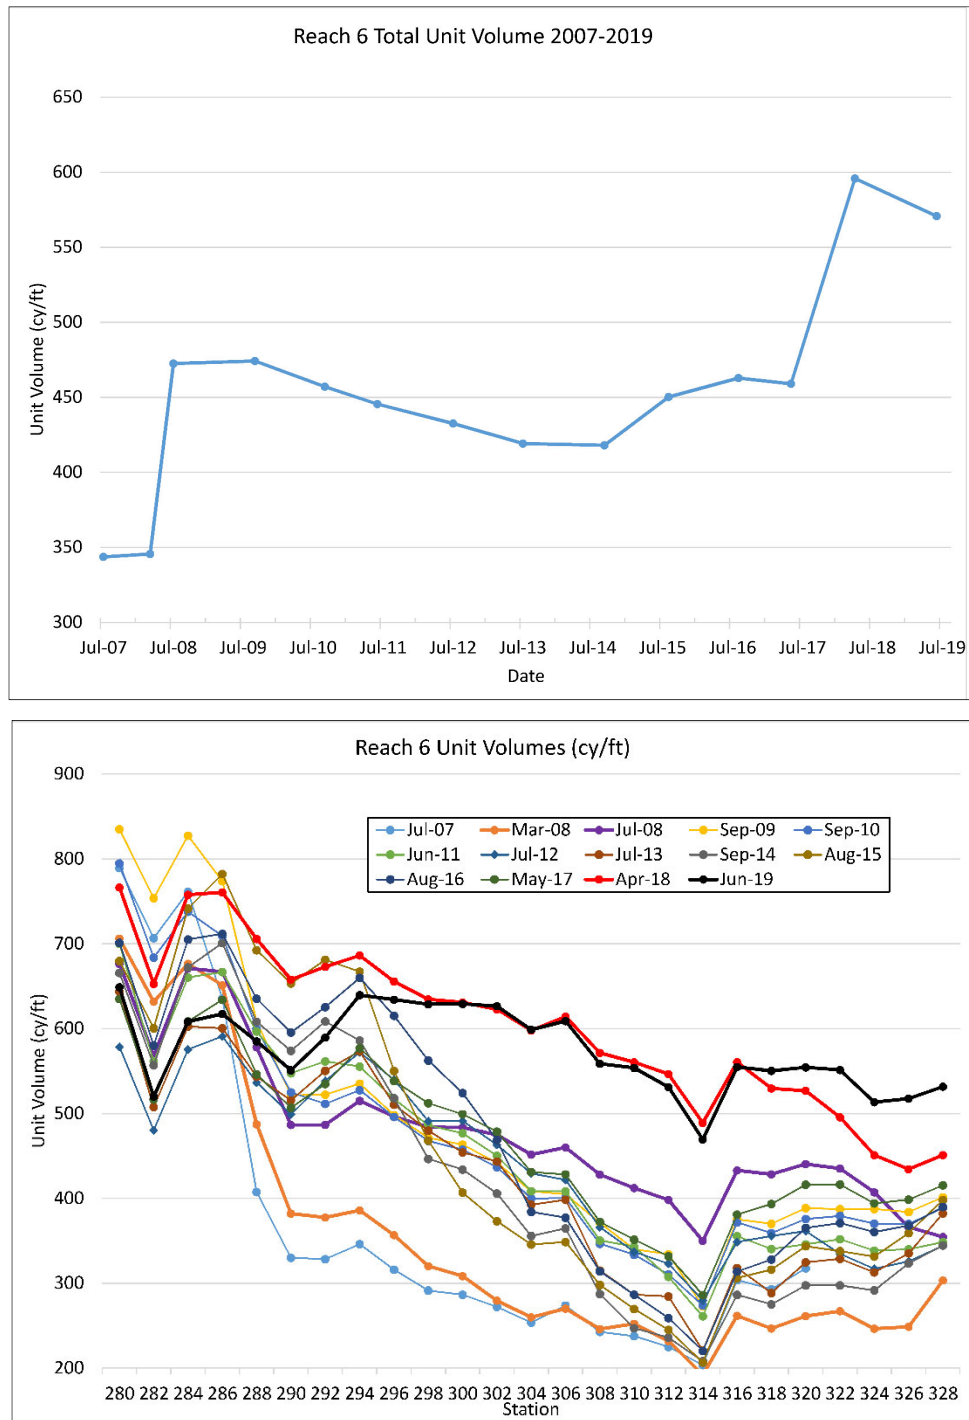
From April 2018 to June 2019, Reach 6 lost 123,000 cy (25.1 cy/ft). The volume change pattern showed a distinct trend of significant erosion along the west end of the reach, general stability at the center of the reach, and accretion along the eastern end (Figure 4.9). Erosion was severe at the western end of the reach, with the area fronting Beach Club Villas (~Station 284) losing nearly 150 cy/ft. This was nearly all of the nourishment quantity in that area. Erosion quickly tapered off to the east, with Station 298 only losing 6 cy/ft. The rapid erosion of the western end is most likely a continuation of the higher erosion trend observed prior to the project in this area, which was due to the spreading of a large shoal bypass event that attached in 2015 (Figure 4.10). Pre-project losses were nearly 100 cy/ft in the 8-month period

prior to the project near Beach Club Villas. A large portion of the sand lost from the west end of the reach was deposited at the eastern end, which caused areas to gain up to 80 cy/ft. Additional sand was likely deposited east of Line 328 beyond the limits of the cross-shore survey lines. This sand will be accounted for in the comprehensive 3D model of the Dewees Inlet delta presented in later sections.

FIGURE 4.9. [UPPER] Total beach volume in Reach 6 since 2007. **[LOWER]** Profile unit volumes for each monitoring line in Reach 6.

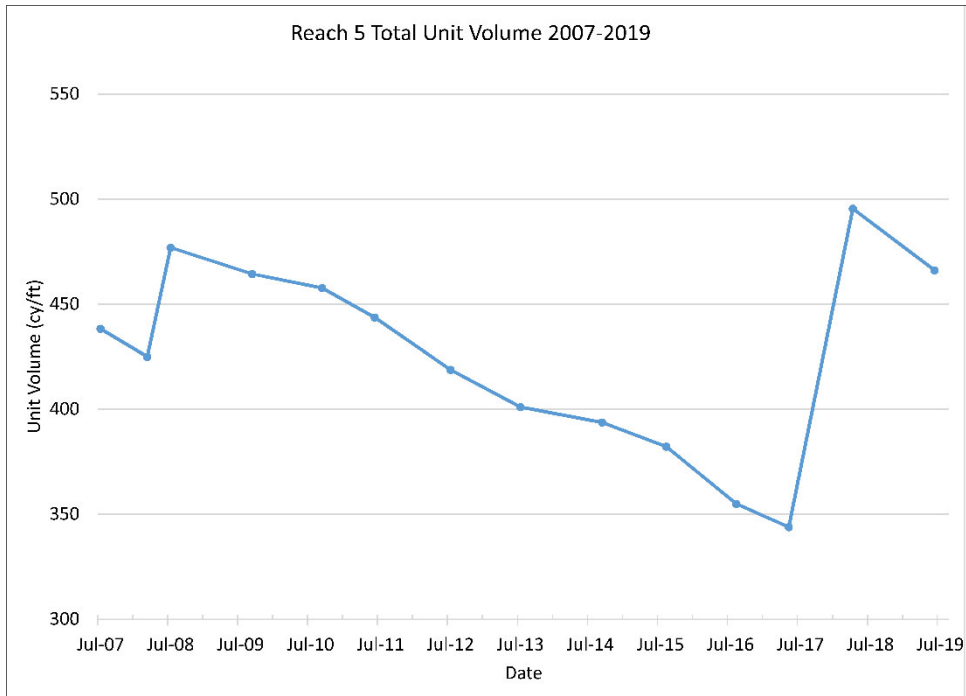
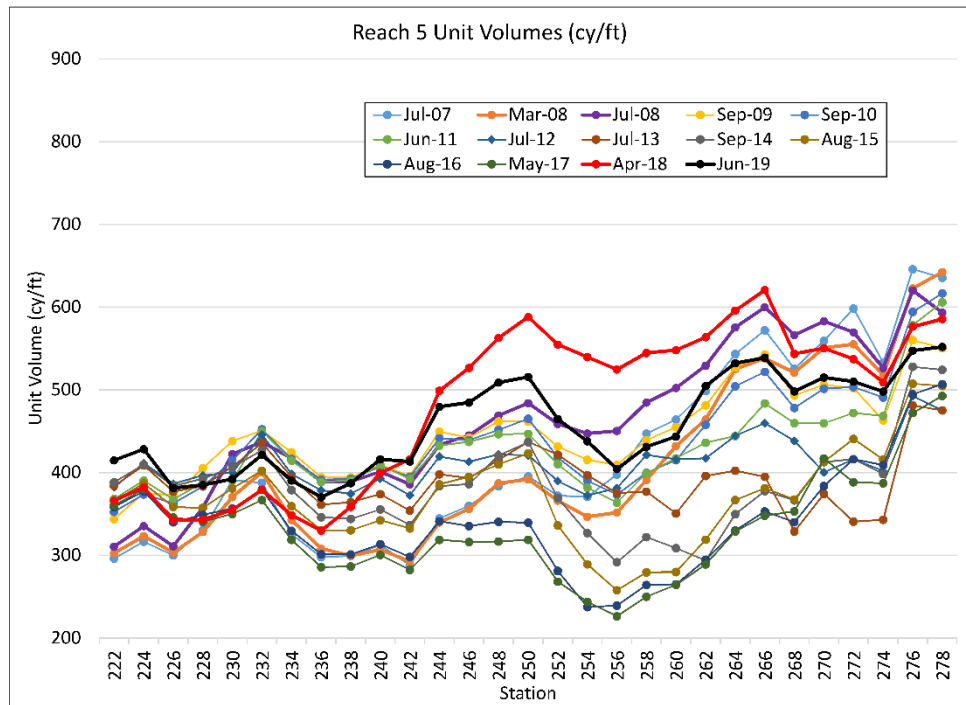
The reach lost 176,000 cy (29.4 cy/ft) of sand between April 2018 and June 2019. Losses over the past year were greatest along the central portion of the reach, from stations 246–268 (Grand Pavilion to Beachwood East). Figure 4.14 (lower) shows the profile volume record for Reach 5 since 2007. The difference between the red and black lines represents the 2018–2019 change. The position of the 2019 (black) line relative to the other dates provides an indication of how the present condition compares to earlier conditions. Generally, the 2019 condition is near the healthiest condition observed since 2007 along most of the reach, with the exception being at the very eastern end of the reach. The 2019 condition shows at least 100 cy/ft more sand than the most eroded condition along the majority of the reach, and over 200 cy/ft greater along the central portion of the reach.

FIGURE 4.14. [UPPER] Total beach volume in Reach 5 since 2007. **[LOWER]** Profile unit volumes for each monitoring line in Reach 5.

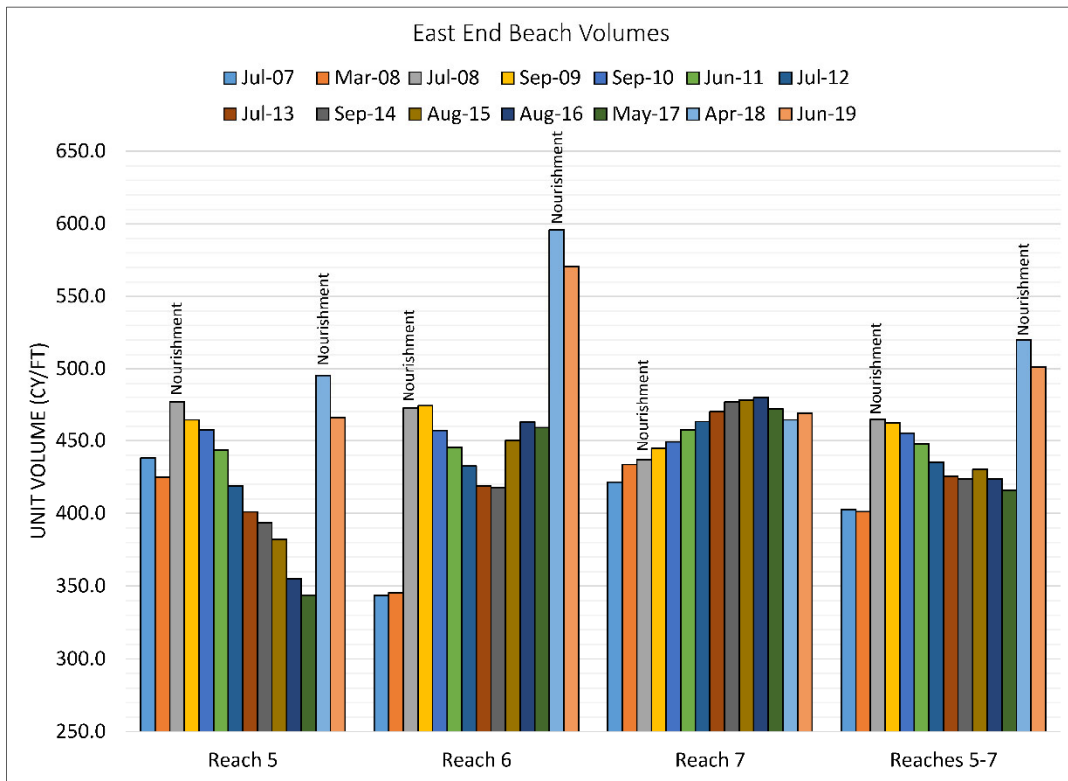
FIGURE 4.17. The beach volume history of the eastern end of the island since 2007, with dates following nourishment indicated

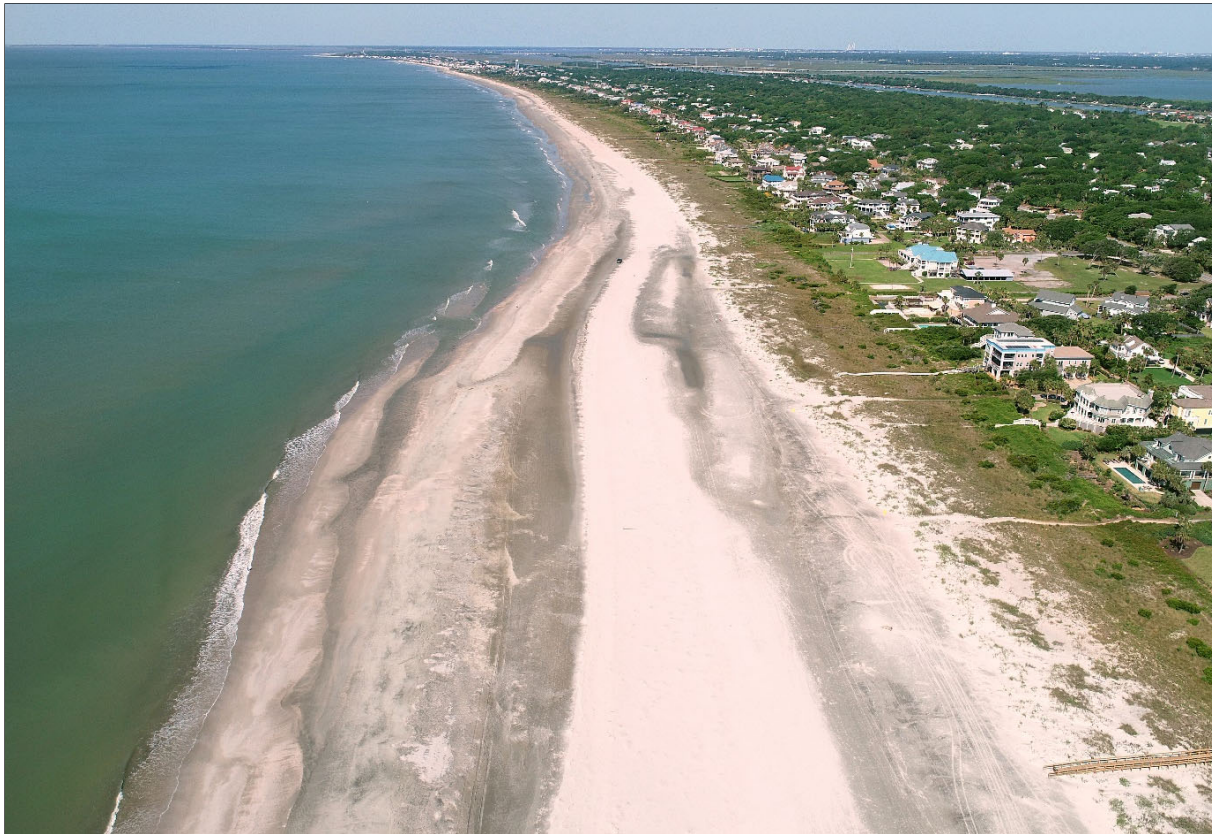
FIGURE 4.19. By being positioned downdrift of the nourishment area, Reach 4 receives nourishment sand spreading from the placement area as well as spreading shoal sand. This reach has gained sand every year since 2009 except 2016.

Overall the reach gained 73,800 cy (8.0 cy/ft) of sand over the past year. The beach volume in Reach 4 has increased by over 500,000 cy since 2009, which is an average annual accretion rate of 6.6 cy/ft per year. The dune width has increased by at least 50 ft along the reach, not including the wider dry sand berm seaward of the dune. This level of accretion is of similar magnitude to many beach nourishment projects conducted along coastal communities in South Carolina and is equivalent to an \$8-10-million-dollar nourishment investment. The dune has grown ~3 ft in elevation and offers substantially more storm protection than the 2009 condition. CSE anticipates additional accretion over the next few years as more sand spreads from the 2018 project area.

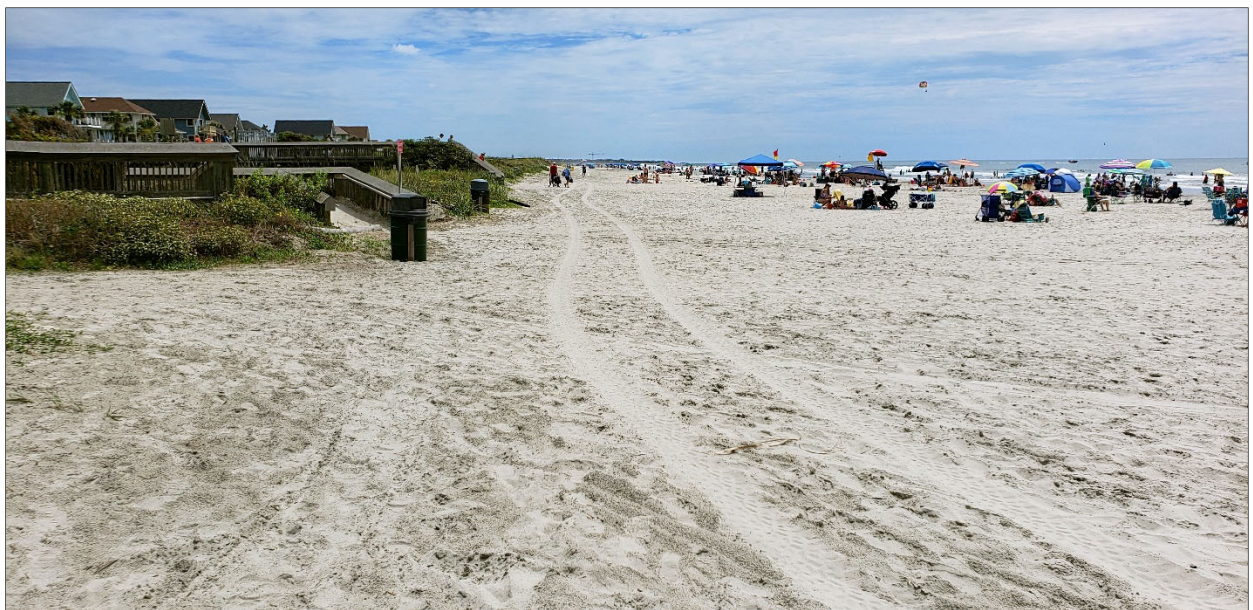
Reach 3 extends from the Sea Cabins Pier to 31st Avenue (OCRM monuments 3125 to 3140 – Fig 4.22 and Fig 4.23). Like Reach 4, the long-term trend in this area is stable to accretional. Dwellings in the reach are well set back from the beach, generally between 400 ft and 500 ft except at the western end where Sand Dune Lane and the county park are set back ~150 ft. The reach has shown periods of erosion and accretion since CSE began island-wide monitoring in 2009. This is typical for stable to moderately accretional beaches as variations in wave conditions from year to year and temporary changes in sediment supply lead to minor fluctuations in yearly volume change. Over the long term, the trend is accretion.

FIGURE 4.23. The long-term trend for Reach 3 is stable to accretional. Dwellings in the reach are generally set back from the beach between 400 ft and 500 ft.

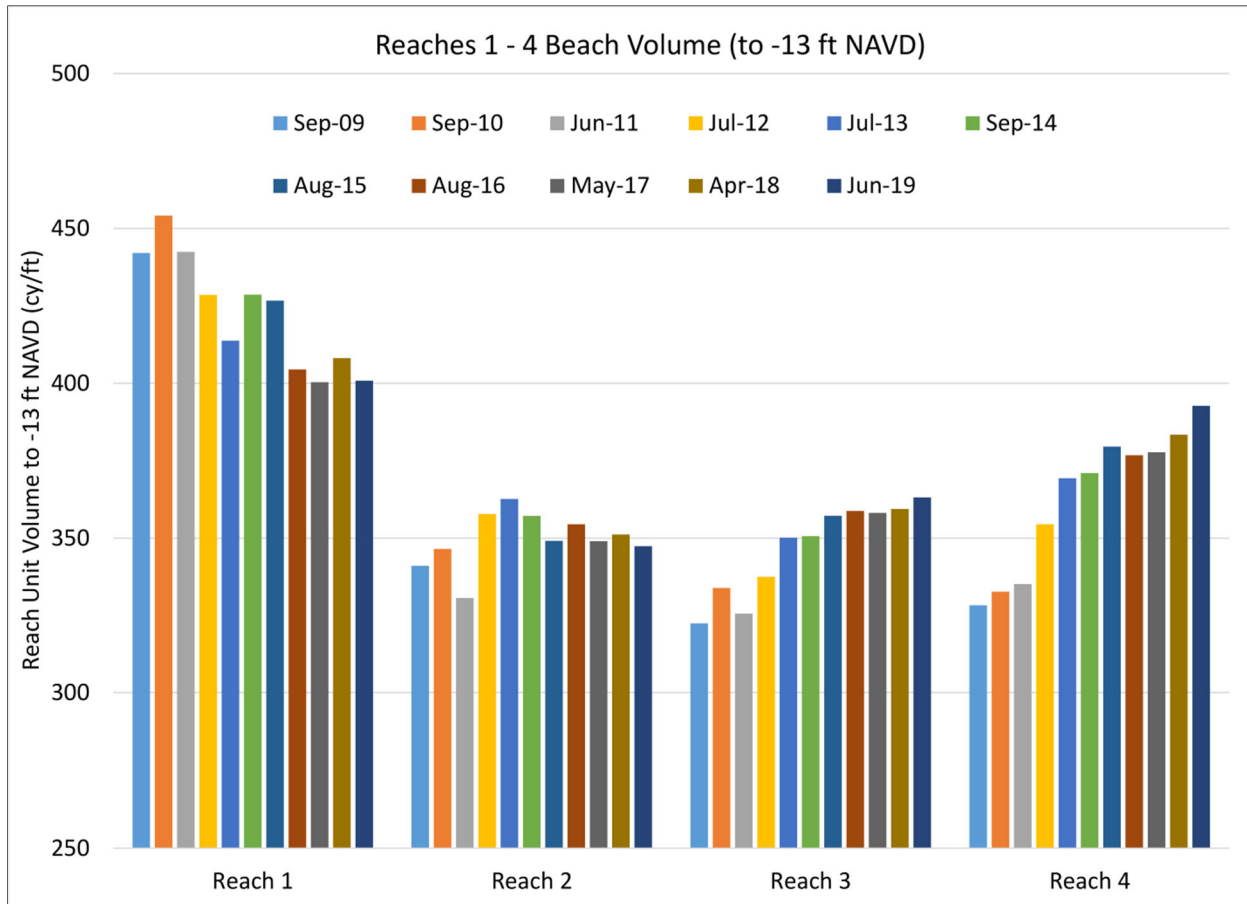
Overall the reach holds 230,000 cy (41 cy/ft) more sand than the 2009 condition, which is equivalent to an average annual accretion of 4.2 cy/ft per year. Figure 4.25 shows the accretional trend over the past decade. Photos of the reach in June 2019 show a recovering dune system with a significant dry sand beach seaward of the growing dune (Fig 4.24). A site visit in early 2020 shows the dune is continuing to grow and vegetate, and the wide dry beach seaward of the dune is protecting it from eroding during spring tides or minor storms.

FIGURE 4.25. This graphic illustrates the accretional trend of Reaches 3 and 4 over the past decade.

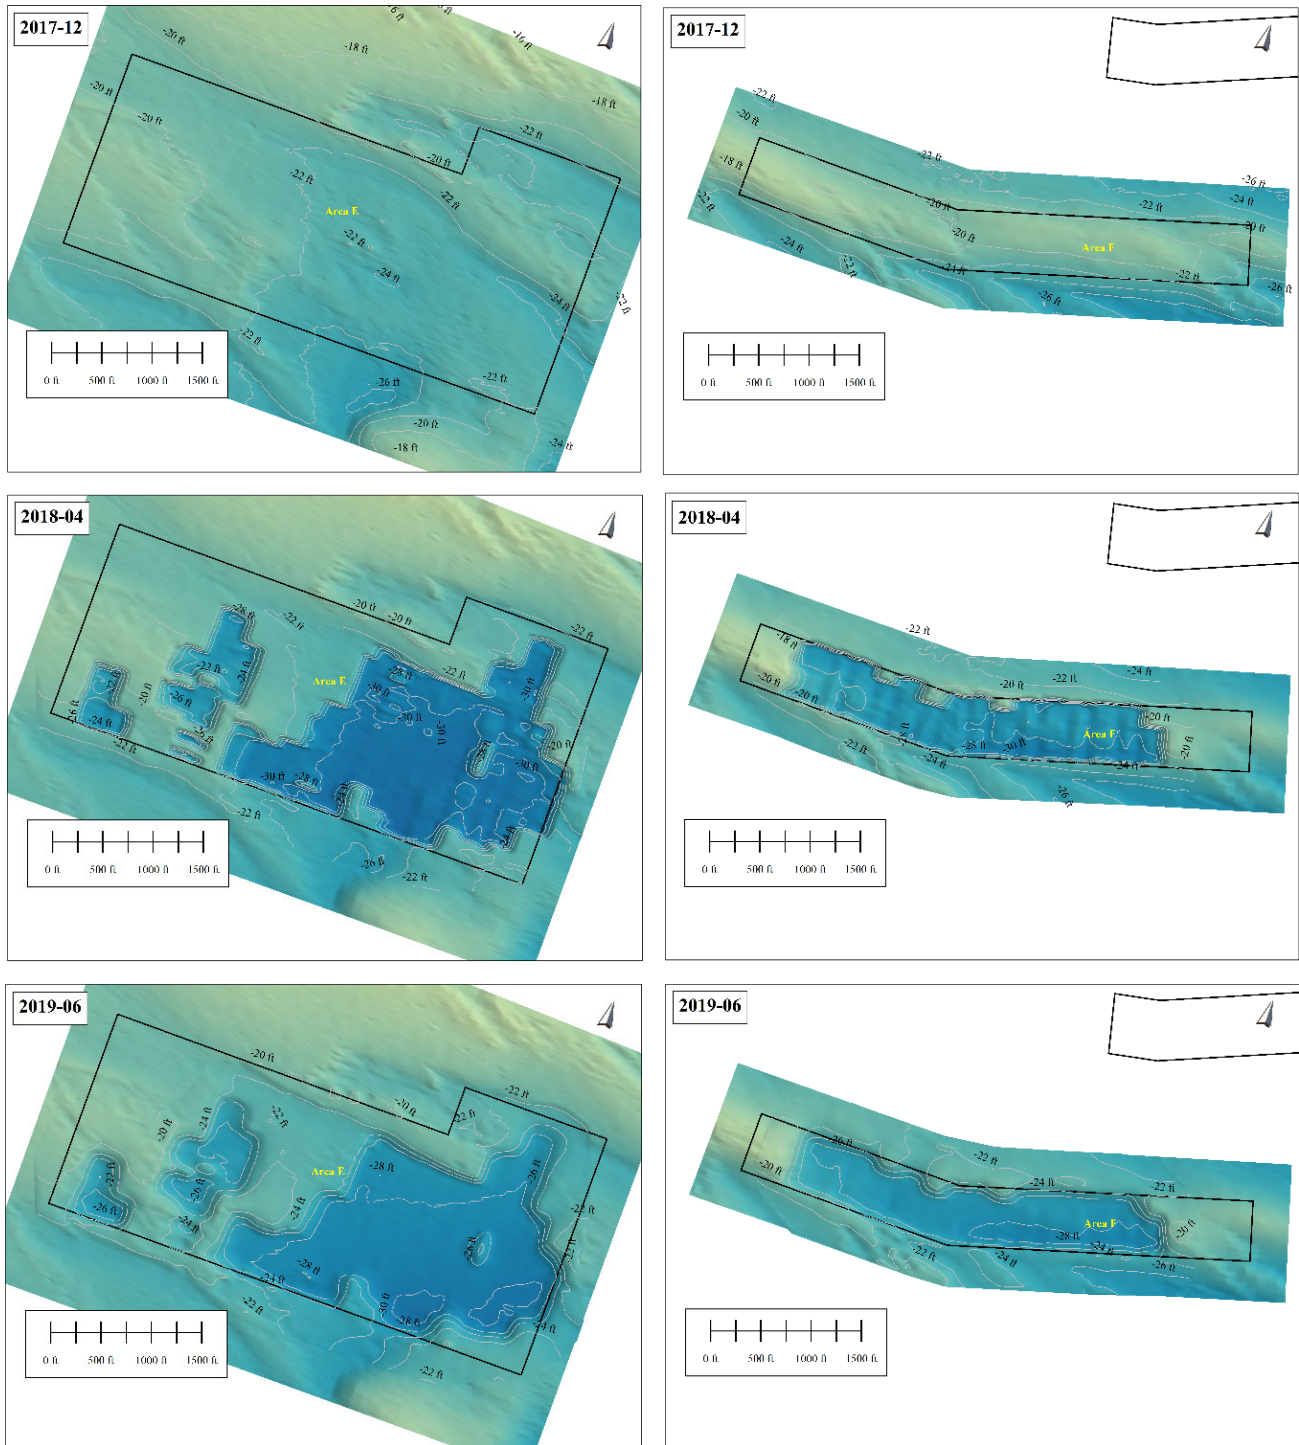
Per conditions of the permit for the 2018 nourishment project, the City is required to obtain bathymetric surveys of the borrow areas to monitor rates of infilling. CSE collected bathymetric data at 100 ft spacing over all dredged areas within permitted borrow areas E and F in June 2019. Data were used to generate digital terrain models of the borrow areas and compared to pre- and post-project surveys. Figure 5.1 shows the models for both borrow areas used in the project for each survey. The effects of the 2018 nourishment are clearly visible as the blue shaded colors in the elevation models. The 2018 post-project model shows a rough surface of the seafloor which was generated by the arcing motion of the cutterhead during dredging. By 2019, the contours reveal a less rugged bathymetry as sediment shifted from high spots and infilled lower areas. Generally, the boundaries of the dredged areas showed erosion of the top of the slope and accretion along the foot of the slope.

FIGURE 5.1. Terrain models for both borrow areas used in the project for each survey.

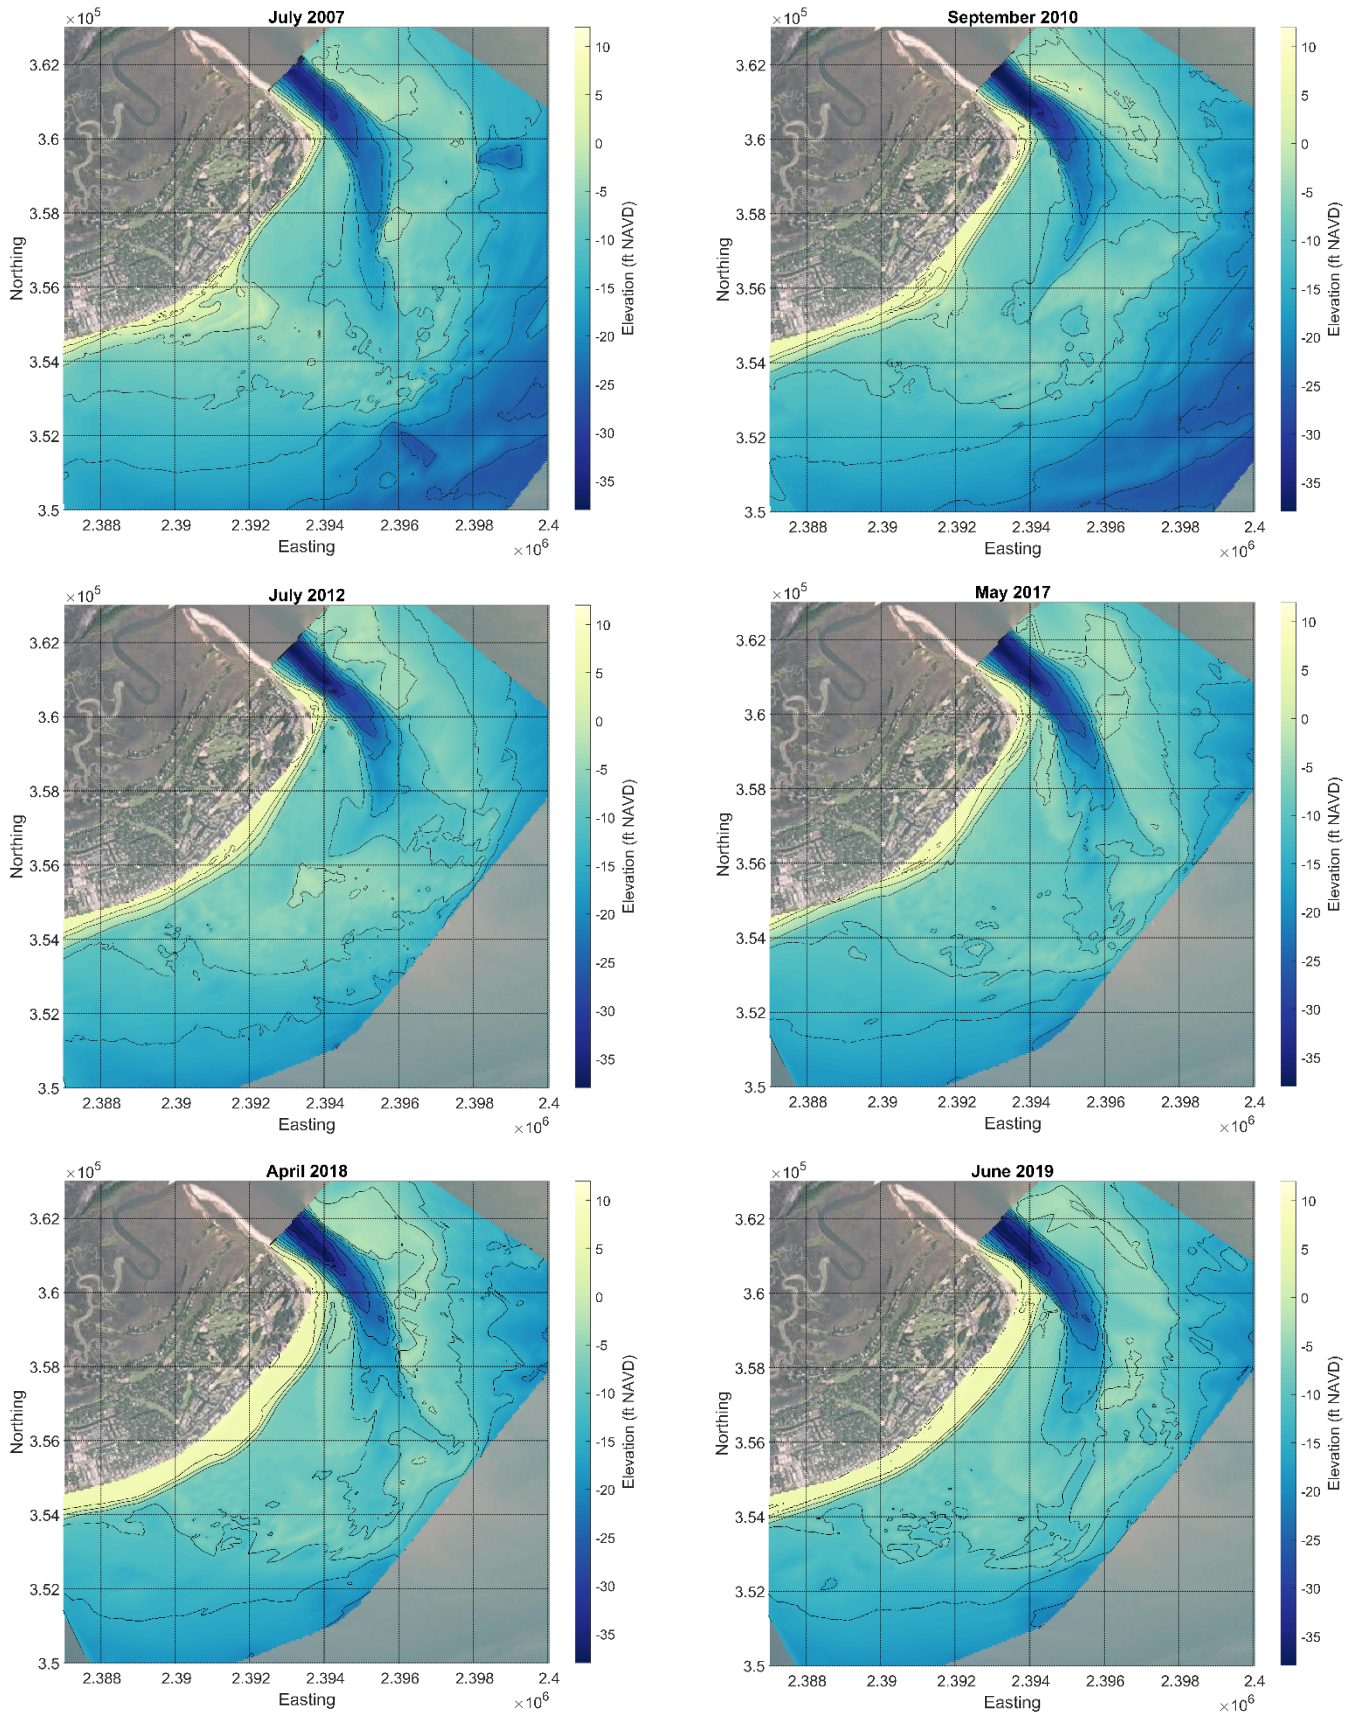
Figure 6.1 shows selected models of the Dewees Inlet delta since 2007. While the main channel is presently in a location similar to the 2007 condition, there are substantial differences in the delta that are a benefit to the long-term health of Isle of Palms. Most notably is the existence of a significant sand body connected to the northeast end of the island called a “trailing ebb spit.” This feature grew following the 2008 project as nourishment sand shifted to the north end of the island and began to recirculate within the inlet. Much of the sand was deposited into this trailing ebb spit on the landward side of the channel body. This sand acts to break wave energy before it reaches the beach, which reduces the rate of sediment transport on the beach. It also shields the beach from waves focusing on gaps in the offshore delta. These effects should help stabilize the eastern end of the Wild Dunes area (Reach 6) over the next several years.

The terminus of the main channel appears to be undergoing another major relocation process, as the existing channel throat at the southern end of the delta is being constricted by a significant shoal. At the same time, there is a deepening and widening of an area along the northern end of the delta, seaward of the deep channel between Isle of Palms and Dewees Island. Of note is that a secondary channel exit which was present in 2018 along the central lobe was not as evident in 2019, suggesting that the northern pathway will become the dominant channel over the next few years.

The present configuration of the delta shoals suggests that there will be substantial shoal bypassing events occurring within the next 2–5 years that will bring several hundreds of thousands of cubic yards of sand to the beach. While the net volume increase will be a positive result; shoal-induced erosion of localized areas may be significant and needs to be monitored closely. As mentioned previously, the two large-scale nourishment projects have increased the total volume of sand within the beach and delta system at the northeast end of the island by over 2,000,000 cubic yards. The volume will help to buffer development from impacts of the shoal events and hopefully allow the processes to occur without the need for mitigation via sand transfers.

FIGURE 6.1. Selected models of the Dewees Inlet delta since 2007. Although the main channel is currently in a location similar to the 2007 condition, there are substantial differences in the delta — most notably is the existence of a significant sand body connected to the northeast end of the island called a “trailing ebb spit.”
