# 2018 Isle of Palms Restoration Project

## Year 2 (2020) Monitoring Report Annual Beach and Inshore Surveys

[2492YR2 — Monitoring Year 2]

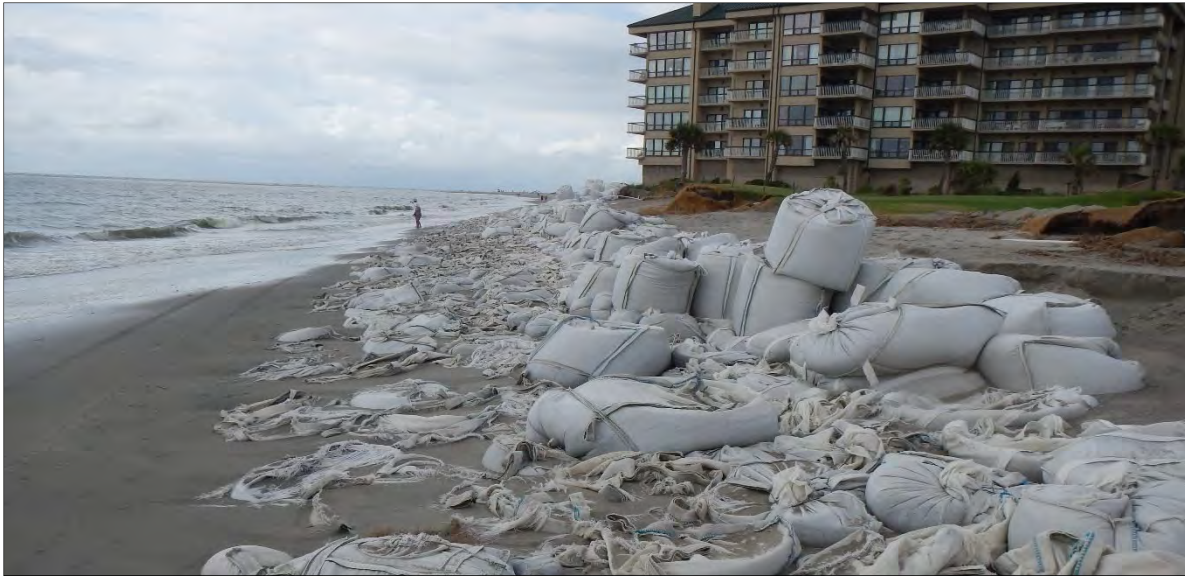
**FIGURE 2.5.** To prevent additional erosion, sandbags were installed along several structures from Shipwatch to Ocean Club from 2004 to 2007.

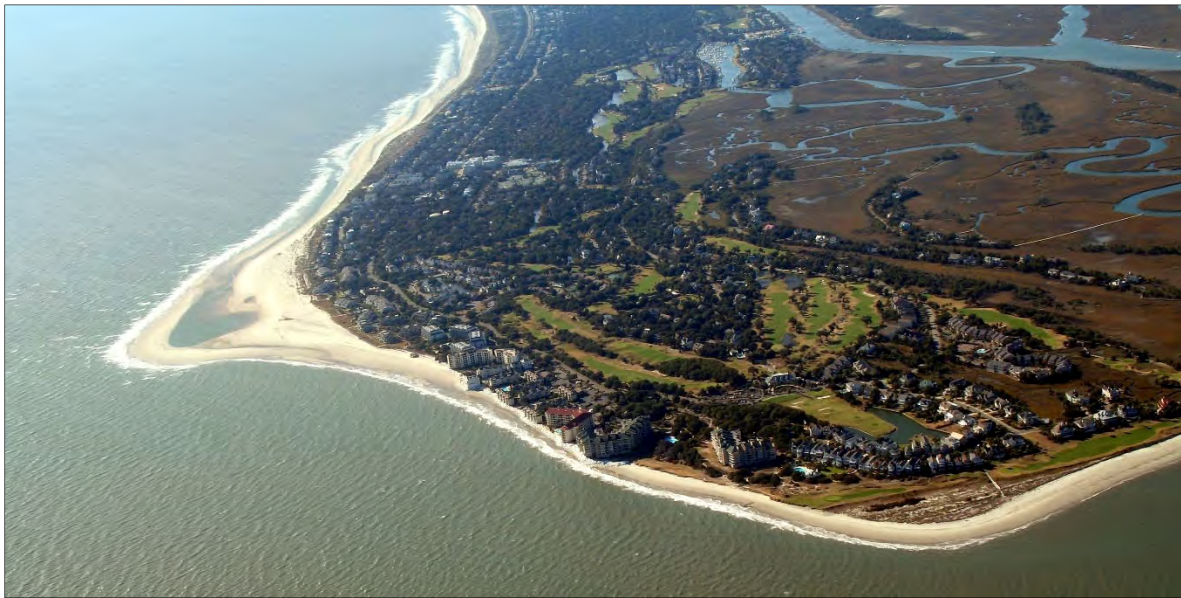
Erosion reached such a severe condition in 2007 that there was little-to-no beach along portions of the east end of the island, even at low tide (Figure 2.6). The Wild Dunes Community Association contracted with CSE to evaluate the causes of erosion and prepare a feasibility study outlining alternatives for restoration (CSE 2007). CSE recommended nourishing the beach using sand from an offshore borrow area and began the steps to obtain a permit for the work. The City of Isle of Palms then took ownership of the project and served as the applicant for the permits. Permits were obtained (P/N 2007-02631-2IG), and the City contracted with Weeks Marine for a project including nourishment of 847,000 cy of sand over 10,200 lf (linear feet) of beach. The project extended from 200 ft north of 53rd Avenue to the 17th green of the Links Course.

**FIGURE 2.6.** Isle of Palms in 2007 prior to beach nourishment.

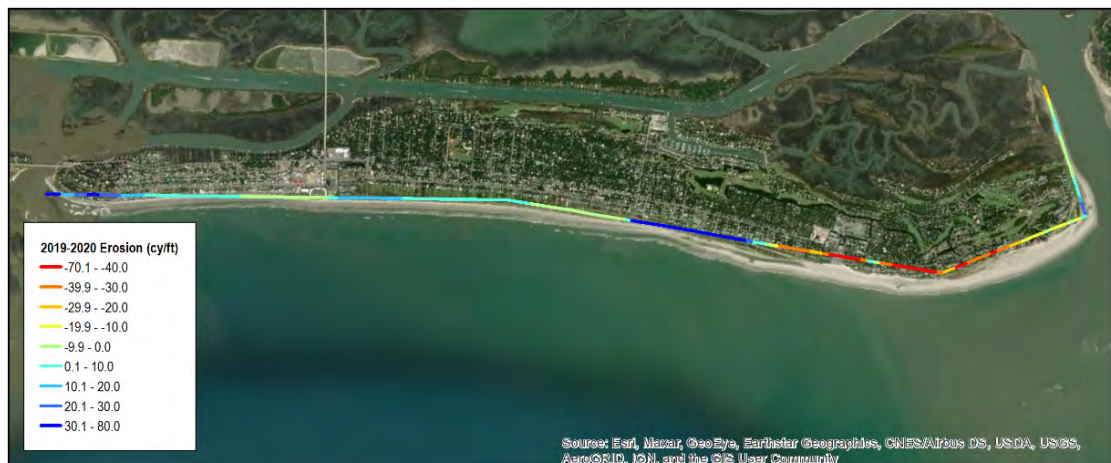
**The Isle of Palms beach lost 59,600 cy of sand between June 2019 and June 2020.** This compares to a loss of 234,583 cy of sand between April 2018 and June 2019. Figure 4.1 shows a map of the island with the distribution of volume change as colored lines. In the figure, warmer colors indicate erosion, while cooler colors show areas that gained sand. The image shows that erosion dominated the east end of the island (2018 project area), while the remainder of the island south of 53<sup>rd</sup> Ave was accretional. Erosion was most severe along Dunecrest Lane and Beach Club Villas. Accretion was most pronounced south of 53<sup>rd</sup> Ave and along Breach Inlet. Figure 4.2 provides a graph of the beach volume change for each profile line. Overall, the island holds 1,351,000 cy more sand than the 2017 pre-nourishment condition and 1,105,000 cy more sand than in 2009 (Figure 4.3). Details of beach volume change for each reach of the island are discussed in the following sections.

**FIGURE 4.1.** Line map showing erosion and accretion patterns over Isle of Palms from April 2019 – June 2020.

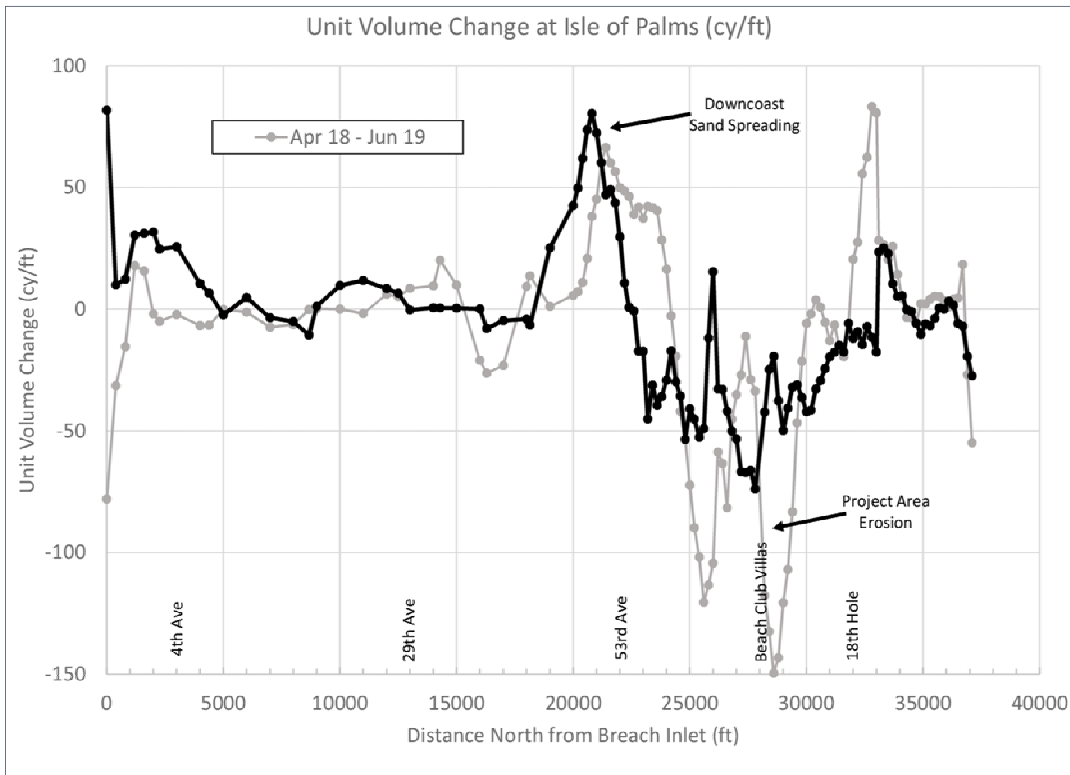
**FIGURE 4.2.** Beach unit volume change from 2018–2019 and 2019–2020 for each monitoring line at Isle of Palms. The X axis represents distance from Breach Inlet in feet. This graph highlights the erosion occurring in the project area and accumulation of spreading sand adjacent to the project area.

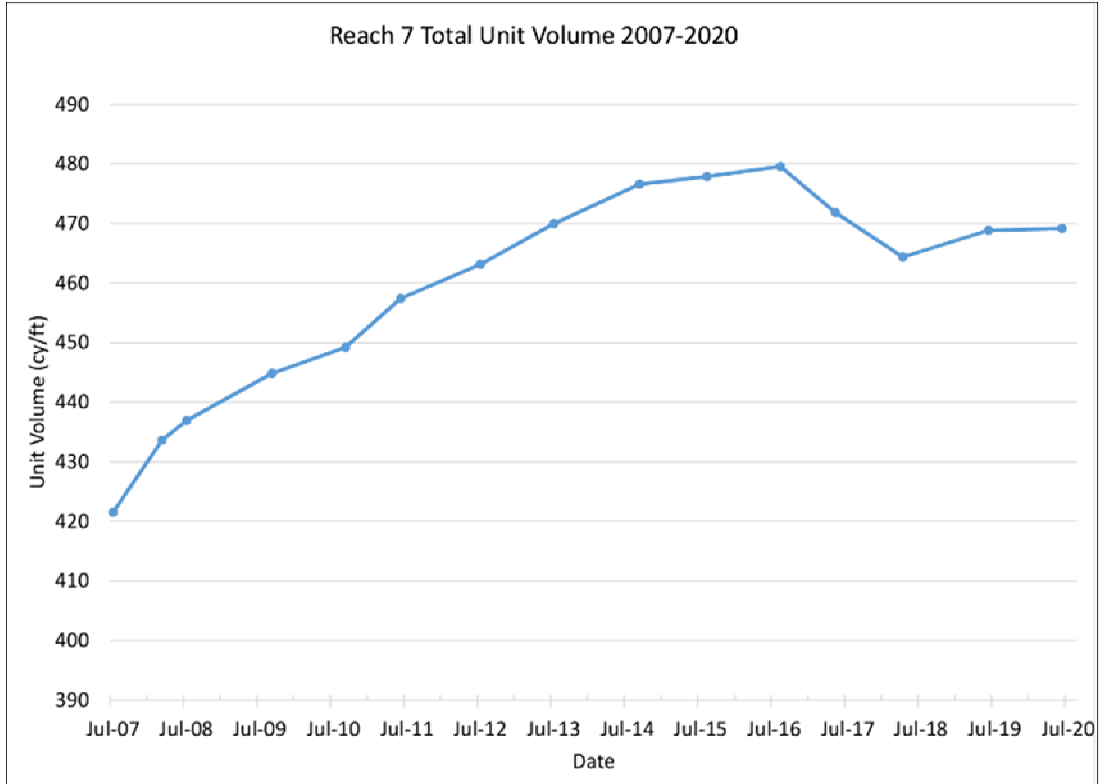
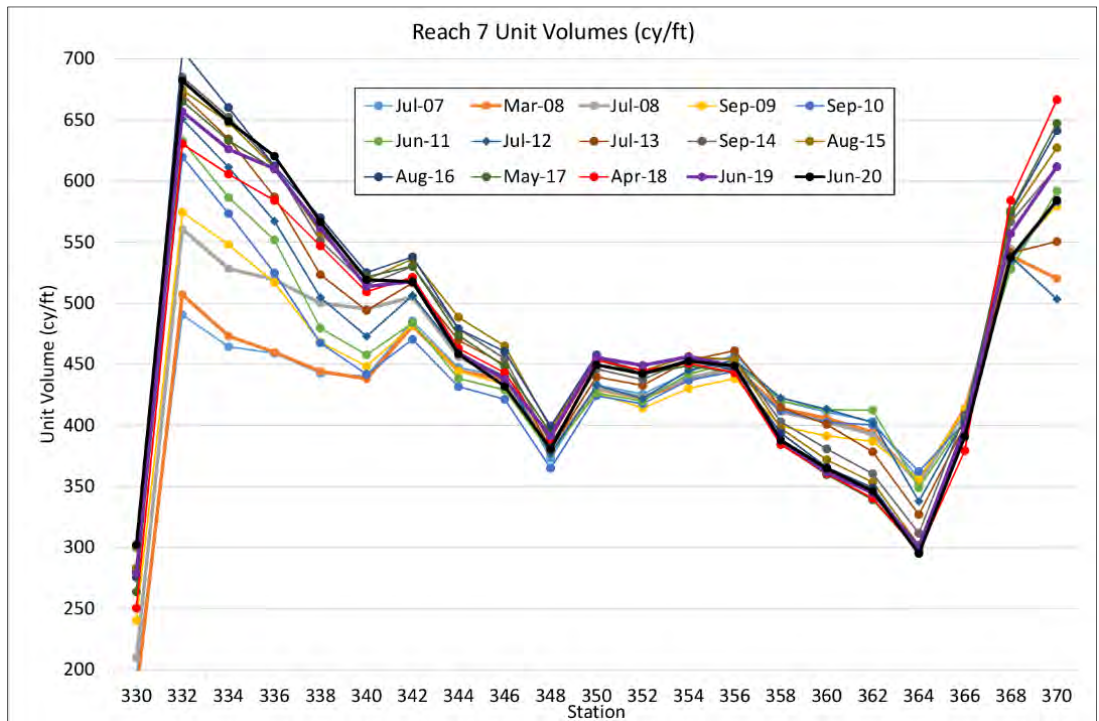
Reach 7 was essentially stable from 2019 to 2020, gaining 1,319 cy (0.3 cy/ft). The previous year, the reach gained 17,837 cy (4.5 cy/ft) of sand. Similar to 2018–2019 monitoring results, the seaward end of the reach was highly accretional, with profiles gaining over 50 cy/ft of sand due to spreading from the front beach. Only one profile located just seaward of the groin at the 17th tee measured erosion. Figure 4.6 shows the beach volume trends for the reach since 2007, with the upper figure showing the total reach volume and the lower figure showing the volume history for each monitoring line. Figure 4.7 provides beach profiles and representative photos of the reach in 2020. Profiles from the seaward end of the reach (ie – Station 332) show substantial growth of the dry sand berm from 2018 to 2020, with the area gaining approximately 150 ft in width and increasing in elevation. Stations

**FIGURE 4.6.** [UPPER] Total beach volume in Reach 7 since 2007. [LOWER] Profile unit volumes for each monitoring line in Reach 7.

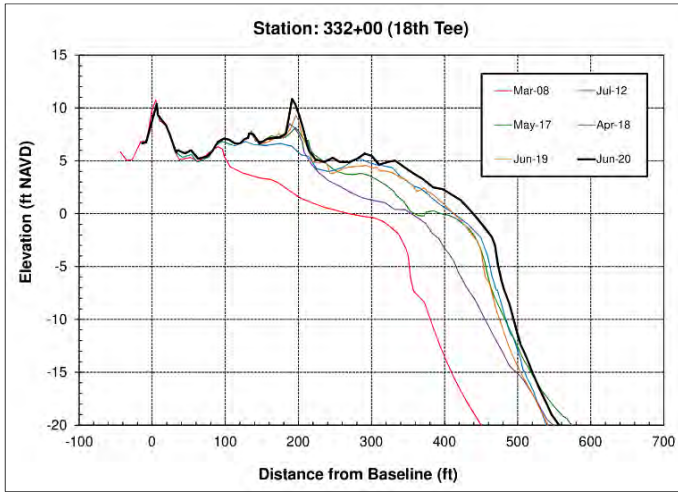
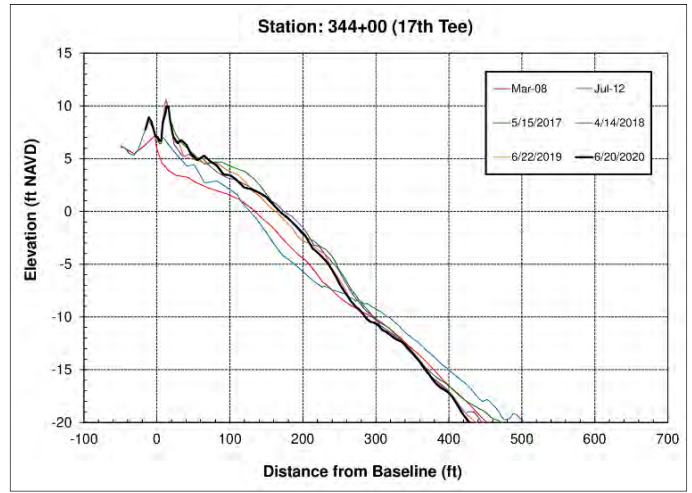
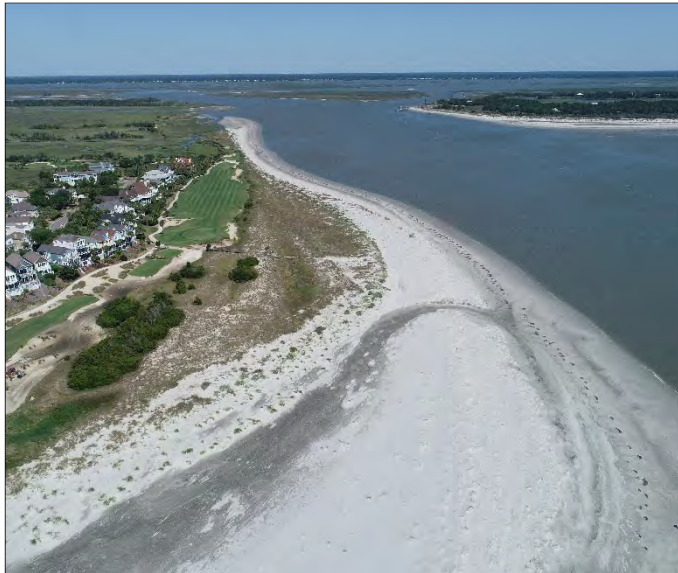
**FIGURE 4.7.**  
Beach profiles and photos from Reach 7.

Ground photos are from stations 334 (bottom left) looking landward and 350 looking seaward (bottom right) in June 2020.

Aerial photo (center left) of Reach 7 is from May 2020.

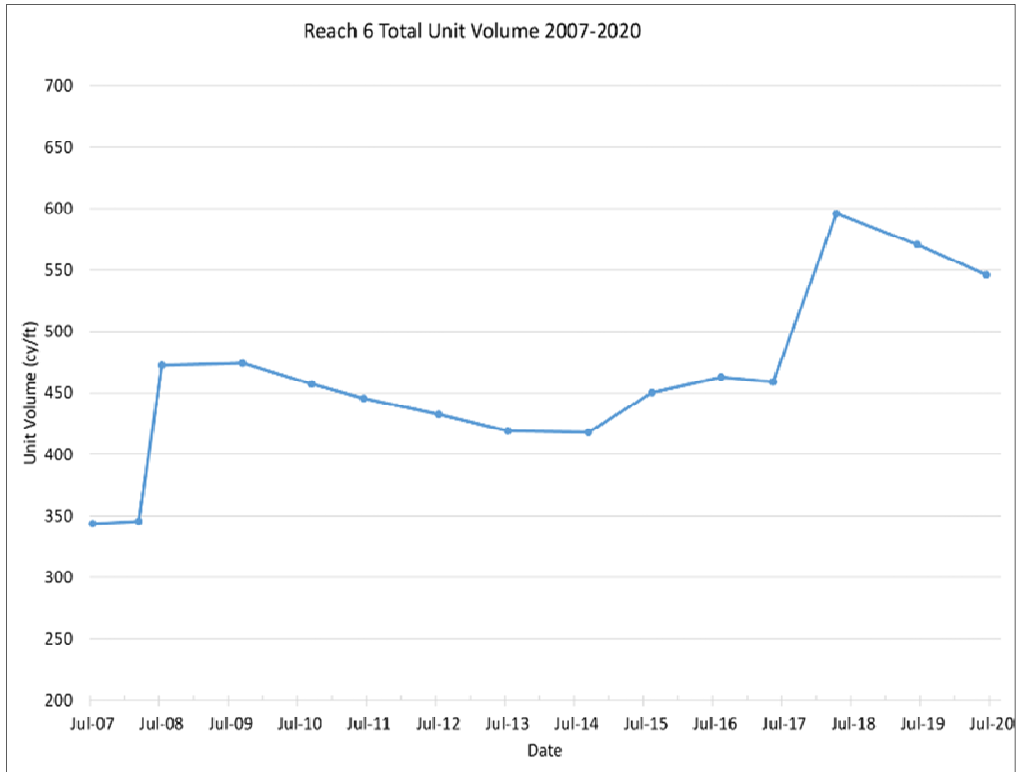
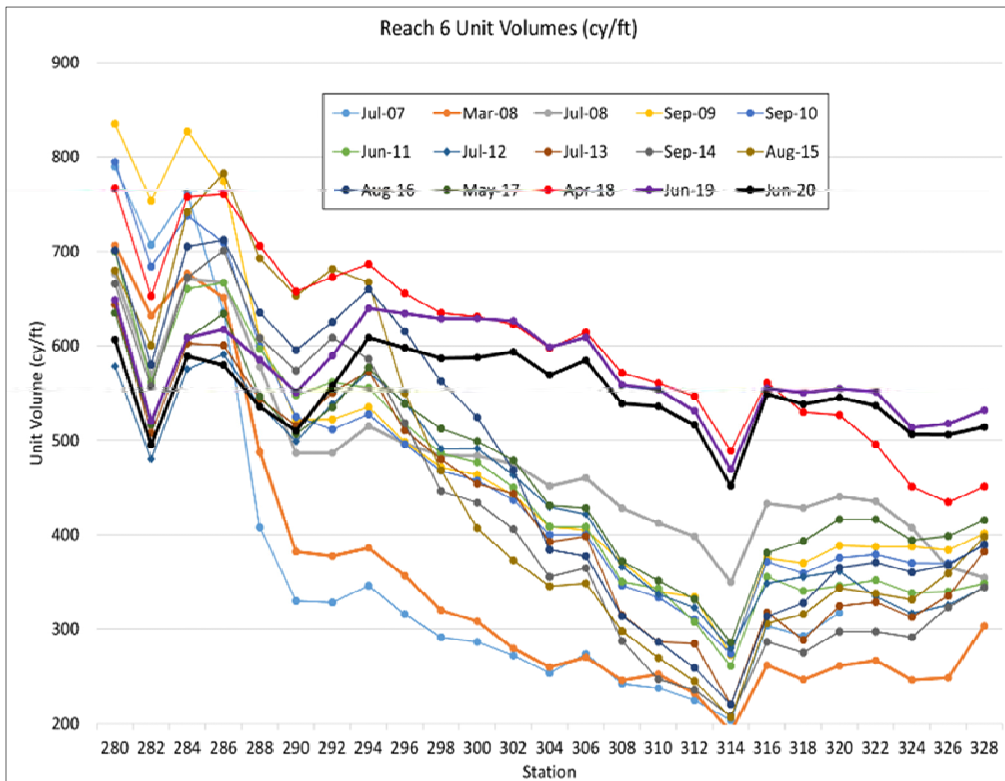
Reach 6 showed similar erosion from 2019–2020 as it did from 2018–2019. From April 2018 to June 2019, Reach 6 lost 123,000 cy (25.1 cy/ft), and this reach lost 120,183 cy (24.5 cy/ft) over the past year. The erosion pattern within the reach differed from last year, with significant erosion along the western end of the reach (Beach Club Villas, Mariners Walk) and accretion of the eastern end. From 2019–2020, erosion was spread more consistently throughout the reach, with every station in the reach measuring erosion. Erosion values ranged from -5.8 cy/ft to -49.8 cy/ft.

Beach profiles from within the reach reflect the volume trends, with the west end showing a loss of ~50 linear feet (lf) and the east end losing ~25 ft (Figure 4.9). Throughout the reach, the berm elevation remains close to the +6 ft design elevation; however, along the seaward edge of the berm, the elevation tends to increase from washover deposits. Dune growth is evident along the landward end of the nourishment berm at many stations within the reach. While some stations near Beach Club Villas (stations 280–288) show a net reduction in volume compared to the pre-project (2017) condition, the beach remains wider than in 2017. Volume losses are mostly due to changes in the offshore sand volume beyond the recreational beach.

**FIGURE 4.9.** [UPPER] Total beach volume in Reach 6 since 2007. [LOWER] Profile unit volumes for each monitoring line in Reach 6.

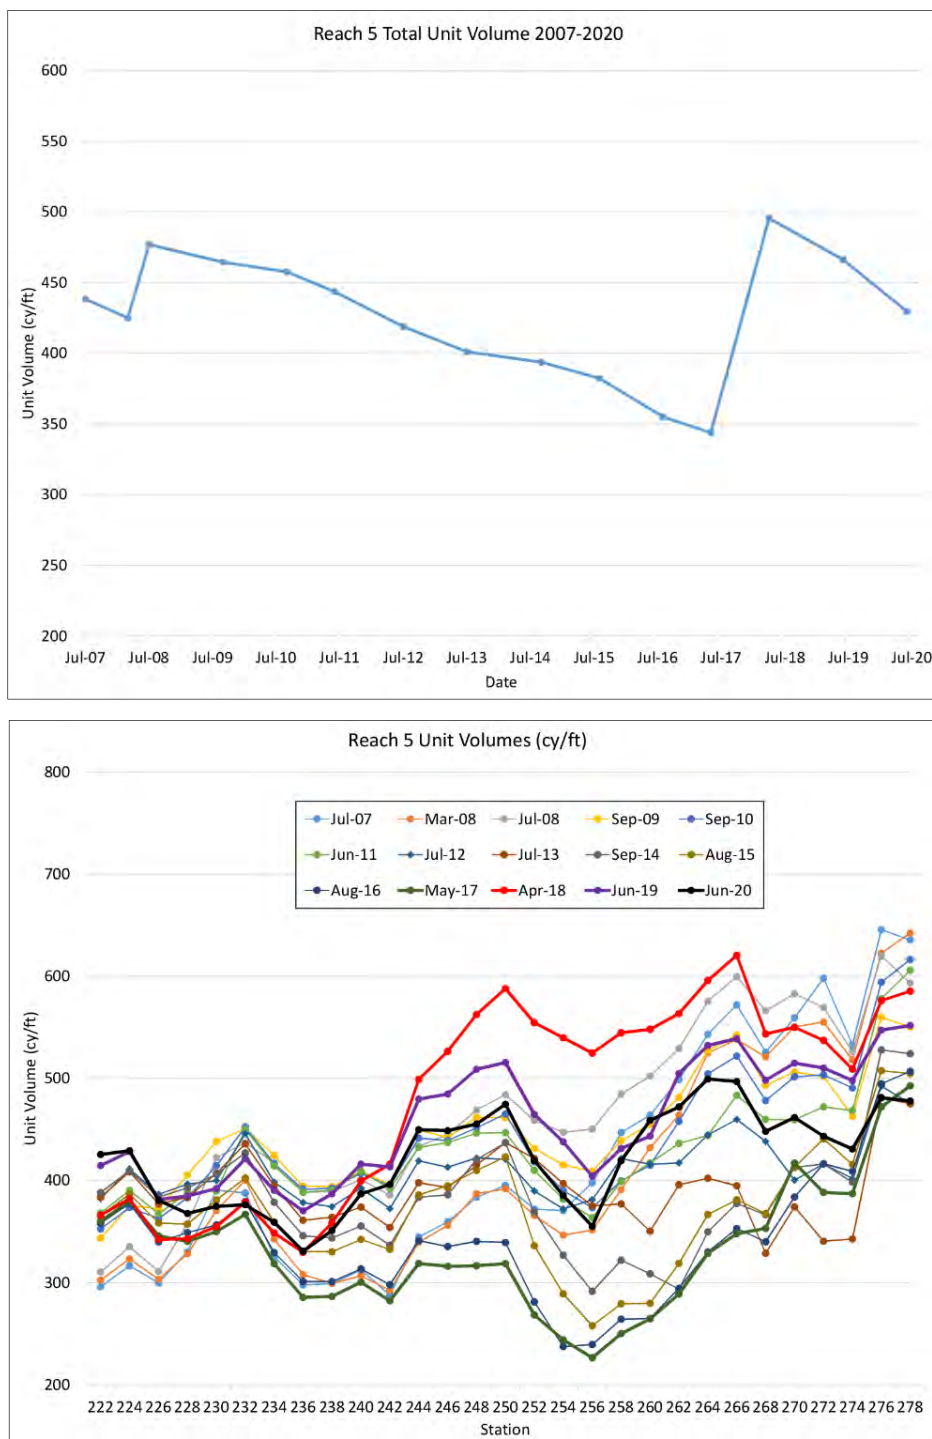
Reach 5 gained 909,000 cy of sand (151 cy/ft) from 2017 to 2018 (including nourishment and background changes – Figure 4.14). This was nearly three times the volume added during the 2008 project. Beach width increased by over 500 ft in some locations, and like Reach 6, a dune was constructed as part of the nourishment design. The City installed dune vegetation and sand fencing to promote natural dune building.

The reach lost 176,000 cy (29.4 cy/ft) of sand between April 2018 and June 2019 and an additional 219,000 cy (36.5 cy/ft) from 2019–2020. Over the past year, erosion was more consistent than typical throughout the reach compared to other years. The magnitude was higher along the eastern part of the reach, with stations 268–278 all losing more than 50 cy/ft, while the remainder of the reach generally showed losses less than 40 cy/ft. Figure 4.14 (lower) shows the profile volume record for Reach 5 since 2007. The difference between the red and black lines represents the 2019–2020 change. The position of the 2020 (black) line relative to the other dates provides an indication of how the present condition compares to earlier conditions. Overall, there has been a substantial loss of sand east of the Grand Pavilion (Station 248), though most of the area holds at least 100 cy/ft more sand

than the most eroded condition. At the very eastern end of the reach, near Beach Club Villas, the beach volume is near the lowest observed condition; however, as mentioned previously, the beach width is greater compared to earlier conditions. Volume losses have been mostly found in the underwater portion of the profile.

**FIGURE 4.14.** [UPPER] Total beach volume in Reach 5 since 2007. [LOWER] Profile unit volumes for each monitoring line in Reach 5.

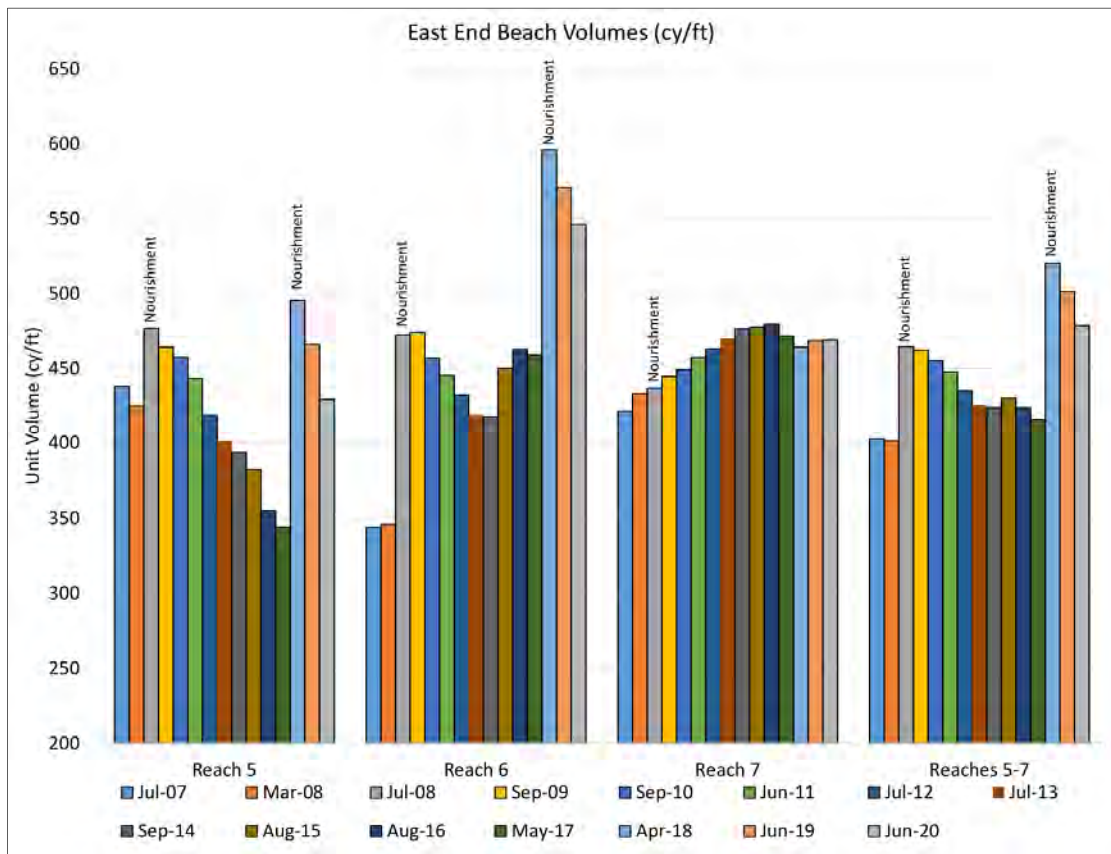
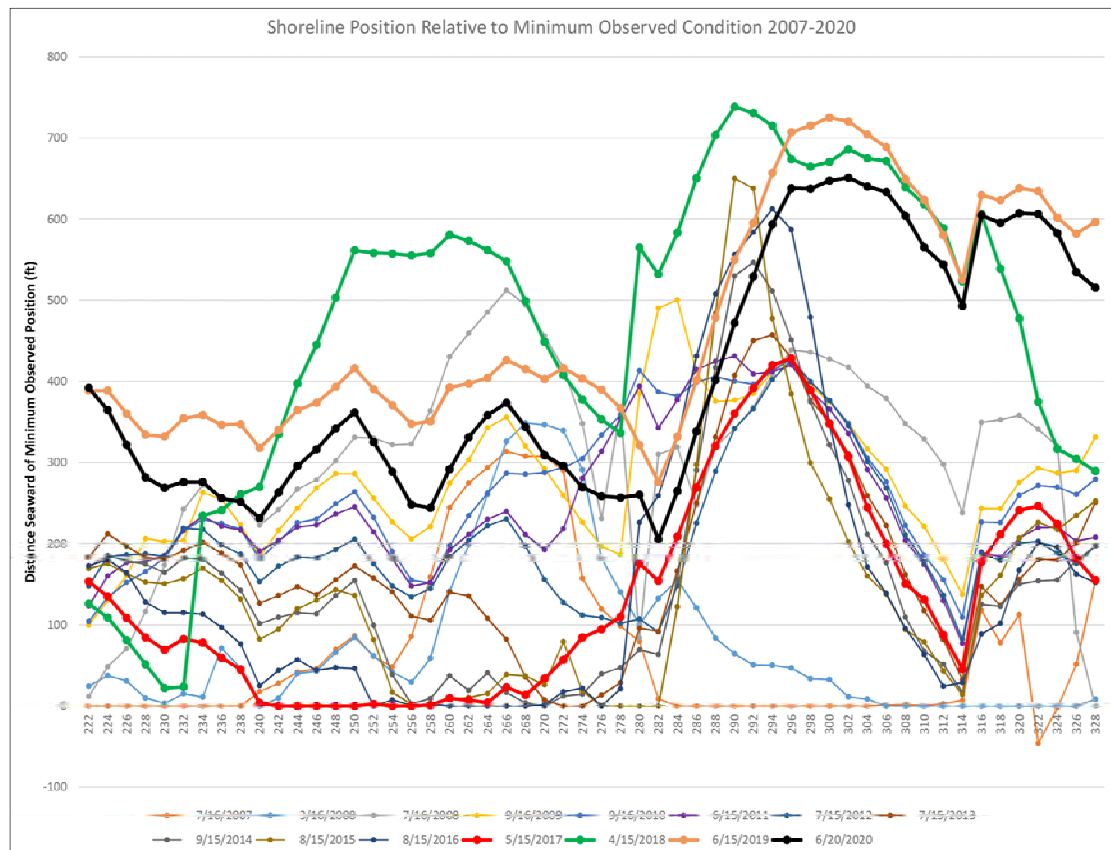
**FIGURE 4.17.** The beach volume history of the eastern end of the island since 2007, with dates following nourishment indicated

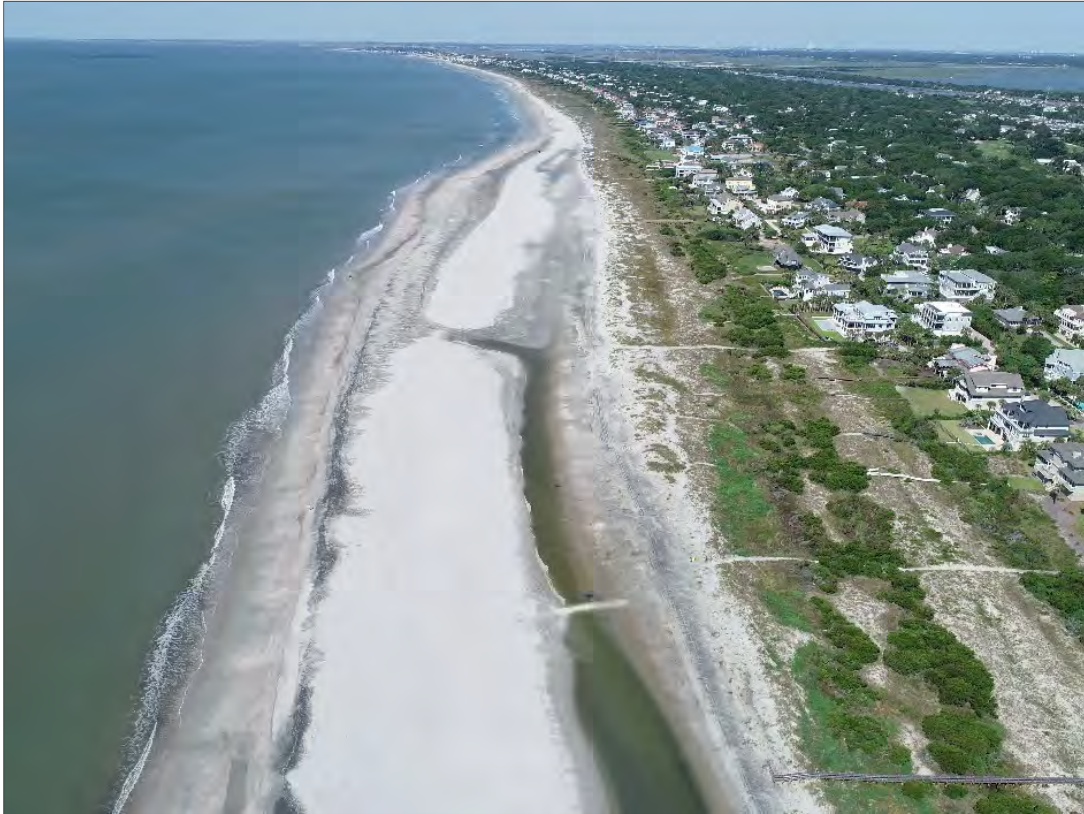
The accretional trend of the reach is fueled by sand moving from the east end of the island, with that sand originating from shoal bypass events or from nourishment. Following the 2018 project, CSE observed a significant influx of sand along the northern half of the reach. Profiles along the northern 2,000 lf of beach gained up to 66 cy/ft of sand from 2018–2019. This accretion resulted in a large ridge and runnel system along the wet sand beach and a shift of the dry sand berm over 200 ft seaward (Figure 4.20). Over the past year, the eastern end of the reach continued to accrete rapidly, with stations 190–220 gaining an average of 53 cy/ft. The western end of the reach was more stable, though an erosional area was present from station 3145 to 3150.

The erosion observed along the eastern end extended further to the west than the previous year, indicating that an accretional wave of spreading nourishment sand is moving towards the west. This results in increasing beach width and growing dunes along Reach 4. Even in the areas measuring net erosion (volume loss), the dry beach width increased, and dune growth was evident. Here, volume losses are occurring underwater and likely are a result of a ridge and runnel process migrating through the area. At Station 208 (48<sup>th</sup> Ave), the dry beach width increased by nearly 200 ft over the past year and is nearly 300 ft wider than the 2008 condition. The profile holds ~175 cy/ft more sand than in 2008. At the west end of the reach, Station 160 holds ~72 cy/ft more sand, and the dry beach is ~100 ft wider than in 2009.

**FIGURE 4.19.** By being positioned downdrift of the nourishment area, Reach 4 receives nourishment sand spreading from the placement area as well as spreading shoal sand. This reach has gained sand every year since 2009 except 2016.

Overall the reach gained 150,700 cy (19.1 cy/ft) of sand over the past year, which is approximately double the gains observed the previous year. The beach volume in Reach 4 has increased by over 660,000 cy since 2009, which is an average annual accretion rate of 7.8 cy/ft per year. The dune width has increased by at least 50 ft along the reach, not including the wider dry sand berm seaward of the dune. This level of accretion is of similar magnitude to many beach nourishment projects conducted along coastal communities in South Carolina and is equivalent to a \$10–12-million-dollar nourishment investment. The dune has grown ~3 ft in elevation and offers substantially more storm protection than the 2009 condition. CSE anticipates additional accretion over the next few years as more sand spreads from the 2018 project area.

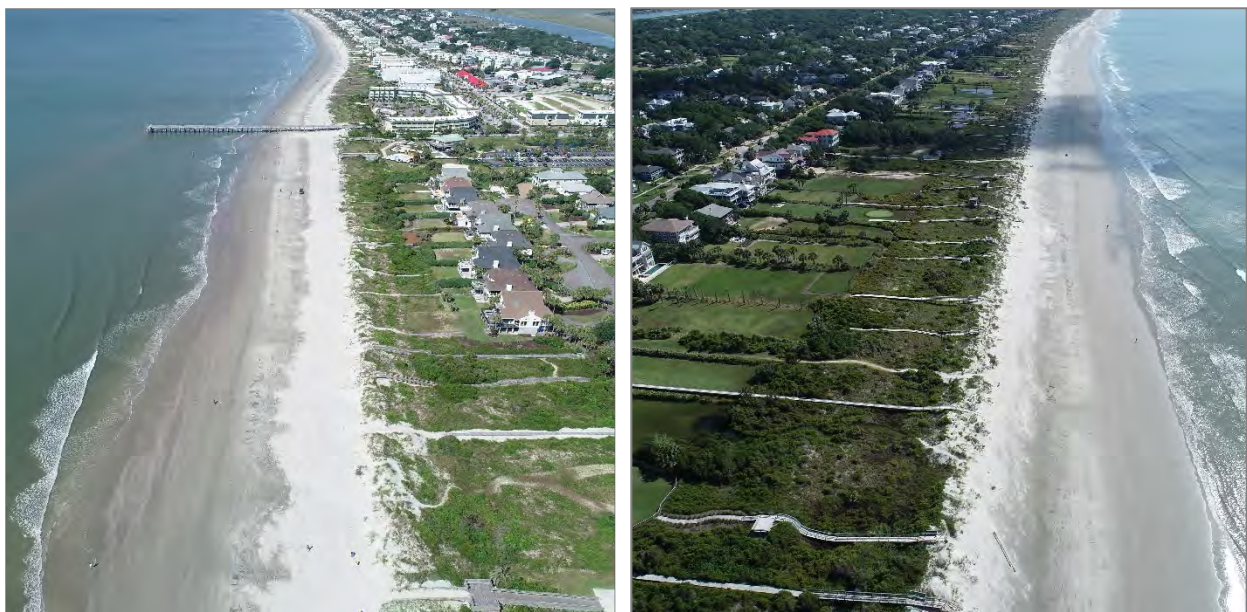
Reach 3 extends from the Sea Cabins Pier to 31st Avenue (OCRM monuments 3125 to 3140 – Fig 4.22 and Fig 4.23). Like Reach 4, the long-term trend in this area is stable to accretional. Dwellings in the reach are well set back from the beach, generally between 400 ft and 500 ft except at the western end where Sand Dune Lane and the county park are set back ~150 ft. The reach has shown periods of erosion and accretion since CSE began island-wide monitoring in 2009. This is typical for stable to moderately accretional beaches as variations in wave conditions from year to year and temporary changes in sediment supply lead to minor fluctuations in yearly volume change. Over the long term, the trend is accretion.

**FIGURE 4.23.** The long-term trend for Reach 3 is stable to accretional. Dwellings in the reach are generally set back from the beach between 400 ft and 500 ft.

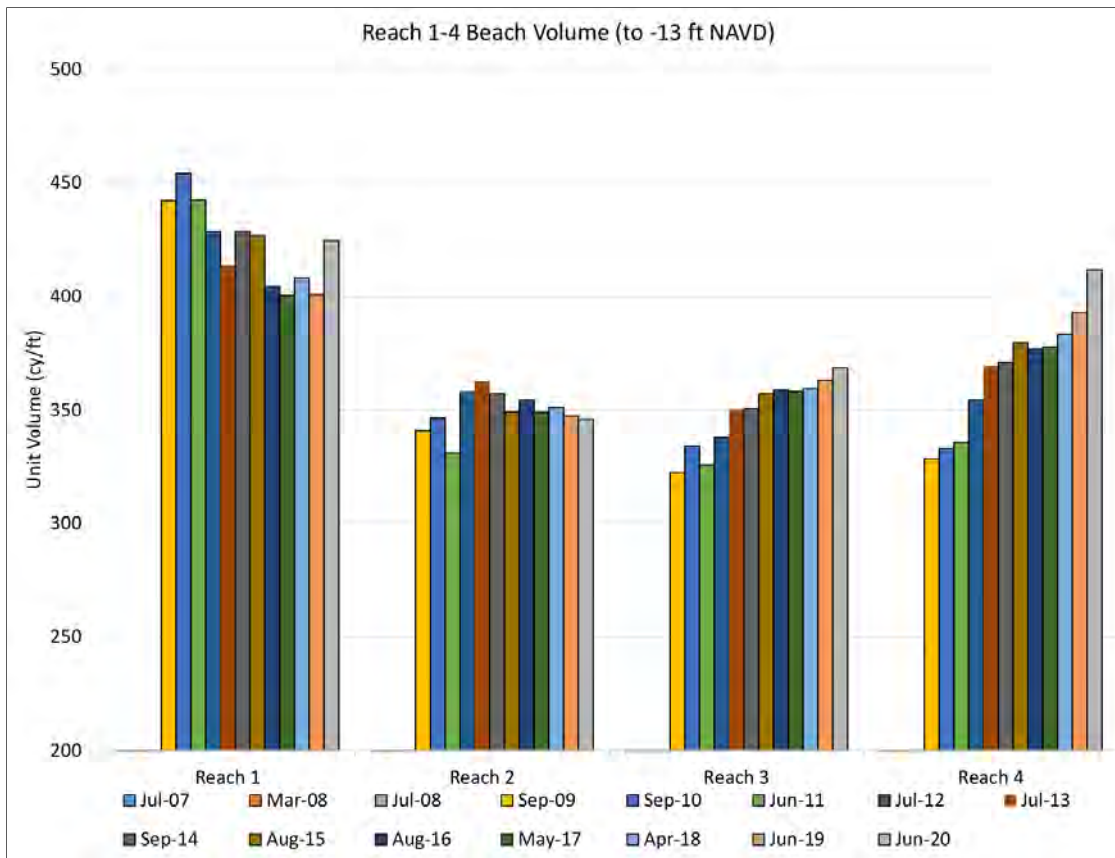
Overall the reach holds 260,000 cy (46 cy/ft) more sand than the 2009 condition, which is equivalent to an average annual accretion of 4.3 cy/ft per year. Figure 4.25 shows the accretional trend over the past decade. Photos of the reach in June 2020 show a recovering dune system with a significant dry sand beach seaward of the growing dune (Fig 4.24).

**FIGURE 4.25.** This graphic illustrates the accretional trend of Reaches 3 and 4 over the past decade.

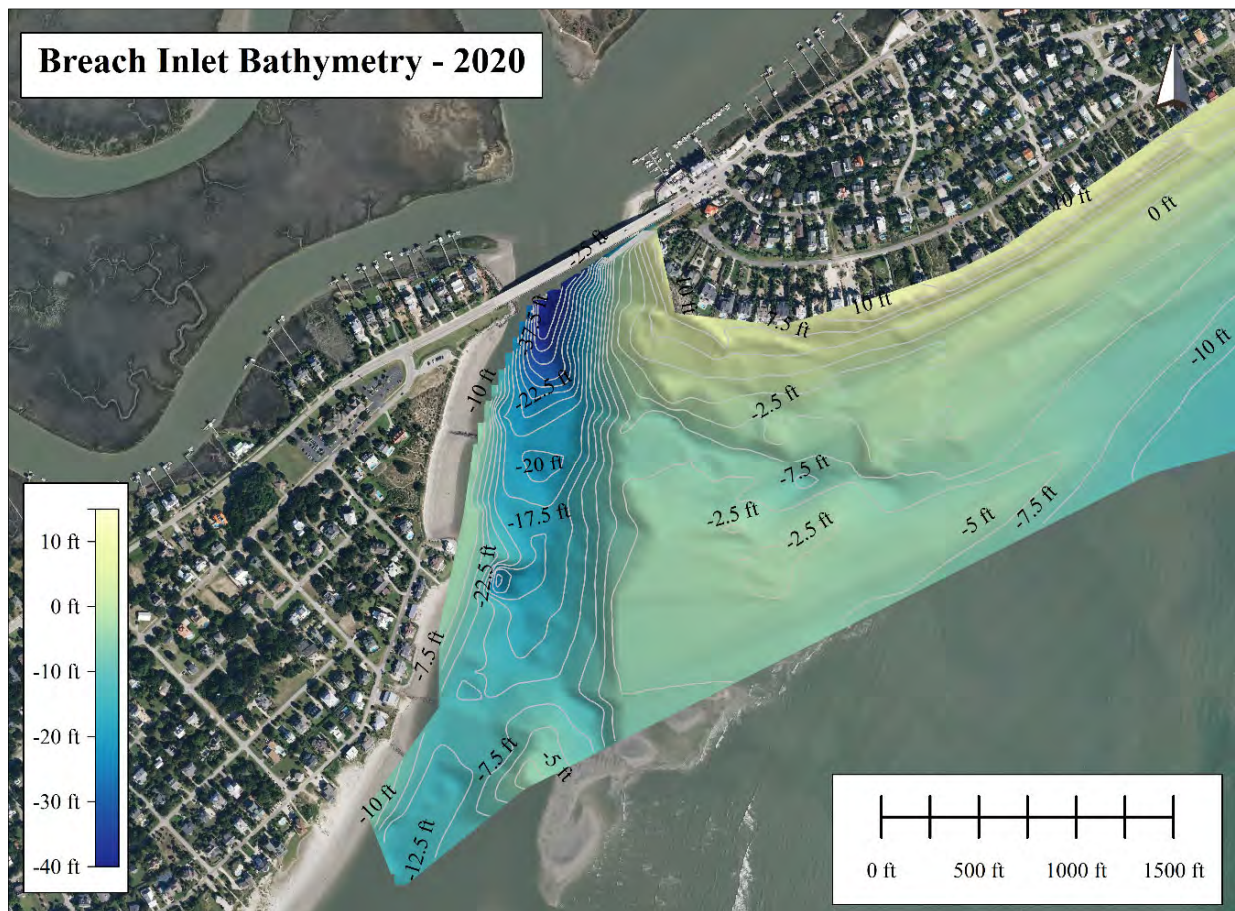
CSE obtained bathymetric data spanning the majority of the Breach Inlet channel and created a digital terrain model of the data, shown in Figure 4.32. The model shows a well-defined main channel abutting Sullivan’s Island. In 2019, there were no secondary channels present in the data coverage area; however, by June 2020, there was a distinct secondary channel oriented to the south. The channel was fairly far away from the Isle of Palms shoreline but may help encourage sand to accumulate along the IOP beach. This was predicted in last year's monitoring report and seems to have proven true based on the observed accretion along Breach Inlet over the past year. The other notable feature is the better developed marginal flood channel that sits just offshore of the Isle of Palms spit. This feature is formed from flood currents entering Breach Inlet and can impact the shoreline condition. It appears to be further offshore than previous years, which is likely also contributing to the observed accretion. The shifting channel morphology is a frequent occurrence at Breach Inlet and has contributed to the dynamic sediment gains and losses at both Isle of Palms and Sullivan’s Island. CSE will continue to monitor the configuration of the inlet to better infer the relationship between beach health and channel/delta morphology.

**FIGURE 4.32.** A digital terrain model spanning the majority of the Breach Inlet channel. The model shows a well-defined main channel abutting Sullivan’s Island, a smaller, secondary channel oriented to the south, and a well-developed marginal flood channel abutting the southern end of Isle of Palms.

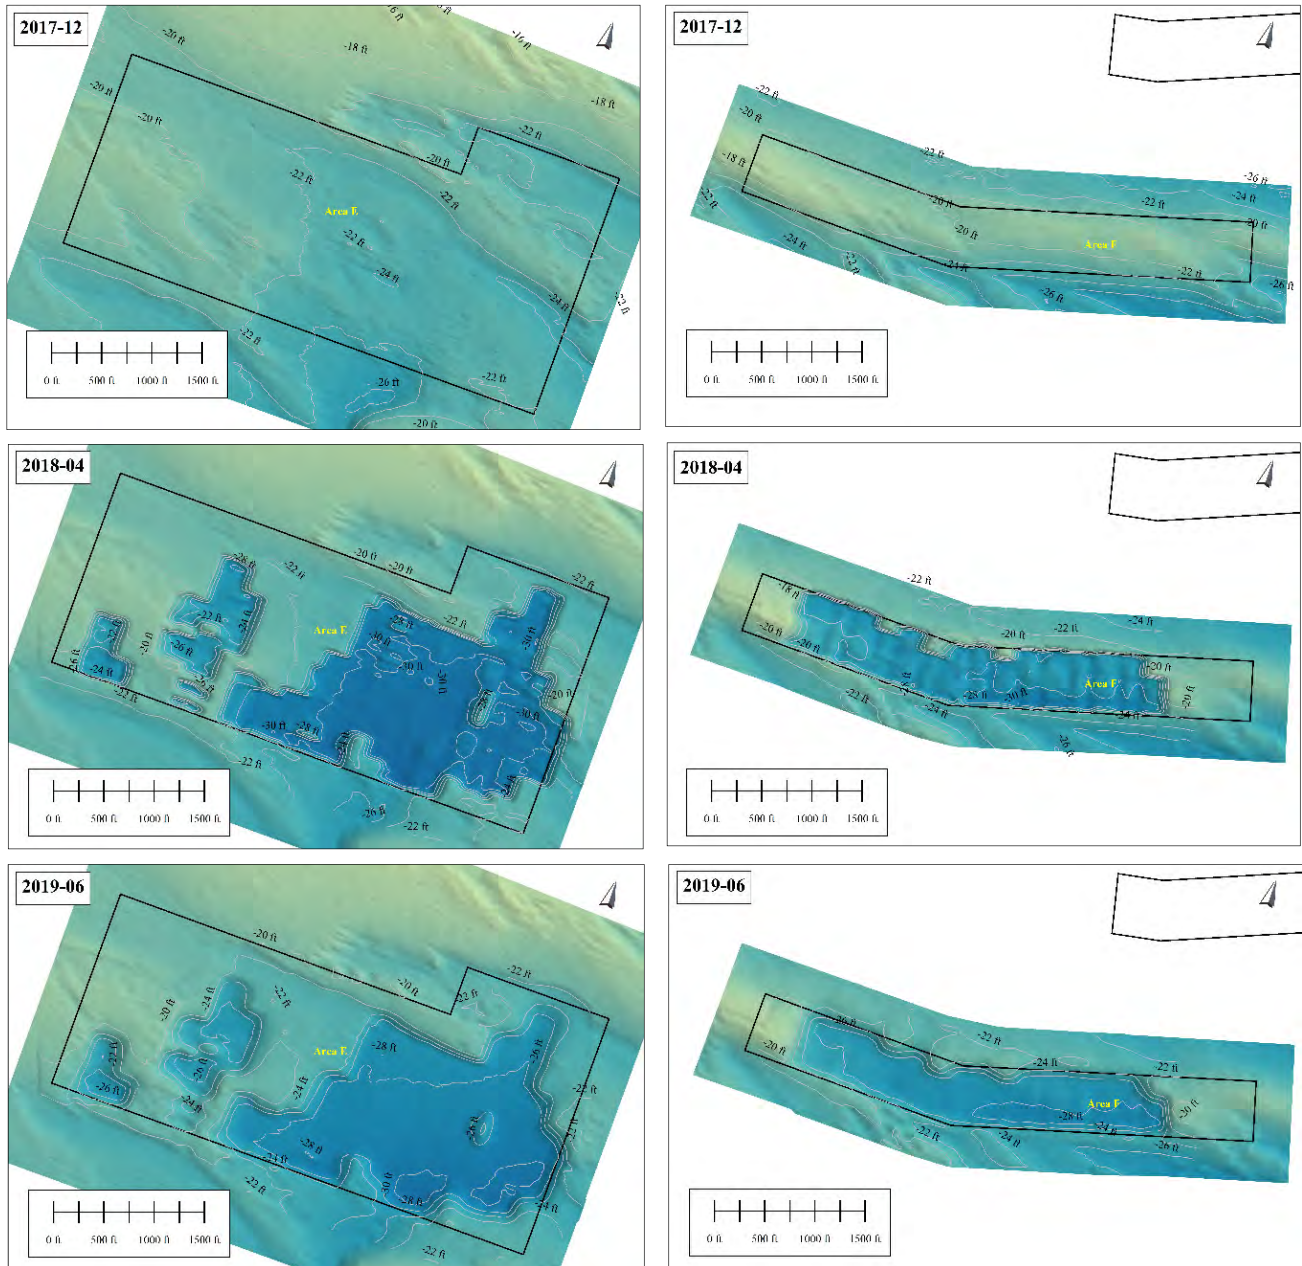
Per conditions of the permit for the 2018 nourishment project, the City is required to obtain bathymetric surveys of the borrow areas to monitor rates of infilling. CSE collected bathymetric data at 100 ft spacing over all dredged areas within permitted borrow areas E and F in June 2019. Data were used to generate digital terrain models of the borrow areas and compared to pre- and post-project surveys. Figure 5.1 shows the models for both borrow areas used in the project for each survey. The effects of the 2018 nourishment are clearly visible as the blue shaded colors in the elevation models. The 2018 post-project model shows a rough surface of the seafloor, which was generated by the arcing motion of the cutterhead during dredging. By 2019, the contours reveal a less rugged bathymetry as sediment shifted from high spots and infilled lower areas. Generally, the boundaries of the dredged areas showed erosion of the top of the slope and accretion along the foot of the slope.

Less infilling was observed in Area F, as the section's lines from 2018 and 2019 generally average a similar depth. The north/south section view shows the landward and seaward edges of the dredged area showed significant shifting of sand from the upper slope to the lower portion of the slope.

Borrow Area E gained 130,300 cy of sand from 2018 to 2019, which is ~10 percent of the volume removed during nourishment. Area F showed a further loss of sand, losing 23,000 cy from 2018–2019. Measured losses are due to erosion of the upper slopes of the borrow area boundary and potentially some landward movement of sediment from the measurement area. Also, for an area the size of the borrow area, a

volume of 23,000 cy represents a vertical elevation change of only two inches, which is within the accuracy limitations of survey equipment in this setting. Future surveys will allow for long-term trends to be more accurately determined if relative volume changes are low magnitude. Overall, the net volume change in the borrow areas was 107,290 cy, which is 5.5% of the dredged volume. Of note is that sufficient beach compatible sand infilled the 2008 borrow areas to allow for a portion of one of the dredge areas to be reused for the 2018 project (the central-southern portion of Area E). Over time, the offshore zone may prove to be a renewable borrow source for future projects.

**FIGURE 5.1.** Terrain models for both borrow areas used in the project for each survey.

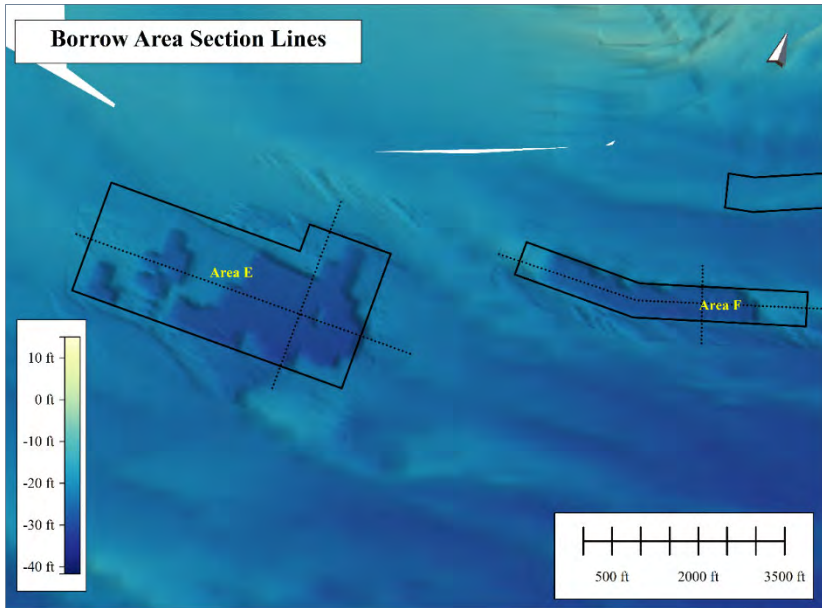
Figure 5.2 shows cross-sections of the borrow area bathymetry. At borrow area E, the sections show ~2 ft of infilling along the north/south section line, except at the southern (seaward) end of the area. Some erosion of the upper boundaries of the side slopes is also evident, with up to one foot of loss along the landward slope. The west-to-east section shows limited infilling of the small area dredged along the western half of the borrow area and ~2 ft of infilling along the eastern half of the area. Of note is a small mound that was not dredged along the eastern end of the area showed flattening, as would be expected.

**FIGURE 5.2.** Cross-sections of the borrow area bathymetry for Borrow Area E and Borrow Area F.
