# 2018 Isle of Palms Restoration Project

## Year 2 (2020) Monitoring Report Annual Beach and Inshore Surveys

[2492YR2 — Monitoring Year 2]

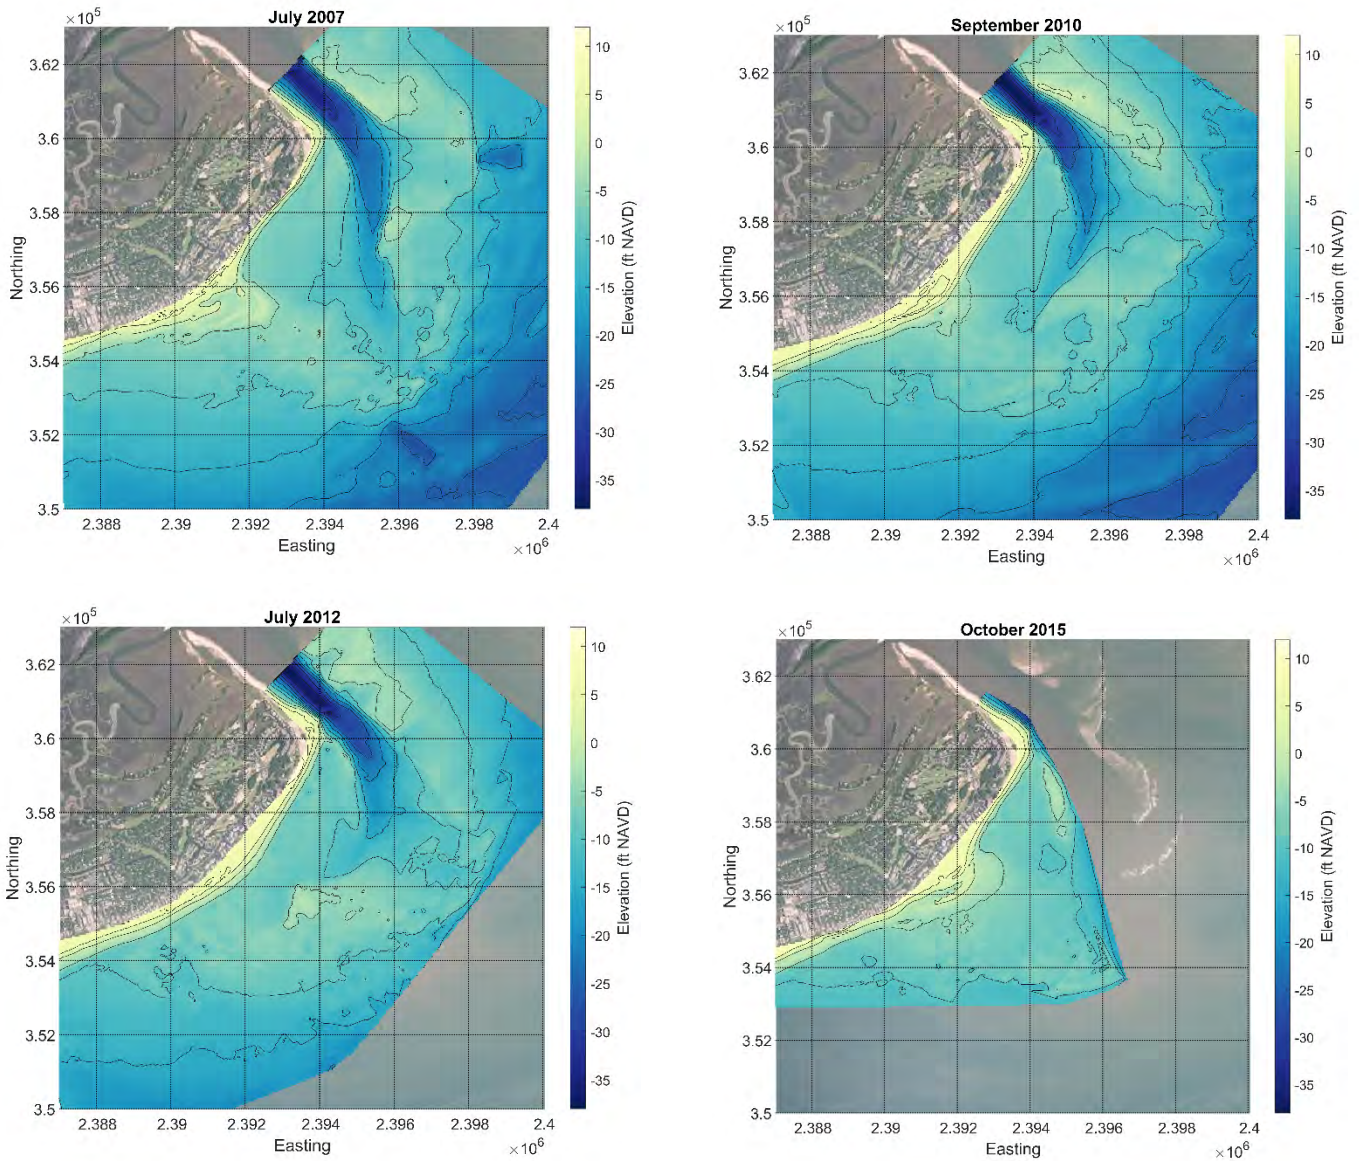
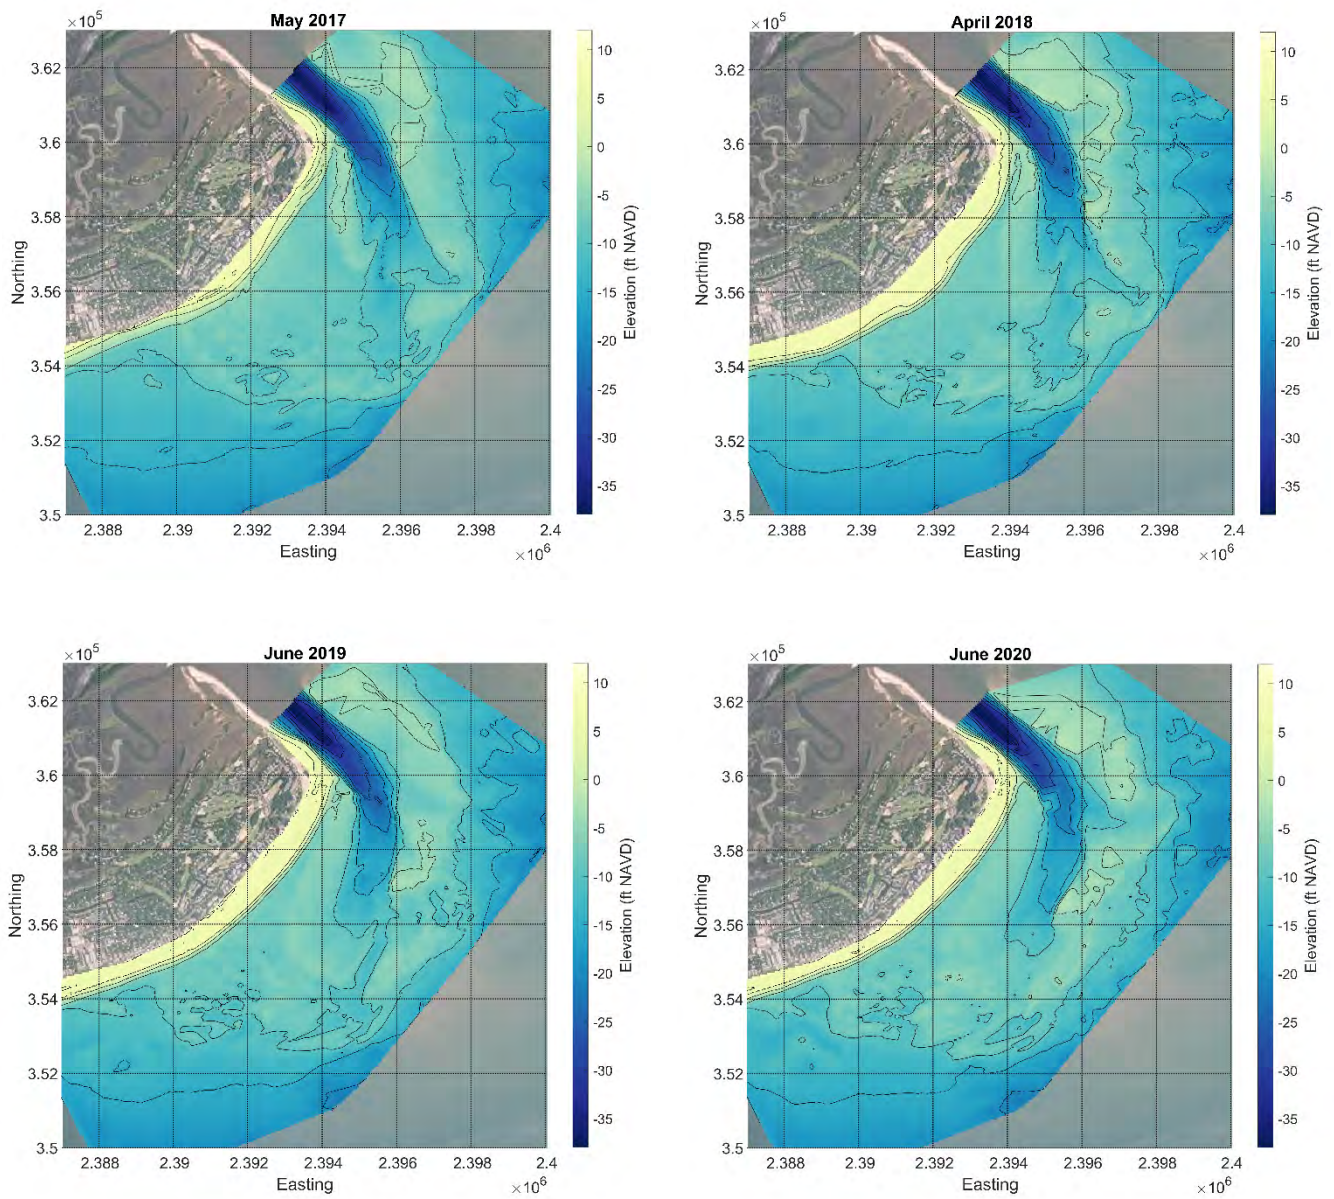
Figure 6.1 shows selected models of the Dewees Inlet delta since 2007. The 2019 monitoring report discussed the importance of the trailing ebb spit and how it acts to trap sand along the northeast end of the island. CSE has been monitoring the spit and predicting that at some point, it would merge with the beach. Over the past year, the spit has begun to merge with the low tide beach, as was discussed in Section 4. The attachment is closer to the beach at the northeast end of the island and tapers further offshore to a point where it merges with the terminus of the Dewees Inlet delta lobe near Beach Club Villas.

While the net volume increase will be a positive result, shoal-induced erosion of localized areas may be significant and needs to be monitored closely. As mentioned previously, the two large-scale nourishment projects have increased the total volume of sand within the beach and delta system at

**FIGURE 6.1. (page 1 of 2)** Selected models of the Dewees Inlet delta since 2007. Although the main channel is currently in a location similar to the 2007 condition, there are substantial differences in the delta — most notably is the existence of a significant sand body connected to the northeast end of the island called a “trailing ebb spit.”
