**Beach Preservation Ad Hoc Committee
9:00 a.m., Friday, September 6, 2024
City Hall Council Chambers
1207 Palm Boulevard, Isle of Palms, SC 29451**

Beach Preservation Ad Hoc Committee
Recommendation Considerations
July 12, 2024

Isle of Palms Beach Management Planning Scenarios

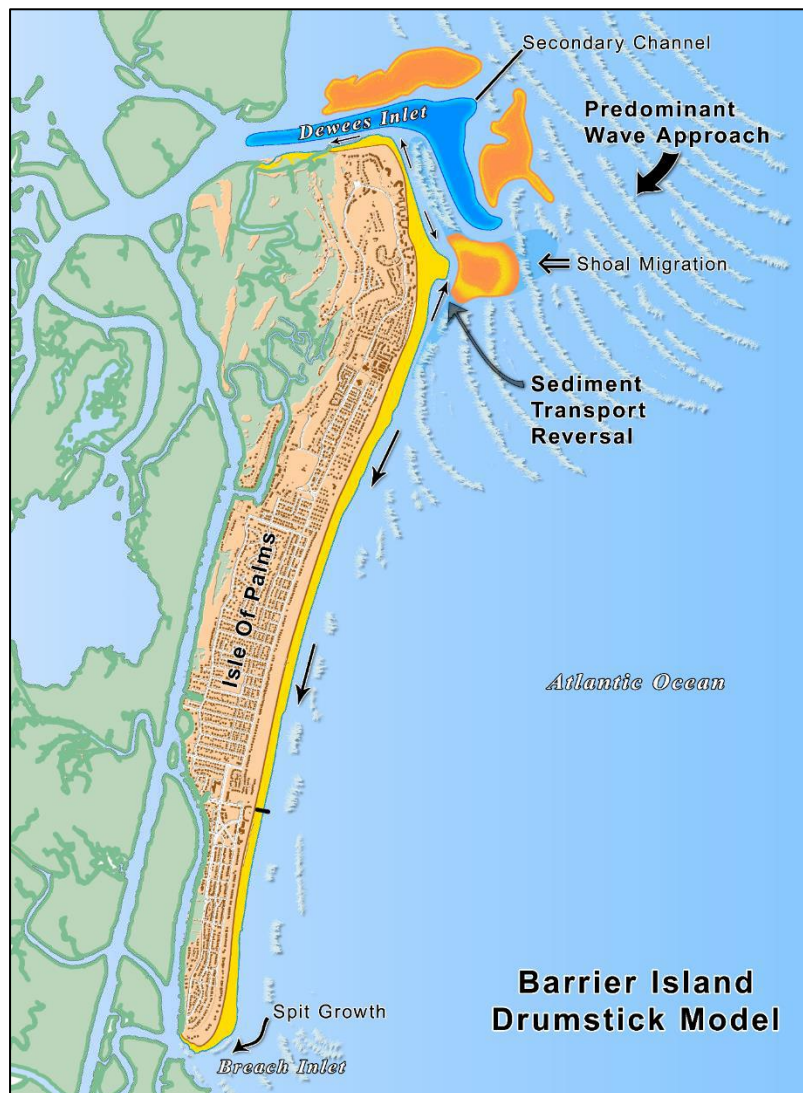
FIGURE 1. "Drumstick" barrier island model developed from Hayes (1979).

Isle of Palms (IOP) is a classic “drumstick” barrier island (Hayes 1979), with a bulbous updrift end at the northeast, and a narrow recurve spit on the southwest (Figure 1). Generally, sand comes to the island via shoal bypassing at Dewees Inlet and then migrates south, maintaining a historically stable shoreline along the central portion of the island. Sand eventually accumulates along the southern spit of the island and then into the shoals of Breach Inlet. The shorelines near the inlets are highly dynamic and are classified as “unstabilized inlet erosion zones” by SCDHEC–OCRM due to the episodic fluctuations in the shorelines. Figure 2 provides a map of the monitoring stations referenced herein.

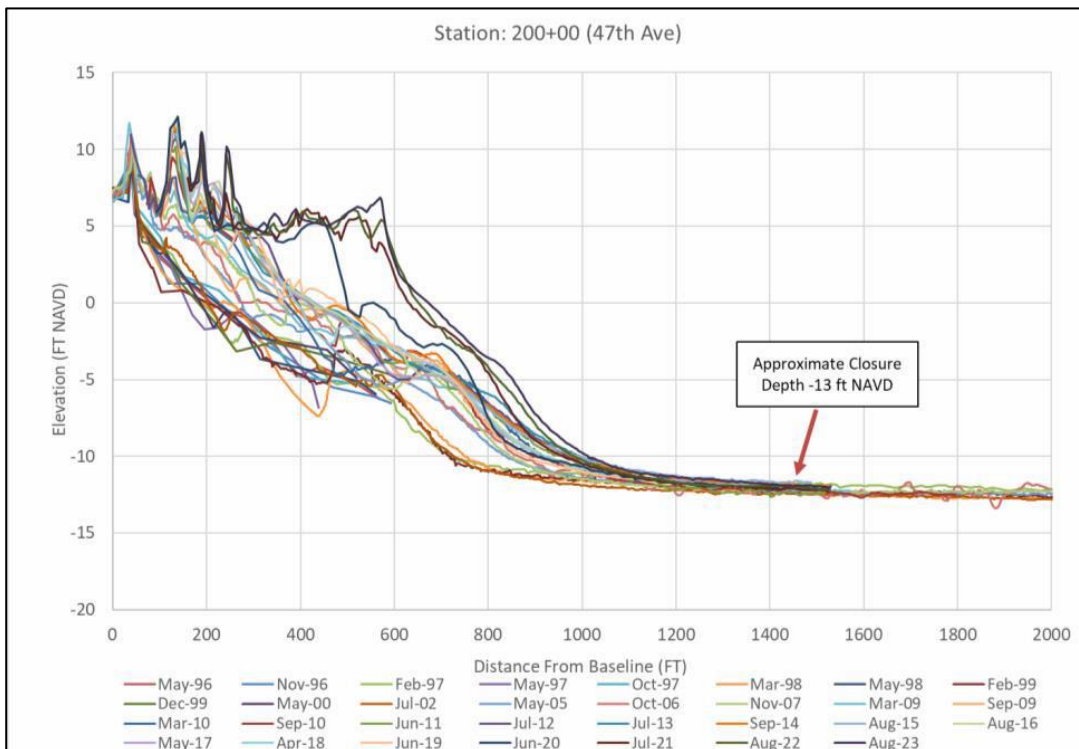
FIGURE 3. Example of "Closure Depth" at Isle of Palms. Repetitive surveys eventually overlap near -13 ft NAVD, which is considered the limit of measurable profile change.

The condition of the beach is determined by the volume of sand in the beach profile. This includes all sand between the reference line along the landward boundary and a point offshore where little or no measurable elevation change occurs. The landward boundary can be at the crest of the primary dune or from a point of significance, such as a structure. For developed beaches, the beach volume seaward of structures is typically the main interest. The seaward boundary is referred to as the “closure depth,” and is a unique depth for every beach determined by sediment grain size, tide, and wave climate. Larger waves increase the depth of closure as the higher energy allows sand to be moved at greater depths. At Isle of Palms, the typical depth of closure is ~-13 ft NAVD (note 0 ft NAVD is approximately equal to mean sea level) (Figure 3).

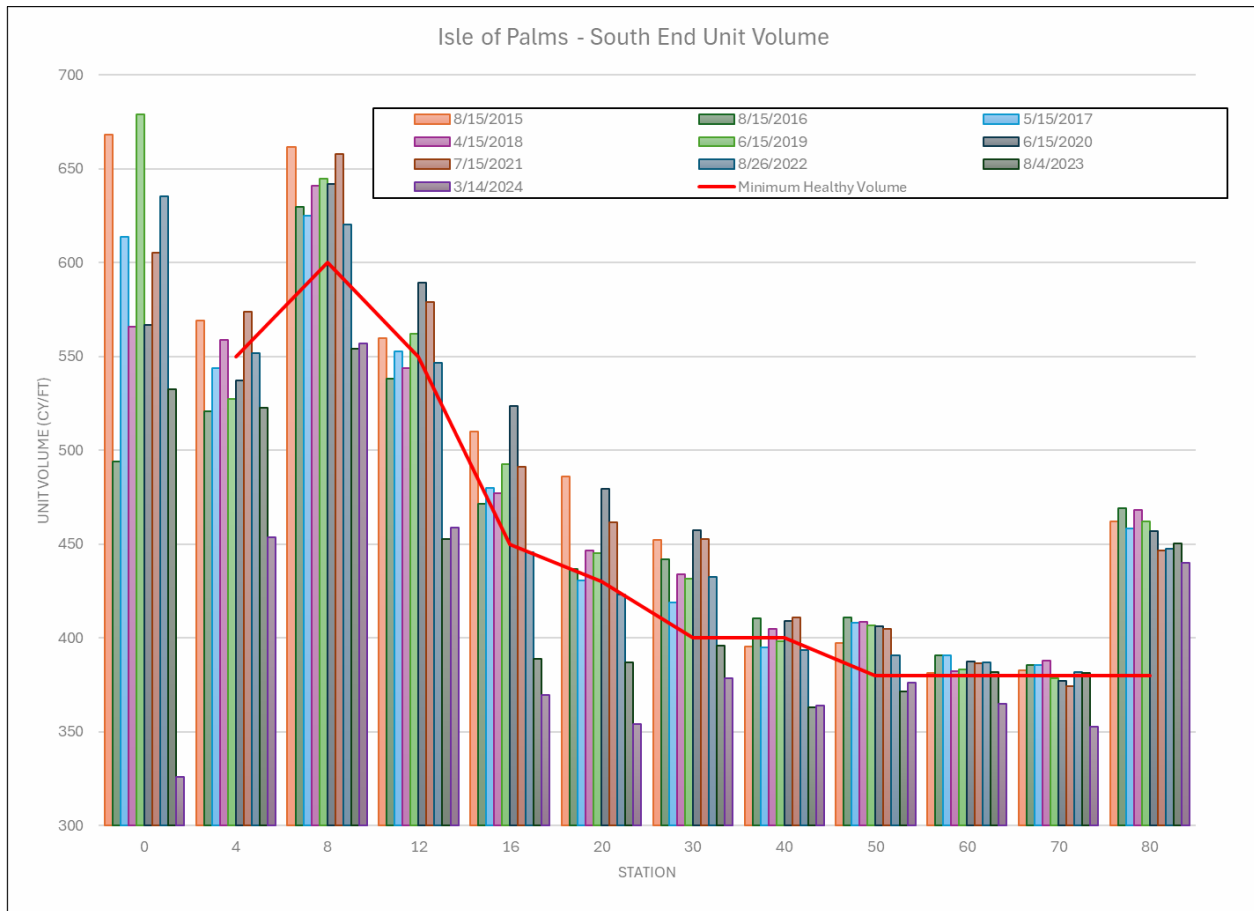
FIGURE 6. Beach Unit Volumes for the southern area of Isle of Palms. The local minimum healthy beach condition is shown in red. Note the dynamic trend south (left) of station 50 due to effects of Breach Inlet. Volume trends become more consistent away from the inlet (Stations 50–80).

Figure 6 shows unit volumes for monitoring stations along the southern end of IOP since 2015. The bars show the beach volume for each year at each station, and the variability in erosion and accretion trends is apparent through 2021. Beginning in 2022, an erosional event was beginning, decreasing beach volumes at stations south of 50+00. The erosion accelerated from 2022–2023, leaving stations 8+00–50+00 (Breach Inlet to 6th Ave) below the healthy beach condition. Additional erosion was present in many stations as of March 2024.

The data in Figure 6 are useful in trying to predict future volume change where erosional patterns are generally consistent. It is more difficult to predict when a beach may reach the minimum healthy volume when erosion patterns vary, as in the case of the south end of IOP. Volumes fluctuate up and down from year to year before falling off dramatically in 2023. Figure 7 shows a similar graphic from beach monitoring at Edisto Beach, SC. Here, the areas represented by Reaches 1–4 are the main project area and show relatively consistent erosion trends since the last nourishment was constructed in 2017. This makes forecasting future beach conditions easier, as annual losses can be projected with more confidence.
